The Behavior of Retaining Walls Under 1999 Chi-Chi Earthquake

THE BEHAVIOR OF RETAINING WALLS UNDER 1999 CHI-CHI EARTHQUAKE

Yung-Show Fang, Tsang-Jiang Chen, Yu-Chih Yang and Cheng-Chieh Tang
National Chiao Tung University
Hsinchu, Taiwan, ROC, 30010

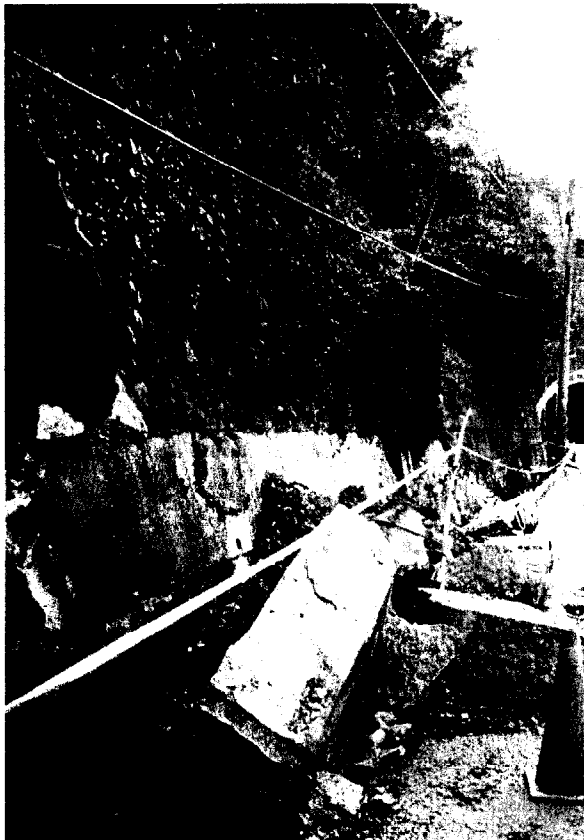
Fig. 3. Sliding and falling of gravity wall.

The failure of a gravity wall located near the entrance of Gan-Lin tunnel (Site 1) is shown in Fig. 3. The upper part of the 1.8 m-high wall slid along the construction joint during the earthquake, and eventually fell down to the ground. It is possible that the frictional resistance at the flat construction joint was not sufficient to resist the dynamic earth pressure and the inertia force of the upper part of the wall. It is also

possible that lateral spreading of the uphill slope as a result of earthquake shaking helped to push the wall to slide. About two months after the earthquake, the damaged wall had been repaired. Shearing reinforcements were fabricated at the construction joint as indicated in Fig. 4. Steel H-piles were driven to resist earth pressure during construction. The repaired wall is illustrated in Fig. 5. A shearing key would be another efficient method to prevent sliding at the construction joint.

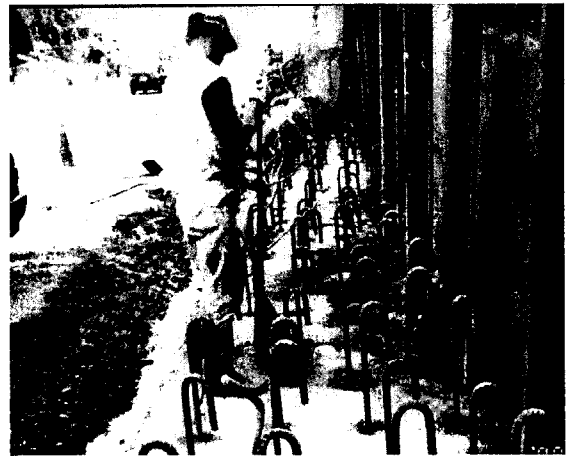
Fig. 4. Shearing reinforcement at construction joint.

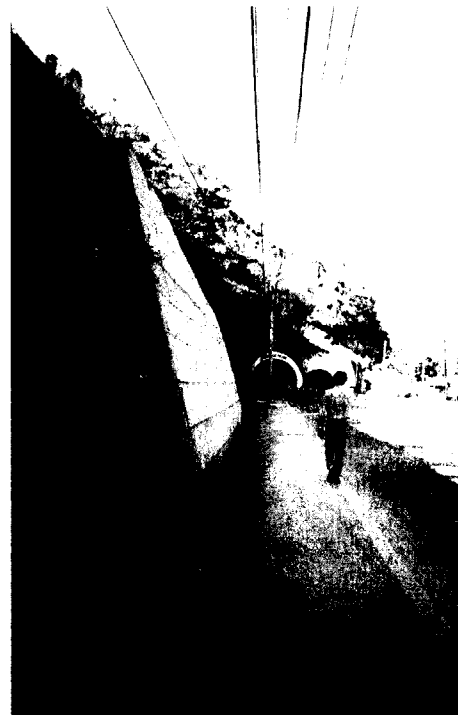
Fig. 5. Repaired gravity wall.

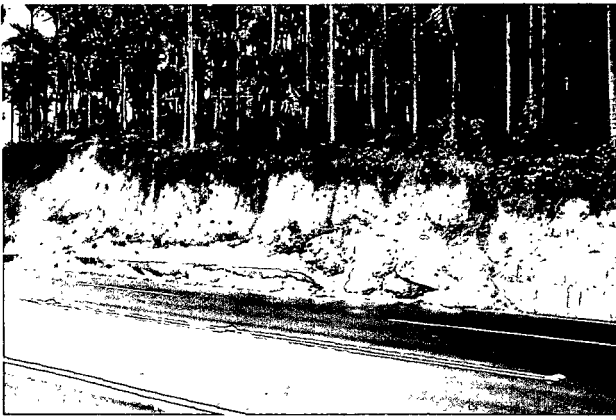
Fig. 6. *Overturning failure of gravity wall.*

The overturning of a gravity wall located near Tou-Sheh (Site 2) is shown in Fig. 6. The wall is 2.5 m-high, 0.6 m-thick, and the length of collapse is about 40 m-long. Weep holes with diameters of 80 mm, spaced 2.5 m-apart were fabricated on the wall. It can be observed in Fig. 1 that Site 2 is quite close to the epicenter of the Chi-Chi earthquake. The horizontal PGA measured at the nearby seismograph TCU-078 was 440 gal (0.45 g). The unexpected strong ground shaking is probably the main cause of the overturning. Insufficient bearing capacity of the ground below the toe would be another possible reason for the wall to overturn. The repaired wall is indicated in Fig. 7. Seed and Whitman (1970) have mentioned that, as can be observed in

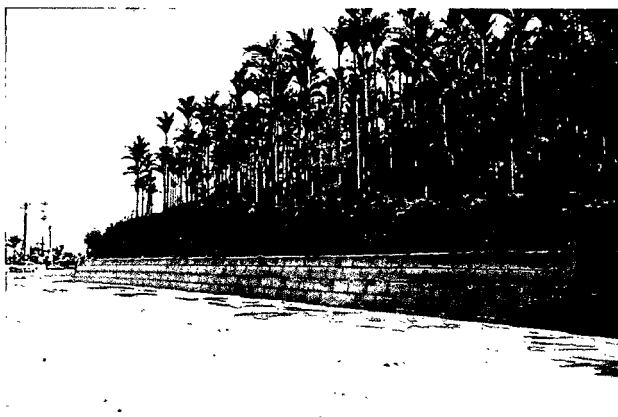
Fig. 7. *Repaired retaining wall.*

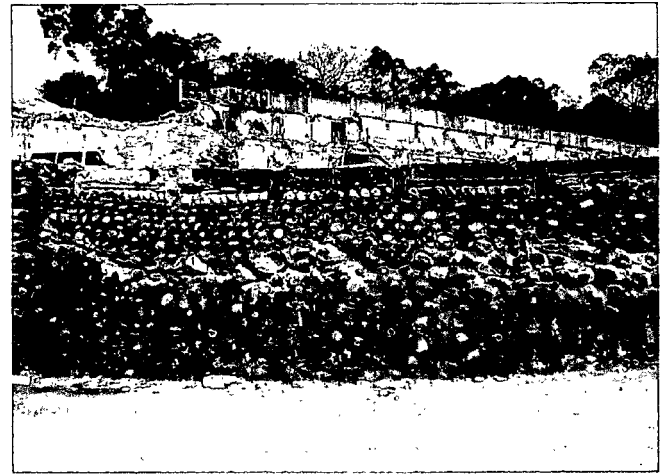
Fig. 8. *Shearing failure on a masonry wall.*

The horizontal shear rupture of a masonry wall located at the Temple of Ten-thousand Buddha (Site 3) is shown in Fig. 8. The wall is made of 0.25 to 0.30 m-diameter cobbles cemented with mortar. After the Chi-Chi earthquake, the upper part of the wall shifted outward with respect to its lower part for about 0.2 m. It is clear in Fig. 9 that the weak mortar among cobble particles actually disintegrated. However, the high-strength cobble particles remained intact. During the earthquake, the Che-Lung-Pu fault cut through its path. The horizontal PGA measured at seismograph TCU-065 was 774 gal (0.79 g). Apparently, the weak mortar among the cobble particles was not strong enough to resist the dynamic earth pressure and the inertia effect as a result of ground shaking. It should be mentioned that the use of masonry retaining walls had been abandoned by the Taiwan Highway Bureau about 15 years ago.

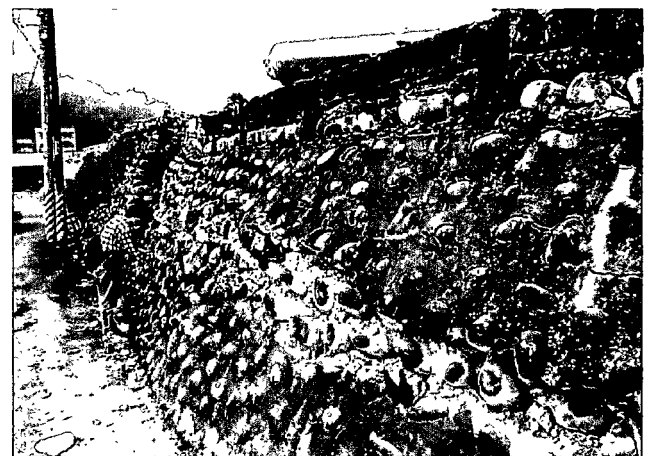
Fig. 9. *Disintegration of weak mortar among cobble particles.*

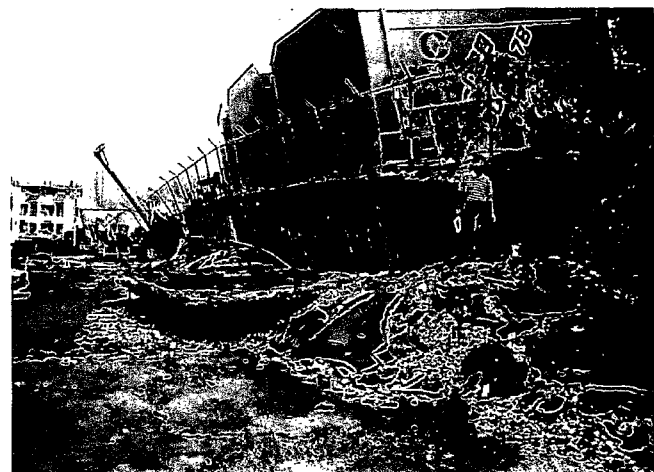
Fig. 11. Wall movement due to fault rupture.

Fig. 11 shows the failure of a gravity wall located at the Cinema Culture Town (Site 4). The wall sits right above the Che-Lung-Pu fault. During the earthquake, the fault rupture caused the wall to slide and overturn. The ground in front of the toe heaved, and the backfill behind the wall subsided and cracked. The buildings constructed on the backfill were severely damaged by the strong ground shaking and differential settlement. It may be concluded that it is of critical importance to locate the active faults and not to construct any structure on top of or even near active fault zones.

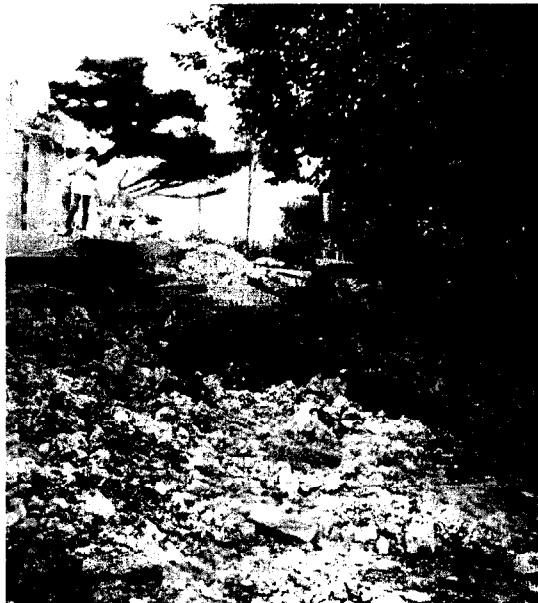
Fig. 14. Pavement and backfill damaged.

shows the pavement cracked and subsided for about 1.3 m. It may be concluded that besides checking the factor of safety against sliding, overturning, and bearing capacity failures, overall stability of the wall should also be carefully investigated

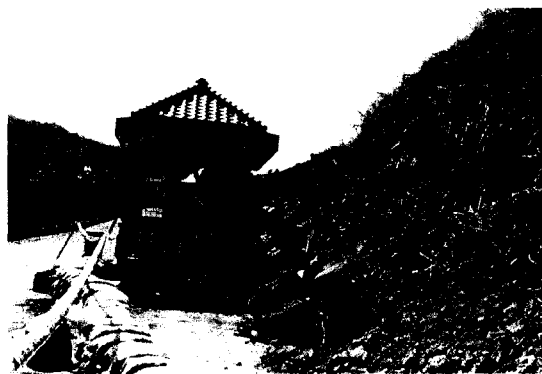
Fig. 17. Lanes to enter NCNU buried and guard post struck.
