SOME GEOTECHNICAL ASPECTS OF 1999 CHI-CHI, TAIWAN EARTHQUAKE

ABSTRACT

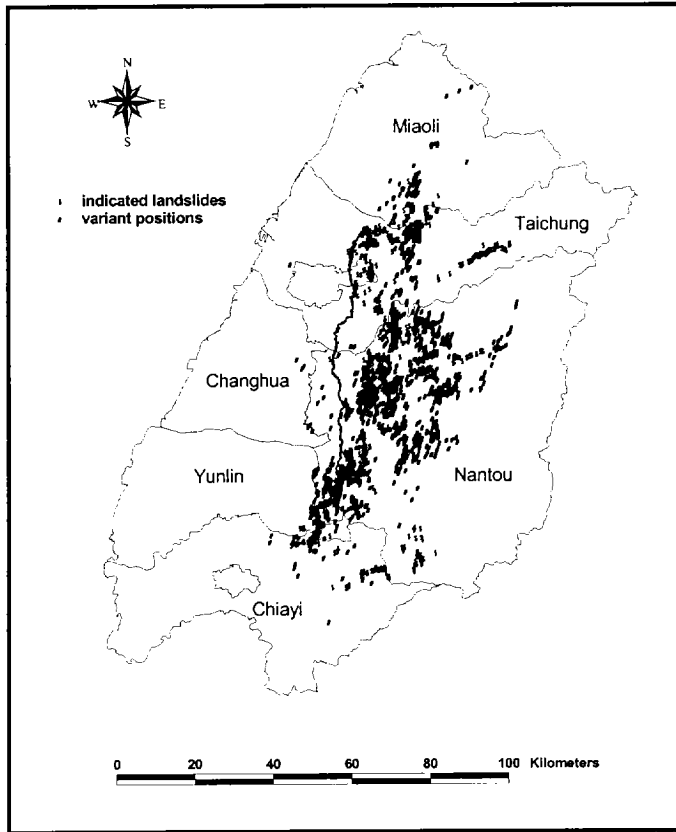
According to the aerial photos and SPOT satellite photos, there were more than 2,000 scores of landslide caused by the earthquake. Figure 1 shows the locations of identified ground surface changes and 436 landslide sites investigated shortly after the earthquake. Most of the slope failures located on upper portion of the Chelungpu thrust fault. However, the area of the mountain terrain is also to the same side of the fault, therefore, it is not sure about the relation between the slope failure and location of the fault rupture.

Fig. 1. Locations of investigated sites of landslide and variant points of ground surface.

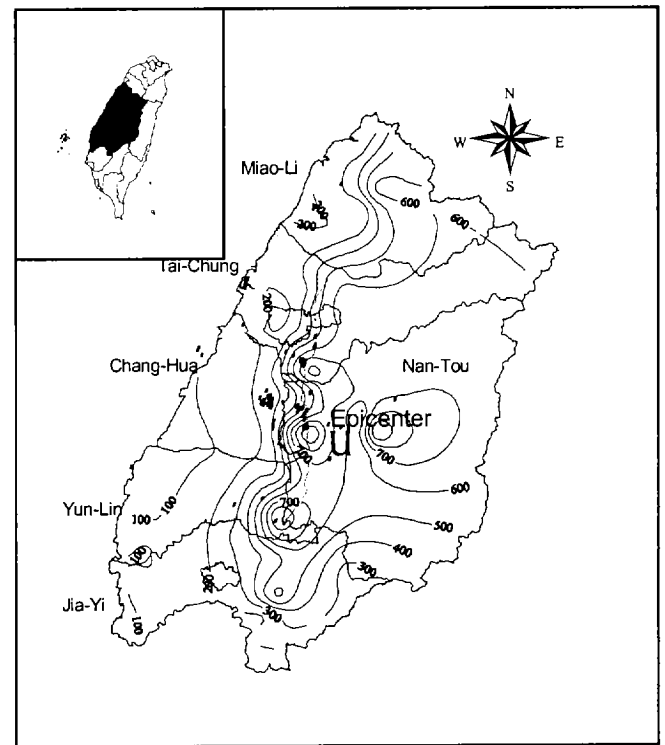
According to the field investigations, the soil liquefaction during Chi-Chi earthquake occurred mostly in three types of grounds: (1) hydraulic reclaimed lands on the west coast of Taiwan, (2) alluvial deposits of the old river channels, and (3) recent deposits along the riversides. The groundwater levels in these areas are generally high within 1 to 3 meters from the ground surface. Figure 3 shows the locations with reported soil liquefaction. The intensity contours of the ground shaking are also shown on the same figure. Among these locations, Taichung Harbor, Yuen-Lin and its vicinity, Wu-Feng, and Nan-Tou are the sites with the most widespread liquefaction and severe damages to buildings, levees, roadways, retaining walls, and other structures.

Fig. 3. Distribution of locations of soil liquefaction.

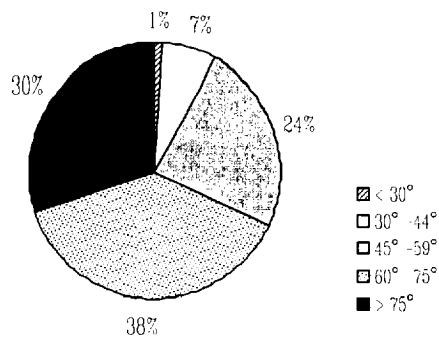
The distribution of the slope angles of the failure slopes is shown in Fig. 2 [NCREE, 1999]. The slopes with angles of larger than 75° account for 30 % of all failures, and slope angle in the range of 60° to 75° takes up 38 % of the failures. Typically, the shallow slides and toppling/rock falls occurred at the slopes with steep slope angles.

Fig. 2. Distribution of slope angles of landslides.

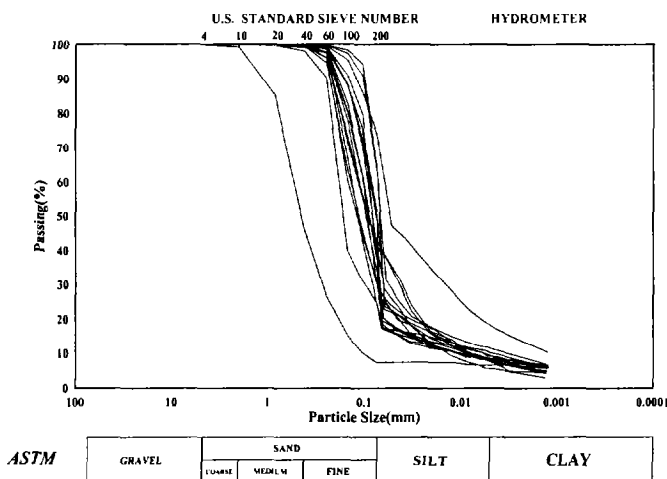
some of these soils. They are mostly uniform fine sand and silt, which are considered potentially liquefiable materials. It can be seen that most of them contain high percentages of fines. It was first suspected that some of the fines were carried out in the process of sand boiling during liquefaction. The grain size analyses were also performed for the soil samples obtained in the subsurface explorations. Figure 5 shows the grain size distributions of those soils that were probably liquefied during the earthquake judging from the field observations, the SPT results, and the soil type. There seems a similar large amount of fines content in these materials. According to the grain size analyses, the fines are predominantly silt size with no plasticity. Gravel contents of about 20% to 30% are also found in two of these soils.

Fig. 4. Grain size distribution curves for the ejected soils at sand boiling sites.

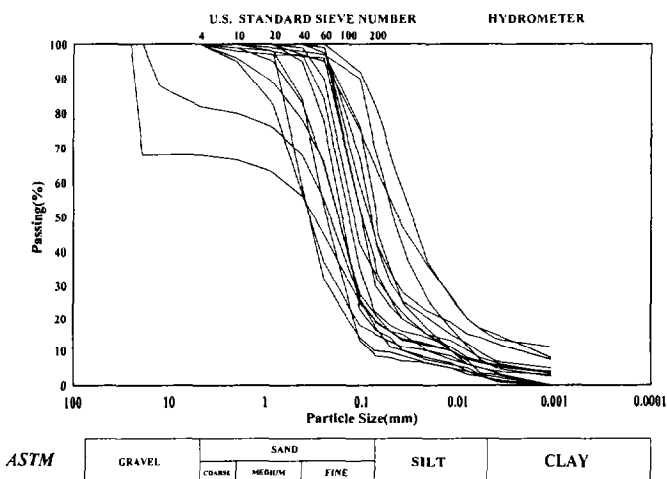
Fig 5. Grain size distribution curves for the probable liquefied soil samples from boreholes.

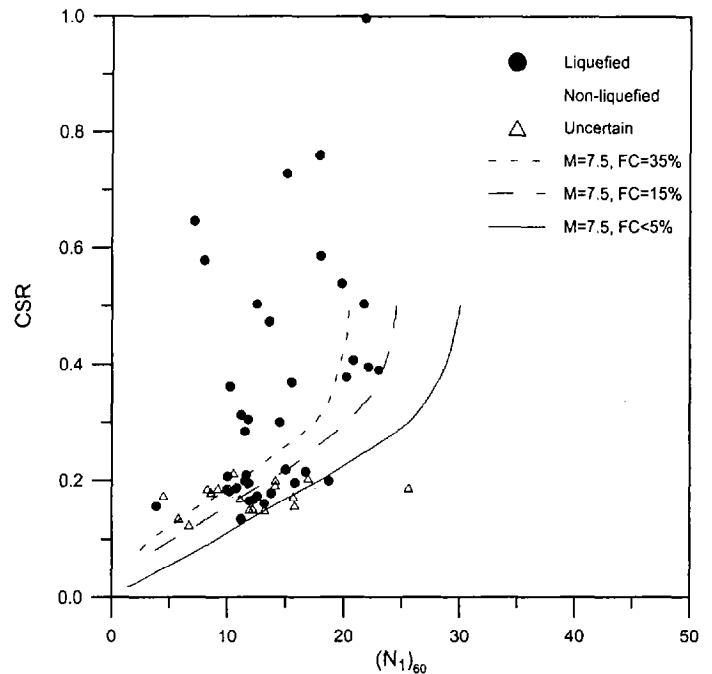
The observations of the wide-spreading soil liquefaction during Chi-Chi earthquake provided a unique opportunity for the geotechnical engineers in Taiwan to collect the data to develop their own liquefaction evaluation criteria. Figure 6 shows the preliminary data on the plot of seismic stress ratio versus corrected SPT-N value. The Seed's liquefaction evaluation criteria are also shown on the same plot.

Fig. 6. Seismic stress ratio versus corrected SPT N-values for soils in the liquefaction areas.
