Study of Liquefaction Damages of Quay-Walls and Breakwaters During Kobe Earthquake

STUDY OF LIQUEFACTION DAMAGES OF QUAY-WALLS AND BREAKWATERS DURING KOBE EARTHQUAKE

Yasuo Tanaka
RCUSS, Kobe
University, Kobe,
Japan 657-8501

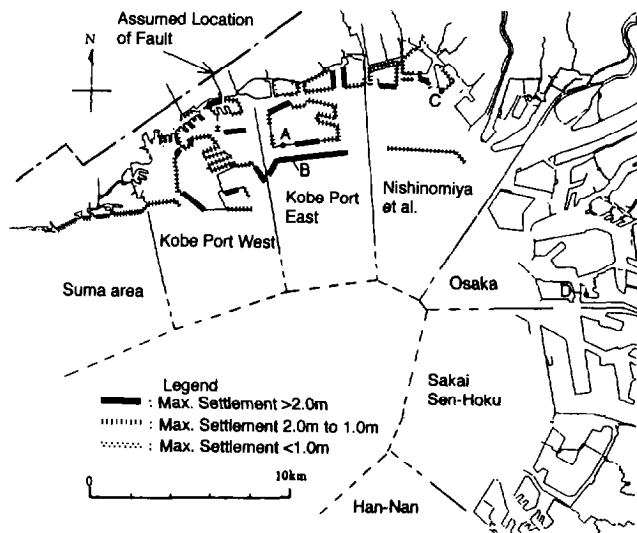
The earthquake damages of port facilities in the Osaka Bay were surveyed by dividing all port facilities into 7 zones, such as Suma to Han-Nan as shown in Fig. 1. Damaged quay-walls and breakwaters in Fig. 1 were identified by the amount of measured vertical settlement that reached in excess of 20-30cm. As shown in the figure, the significant damages are only found in the port facilities in the vicinity of Kobe Port, Fig. 1 also shows four locations, points A to D, that are selected for numerical liquefaction analysis.

Fig. 1 Distribution of damages of harbor facilities

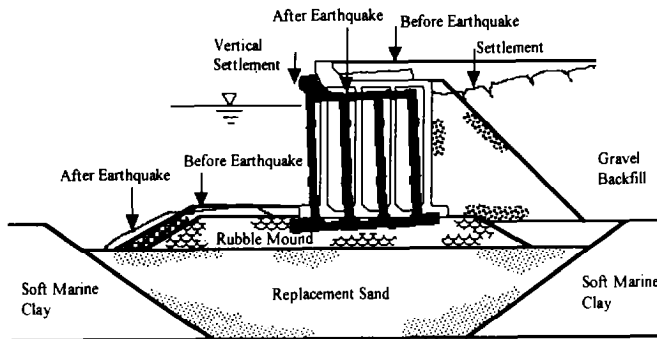
Almost 90% of quay-walls in Kobe Port were constructed by placing a massive concrete caisson on a granular fill with thickness varying from 10 to 15m that was placed by excavating the superficial soft marine clay of seabed. A typical cross section of quay wall is shown in Fig. 2. Due to

Fig. 2 Typical section of quay wall and damages

the earthquake, the granular fill materials behind the caisson and also below the caisson liquefied. Also a large horizontal thrust was exerted on the massive caisson due to the earthquake. Because of combined effect of these phenomena, the concrete caisson of quay-wall moved seawards extensively at many reclaimed lands, for example at Kobe Port Island and Rokko Island, as much as 5 to 6 meters and settled more than 1 to 2 meters along the perimeter.

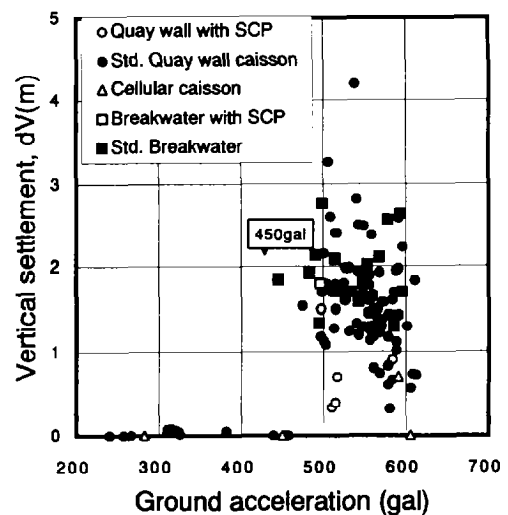
Fig. 3 Relationship between ground acceleration and damages

First the relationship between the ground acceleration and the degree of damage was examined as shown in Fig. 3. The vertical settlement, δV , of all structure, including those with sand compaction piles (SCP) and cellular caisson of light weight, was compared against the estimated ground acceleration. The figure shows that the damage occurs when the acceleration exceeds $A=450$ gal irrespective of structural differences. The amount of settlement is smaller for those structures with SCP and cellular caisson because of their less liquefaction potential and light weight respectively. Thus in the foregoing analysis, only the damage records that correspond $A>450$ gal were used for analysis.

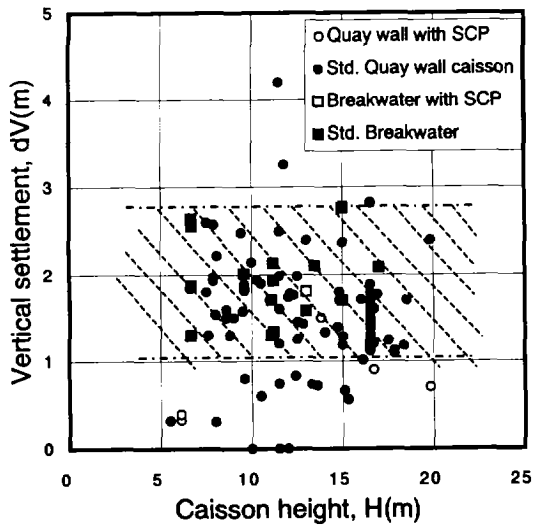
Fig.4 Relationship between caisson height, H , and settlement, dV .

The height of caisson, H , represents the total weight on the granular-fill, and therefore it might be possible to correlate the amount of settlement, dV , to the height of caisson, H . The relationship between dV and H is shown in Fig.4, but there seems to be no relation between the two.

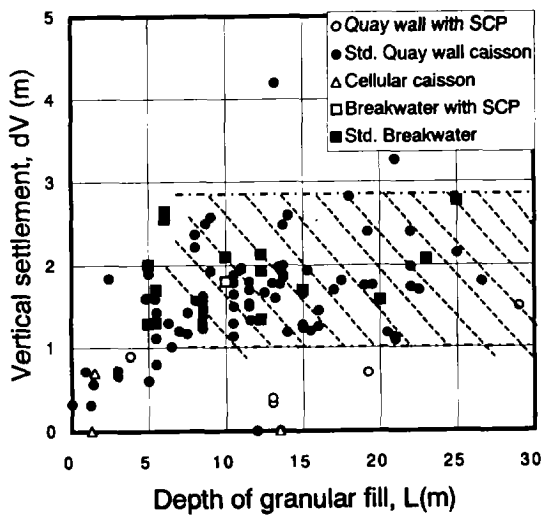
Fig.5 Relationship between depth of granular fill, L , and settlement, dV .

Next, the relationship between the depth of granular fill, L , below caisson and the damage was examined in Figs. 5 and 6. In Fig.5, the vertical settlement, δV , was depicted against the depth, L . The amount of settlement ranges about the same value between 1 to 3 m when L exceeds 5m. In Fig.6, the vertical settlement, δV , was normalized by the depth of granular fill or the length of SCP, L , and the ratio, $\delta V/L$, decreases steadily with the increase of L value. This indicates that the amount of settlement stays nearly constant, about 10 to 20% of L , with the increase of depth of granular fill. Again, those structures with SCP and cellular caisson show smaller settlement.

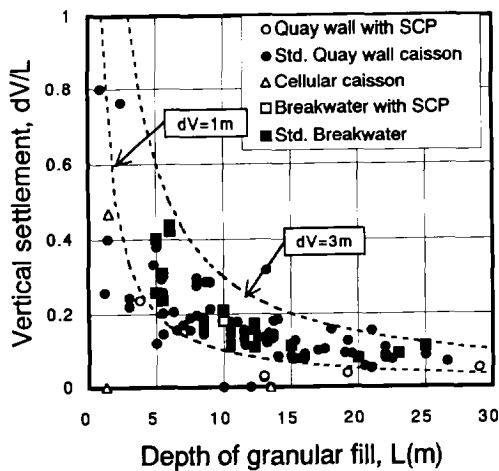
Fig.6 Relationship between depth of granular fill, L , and normalized settlement, dV/L .

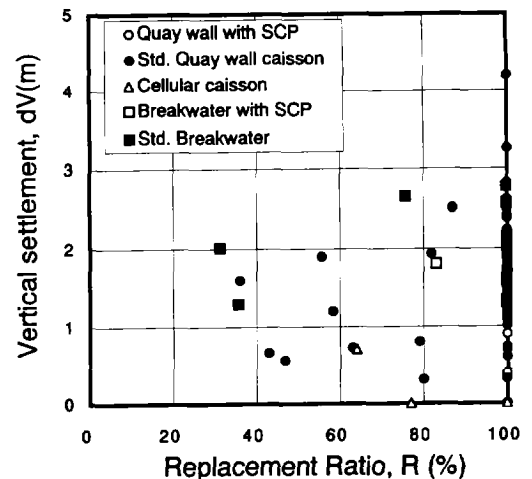
Fig.7 Relationship between replacement ratio, R , and settlement, dV .

Most of quay wall and breakwater foundations have their entire original soft clay base being replaced by the granular fill or SCP. However, in some cases, the soft clay foundation was not entirely replaced or improved by the granular fill replacement or SCP respectively. In Fig. 7, the settlements of those structures with their foundation partially replaced or improved are examined. A parameter, R , which is the ratio between L and the thickness of soft clay, represents the

improvement ratio of the foundation. It can be seen that the structures with R value less than 100% also show large settlement ranging from 0.5 to 2.5 m. This result suggest that the deformation or compression of granular fill to cause the structural settlement is mostly occurring in the upper zone of sand fill replacement.

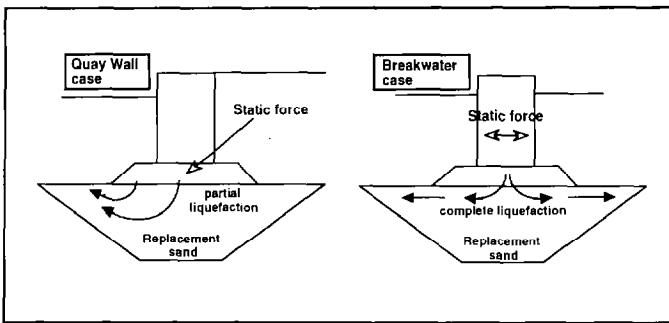
It may be appropriate here to discuss the different modes of structural deformation between the quay wall and the breakwater. From the survey records, it was clear that the horizontal movement of quay wall was very large ranging from 2 to 5 meters, while that of breakwater is nearly zero. Thus there is a clear difference between the deformation mode of foundation soil between these two structures. Iai et al. (1998) has shown by using numerical analysis that the soil beneath the quay wall fails rotationally in the direction of a combined static force resulting from the caisson weight acting vertically and the horizontal thrust of back fill. They also pointed out that the granular soil beneath the caisson does not entirely liquefy. On the other hand, for the breakwater, the soil beneath the structure liquefies extensively and large deformations and compressions in simple shear mode take place near the surface of granular fill. They further noted for the breakwater that the compression of soil due to the reconsolidation after liquefaction is large, about 3% of fill thickness, L. The difference in the deformation modes of foundation soil as discussed by Iai et al. (1998) is illustrated in Fig. 8. The results as given in Figs. 4 to 6 have all indicated the amount of settlement is independent of the total thickness granular fill, thus this suggests that the deformation is contained only in upper part of granular fill. Such results are consistent with the mode of foundation deformation as illustrated in Fig. 8.

Fig.8 Schematics of different failure modes of granular fill under the caisson.

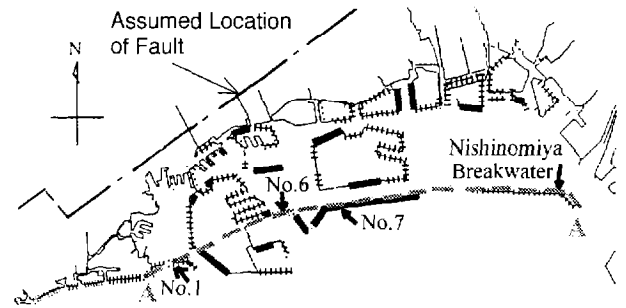
Additional data to indicate the magnitude of recompression after liquefaction for breakwater were obtained by the settlement records of breakwaters at south of Kobe Port. Fig. 9 shows a variation of settlement along a long stretch of breakwater along Line A-A in Fig.10. It shows a continuous and consistent change in the amount of settlement from the west to the east. The settlement amount was compared against the thickness of soft clay that was replaced by the granular fill in Fig. 11. A comparison between the settlement and the thickness of granular fill shows an almost linear relationship, excluding the data for Nishinomiya area. The breakwater in Nishinomiya area stretches South-East direction along which

Fig.9 Location of breakwater surveyed

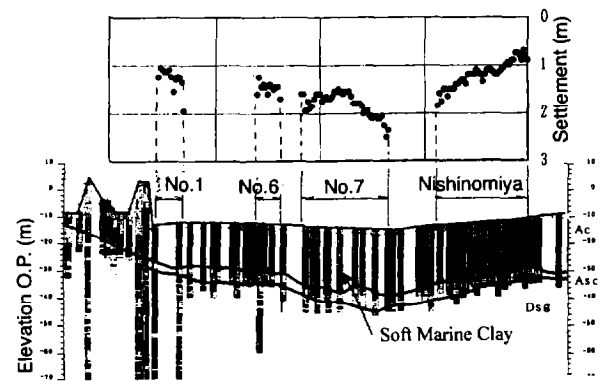
Fig.10 Variation of vertical settlement of breakwater along Section A-A.

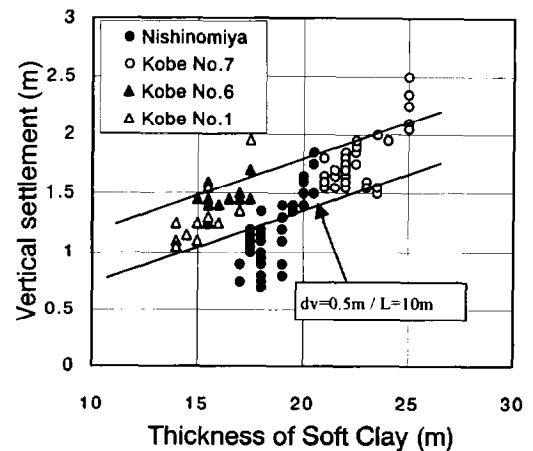
Fig.11 Relationship between the thickness of soft clay and the vertical settlement, dV

direction the ground acceleration reduces significantly. Thus the trend of these data was neglected from further analysis. For the settlement of breakwater, it has been noted that the reconsolidation after liquefaction takes a large part in the total amount of settlement. The results shown in Fig. 11 suggest the re-compression of granular fill increases about 0.5m over a 10m increase of fill thickness, and this may be suggested that

the recompression was about 5% compression of the fill thickness.

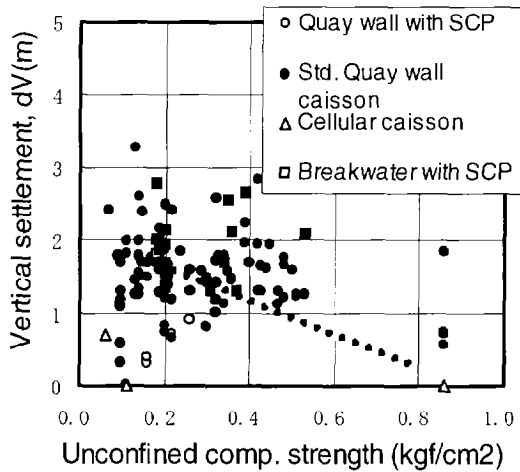
Fig.12 Relationship between the unconfined compression strength of soft clay and the vertical settlement, dV

Lastly, the strength properties of soft marine clay was compared with the amount of settlement in Fig.12. The strength in Fig.12 represents an average strength for a 5m thick surface layer of soft clay. The trend is not so clear, but the strength of clay near the surface may influence the amount of lateral movement of granular fill as suggested by the above arguments.

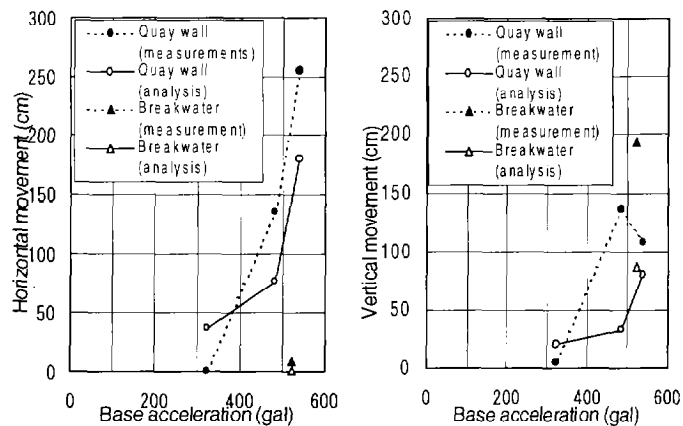
A comparison of the computations and the measurements is depicted in Fig.15. As can be seen from the figure, there is a fair agreement in the changing trend of damage level that increases significantly with the increase of acceleration. However, the amounts of predicted movement are much smaller than the actual, especially under smaller acceleration. In addition to the discrepancy in the numerical values, it was also difficult to obtain a stable computation result without paying a large effort on selection of damping parameter for the analysis. Further work on the selection of suitable input parameters for the analysis is warranted.

Fig.15 Comparison of horizontal and vertical movements with the results of liquefaction analysis.
