A Field Study and Dynamic Finite Element Analysis of Railway Retaining Structures Damaged by the Hyogoken-Nambu Earthquake (1995)

A FIELD STUDY AND DYNAMIC FINITE ELEMENT ANALYSIS OF RAILWAY RETAINING STRUCTURES DAMAGED BY THE HYGOKEN-NAMBU EARTHQUAKE (1995)

The seismic damage to embankments and retaining walls caused by the Hyogoken-nambu Earthquake (1995) was reviewed, rather focusing on railway structures. Nearly eight kilometers of damaged retaining structures were divided into five structural types, such as gravity-type walls, leaning-type walls, embankments, geo-textile-reinforced earth walls, and reinforced concrete walls, and into three categories of the damage, such as collapse, tilt, and crack. It was observed that the damage to gravity-type and leaning-type walls was greater than that to embankments, geo-textile-reinforced earth walls, and reinforced concrete walls, when they are lower than five meters. But some leaning-type walls higher than seven meters remained un-collapsed. In a smaller limited section, damage analyses of stone masonry walls of gravity type were carried out including undamaged ones. The percentage of heavy damage to stone masonry walls with slopes

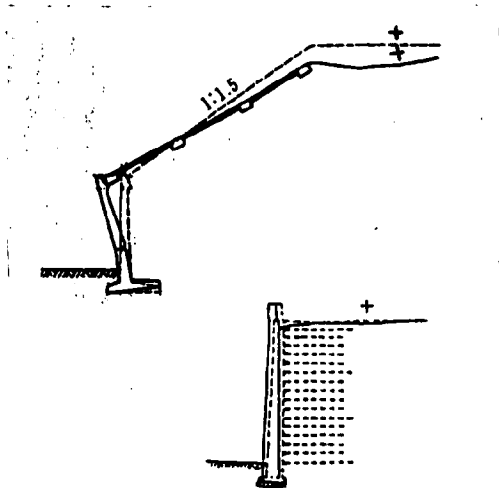
The degree of damage was divided into three categories, such as collapse, tilt, and crack. Cracks in a retaining wall are internal damage, while tilting of a wall is external damage. But it should be noted that collapse of retaining structures would happen both internally and externally. Fig.1 shows

Fig. 1. Collapse of RCW (above) and tilt of GRW (below)

some examples of combination of structural type and degree of damage. That is, the above figure shows an example of collapse of RCW, and the below an example of tilting of GRW.

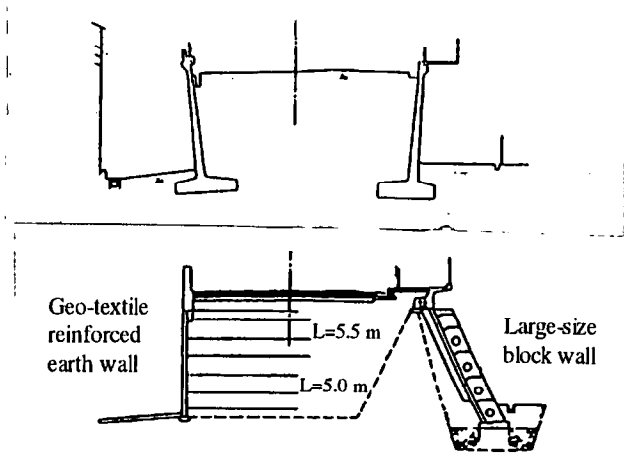
Fig. 2. Restoration of a highway embankment: before (above) and after (below)

Restoration of damaged retaining walls of a municipal highway was conducted, using a geo-textile-reinforced earth wall and a large-size block wall, as shown in Fig. 2.

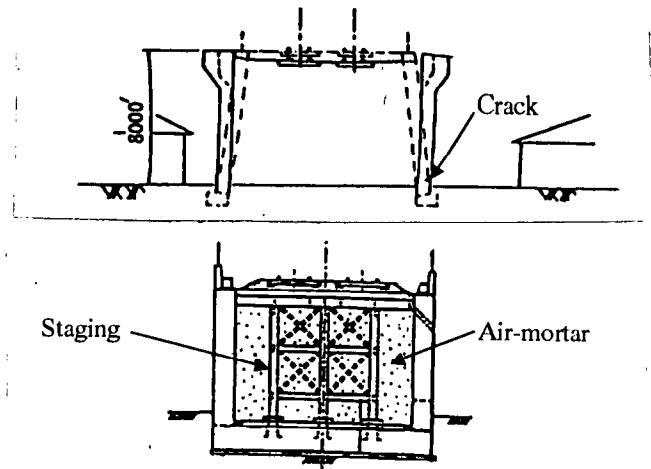
Fig. 3. Restoration of a Hankyu Railways leaning-type wall: before (above) and after (below)

Collapsed retaining walls of Hankyu Railways are shown in Fig. 3. As for the restoration, the damaged walls were removed, the railway tracks were temporarily supported by staging, then a U-shaped concrete wall was constructed, and finally air-mortar was poured into the space inside the U-shaped wall.

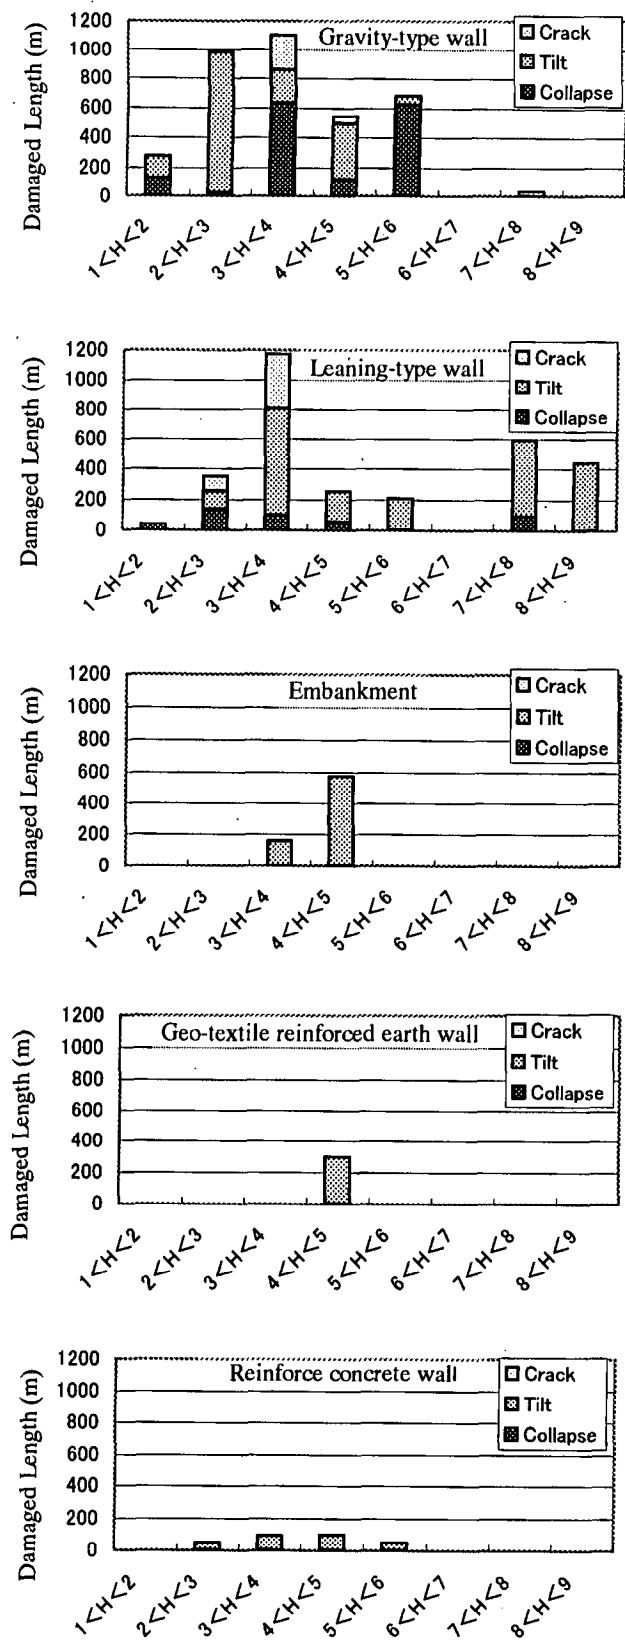
- Damage to embankments, GRWs, and RCWs was smaller than that to gravity-type or leaning-type walls,
- RCWs suffered internal damage but had no external damage, and
- Gravity-type walls of higher than 5 meters tend to collapse but leaning-type walls of higher than 7 meters remained tilted without collapse.

Fig.4. Degree of damage according to the height H (m) and type of retaining structures

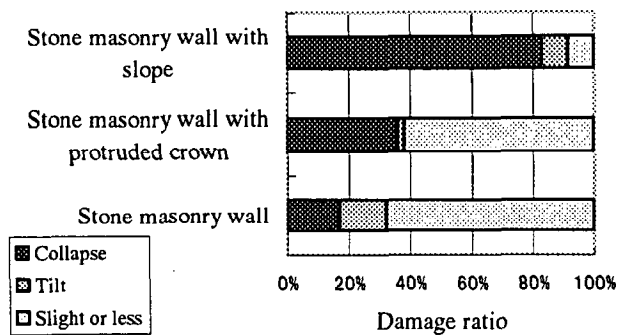
In a smaller limited section, all stone masonry retaining structures including non-damaged ones were analyzed, and the damage ratio was calculated. The retaining structures in this section were composed from stone masonry wall, stone masonry wall with protruded crown, and stone masonry wall with slope as shown in Fig. 5. Figure 6 shows that the damage ratio of stone masonry wall with slope is twice greater than that without slope. The ratio of collapse in stone masonry wall with protruded crown is nearly twice greater than stone masonry wall. But even if tilted structures are included to the collapsed, the damage ratio with protruded crown does not change so much. From this figure, it is suggested that in the

applied aseismic design of retaining walls with slope, seismic active earth pressure can be estimated to be too small. Figure 7 shows the assumed slope for calculating seismic earth pressure in the applied seismic design. The shaded triangular soil mass over the assumed slope is considered to slide during earthquake, and neglected in the calculation of seismic earth pressure. This underestimation of seismic earth pressure may contribute to the large ratio of collapse. Moreover, some other factors such as slope protection works might accelerate the damage.

Fig.6. Damage ratio of stone masonry walls

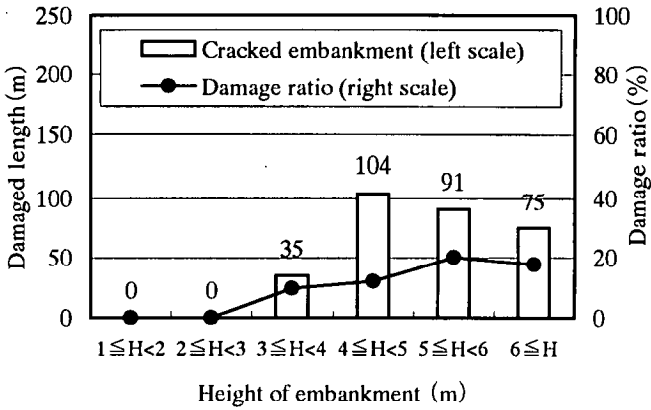
Damage to embankments of national highways was analyzed. Figure 8 shows the relationship between height of embankment and damaged length or damage ratio. The damage ratio is found to become greater as increasing the height of structures (Kunitomi *et al* 1998).

Fig.8. Damage to highway embankment

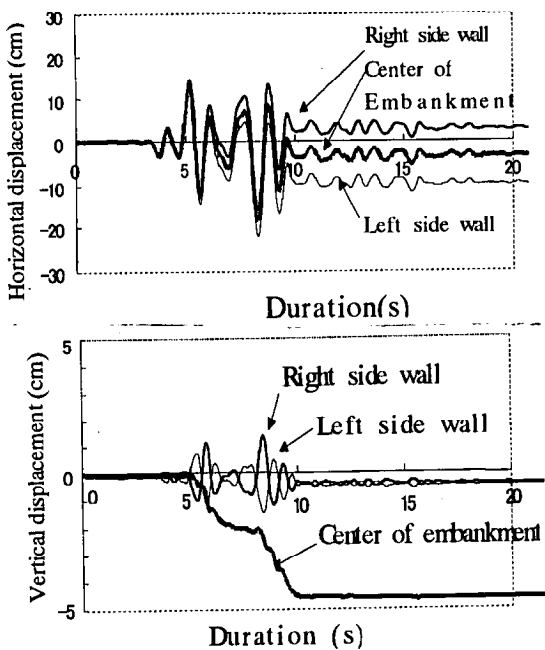
Figure 12 shows response of the gravity-type wall and the backfill. The gravity-type walls and the backfill horizontally oscillate in the same phase as shown in the upper figure of Fig.12. But, as shown in the lower figure of Fig.12, the settlement of backfill accumulates from the earlier stage, and the surface of embankment can not hold the original level.

Fig.12. Response of the gravity-type wall and the backfill: horizontal (above) and vertical (below)

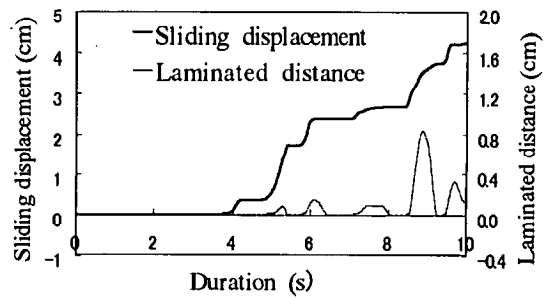
The gravity-type walls develop de-lamination at the contact plane to backfill as shown in Fig.13. This soil-wall slippage displays non-reversible character. This type of relative displacement is also developed in the leaning-type walls.

Fig.13. Relative displacement between the gravity-type wall and the backfill

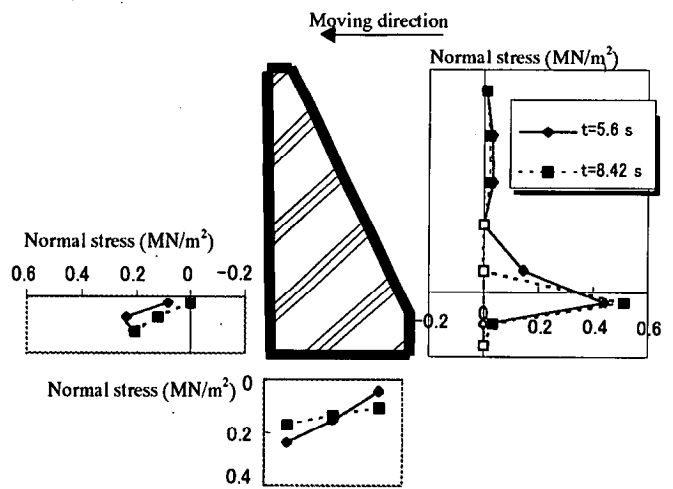
Figure 14 shows stress distribution at the contact face between gravity-type wall and backfill. The gravity-type wall develops earth pressure when the whole structure is moving from backfill side to wall side as shown in Fig. 14, but has no earth pressure when moving the other way around. This means that the gravity-type wall suppresses the movement of the backfill.

Fig.14. Stress distribution at the contact face between gravity-type wall and backfill

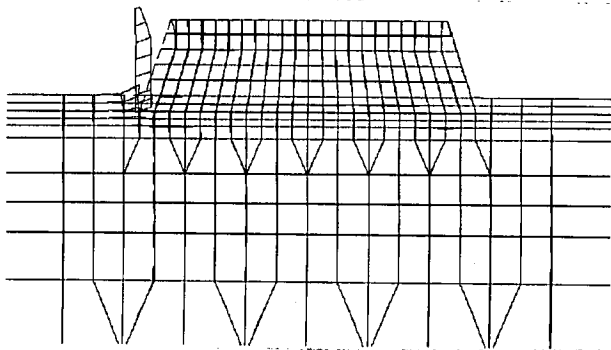
Figure 15 shows displacement of leaning-type wall at 9.7 seconds. The leaning-type wall does not develop any earth pressure at the contact face with the backfill whether it is moving right or left. It moves as if it was on the side slope of the embankment and toppled after as shown in Fig.15.

Fig.15. Displacement of leaning-type wall at 9.7 seconds

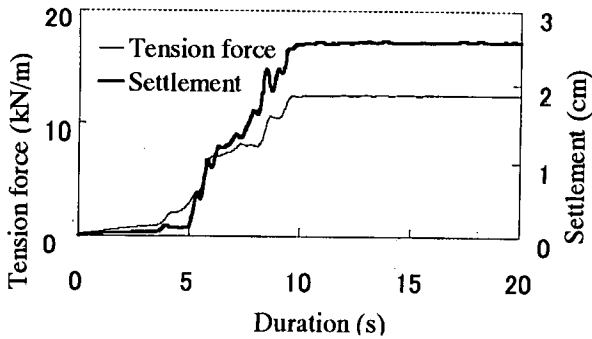
Figure 16 shows tension force in the geo-textile and settlement of reinforced embankment. The geo-textile material develops tension force in accordance with the settlement of backfill as shown in Fig.16. The distribution of the tension force in geo-textile does not change so much

Fig.16. Tension force in the geo-textile and settlement of reinforced embankment

whether the wall is moving right or left. Therefore, the tension force is not directly caused by the horizontal movement of the wall, but by the settlement of backfill. This tension force suppresses sliding of the wall. Figure 17 shows the distribution of tension force when the whole structure is moving from the left to the right.
