The Loma Prieta Earthquake: Implications of Structural Damage

S.A. Mahin

Professor of Civil Engineering, University of California, Berkeley

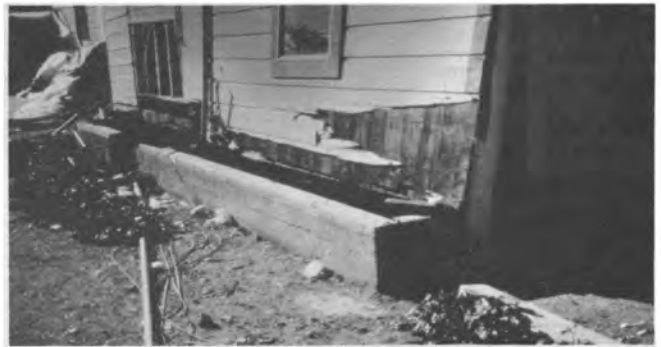
As indicated previously nearly 20,000 dwelling units were damaged during the Loma Prieta earthquake and 10,000 individuals were forced to relocate as a result. A majority of these displaced people lived in wood frame houses and apartments. Many homes located in the Santa Cruz mountains, in the immediate epicentral region, were damaged. Damages ranged from fallen chimneys and porches to partial or complete collapse. Many wood frame buildings in the hardest hit areas were overwhelmed by the seismically induced inertia forces. Sadly, the majority of the damage occurred in older wood frame buildings where the structures were simply not connected to their foundations. During the earthquake, as they have in innumerable past earthquakes, the structures simply shifted off their foundation with resultant vertical dislocation (Fig. 2).

Fig. 2 Damage to House Not Bolted to Foundation

The unfortunate aspect of both of these forms of damage is that simple and economical retrofit procedures, if implemented prior to the earthquake, could have prevented or significantly reduced the severity of the observed damages. Repair following the earthquake was generally extremely expensive as a result of not only the required structural repairs, but because of wide spread damages to architectural, electrical and mechanical features. Pre-earthquake retrofits to these walls and foundations were seen to be effective in several instances in Santa Cruz and elsewhere.

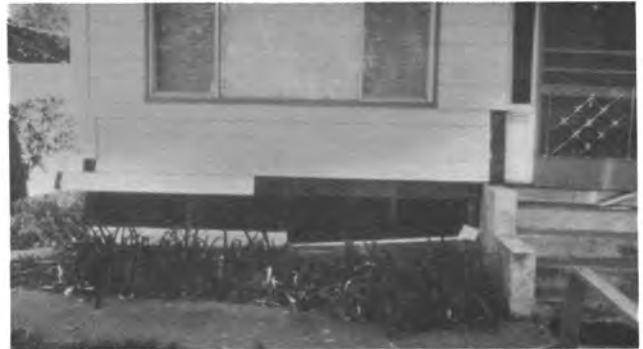
Another common type of failure that was observed related wood frame dwellings built upon short pony or cripple walls. These short walls provided a two to four foot tall access space that was used for storage, ventilation and to accommodate sloped sites. In many older buildings the framing between the ground floor and the foundation consisted of vertical studs and horizontal siding. Even though diagonal braces were provided in the upper levels to resist lateral loads, the braces were typically omitted from the pony walls. In addition, the horizontal siding covering these walls in most cases had badly deteriorated and effectively provided little or no lateral resistance (Fig. 3). The failure of these short support walls resulted in large vertical and lateral displacements of the supported structures (Fig. 4).

Fig. 3 Damage to "Pony" Wall

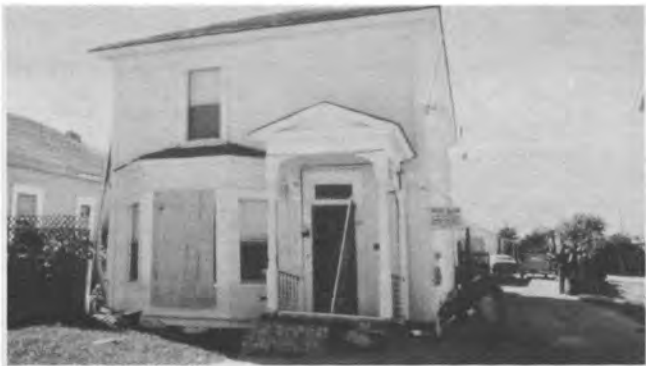
Fig. 4 Collapse of Home on "Pony" Walls

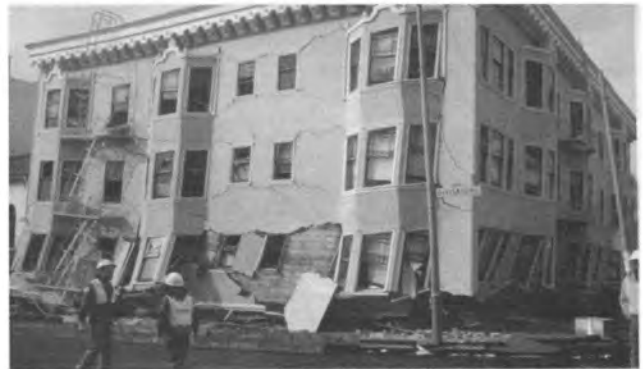
Many wood buildings were damaged or collapsed in this area. However, a detailed inspection of the damages indicates that the collapses concentrate in three or four story apartment buildings (Fig. 5) located on the corners of blocks (or where a structure was not sandwiched between two other adjacent buildings with little or no separation). These older apartment buildings were generally constructed with relatively massive apartment floors supported over a level of garages (Fig. 6). The bottom level thus was largely open to allow for multiple garage door openings. Typically, parking stalls were several cars deep and often extended out though the back of the building to provide for even more parking. This situation resulted in a soft first story. Lateral load resistance was provided by horizontal wood sheathing (covered by brick veneer) placed over only a few walls. This sheathing was observed to have decayed severely in many cases during the life of the structure.

The amplified seismic motions in the Marina District resulted in the collapse of the lower level of these corner apartment buildings in many cases. It is significant to note that these types of apartment complexes are quit common throughout San Francisco. Some apparently identical buildings located only a few blocks away from the heavily damaged area, but on firmer ground, remained virtually undamaged following the earthquake. Nonetheless, the potential hazard posed by these structures during future more severe earthquakes should be carefully investigated.

Fig. 5 Collapse of Apartment in Marina District

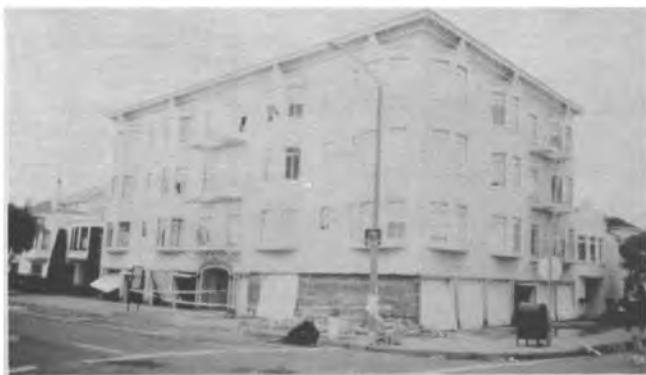
Fig. 6 Typical Marina District Apartment

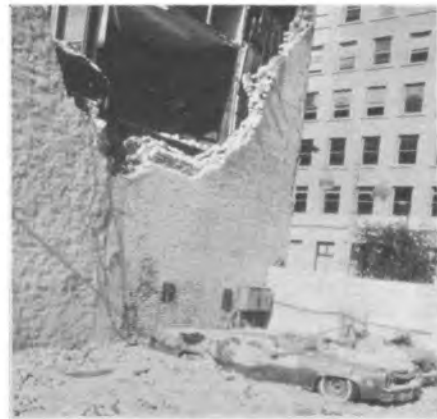
A particularly devastating form of damage resulted when the walls were not tied to the floor diaphragms. In many cases the walls failed out-of-plane, falling into the street (Fig. 7). In several notable cases the walls fell from upper floors of a building onto the roof of a lower adjacent structure (Fig. 8). The damage to the lower building resulted in two deaths in two separate buildings in Santa Cruz. In another instance, five casualties resulted as a wall collapsed in to the sidewalk area in front of an unreinforced masonry structure. For the level of shaking encountered, moderate amounts of tie

Fig. 7 Out-of-Plane Failure of Masonry Wall

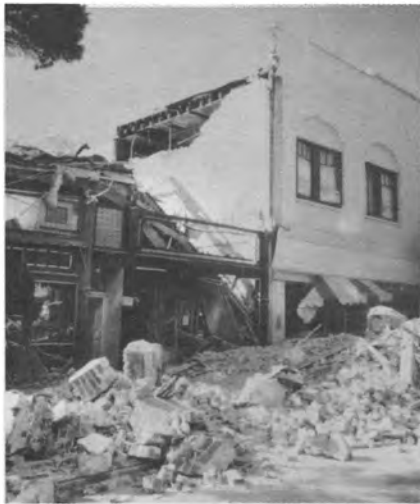
Fig. 8 Masonry Wall Fell on to Adjacent Roof

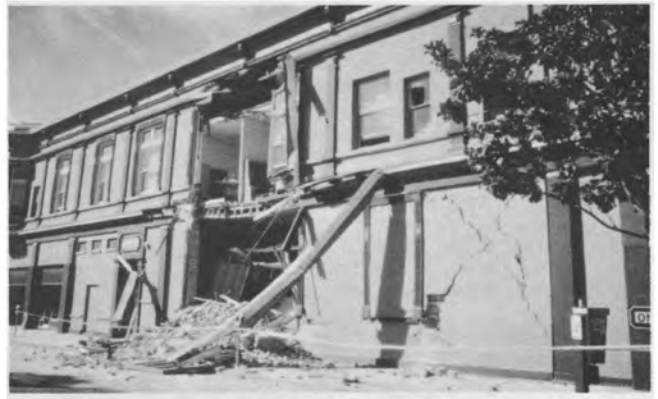
In some cases in-plane shear failures of brick walls was observed (Fig. 9). In some cases this distress resulted in local collapse of wall panels. In other buildings wide spread, inclined cracks developed, stepping along weak mortar joints. In many cases buildings with moderate cracking have been left un-repaired with continued occupancy or the cracks have been simply repaired with epoxy injection to insure water tightness.

Fig. 9 In-Plane Failure of Masonry Wall

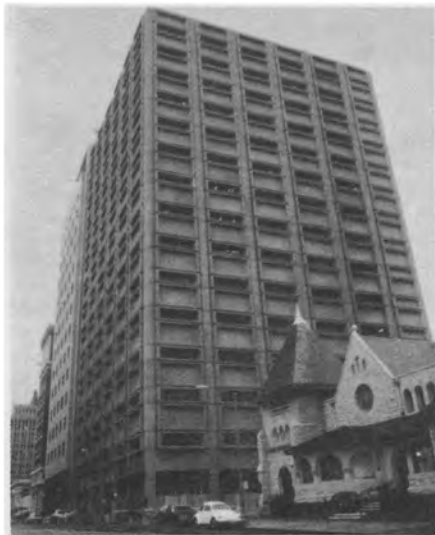
Fig. 10 Lightweight Concrete Shear Walls Failed at Base of Building

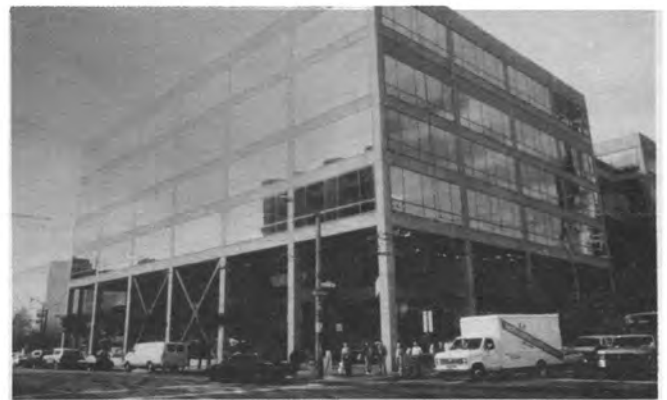
One example of this situation is a 6 story reinforced concrete building constructed in San Francisco at the order of corner and Fourth Street during the early 1980's (Fig. 11). During change of ownership a few years after it was built a number of seismic deficiencies were identified. These were remedied on the basis of

Fig. 11 Retrofit of New Reinforced Concrete Building

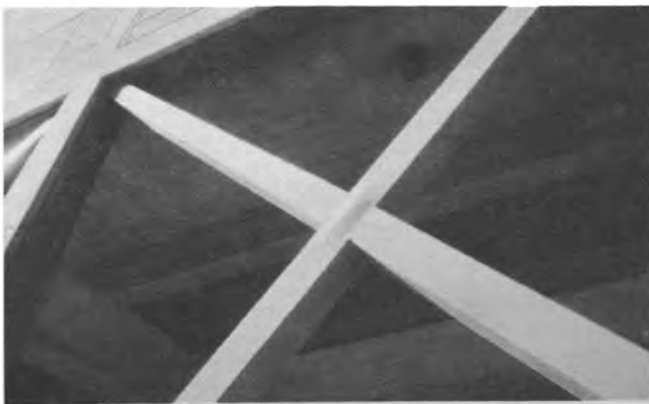
protection of the life safety of the occupants by adding steel braces and shear walls. Following the earthquake, the connections in the steel braces were observed to buckle (Fig. 12), the attachments of the braces to the concrete frame had slipped (in some cases due to faulty installation of anchor bolts), extensive cracking occurred in the shear walls, and initiation of punching shear failures in a few column to flat plate connections. The building has been since repaired (Fig. 13) to restore the capacity that existed at the time of the earthquake.

Fig. 12 Buckled Brace Intersection

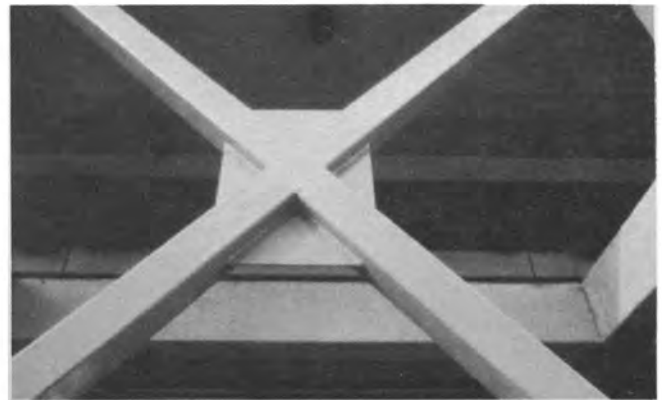
Fig. 13 Repair of Damaged Intersection

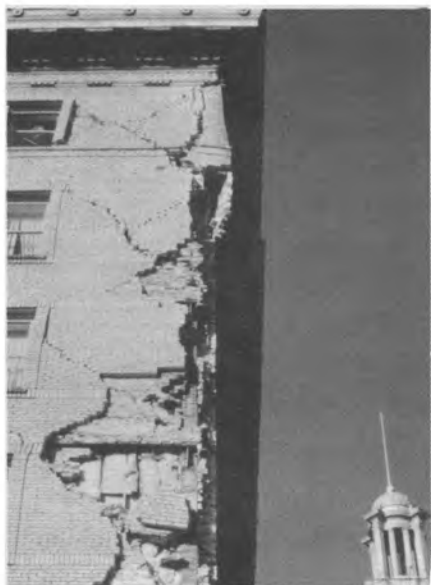
Another example, is the Hotel Oakland in Oakland. This is a steel frame building with extensive masonry infill panels. In retrofitting this structure new lateral load resisting elements were added and the exterior masonry elements were positively attached to the building to prevent large panels from falling into the street. As result of the earthquake nearly all of the masonry piers in the building developed distinctive x-shaped shear cracks. In addition, at a few locations masonry elements were dislodged from the building and fell to the street (Fig. 14). This building apparently preserved life safety as intended, but extensive and expensive repairs were required to restore the building fully to service.

Fig. 14 Damage to Retrofit Steel Frame Building with Masonry Infilled Walls

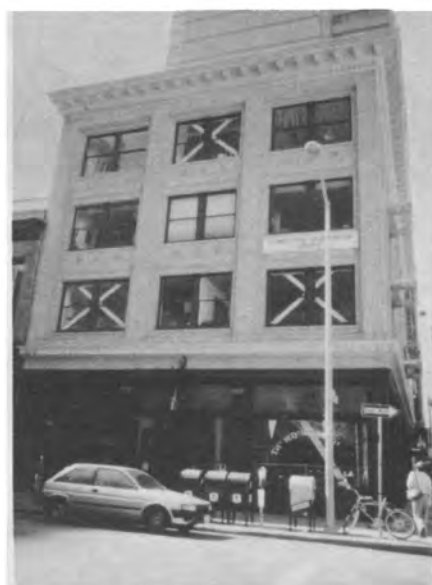
One of these structures (259 Front Street) was located at the corner of a block and it was heavily braced along two street sides (Fig. 15). The added braces at the street level buckled out of plane significantly (Fig. 16), but no damage was actually found in the masonry portions of this four story building. The second structure (1051-1075 Battery Street) was also braced but the mortar in the existing masonry walls was apparently so poor that random sections of the exterior wall fell from the building. Another building (located at Sixth Street and Bluxome Streets) had apparently been partially retrofitted by addition of wall anchors. Five people were killed as the upper level wall on one side of the structure fell onto the sidewalk and street. In all of these cases it is clear that the lack of a consistent, systems approach to the design of the retrofits had a detrimental effect and that a new class of potentially hazardous buildings (i.e., the inadequately retrofit structure) needs to be investigated.

Fig. 15 Retrofit URM Building with Steel Braces

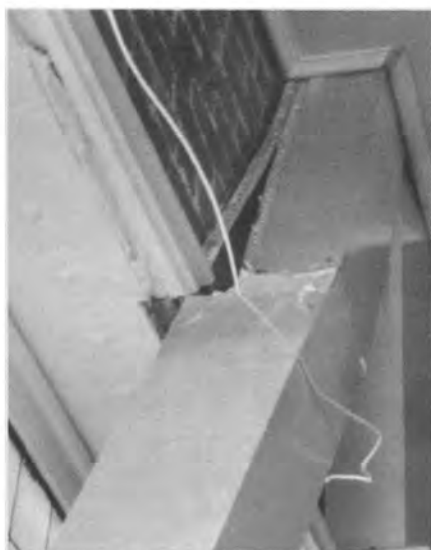
Fig. 16 Buckled Brace in URM Building

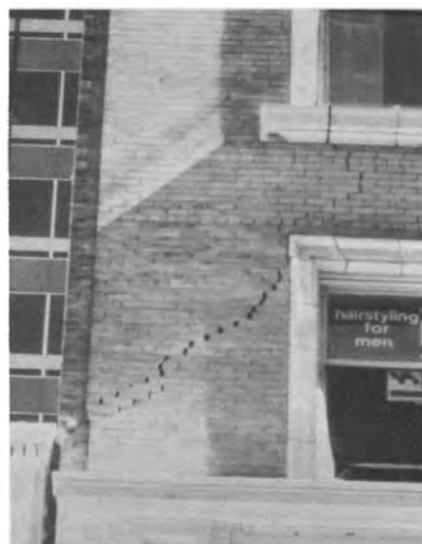
Another important observation from the Loma Prieta earthquake is that many buildings suffered damage due to pounding. The separation of many buildings was insufficient to avoid collision of the upper stories. As a result a wide range of damage resulted, from local spalling of veneers near the impact point through cracking of vertical supporting members to failure (though not collapse) of columns. Field inspections have identified several hundred cases where pounding contributed to the observed damage. In many instances it was apparent that a few more cycles of impact could have caused the failure of one of the structures involved (Fig. 17). In many of the severely damaged unreinforced masonry structures evidence suggests that pounding was a contributor to the damage.

Fig. 17 Pounding Damage

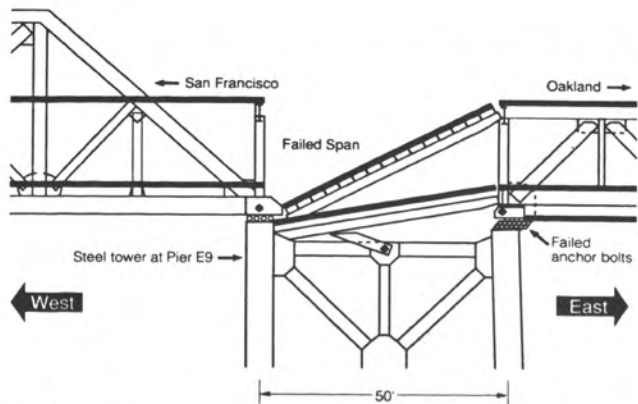
In addition, the bottom chords of the trusses were attached to the tower by means of twenty 1-in. diameter bolts. During the earthquake the bolts in the connection on the east side of the tower sheared completely and the bearing plate moved approximately 5-10 inches to the east. This was probably the proximate cause of the roadway beams slipping from their seats.

Fig. 18 Detail at Collapsed Section of Bay Bridge

The bridge was repaired by jacking the eastern segments back into place and providing new roadway beams and supports. The support seats were constructed about 50% longer than in the original design. A more extensive study is currently under way by Prof. A. Astaneh and his colleagues at the University of California, Berkeley and by Caltrans to assess more reliable long term retrofits.

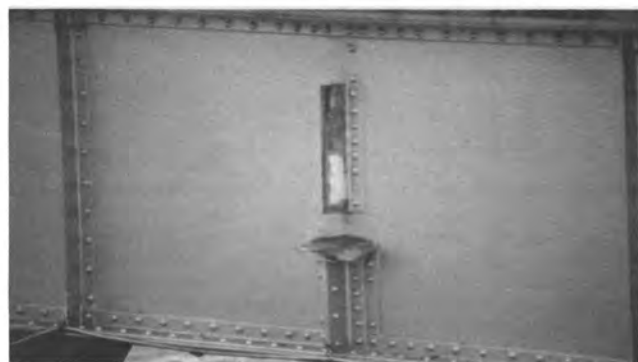
Fig. 19 Detail of Seat Connection on Bay Bridge

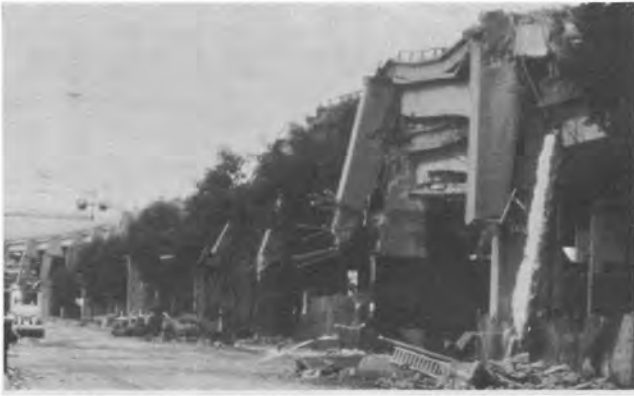
The most spectacular damage to reinforced concrete bridges was the catastrophic collapse of nearly a mile long portion of the upper deck of the Cypress Street Viaduct located in west Oakland on poor soil reclaimed from the bay (Fig. 20). This structure was designed in the early 1950's and construction was completed in 1957. The death toll for his collapse was 42, though as mentioned earlier a thousand fatalities or so casualties might have been expected had the earthquake occurred during congested rush hour traffic. A variety of factors contributed to the failure of the structure. These include the amplification of the ground motions in the vicinity due to the soft soil conditions, traveling wave effects, and variable soil conditions. The structure also was designed at a time when earthquake resistant design procedures were not highly developed. Thus, while the bridge appears to have been conservatively designed relative to the structural requirements in force at the time of its construction, it has a number of major deficiencies with respect to current construction practices.

Detailed studies by Nims et al (1989) and others have indicated that any of a number of structural deficiencies could have triggered the collapse. The lack of redundancy (needed to redistribute forces in the event of the failure of an element, and the brittle details utilized made the final catastrophic outcome a certainty, regardless of the actual trigger of the failure and input details.

Fig. 20 Collapse of Cypress Street Viaduct

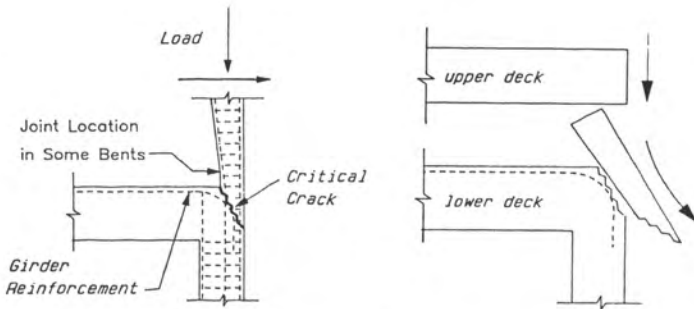
The dominant features of the typical collapse mechanism are shown in Fig. 22. Shear cracks in the pedestal supporting the hinged upper level columns were able to extend downward into the joint region following the projection of downward bending hooks on the end of the transverse girder's (cap's) top level reinforcement. The lack of shear reinforcement in the joint allowed this inclined crack to act like a slide, with the resultant pancake collapse of the upper level.

Fig. 22 Postulated Failure Mode

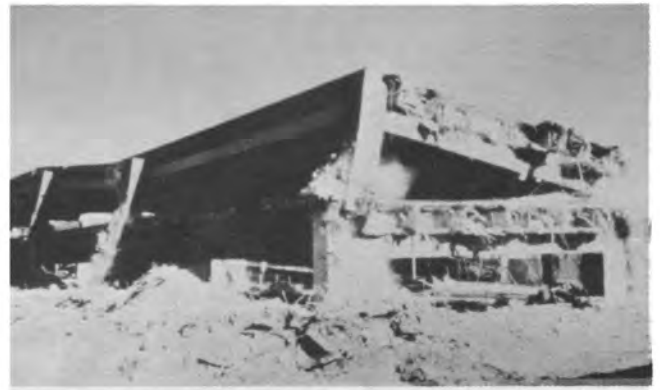
The sudden and catastrophic nature of this failure mechanism was demonstrated convincingly during the demolition of the Viaduct. A wrecking ball was used to initiate failure in a single column. Almost immediately progressive collapse occurred throughout the upper level not only extending transversely across the roadway, but also longitudinally for six bays to the end of the remaining standing portion of the viaduct. Clearly, such brittle structures are not compatible with seismic resistant design.

Fig. 23 Failure Mode Observed during Demolition

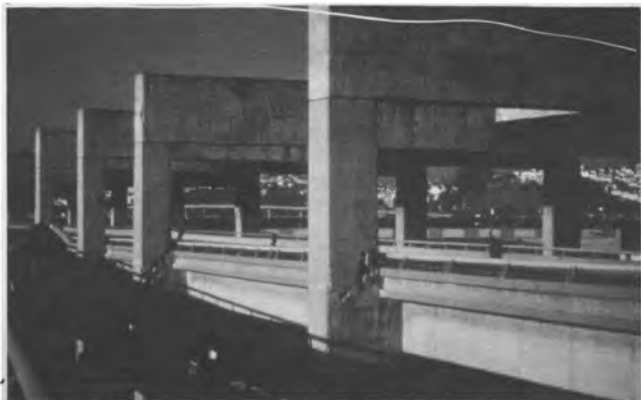
Fig. 24 Damage to Southern Freeway

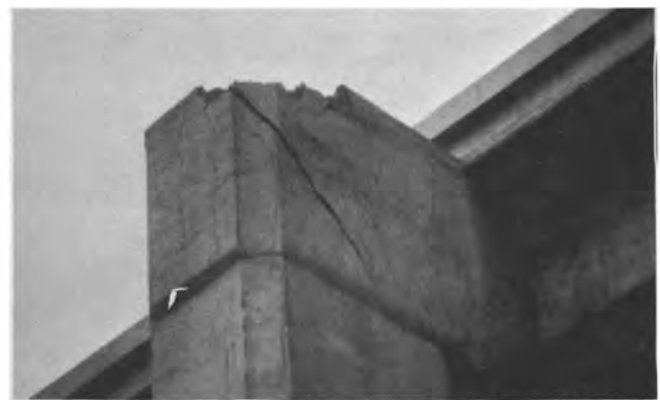
Fig. 25 Damaged Knee Joint in New Freeway

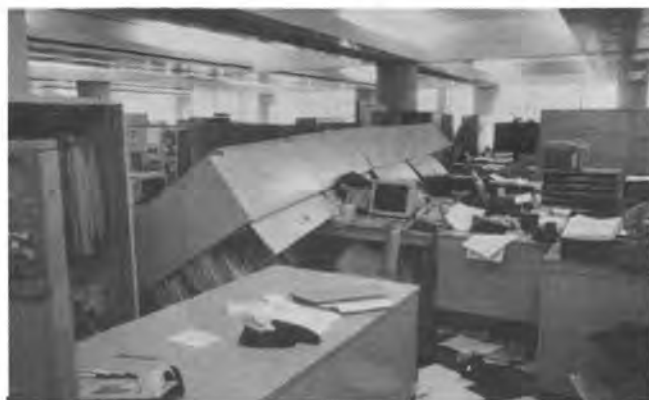
Fig. 28 Damage to Building Contents
