1991 - Second International Conference on
Recent Advances in Geotechnical Earthquake
Engineering & Soil Dynamics

Liquefaction of Soils in the 1989 Loma Prieta Earthquake

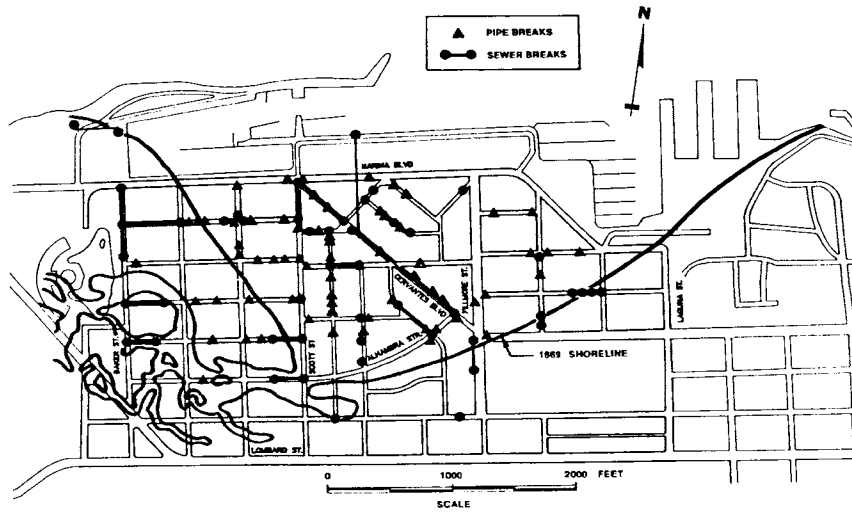
Figure 4 shows the locations of breaks in water pipes greater than 4-inches in diameter, as well as breaks in main sewer lines. Considerable damage to buried utilities occurred

Fig. 4 Location of Major Water Pipe and Sewer Breaks; Marina District, San Francisco

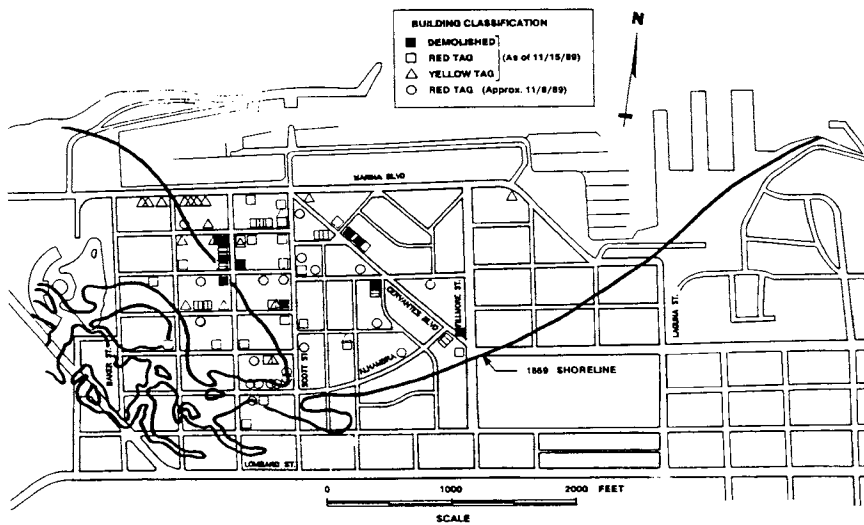
Fig. 5 Locations of Demolished Structures, and Structures Marked with Red and Yellow Post-Earthquake Inspection Tags as of Mid-November, 1989: Marina District, San Francisco

Figure 5 shows the locations of heavily damaged structures, as indicated by post-earthquake inspection "tags", roughly one month after the earthquake. As illustrated in Figure 5, a majority of the structural damage occurred near the heart of the Marina District. Much of this ground is underlain by the loose hydraulic fill placed in 1910-1912, and much of the rest is underlain either by fill placed to reclaim the perimeter marshes or by naturally deposited

loose to medium dense beach and dune sands which occur at the edges of the region. This does not mean, however, that this concentration of structural damages is due primarily to soil liquefaction. Instead, a majority of the damage to structures in the Marina District on October 17, 1989 was caused by strong shaking, as the fill in much of the region of heaviest structural damage is underlain by relatively soft and compressible recent clayey estuarine deposits which served to amplify the levels of shaking in this area. Although strong shaking was the primary cause of structural damage in this region, soil liquefaction also damaged structures, as a number of structures were wracked by differential settlements, lateral spreading, or partial bearing failures. Many of these structures were found to have sand intrusions in their garages and basements, and in some cases this sand spilled out so as to be visible from external inspection.

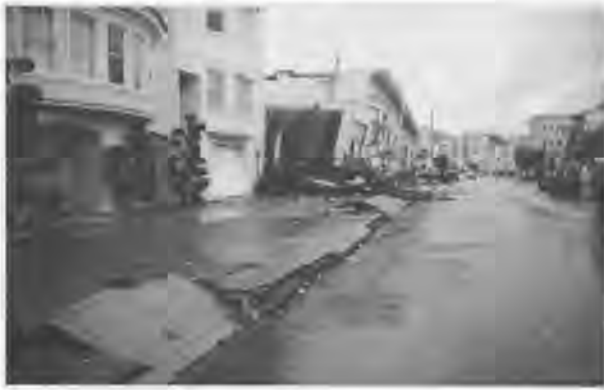
Figure 6 illustrates conditions near the center of the Marina District immediately after the earthquake. In addition to the collapsed structure, this figure clearly shows buckling of the sidewalk at two locations. This buckling is not the result of settlement, but rather of lateral compression of the pavement due to lateral spreading associated with liquefaction of the underlying fill in this area. Similar evidence of lateral spreading, including extension and/or compression of pavements, as well as massive and widespread damage to critical buried utilities, occurred throughout much of the District.

Fig. 6 Pavement Buckling Indicative of Lateral Compression; Marina District, San Francisco

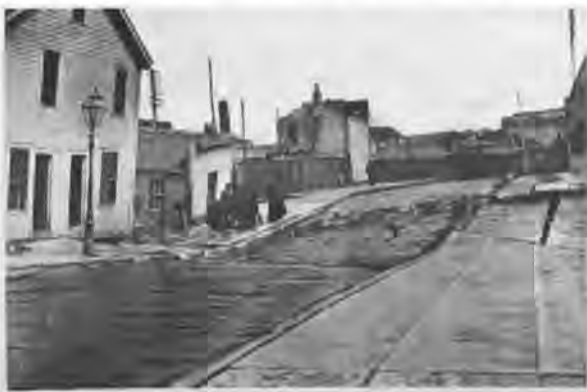
Fig. 9 Conditions on Dore Street Near Brannan After the 1906 San Francisco Earthquake [Lawson et al., 1908]

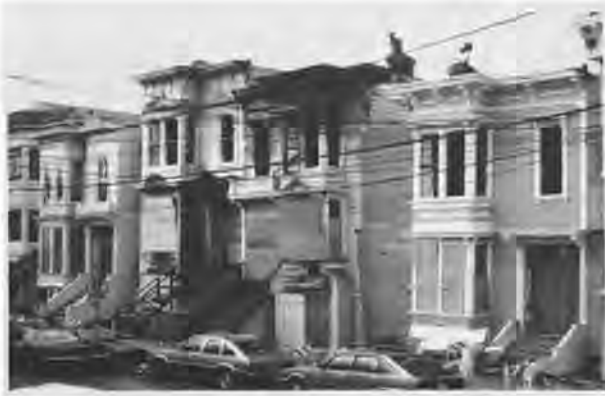
Fig. 10 Four Buildings on Shotwell near 18th Street Damaged by Liquefaction-Induced Foundation Displacements in the Loma Prieta Earthquake

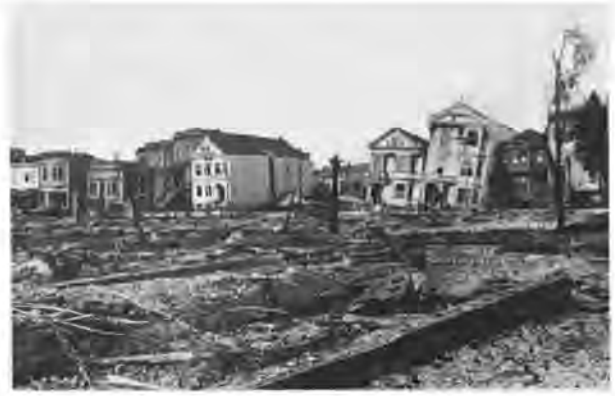
Fig. 11 Conditions at 18th and Shotwell Streets After the 1906 San Francisco Earthquake [Lawson et al., 1908]

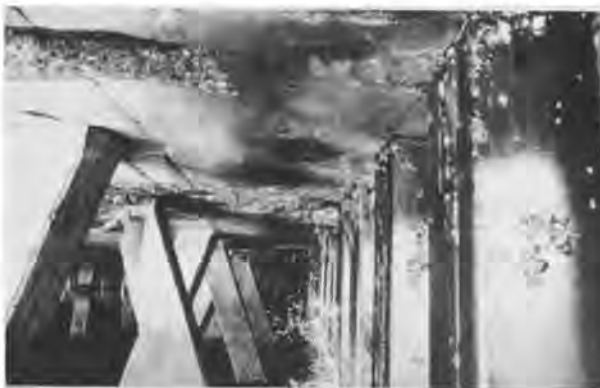
Most of the concrete wharves at the edges of the terminal fills were supported primarily on vertical concrete piles, but the inboard two rows of piles at the 7th Street terminal were battered to provide lateral load resistance as shown in Figure 13. These battered piles were massively damaged at their tips, as shown for example in Figure 14, illustrating the problems inherent in the use of battered piles to withstand seismic forces in an otherwise compliant soil system. Most of the terminal wharves at the affected Port facilities had at least one row of battered piles, and these consistently behaved poorly. The damaged piles (both battered and vertical) from the wharves supported on a combination of battered and vertical piles are currently being replaced by vertical piles only.

Fig. 14 Tensile Failures at Top of Battered Piles at the 7th Street Terminal [Photo courtesy of the U.S. Army Corps of Engineers, South Pacific Division]

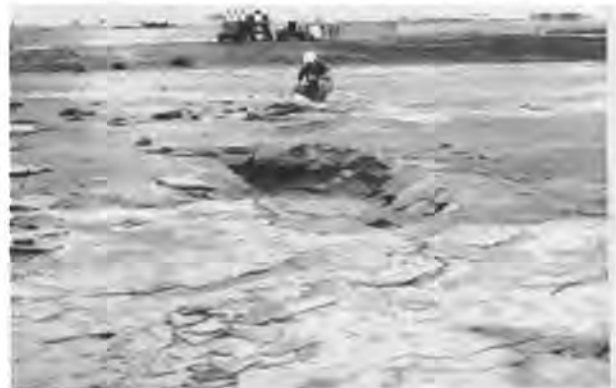
Station (NAS) and the Oakland International Airport were damaged by liquefaction of hydraulic fills. Figure 15 shows a sand boil adjacent to a runway at Alameda NAS. Lateral spreading, settlement, sand boils and pavement damage occurred at and near the runways at the northern end of Alameda NAS, though farther south in areas containing structures liquefaction was limited and damage to structures was relatively minor.

Fig. 15 Large Sand Boil and Sinkhole Adjacent to Runway at Alameda Naval Air Station

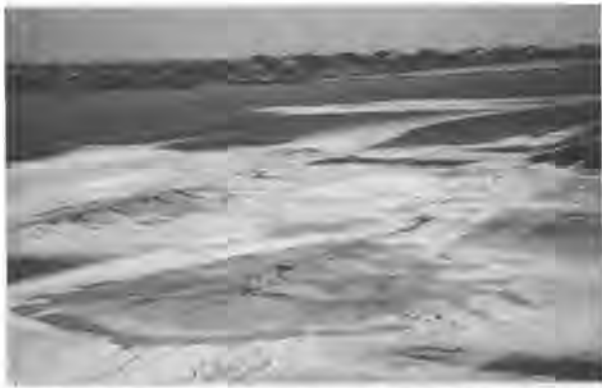
Soil liquefaction caused significant damage to the northwest end of the main runway at Oakland International Airport, as shown in Figure 16, and also damaged levees surrounding the edges of the airport's hydraulic fill. In addition to the damage to the main runway, sand boils and fissures resulting from lateral spreading occurred over significant portions of the airport fill, and a significant sand

Fig. 16 Fissures and Exuded Boil Materials, Main Runway, Oakland International Airport

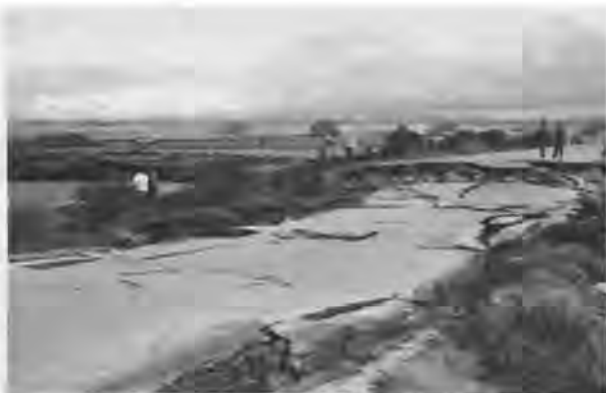
Fig. 18 Flow Failure of the Moss Landing Approach Road Embankment

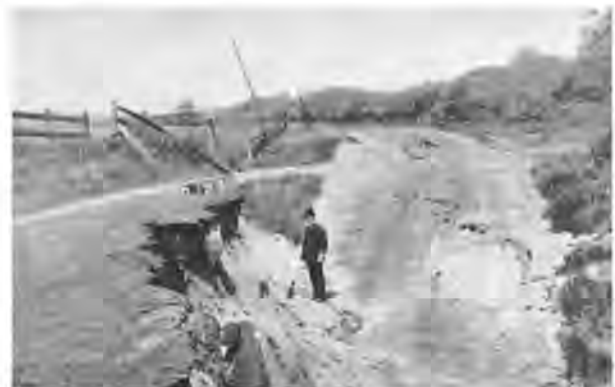
Fig. 19 Apparent Massive Lateral Spreading and Settlement at the Edge of the Salinas River, Near Spreckels, After the 1906 San Francisco Earthquake [Lawson et al., 1908]

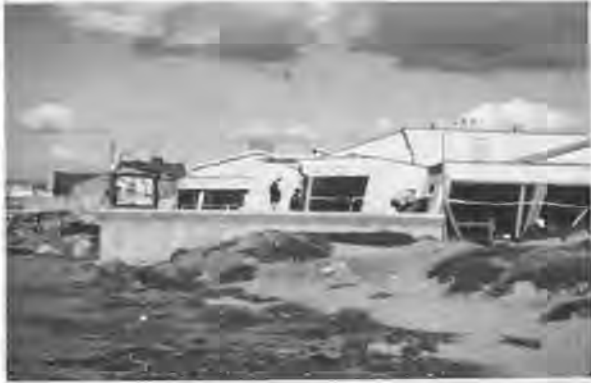
One of the clearest examples of the structural damage that can result from soil liquefaction was the destruction of the Marine Research Facility at Moss Landing. This facility was a group of low, modern 1- and 2-story structures founded on concrete slabs. The structures were grouped together to provide a series of classrooms and laboratories surrounding a central courtyard. The buildings do not appear to have been significantly damaged by shaking during the Loma Prieta Earthquake. This facility was, however, destroyed beyond repair by foundation displacements (settlement and lateral spreading) as a result of liquefaction of the foundation soils. The inboard roadway adjacent to this structure settled several feet, and lateral spreading deformations of the foundation soils stretched the facility by 6 feet, literally pulling it apart. Figure 20 presents an exterior view of this facility, clearly showing the massive damage caused by these foundation movements. Figure 21 shows a large warehouse which was destroyed at essentially this same site by similar lateral spreading in the great 1906 San Francisco Earthquake.

Fig. 20 Damage to the Moss Landing Marine Research Facility as a Result of Settlement and Lateral Spreading
