Lifeline and Geotechnical Aspects of the 1989 Loma Prieta Earthquake

SYNOPSIS: This paper provides an overview of areas in San Francisco which were affected by soil liquefaction and significant ground deformation as a result of the Loma Prieta earthquake. The distribution of pipeline system damage is examined, and comparisons are made between 1989 and 1906 patterns of water supply damage. Special attention is given to the Marina to illustrate how the natural site conditions and artificial fills contributed to soil liquefaction and buried pipeline damage of both the water and gas distribution networks. Finally, the liquefaction potentials of natural beach and sand bar deposits, land-tipped fill, and hydraulic fill are evaluated and compared.

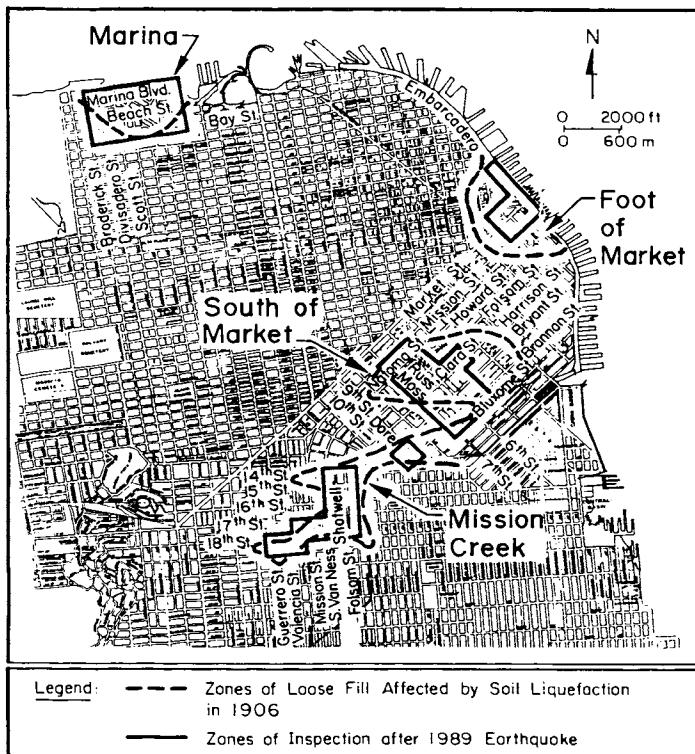
Figure 1 shows four areas within San Francisco for which there is historical evidence of soil liquefaction and large ground deformations during the 1906 earthquake. These areas, which are bounded by dashed lines, include the Mission Creek, South of Market, Foot of Market, and Marina districts. Each of these areas was investigated after the 1989 earthquake by one or more of the coauthors within the approximate boundaries shown by the solid lines.

Figure 1. Zones of Soil Liquefaction in San Francisco Caused by 1989 Loma Prieta Earthquake (after O'Rourke, et al., 1990)

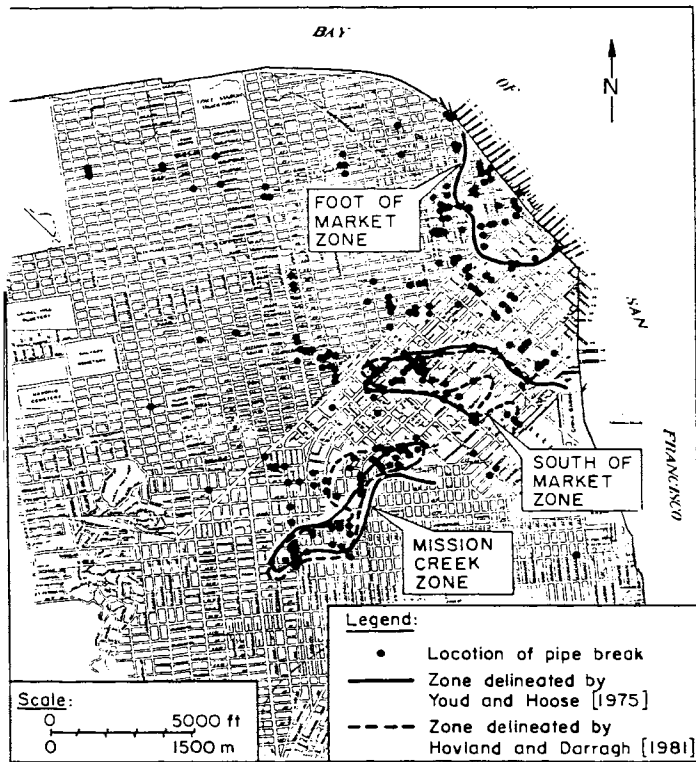
Figure 2. Water Supply Pipeline Breaks and Zones of Soil Liquefaction Caused by 1906 San Francisco Earthquake (after O'Rourke, et al., 1985)

San Francisco after the 1906 earthquake (O'Rourke, et al., 1985). This plot of pipeline breaks was developed on the basis of maps by Schussler (1906) and Manson (1908), which show the locations of principal water main ruptures. Superimposed on the plot are the boundaries in which lateral spreading from soil liquefaction was observed during the 1906 earthquake. The boundaries of lateral spreading are plotted on the basis of zones delineated by Youd and Hoose (1975) and Hovland and Darragh (1981). The agreement among the zone boundaries from the different studies is good. Although the zones of lateral spreading account for only 5% of the built-up area of 1906 affected by strong ground shaking, approximately 52% of all pipeline breaks occurred inside or within one city block of these zones.

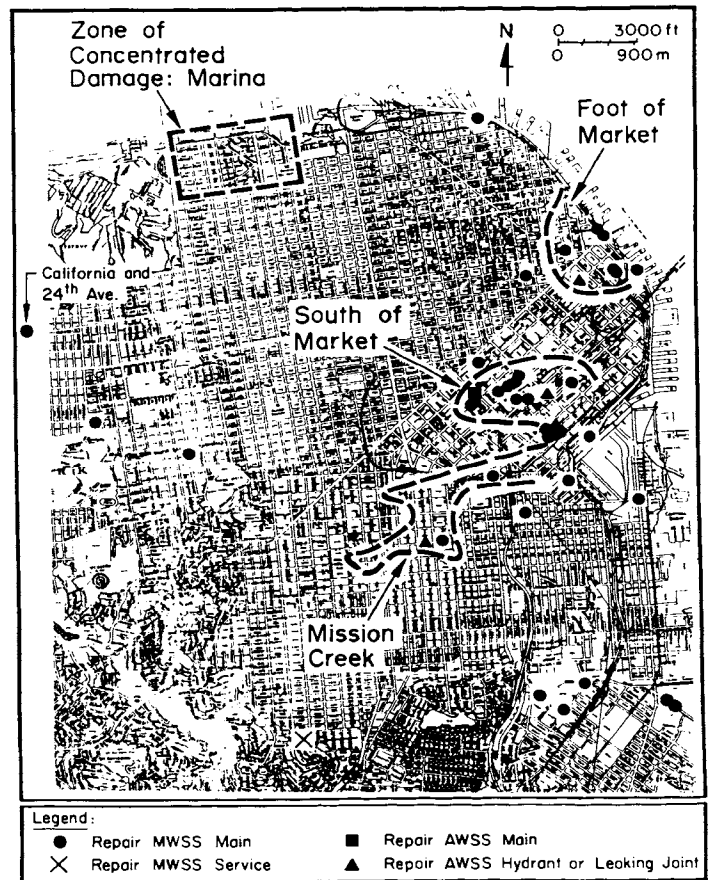
Figure 3 shows the locations of water pipeline system repairs after the 1989 Loma Prieta earthquake. Zones of potential soil liquefaction, based on maps by Youd and Hoose (1975) and Hovland and Darragh (1981) also are shown. Repairs to both the current Municipal Water Supply System (MWSS) and Auxiliary Water Supply System (AWSS) are indicated by the appropriate symbols. The MWSS supplies potable water for domestic and commercial uses, as well as for fire fighting via hydrant and sprinkler systems. After the 1906 earthquake, the AWSS was constructed to provide emergency fire protection. This system is intended to augment the city's existing fire fighting capacity by providing a supplementary network that works independently of, but in par-

Figure 3. Water Supply Pipeline Breaks and Zones of Soil Liquefaction Caused by 1989 Loma Prieta Earthquake

By comparing Figures 2 and 3, it is clear that pipeline breaks in 1989 and 1906 were clustered at similar locations in liquefaction-prone areas. The consistency in damage patterns, combined with the facts that: 1) pipelines tend to deform as the ground deforms, and 2) a pipeline network covers a broad area, provides us with the opportunity to use the pipeline system as an observational tool which reflects local earthquake severity. At the same time, the damage observations give us an empirical framework from which to estimate the potential levels of pipeline repairs relative to local geologic and geotechnical site characteristics.

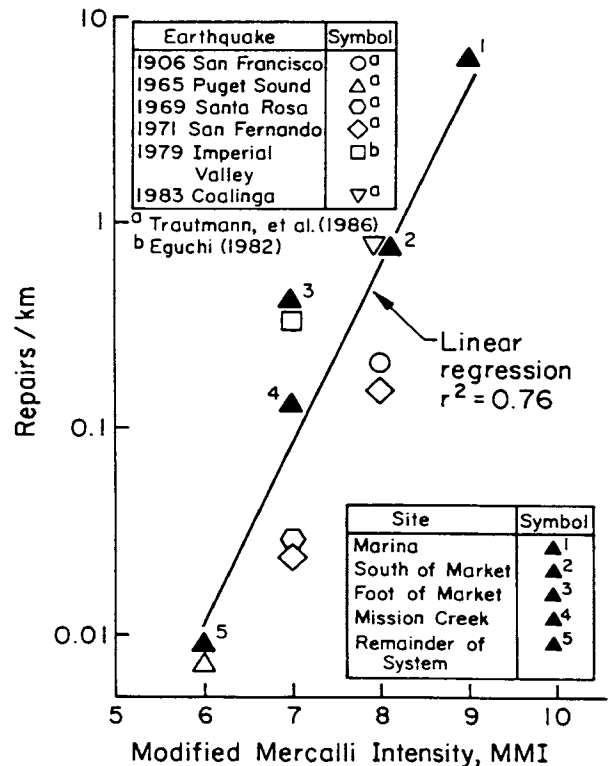
Table 1 shows substantial differences in pipeline repair rates for different sectors of the city. In effect, the repair rate is an index of seismic intensity. In Figure 4, the repair statistics for Loma Prieta are combined with repair statistics for other earthquakes to explore further the relationship between pipeline damage and MMI. All data in the plot represent systems composed entirely or predominantly of cast iron lines.

As illustrated in the figure, there is a clear linear trend of repairs/km with MMI. Moreover, the trend in the Loma Prieta data is consistent with that of the other western U.S. earthquakes. Such empirical evidence implies that cast iron pipeline damage varies exponentially with MMI. Repair rates increase by roughly an order of magnitude for each single digit advance in the MMI scale.

Figure 4. Repair Rate of Cast Iron Pipeline Systems versus Modified Mercalli Intensity

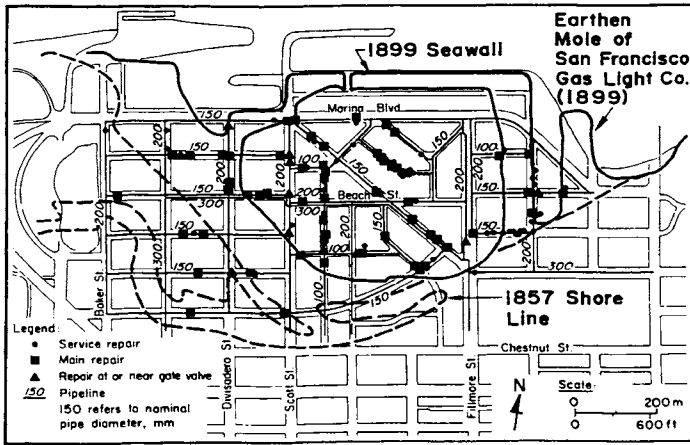
Figure 5 shows a plan view of the MWSS pipelines and repairs relative to the current street system, 1899 shoreline (Sanborn Ferris Map Co., 1899) and 1857 shoreline (U.S. Coast Survey, 1857). Most repairs were concentrated in the area of hydraulic fill within the lagoon bounded by the 1899 seawall, or along the eastern margins of the seawall and 1857 shoreline.

There were about 123 repairs in the Marina, more than three times the number of repairs in the entire MWSS outside the Marina. Repairs were made at locations of sheared or disengaged service connections with mains, flexural round cracks in mains, and longitudinally split sections of main. In some cases, damage was concentrated at or near gate valves. These devices tend to anchor the pipelines, and therefore may contribute to locally pronounced deformation and stresses. The figure shows the locations of repairs to: a) services, b) mains, and c) sections of line at or near gate valves. The MWSS pipelines were composed predominantly of cast iron,

Figure 5. MWSS Repairs in the Marina (after O'Rourke and Roth, 1990)

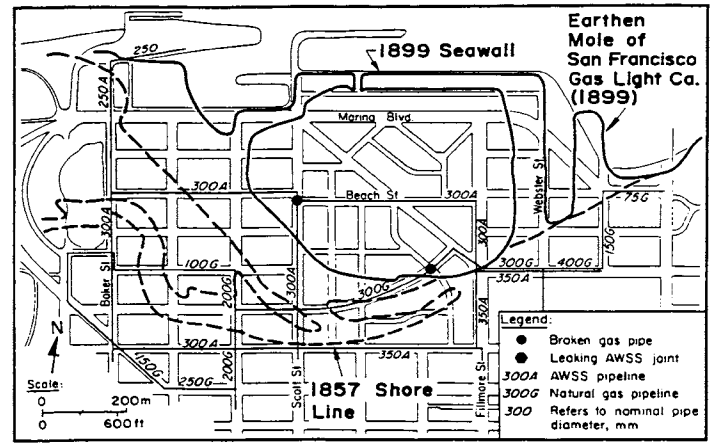
Figure 6 shows the locations of pipeline repairs to the AWSS and high pressure gas distribution network in the Marina. It should be noted that the term "high pressure" is intended to distinguish pipelines conveying gas at approximately 200 kPa from low pressure distribution lines at approximately 2 kPa.

Even though substantial damage was sustained by the MWSS in the Marina, there was only one instance of AWSS repair in this area. This occurred at a leaking joint at Scott and Beach Sts. Pipelines of the AWSS are equipped with sleeved joints, which are restrained against pullout by longitudinal bolts. Cast iron pipelines of 250 and 300-mm diameters are used in the Marina with joint-to-joint lengths of 3.7 m. The relatively large diameter-to-length ratio, in conjunction with joints which are able to rotate and are axially restrained, allows the pipelines to accommodate differential ground movement.

Only one location of damage was reported for the high pressure gas distribution lines at a miter joint near the boundary of hydraulic fill and 1857 shoreline. The high pressure mains were constructed mostly of Grade B steel with electric arc girth welds.

Figure 6. AWSS and High Pressure Gas Distribution Repairs in the Marina

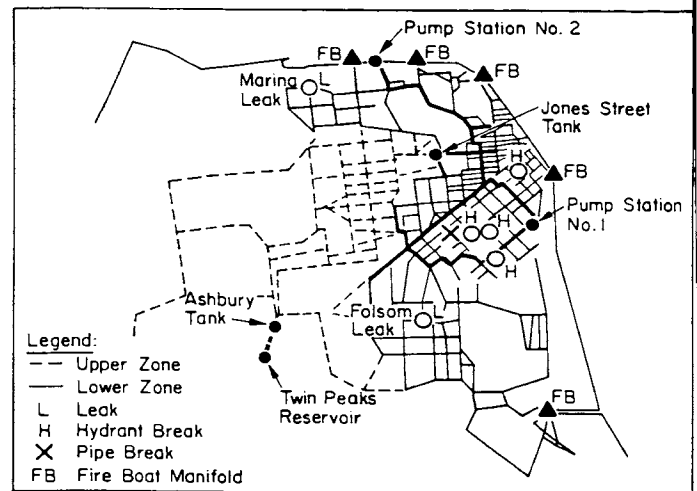
Figure 8 shows a plan view of the system that was simulated to reproduce the conditions on the night of the earthquake. Water in the lower zone was supplied by the Jones St. Tank. The lower and upper zones were isolated from one another with closed gate valves. Pump Stations 1 and 2 were not included in the simulation to replicate the system conditions immediately following the earthquake.

Damage of the AWSS occurred as a broken 300-mm diameter main on 7th St., four broken hydrants, and two leaking joints. The approximate locations of these damaged components are illustrated in the figure. Hydrants were the most vulnerable parts of the system, with damage being concentrated at elbows. Typical construction involves a 200-mm diameter cast iron elbow affixed to a concrete thrust pad beneath the street surface hydrant. Damage at hydrant elbows occurred as 45° fractures centered on the elbows.

Figure 8. Conditions Used in Computer Simulation of AWSS Performance During the Loma Prieta Earthquake

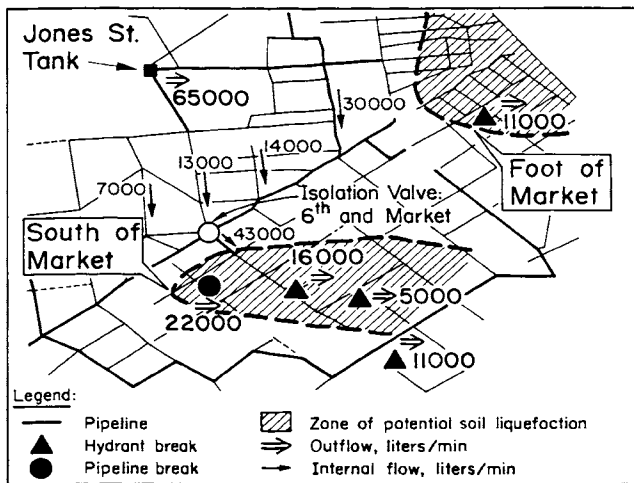
Figures 9 and 10 show the results of the analyses in graphical format. In each figure, open arrows denote water egress either from the Jones St. Tank or damaged components. The solid arrows denote internal flow. Zones of potential soil liquefaction in the South of Market and Foot of Market areas also are shown.

In Figures 9 and 10, the total flow rates from the Jones St. Tank are 65,000 and 78,000 liters/min., respectively. The increase in flow rate for the second case represents the additional draw on the system from modeling leaks as equivalent to open hydrants. Given that the normal operating capacity of the Jones St. Tank is approximately 2.72 million liters of a maximum 2.84 million liters, the time required to empty the Jones St. Tank would have been between 42 and 35 minutes, pertaining to the conditions in Figures 9 and 10, respectively.

Figure 9. Results of AWSS Simulation with Negligible Water Loss from Leaking Joints

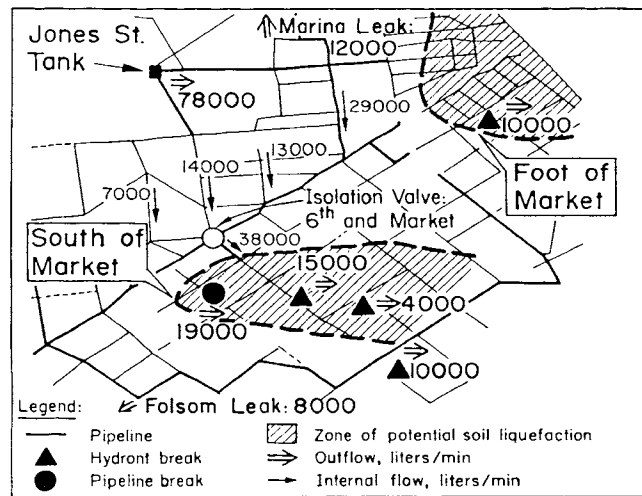
The AWSS performance and computer simulations emphasize how rapidly water can be lost and how important automatic control of isolation gate valves can be. The simulations also underscore the importance of hydrant breaks. In both Figures 9 and 10, the combined flow from two broken hydrants in the South of Market infirm area equals the flow from the ruptured 300-mm main.

Figure 10. Results of AWSS Simulation with Leaking Joints Modeled

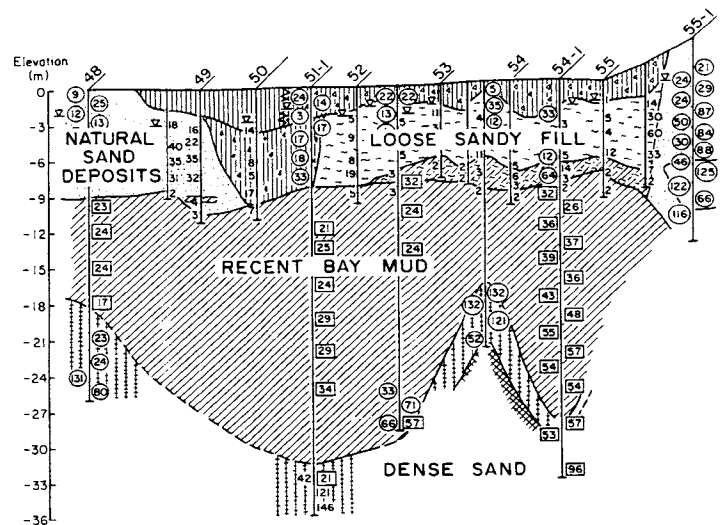
Figure 17 shows loose fill with a maximum depth of about 9 m extending along Marina Blvd. from approximately Baker to Buchanan Sts. This distance correlates well with the distance between locations of the 1857 shoreline shown in Figure 12. The depth to water table is between 1.5 and 2 m. Underlying the loose fills and natural sand deposits is Recent Bay Mud, which varies in thickness along Marina Blvd. from 9 to 23 m and extends to a maximum depth of 32 m. Underlying the Recent Bay Mud are dense sands and stiff to hard clays.

Figure 17. Cross-Section of Subsurface Soils in the Marina

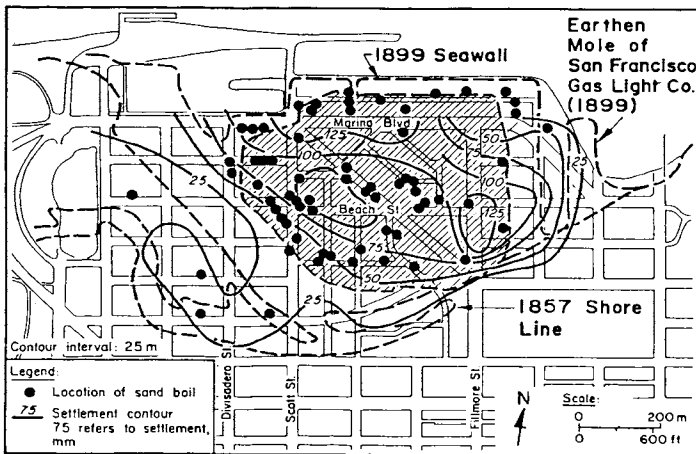
Figure 18 shows contours of soil settlement and sand boil locations in the Marina, as reported by Bennett (1990). It should be noted that the contours in Figure 18 represent the incremental settlements between 1974 and 1989, and thus involve some component of movement which may be attributed to consolidation of the Recent Bay

Mud. Judging from the incremental settlements from 1961 to 1974, which also were reported by Bennett (1990), such time-dependent displacement would represent only a small percentage (10 - 20%) of the vertical movements shown in the area of hydraulic fill. It also should be pointed out that no distinction is made in this figure between sand boils arising from soil liquefaction as opposed to those potentially caused by leaking water pipes, as was done by Bennett.

Figure 18. Sand Boil Locations and Contours of Equal Settlement in the Marina

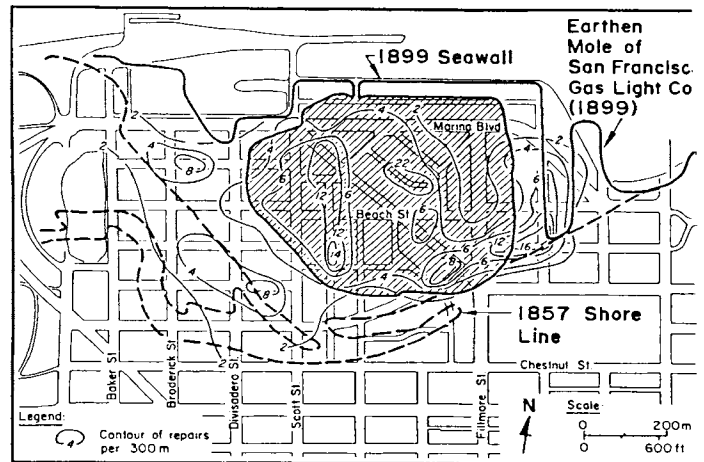
To represent the distribution of MWSS damage, the Marina was divided into a grid of approximately 40 cells, and the number of repairs per length of pipeline in each cell was counted. Each repair rate then was normalized with respect to a reference length of 300 m to provide a consistent basis for evaluation. Contours of equal repairs per 300 m of pipeline were drawn and superimposed on the street system and previous shorelines, as illustrated in Figure 19. The contours of pipeline repair rates are related closely to the settlement contours, hydraulic fill, and 1857 shoreline. High concentrations of pipeline repair fall within the area of hydraulic fill, and the heaviest repair concentration occurs at the junction of the hydraulic fill, 1899 seawall, and 1857 shoreline. Over 80% of MWSS main repairs were for round cracks, which implies that bending and longitudinal tension were the predominant modes of deformation.

Figure 19. Contours of Equal Intensity of MWSS Pipeline Repair in the Marina

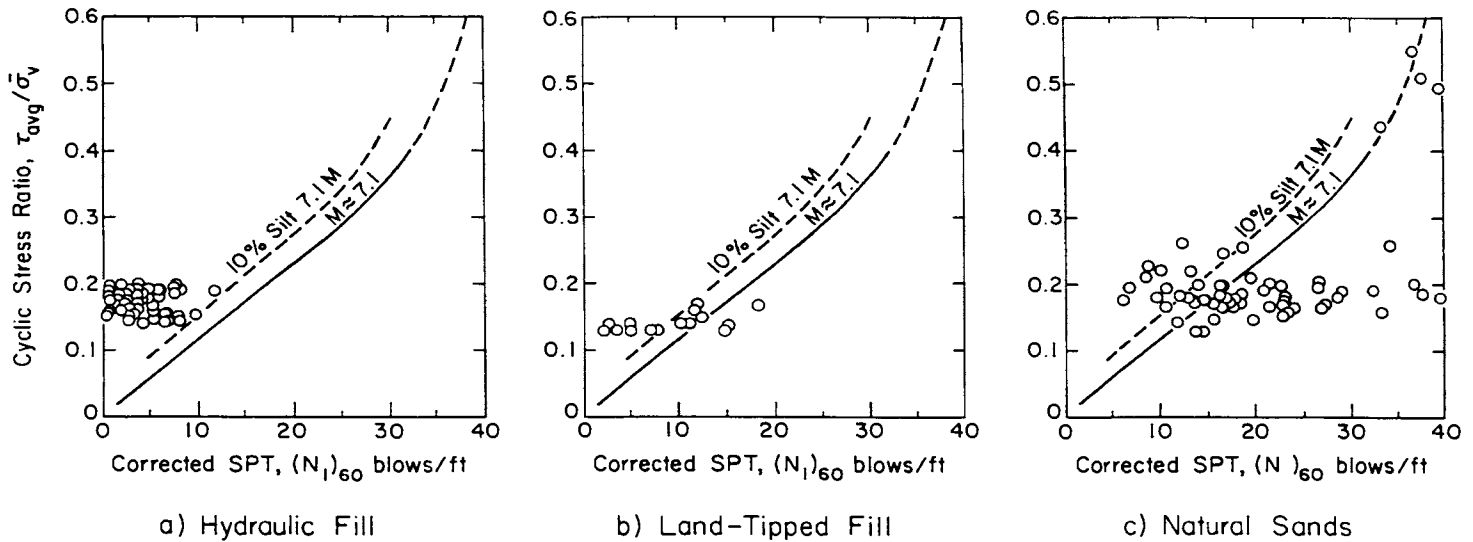
Figure 20 shows the cyclic stress ratio plots for the three types of soil. In each figure, the empirical dividing line between liquefiable (upper left) and nonliquefiable soils is plotted for a magnitude 7.1 earthquake. Curves for both clean sand and sand with 10% fines were drawn in accordance with the recommendations of Seed and DeAlba (1988) and plotted in the figures.

The most striking feature of the plots is the relatively high susceptibility to liquefaction displayed by the hydraulic fill. As illustrated in Figures 18 and 19, concentrations of settlement, sand boils, and MWSS pipeline damage are associated with this highly susceptible material. The corrected SPT values for the majority of measurements in the sample are less than 5. This implies that the hydraulic fill would have a very low undrained residual shear strength, perhaps lower than 5 kPa, based on empirical relationships suggested by Seed (1987). Such low strength makes the hydraulic fill vulnerable to flow failure. Accordingly, the stability of the seawall in the Marina is especially critical because it provides lateral confinement of soil, which might otherwise be subject to retrogressive sliding in the event of a major earthquake.

In contrast, both the land-tipped fill and natural soils show increasing resistance to liquefaction. These soils also show a successively larger range of in-situ densities, reflected by the SPT values. Roughly half the land-based fill data plot to the right of the 10% silt curve. The distribution of settlement and pipeline damage within the land-tipped fills seems consistent with the behavior implied by the plot. The majority of the natural soil data plot to the right of the empirical dividing lines.

The wide range of in-situ densities for the land-tipped fills and natural soils implies a variability in liquefaction response. Such variation in density can affect the extent of liquefaction, as well as the magnitude and pattern of ground deformation once high pore pressures develop in the looser materials. Data such as those in Figure 20 raise questions about the role of soil variability during seismic shaking and its relationship with the loss of shear strength and ground deformation.

Figure 20. Liquefaction Susceptibility of Soils in the Marina for the 1989 Loma Prieta Earthquake
