Lessons Learned from Liquefaction and Lifeline Performance During San Francisco Earthquakes

T. D. O'Rourke
Cornell University, Ithaca, New York

J. W. Pease
Cornell University, Ithaca, New York

Paper No. SOA12

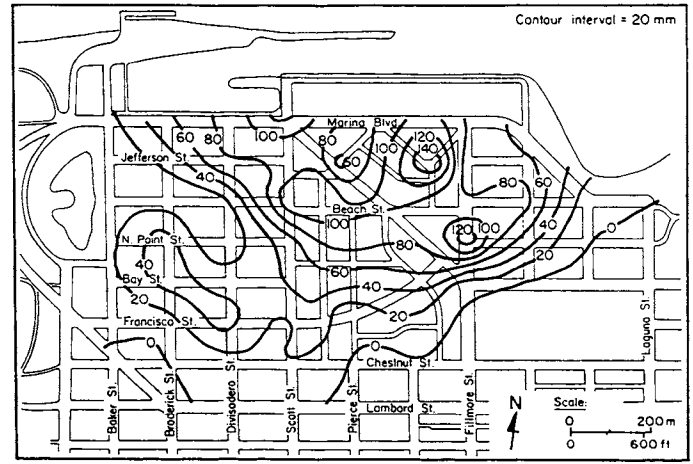
Figure 5. Contours of Corrected Settlement in mm in the Marina District

Secondary settlements for the survey period including the earthquake, 1974 to 1989, were calculated according to procedures explained by O'Rourke, et al. (1992), and at each intersection were subtracted from the unadjusted settlements to yield "corrected" settlements. These corrected settlements, in Figure 5, represent the settlement caused by post-liquefaction consolidation after the Loma Prieta earthquake.

The damage mapped in Figures 6 and 7 and its close relation to the pattern of settlement mapped in Figure 5 indicate a strong link between pipeline damage and differential settlement that is corroborated further by correlations plotted in Figure 8.

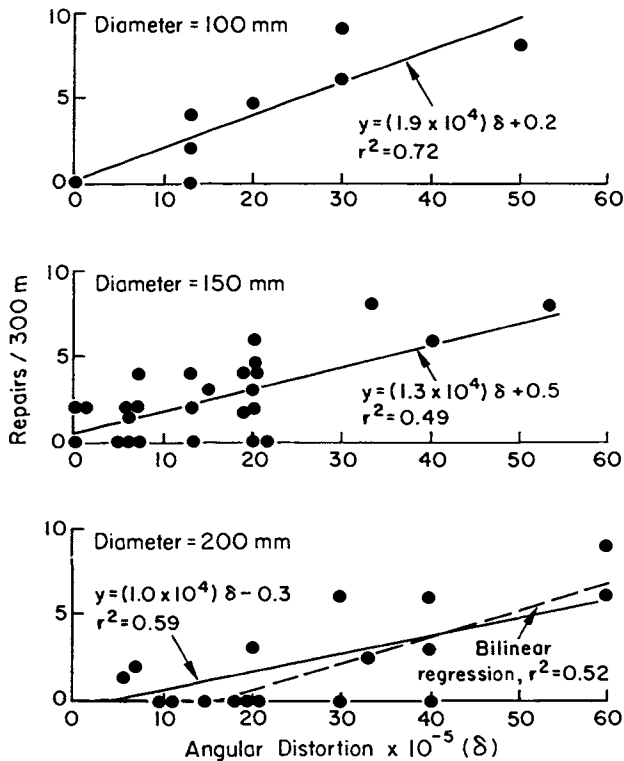
Figure 8. Linear Regressions of MWSS Repair Rate Versus Angular Distortion for Water Mains 100, 150, and 200 mm in Diameter

Only a weak correlation was found between repair rate and the magnitude of settlement. Relatively good correlations were found between repair rate and angular distortion. Regressions were developed for each diameter of main, and the resulting relations between MWSS repair rate and the angular distortion are plotted in Figure 8. An equation and coefficient of determination, r^2 , are given for each regression curve in Figure 8. The slopes of these plots increase in inverse proportion to the nominal pipe diameter. For 200 mm diameter mains, a bilinear plot (dashed curve, Fig. 8) also conforms with the data.

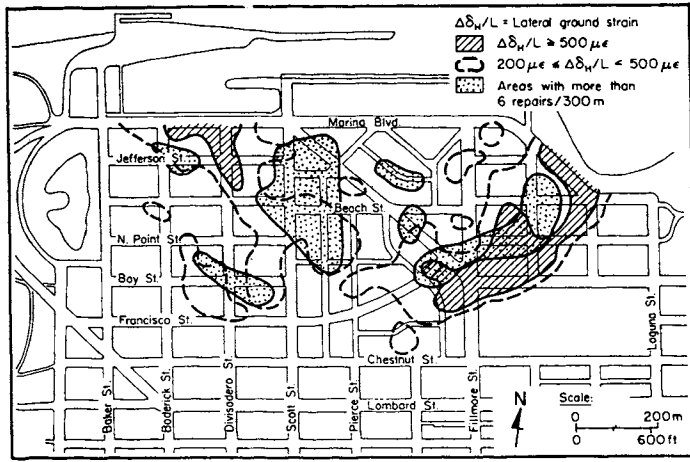
Figure 10. Maximum Lateral Ground Strains Resulting from Ground Oscillation with 1.25 to 2.0% Shear Strain, and Regions with Pipe Damage Exceeding 6 repairs/300 m

Of particular significance is that lateral ground strains varying from 200 to 900 $\mu\epsilon$ are predicted over a significant portion of the submerged fill. These levels of lateral strain, unlike the bending strains calculated from differential settlement, are fully compatible with levels sufficient to cause damage in cast iron pipelines. Moreover, the lateral ground strains are similar in magnitude to the angular distortion calculated from the post-liquefaction settlement contours. This similarity arises because average vertical strains caused by post-liquefaction consolidation are approximately 2% on average (O'Rourke, et al., 1992), which is approximately equal to the best estimate of transient lateral shear strain for the Marina. The use of lateral ground strain caused by oscillatory motion of the liquefied fill provides, therefore, an alternative source of pipeline deformation which not only is compatible with the failure threshold of cast iron pipelines, but also is able to explain why pipeline damage is so closely correlated with differential settlement.

There is good agreement between the areas of maximum lateral ground strain in Figure 10 and those with the highest concentration of pipeline damage. In particular, there is close agreement along the southeastern and western margins of the fill.

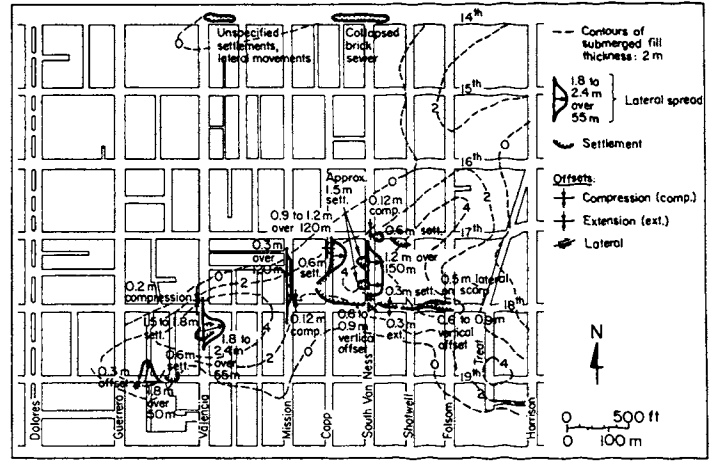
Figure 15. Ground Displacement and Liquefaction Features after the 1906 Earthquake in the Mission District

Figure 15 is a map of ground deformations and liquefaction features observed after the 1906 earthquake in the Mission District. The deformation patterns were previously mapped by O'Rourke and Lane (1989), and have been superimposed over contours of submerged fill thickness. Hatchured lines indicate settlement, with the hatchures pointing toward the area of settlement.

A striking feature of Figure 15 is the occurrence of lateral spread in areas with roughly 2 m or more of submerged fill. A major lateral spread is centered on Valencia St. with over 6 m of submerged fill. The ground under Valencia St. spread east and slightly northward down the center of the former ravine, with maximum lateral displacements of 1.8 m to 2.4 m and settlement of 1.5 m. A second area of lateral spread occurred between Capp St. and South Van Ness Ave, where maximum lateral movement of 1.2 m occurred. The thickness of submerged fill is greater than 2 m in this area, and increases towards the east. Maximum lateral movement and settlement of 0.3 m occurred over a width of 120 m across Mission Street between these two sites. Given the relatively small movement on Mission St., it is possible that lateral spread in Upper Mission Creek may not have been a single continuous feature, but may have consisted of two or more discontinuous features occurring in locations where submerged fill is thickest.

Nearly all liquefaction features were confined within zones of submerged fill. Compressional, extensional, or lateral offsets were prominent at the edges of submerged fill where fill is between 1 and 4 m thick. Buckled curbs, major extension cracks, and distortion of pavements were prominent on 18th St between Mission and Folsom Sts. on the south side of the liquefaction zone. Cracks were widest near Folsom St., where submerged fill thickness is as deep as 4 m.

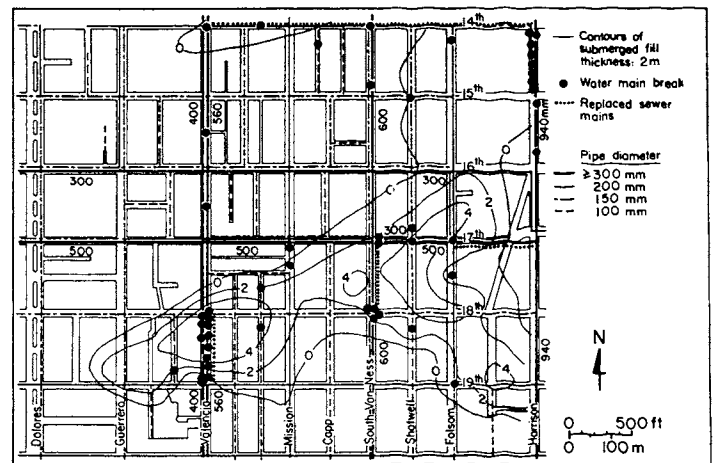
Figure 16. Water Supply Pipeline and Sewer Damage in 1906 in the Mission District

Figure 16 shows damage after the 1906 earthquake to the water supply and sewer system in the Mission District superimposed on the contours of liquefiable thickness. The locations and sizes of water mains are based on 1912 maps of the water distribution system (Edward Denny and Co., 1912). Water main breaks, shown by dark circles, refer to breaks reported by the Spring Valley Water Company (Schussler, 1906, Manson, 1908). In some cases where pipelines cross or run parallel, it is uncertain which pipes were broken. More than one break occurred at locations indicated by Manson on South Van Ness at 17th and 18th, and multiple breaks may have occurred at other locations as well. Sewer damage is based on

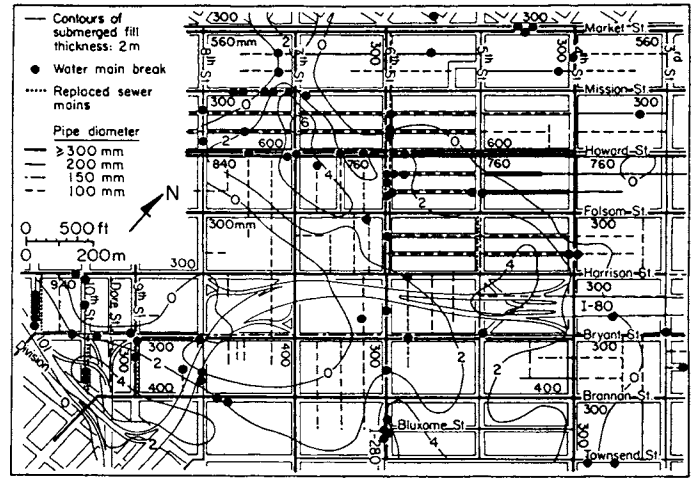
Figure 22. Water Supply Pipeline and Sewer Damage in 1906 in the South of Market

Figure 22 shows damage to the water supply and sewage systems in the South of Market superimposed over contours of liquefiable

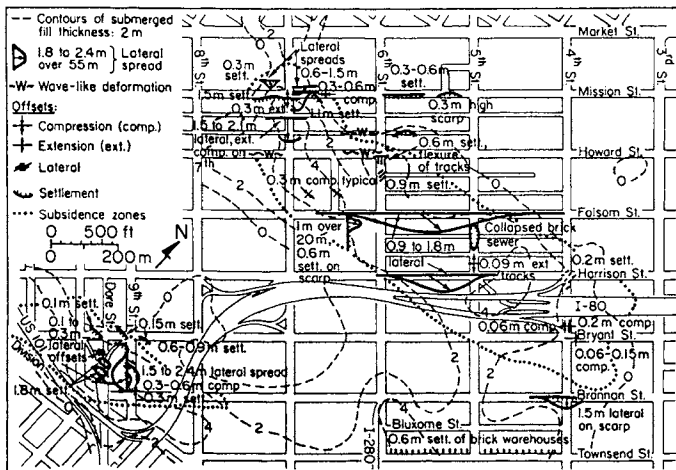
Figure 21. Ground Displacement and Liquefaction Features after the 1906 Earthquake in the South of Market

Figure 21 is a map of ground deformations and liquefaction features observed after the 1906 earthquake in the South of Market. The deformation patterns were mapped previously by O'Rourke and Lane (1989), and are superimposed over contours of submerged fill thickness. Similar symbols are used to describe liquefaction ground deformations. A heavy dotted line shows the outline of the major zones of subsidence as reported by Schussler (1906). Schussler indicates that lateral spread, offsets, and wavelike deformation were common throughout the area. Lawson, et al. (1908) reported settlements of amounts varying from a few millimeters to 900 mm or more throughout the former Sullivan Marsh.

In several places, both compressional and extensional offsets were superimposed. Kurtz (1906) describes a streetcar track at 4th and Bryant where rails were buckled due to 60 to 150 mm of shortening in compression, but then

translated back to their original position, leaving a 150 mm gap in the joints at the same location. In front of the Post Office at Seventh and Mission Sts., a 1 m high compression ridge occurred adjacent to settlement of similar magnitude, and parallel to cracks indicating over 1 m of lateral extension. At Brannan and 9th Sts., a 0.3 m high compression ridge marked the edge of the Dore St. subsidence zone, but settlement of 300 mm occurred immediately adjacent to the buckled pavement. The existence of compressional features adjacent to zones of permanent extensional displacement can occur only if the compression is related to transient effects, such as would occur during ground oscillation.
