1991 - Second International Conference on
Recent Advances in Geotechnical Earthquake
Engineering & Soil Dynamics

Geotechnical Units and the Damages Caused by Earthquakes in Valparaiso - Chile

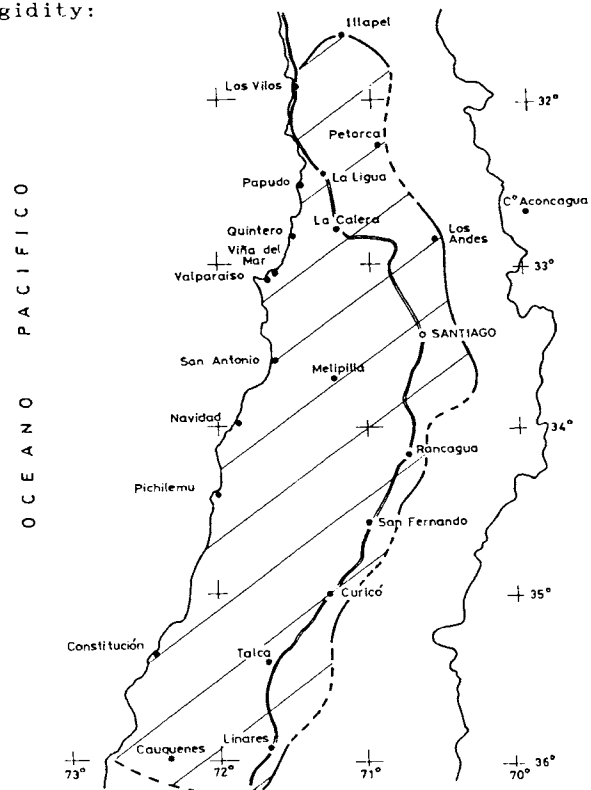
Fig. 1. Area of Damage, Chile Earthquake of March 3, 1985.

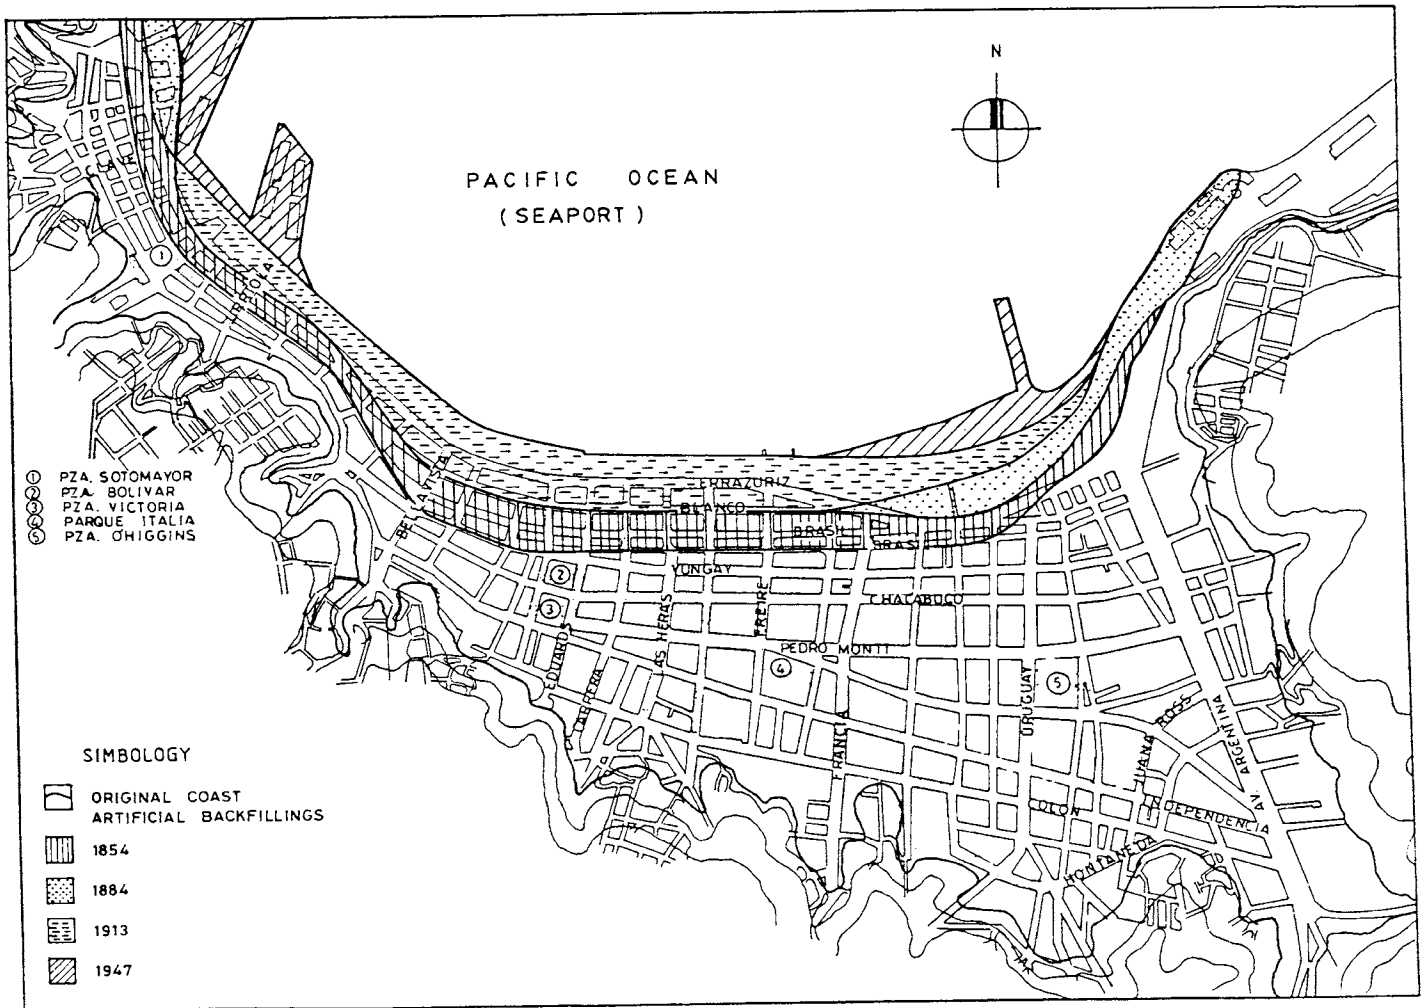
This unit has been produced by a series of partial back-fillings, Figure 2. It has varying composition that includes chiefly sands with demolition rubbish, fragments of brick, concrete slabs, rocky blocks, gravel and cobble stones. Major thicknesses are located along the present coastal line (1 and 12 meters) while minor thicknesses are to be found in the vicinity of contour elevation +20.

Fig. 2 Evolution of Artificial Backfillings Flat-ground Sector of Valparaiso.

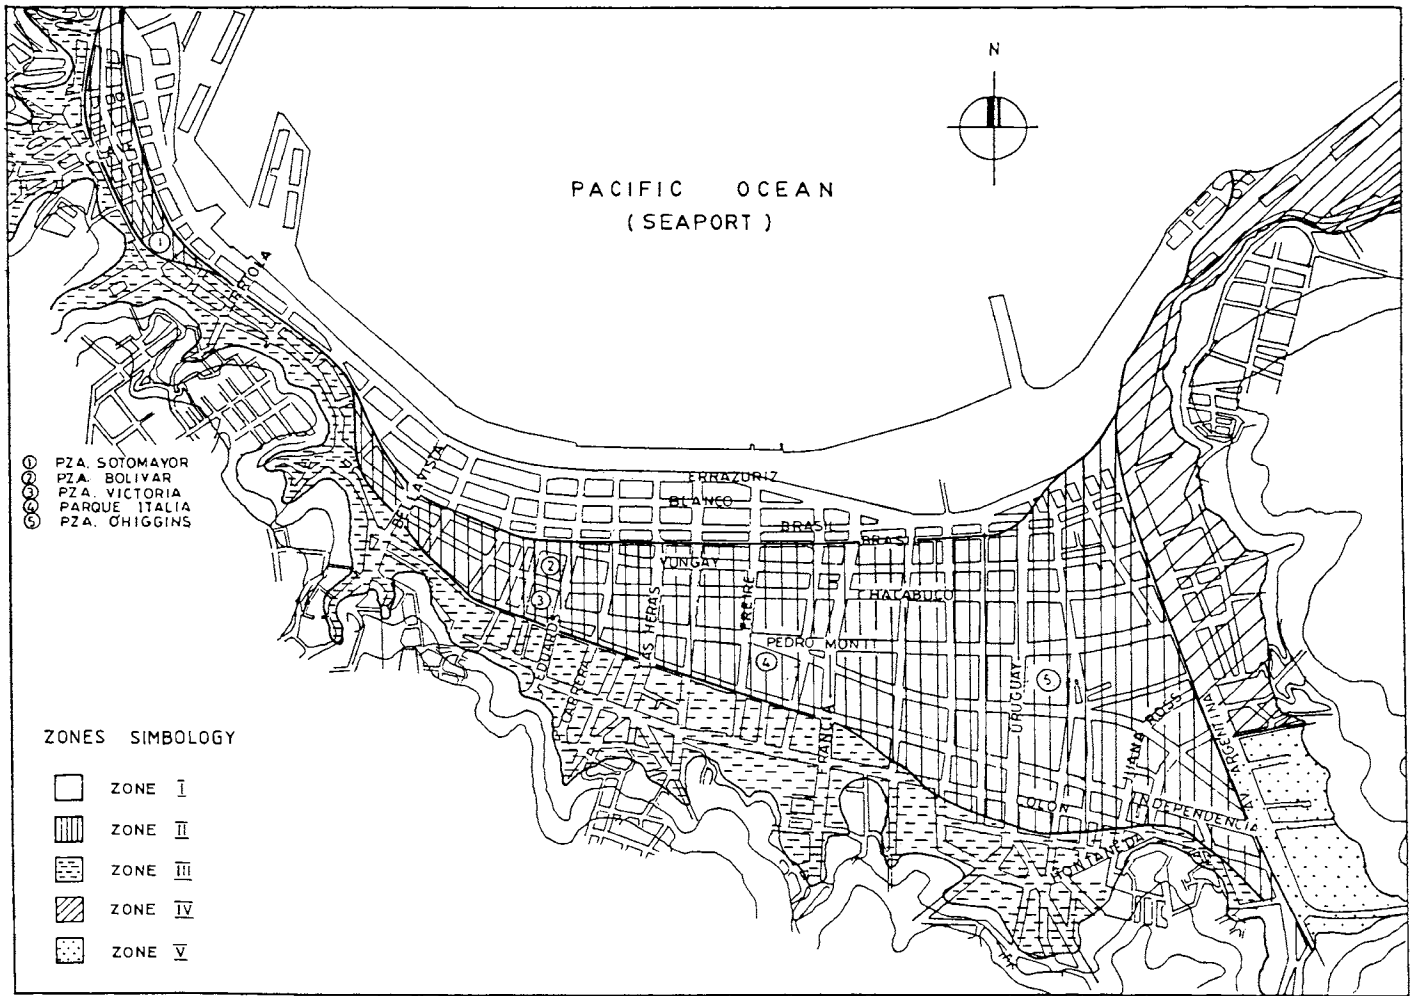
Fig. 3 Zoning of the Foundation Soil in Valparaiso Flat-Ground Sector.

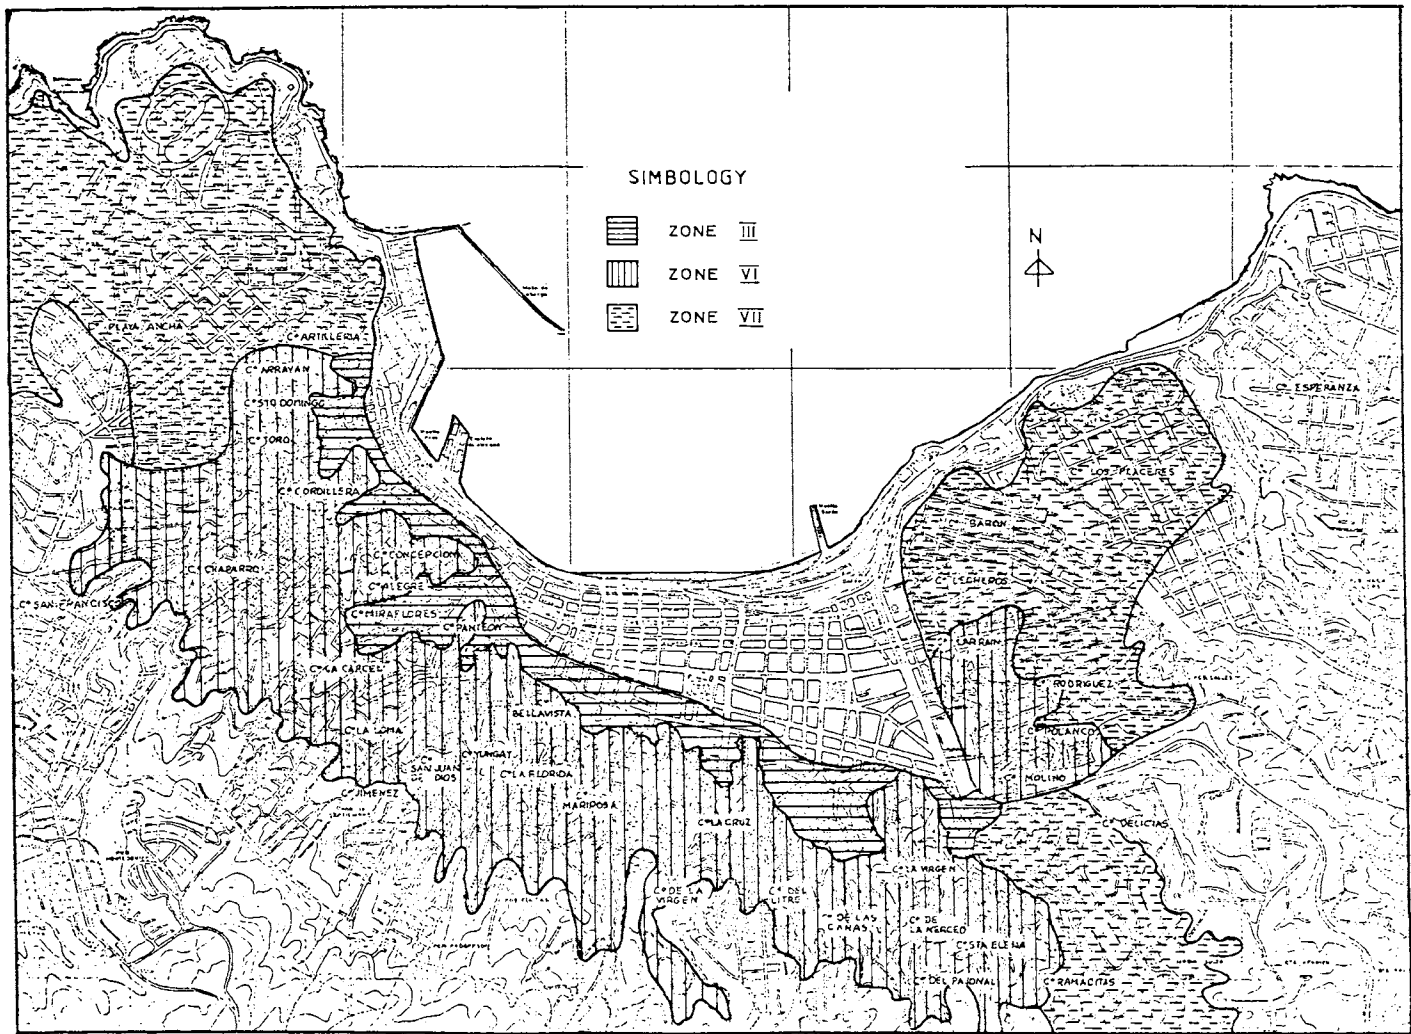
Fig. 4 Zoning of Foundation Soil in the High Sector of Valparaíso City.

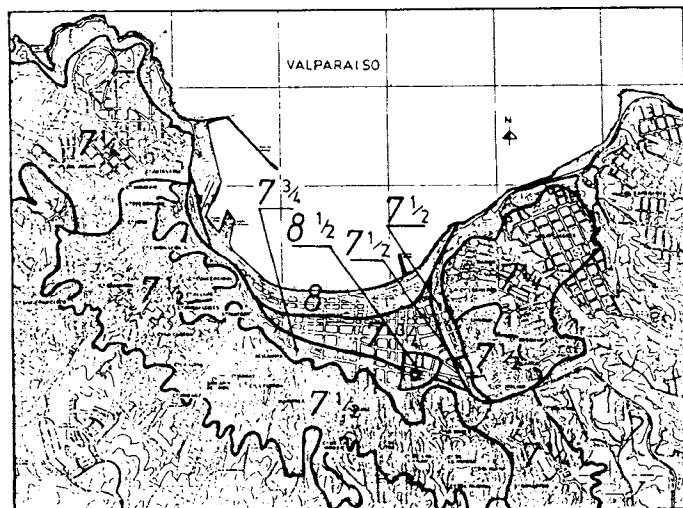
Figure 5 shows the intensity degrees in the sectors of Valparaiso city subdivision. This figure is clearly illustrating a special D-shaped sector formed by the perimeter comprising the streets of Victoria, Montaneda, Rancagua and Uruguay, because this D-sector represents a case of major destruction that has to be taken into account in order to avoid altering the results of adjacent sectors.

Fig. 5 Zoning of Valparaiso City Soils.

In the above mentioned D-sector, that was separately analyzed for the reasons already stated, an intensity of 8 1/2 was obtained. This zone comprising foundation soils II and III, has been particularly affected and this might be due to some local effect of soils interphase at this location. The fundamental rock (E1) in this zone is situated at a greater depth than in the remaining sectors of Valparaiso flat area, and the stratum made of artificial backfillings (E8) is having a compaction or consistency ranging from very loose (soft) to medium.
