2001 - Fourth International Conference on
Recent Advances in Geotechnical Earthquake
Engineering and Soil Dynamics

Damage to Water Supply System and Surface Rupture Due to Fault Movement during the 1999 Ji-Ji Earthquake in Taiwan

DAMAGE TO WATER SUPPLY SYSTEM AND SURFACE RUPTURE DUE TO FAULT MOVEMENT DURING THE 1999 JI-JI EARTHQUAKE IN TAIWAN

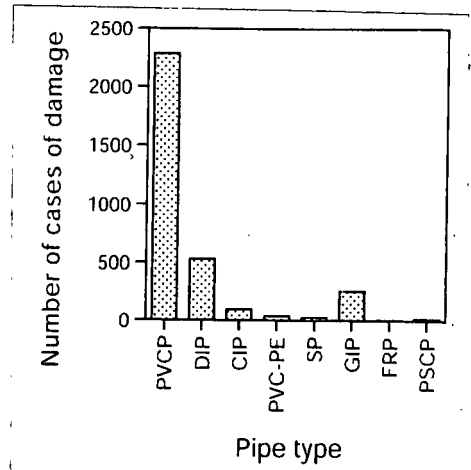
13,274 and the damage rate was 4.56 /km. The number of cases of damage and the damage rate related to pipe type are illustrated in Figs. 3 and 4 for transmission and distribution pipelines. The number of cases of damage for PVC-P was the greatest, but the damage rate was the greatest for GIP. It revealed that the damage rate depends on the pipe length. Figure 5 shows the relationship for number of cases of damage, pipe diameter and type of failure. It is revealed that the majority of failures occurred in the pipelines of relatively small diameter from 80mm to 200mm. The Water Works Association of the Republic of China (Taiwan) indicated the number of cases of damage in relation to the causes as shown in Fig. 6. About a half of the total number of failures was caused by ground shaking and about 35% were by fault movement. Liquefaction was about 2%. This figure clarified that the effect of fault movement to the failure of pipeline was great in this earthquake.

Fig. 3 Number of cases of damage related to pipe type. (transmission and distribution pipelines)

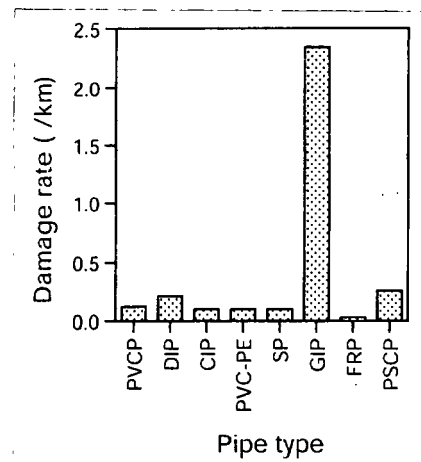
Fig. 4 Damage rate related to pipe type. (transmission and distribution pipelines)

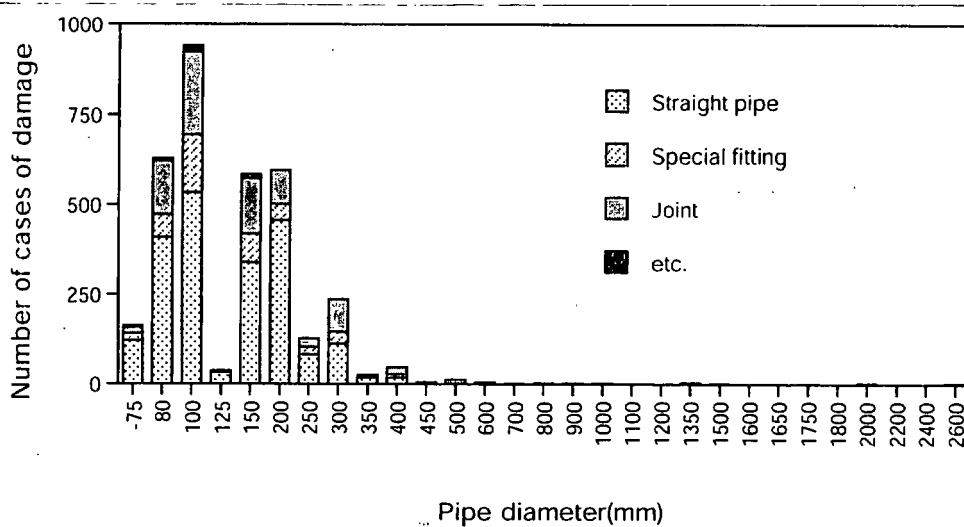
Fig. 5 Relationship for number of cases of damage, pipe diameter and type of failure.

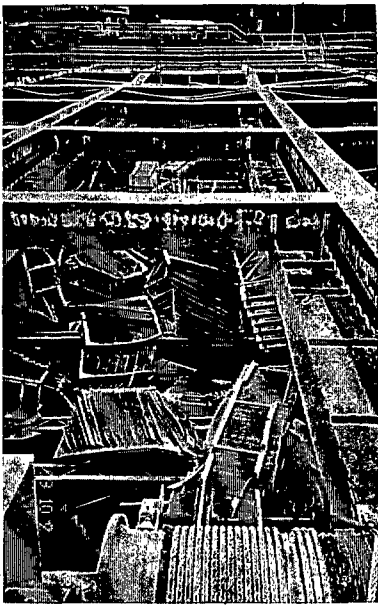
No.1 and No.2 Fonyuan purification plants were damaged severely because ground under the both purification plants went up about 4m due to the fault movement after the earthquake. The No.1 purification plant could not work after the earthquake because of extensive damage to the purification facilities. Photo. 1 shows the damage at the inclined plate clarifier of the No.1 Fonyuan purification plant. Some inclined plates jumped out from the clarifier. The ceiling slab of service reservoir of No.1 Fonyuan purification plant fell down as shown in Photo. 2. These damages seem to show the great ground shaking.

Photo. 1 Damage at inclines plate clarifier (No.1 Fonyuan purification plant).

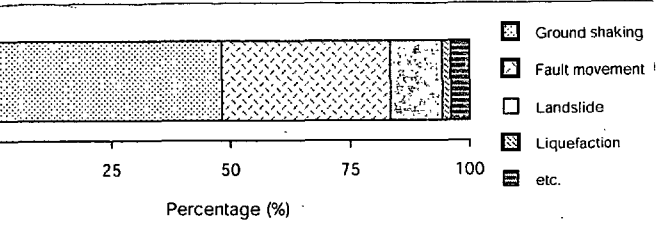
Fig. 6 Number of cases of damage in relation to causes of failure

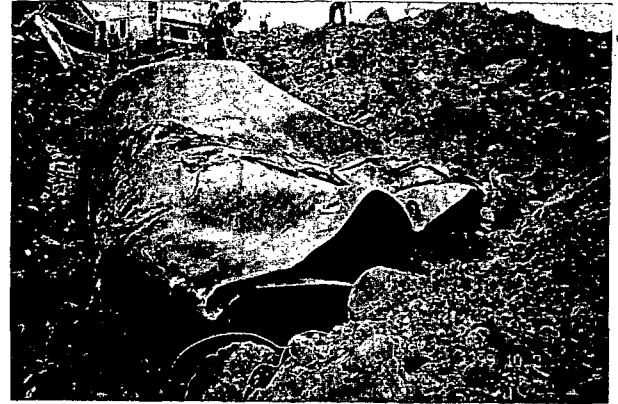
Photo. 3 indicates the damage to water conveyance steel pipe with 2000mm of diameter which was buried cross the fault line. Photo. 4 shows push in each distribution PVC pipe at joints. The displacement was about 80cm. These damages suggest that the ground displacement induced by fault movement was remarkable at the areas close to the fault.

Photo 3 Damage to water conveyance pipe (Diameter: 2000mm).

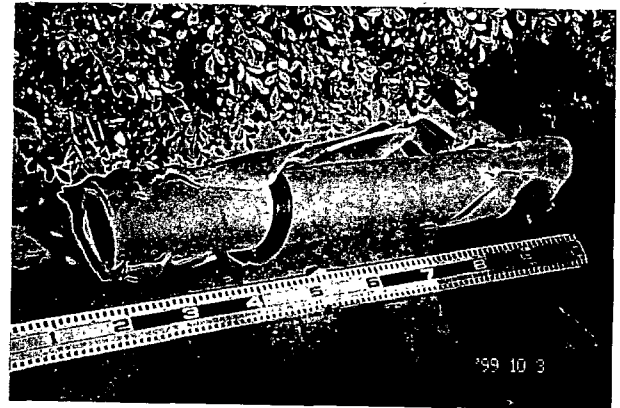
Photo. 4 Push in each distribution pipe (Vinyl pipe) at joint.

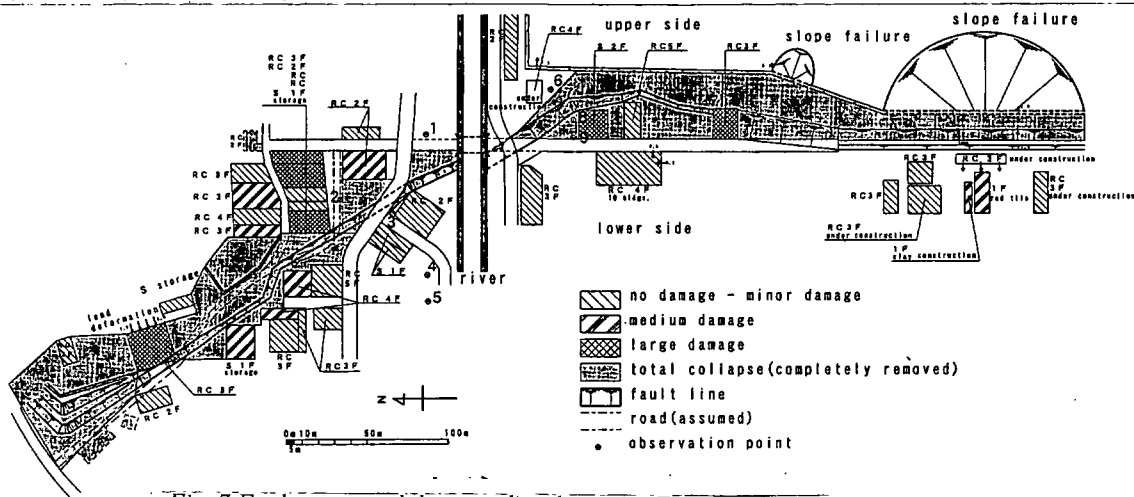
Due to hard soil in Fonyuan city area, steep deformations of 4-5m were observed as shown in Fig. 7. Further, building damage in the lower side of the heaved fault scarp was minimal, whereas the same in the upper side was found severe, with diminishing pattern as far away from the fault scarp.

Fig. 7 Fault scarp and damage distribution in Fonyuan area.

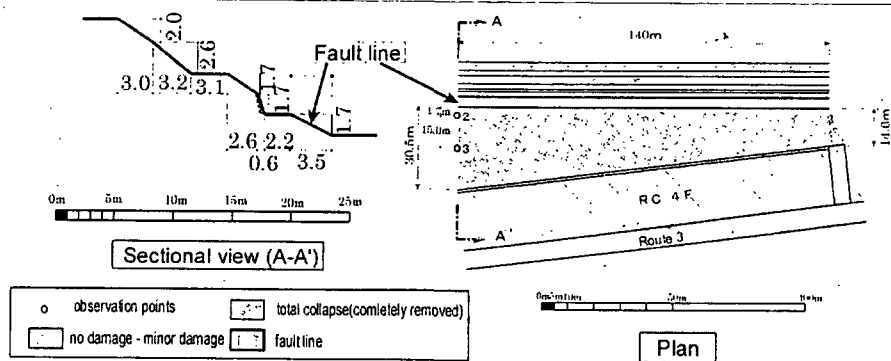
This area between the present slope and State Route 3, consists of slope footage that heaved about 2 m, and though damage was limited to upper side of this upheaval, basically no damage was seen in most locations of lower side. However, there were certain locations of soft soil that lower side too moved with the upper one causing damage to buildings therein.

Fig. 8 Fault scarp and damage distribution close to slope in Chaotuen area.

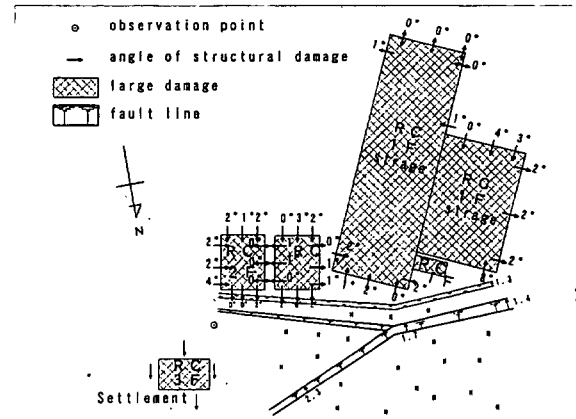
In the area of the paddy field located east of State Route 3 due to the existence of soft soil, curvy deformations in small magnitude were observed. Further, fault branches of extended into the paddy field have caused damage in an area, rather than a linear one. Damage at distances of 50 and 90 m away from the fault was similar, with inclined buildings, while those areas sandwiched by two fault lines showed ground settlement of around 1.0m causing severely inclined buildings.

Fig. 9 Fault scarp and damage distribution at paddy field in Chaotuen area.

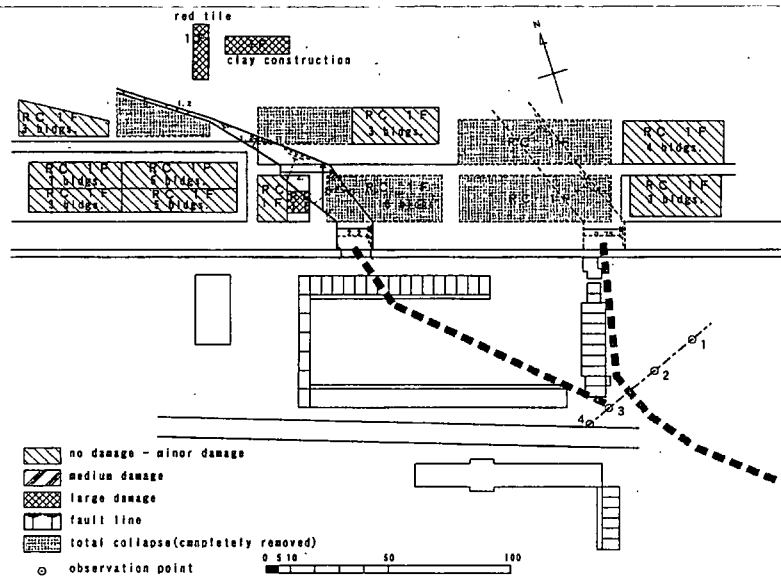
In this area, Architectural Institute of Japan has already conducted a damage survey on a location near a school, as shown in Fig. 10. Continuing on this, the present conducted survey on the north part of the school. It was revealed that deformations of 2-3 m were presented at zones encompassed by two branches of faults and building damages therein were severe.

Fig. 10 Fault scarp and damage distribution in Wufong area.
