Geotechnical Aspect of Damage In Adapazari City During the 1999 Kocaeli, Turkey, Earthquake

GEOTECHNICAL ASPECT OF DAMAGE IN ADAPAZARI CITY DURING THE 1999 KOCAELI, TUEKEY, EARTHQUAKE

This report summarizes detailed investigation on the structural damage and its geotechnical condition in the Adapazarı City, Turkey, during the 1999 Kocaeli earthquake by the reconnaissance team of the Japanese Geotechnical Society. Damages to individual buildings were investigated along several streets in the downtown area. A little rough investigation was made almost all downtown area, in which damages were classified by its cause, i.e., inertia force or soil liquefaction. These investigations as well as hearing investigation and areal investigation by means of helicopters made clear the area where there was an island a few hundred years ago by which the name of Adapazarı i.e., ada (island) + pazarı (market), came from. In addition, the damage in the Adapazarı City is shown to be strongly affected by the ground condition because damage caused by liquefaction was observed only outside the old island and areas where significant structural damage was observed were concentrated near the boundary betwe

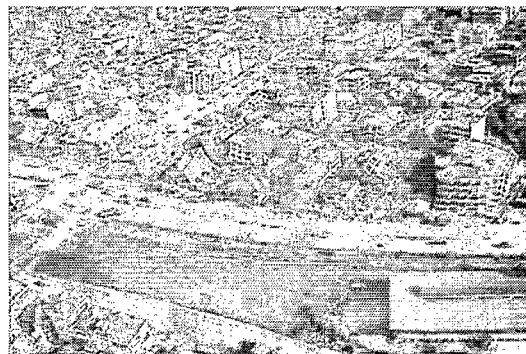
Looking at the damages in the investigated area, damage can be classified into two types. The first one is totally or partially collapsed building because of the failure of the column as typically shown in Fig. 7. These damages are supposed to be caused by inertia effect of the earthquake shaking, therefore will be referred to be an inertia type damage hereafter. Another type is tilt and/or settlement of the building as typically shown in Fig. 8. Soil liquefaction may be the predominant reason of this kind of damage, which will be referred as a liquefaction type damage hereafter. It is also noted that there are many

Fig. 7. Damage to buildings by inertial force.

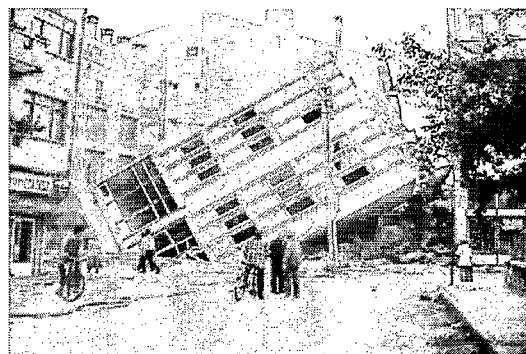
Fig. 8. Damage caused by soil liquefaction.

Liquefaction type damage was especially severe in the north of Cark Cadesi and east of Sakarya Cadesi. Wide cracks runs crossing the road damaging buildings on it as shown in Fig. 9 in the north of Cark Cadesi. A building tilted for more than 60 degrees as shown in Fig. 8. It is noted that tilt of this building was about 30 degrees on the day next to the earthquake and increases to present state taking for about 10 days. Settlement of the buildings was very large near this building. Sewage pipelines were going to replace in the Izmit Cadesi at the time of our visit, which indicates that ground deformation was significant in this area. These areas were supposed to be the old riverbed of the Sakarya River.

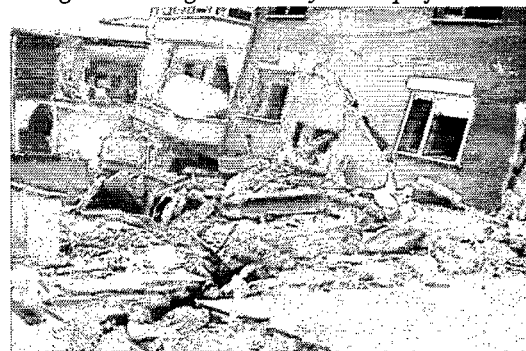
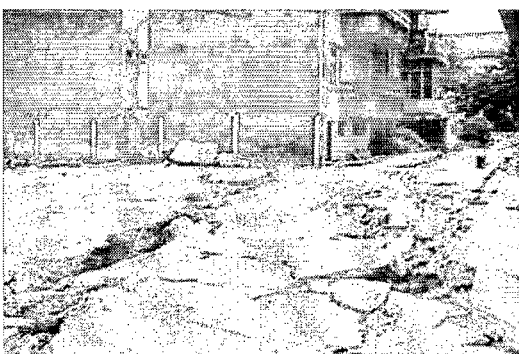
Fig. 9. Damage caused by large ground fissure

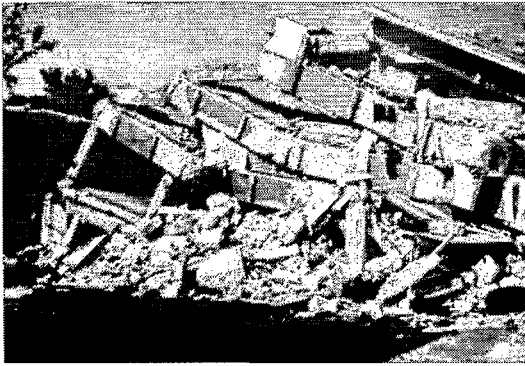
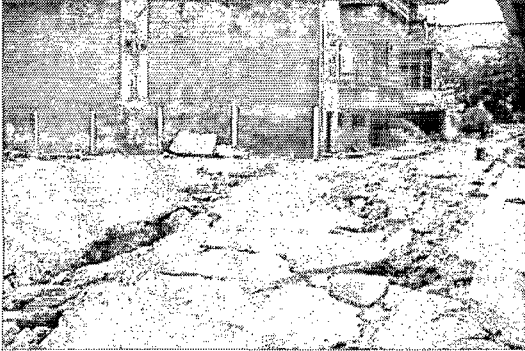
Fig. 10. Typical inertia type damage. Pancake crash (top) and soft first story collapse (bottom) damage.

Inertia type damage was frequently observed in the non-liquefied area. Fig. 10 as well as Fig. 7 shows typical damage of the inertia type damage. This types of damage was especially severe along the road running to the EW direction

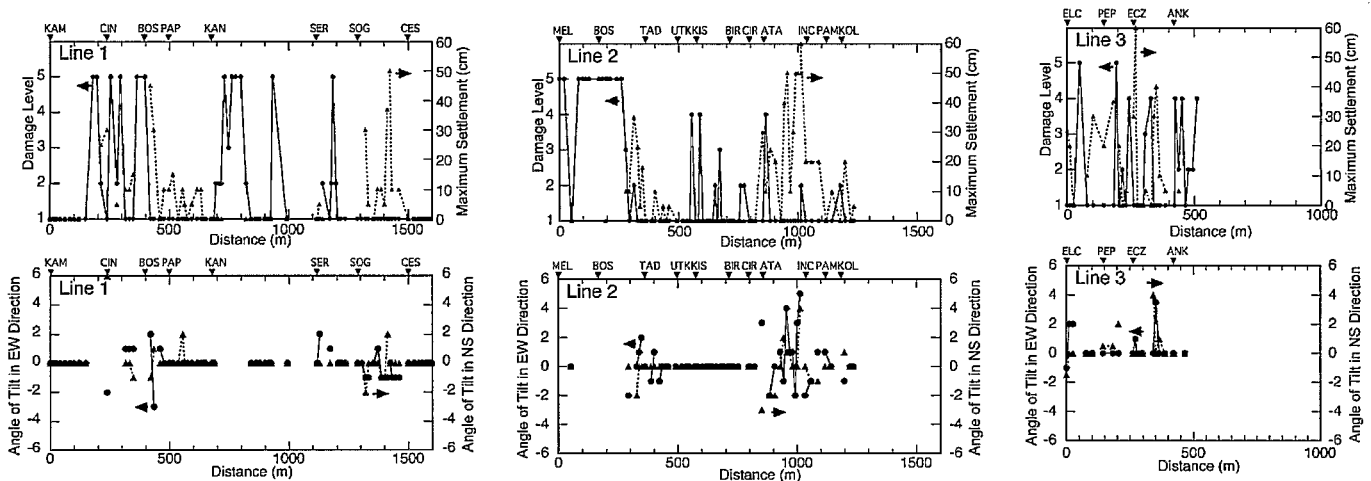
Figure 13 shows the result of damage investigation along three lines; damage level, maximum settlement and angles of tilt in the EW and NS directions are shown in terms of the distance from west or south end of each line.

No severe damage was found in the west end of Line 1 (Cark Cad.) for about 200 m. Damage suddenly becomes significant near Bosna Cad. where many 3 to 5 storied buildings were significantly damaged. There is strong contrast of damage

Fig. 13. Result of detailed damage investigation

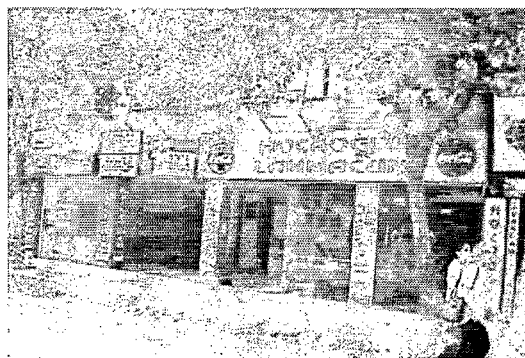
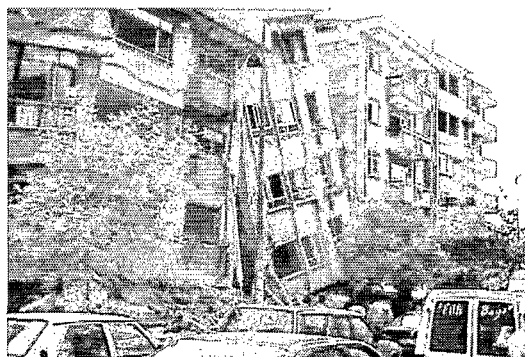
between both side of road from Bosna Cad. to KAN1 point. Buildings in the north of the road are severe liquefaction type damage, whereas buildings in the south of the road are severe inertia type damage as shown in Fig. 14. Structural damage was hardly observed from KAN1 to Line 3 crossing the Sakarya Cad. Buildings again suffered damage in the east of Line 3. The damage is liquefaction type damage without any structural damage. Structural damage was not observed in the east end of Line 1.

Fig. 14. Contrast of damage between the north side (top) and south side (bottom) of Cark Cadesi.

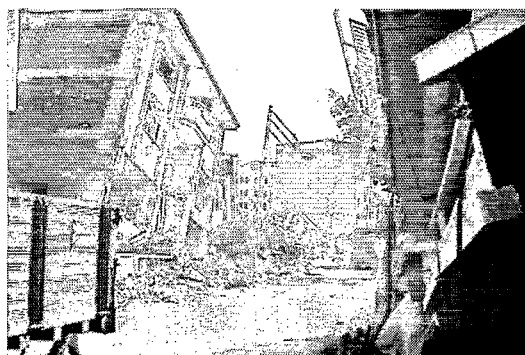
(Fabrika Cad.) was one of the severe one. Almost all buildings except one timber house were collapsed by first story failure or complete failure as can be seen in Fig. 7, where Fabrika Cad. runs horizontally, and 15, and is classified to be damage level 5. Damage, then, becomes moderate and liquefaction type damage comes to be seen; this area is classified as liquefied area. Small damages were observed from the east of the liquefied area to Sakarya Cad. Liquefaction type damage suddenly appears east of Sakarya Cad. Buildings with 4 to 6 stories were settled for 10 cm to 1 m. Center of the road and ground between two buildings was

Fig. 15. Damage to building on Fabrika Cad.

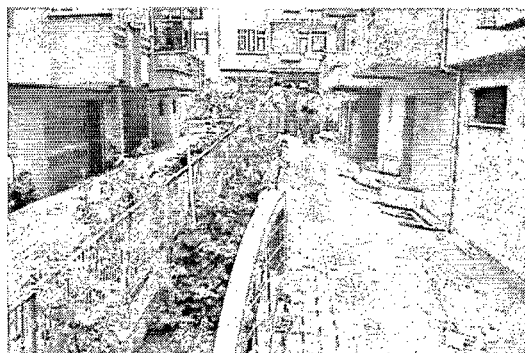
heaved up and ground cracks were frequently observed. Examples of damage in this area are shown in Figs. 8 and 16.

Fig. 16. Heaving between buildings

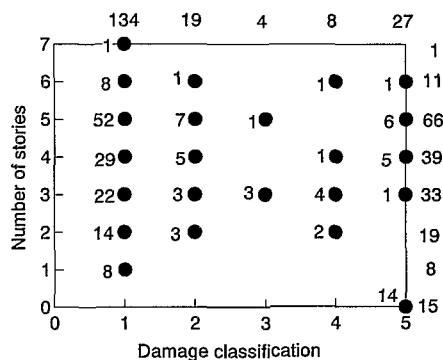
Figure 17 shows the relationship between the damage level and number of stories. Numbers beside each solid circle is a sum total of data that belongs to each dot, and numbers on the top and in the right of the figure are sum total of each classification. Here, number of stories of zero indicates that it is not known because it completely collapsed. In total, 14 buildings are included in this classification. It is, however, sure that number of stories of these building is not small such as 1 or 2; they are probably 4 or more. Two features can easily be obtained from this figure. The first one is that number of buildings with middle damage level is smaller than that with small and large damage levels. It is natural that it is smaller than that with small damage, but not natural that it is smaller than that with large damage. This probably comes from the brittle structural members of the building. The building directly goes to complete failure in brittle structures when earthquake load exceeds the structural load carrying capacity. The second feature is that severely damaged structure is concentrated in 3 to 5 storied buildings.

Fig. 17. Relation between number of stories and damage classification

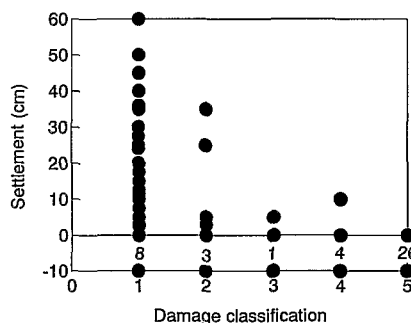
Figure 18 shows the relationships between damage level and settlement of the buildings. Here, settlement of -10 cm indicates the buildings whose actual settlement was not observed partly because the structure is completely collapsed and partly because evaluation was difficult. Number of this classification is written in the figure. There is clear tendency of the settlement. Large amount of settlement can occur only when damage level is small. In other words, buildings that settled did not suffer severe structural damage. It is noted that some damage in damage level 2 to 4 was caused even by soil liquefaction. Tilt of buildings sometimes stops by hitting the neighboring building, in which case structural members in both building sometimes damaged. Moreover, tilt of building itself sometimes becomes the cause of the structural damage. Considering these situations, it can be concluded that building damaged by soil liquefaction did not suffer large inertia force. The separation between liquefied and non-liquefied area shown in Figs. 4 and 11 is justified by this figure.

Fig. 18. Relation between settlement and damage classification.

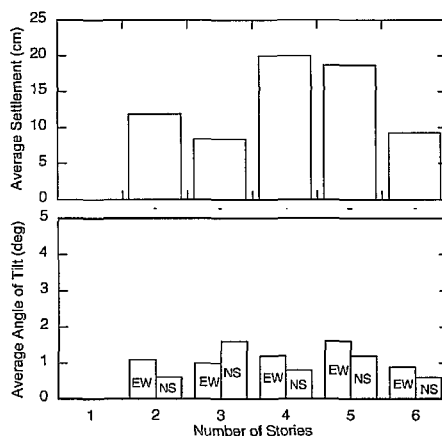
Figure 19 shows the relationships between average tilt and average settlement versus number of stories in the liquefied area. Average settlement is about 10 cm for 2 and 3 storied buildings. It increases to 20 cm for 4 and 5 storied buildings. These values are fairly smaller than past experience such as Niigata City during the 1964 Niigata earthquake, Japan, and Dagupan City during the 1990 Luzon Earthquake, Philippines.

Fig. 19. Effects of number of stories on settlement and tilt of buildings in liquefied area

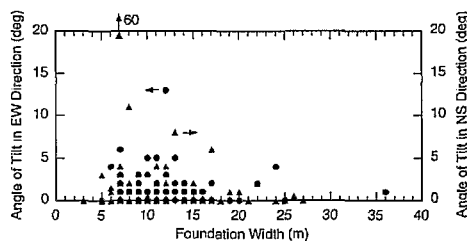
Figure 20 shows the relationship between foundation width and angle of tilt. Although data scatters, the tendency that tilt becomes larger as foundation width becomes smaller is clearly observed.

Fig. 20. Relation between angle of tilt and foundation width of buildings in liquefied area
