Solid Waste Landfill Performance During the 1994 Northridge Earthquake

Paper No. 14.04

A.J. Augello, J.D. Bray, and R.B. Seed
University of California at Berkeley
Berkeley, CA, USA

SYNOPSIS The performance of 22 landfills in the Los Angeles area during the January 17, 1994 Northridge earthquake has been investigated. Observations of damage at these landfills indicate that the overall performance of solid waste landfills was encouraging. None of the surveyed landfills showed any signs of major damage. However, one geosynthetic-lined landfill experienced two tears in the geomembrane liner. Most landfills within 30 km of the zone of energy release experienced some form of cracking in the soil cover. Beyond approximately 40 km from the zone of energy release, little to no damage was observed.

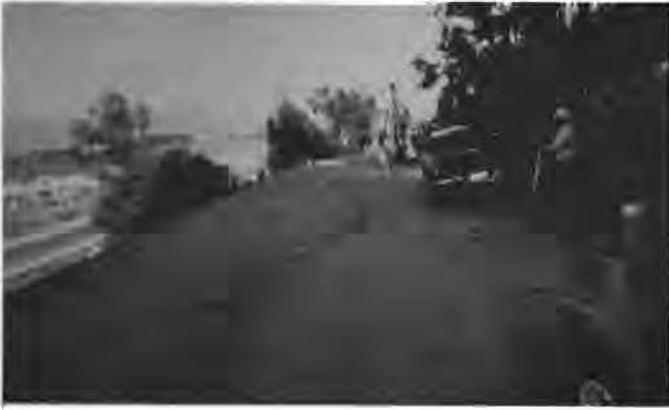
Minor cracking occurred at a number of locations on the faces of slopes of the OII landfill, primarily, but not exclusively, at or near the berm roads. The cracks were generally on the order of 50 to 150 mm or less at their widest point and did not appear to extend fully through the soil cover system into the underlying waste. Figure 2 shows a crack along a berm road on the north face of the OII landfill. Instrumentation data collected after the earthquake indicated that the landfill has not experienced significant horizontal or vertical deformations as a result of the earthquake ground motions. This observation is consistent with previous studies which have indicated that seismic shaking does not induce significant settlement or lateral displacement of solid waste (e.g. Coduto and Huitric, 1990).

Figure 2. Crack along berm road, northside of the OII landfill.

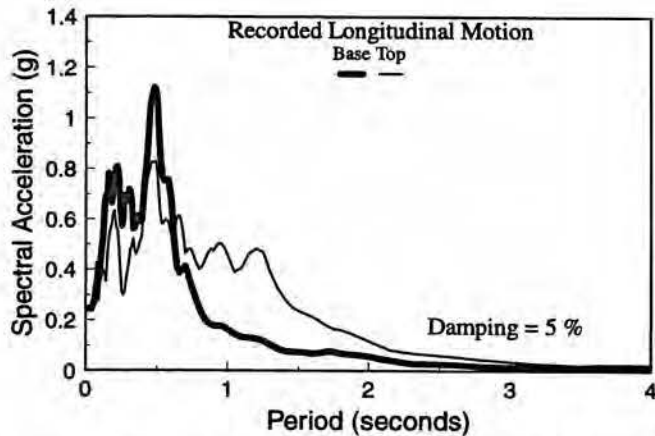
Acceleration response spectra for the longitudinal and transverse motions are shown in Figure 3. For both records,

Figure 3. Acceleration response spectra from the recorded longitudinal motions at the OII landfill.

there was attenuation in the high frequency range. At periods beyond approximately 0.6 seconds, these records show amplification of motion from the base to the top. This was most pronounced in the longitudinal direction at periods of 1 to 1.25 seconds, where the amplification factor was on the order of three. The amplification functions indicate that the fundamental period of the OII landfill is approximately 1.2 seconds in both the longitudinal and transverse directions and that the landfill responded primarily in its first mode (Stewart et al., 1994). This observation is consistent with those made from previous earthquakes which induced motions of lower intensity at the landfill (Hushmand Associates, 1994).

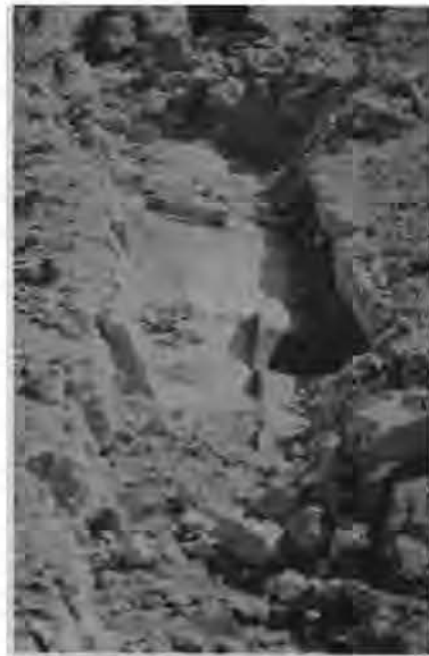
The Chiquita Canyon landfill is separated into 5 different units (Primary Canyon and Canyons A,B,C and D), some of which are separated by canyons. The Primary Canyon Landfill is unlined but Canyons A,C and D are lined with a single composite liner system. Some of the Canyon B Landfill was lined with a single composite liner system, the remainder of this area is lined with a compacted low permeability soil liner. At the time of the earthquake, only one unit (Canyon C) was accepting waste fill. After the earthquake, cracks in the soil cover were observed in all cells of the landfill. In Phase I of Canyon C, longitudinal cracks were observed at the top of the landfill along the interface between the landfill liner and the waste fill. The largest cracks were approximately 300 mm wide, with vertical offsets of 150 to 300 mm. A localized tear in the geomembrane was observed in one area of Canyon C. The tear, which occurred at the top of the slope near the anchor trench where the largest static (pre-seismic) stresses in the HDPE would be expected, was approximately 4 m long and 230 mm wide. Figure 4 shows the tear in the Canyon C geomembrane liner.

Figure 4. Tear in the HDPE geomembrane liner system, Canyon C, Chiquita Canyon Landfill (Photo courtesy of Calif. EPA, Integrated Waste Management Board).

One hypothesis is that these geomembrane tears were caused by the limited downslope movement (300 mm) of the waste fill along the geosynthetic-lined back slope. In both cases, the tears were above the level of the waste and were repairable, though specialty contractors were required to complete the repairs. No disruption of the low permeability soil liner beneath the geomembrane was reported at either canyon. Furthermore, no indication of disruption to the containment system below the top of the waste was reported.

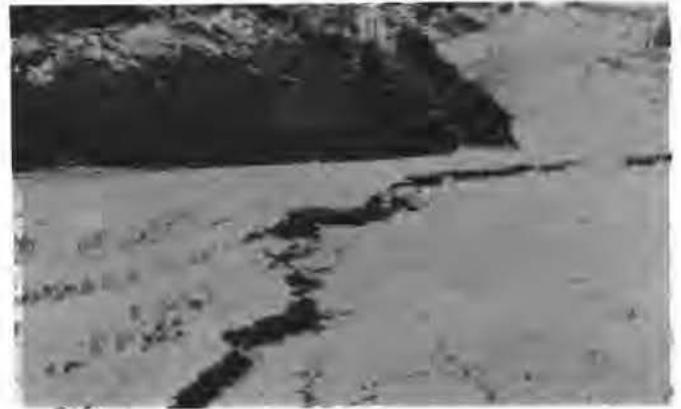
Longitudinal cracks were observed at the top of the waste fill along the interface with the natural canyon walls. The cracks varied from less than 20 mm to as much as 300 mm wide, with 150 to 300 mm of differential vertical offset in some areas. Figure 5 shows the cracking observed in the soil cover of the top deck at the western end of the landfill. Cracking was also observed at the edge of several benches along the face of the waste slope. These cracks were generally less than 20 mm wide. This cracking did not appear to represent any threat to overall instability.

Figure 5. Crack along top deck at the western end of the Sunshine Canyon Landfill (Photo courtesy of Calif. EPA, Integrated Waste Management Board).
