# The Northridge Earthquake of 1994: Ground Motions and Geotechnical Aspects

Paper No. 14.01

**Abstract:** Following the January 1994 Northridge Earthquake in Southern California, the authors traveled to Los Angeles and surveyed the earthquake damage region. Subsequently, seismologic, geologic and ground motion data were compiled and evaluated. This paper presents our observations and evaluation of: geologic and soil effects; soil-structure interaction; liquefaction; slope failures and rock slides; and ground deformations.

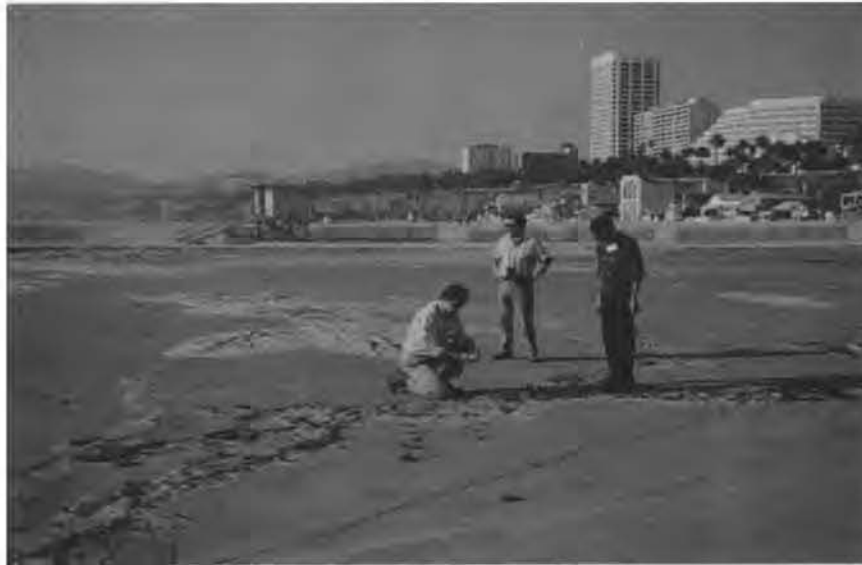
Manifestations of geotechnical failures and damage could be observed at many different locations as far away as 50 km from the general epicentral region. Fig. 4 shows the approximate locations of sites where liquefaction and landslides were observed. Evidence of liquefaction has been observed in the Simi Valley, 15 km northwest of the epicenter. Also, soil liquefaction near the toe region of a section of Highway 126 near the town of Piru may have contributed to its failure. In the parking lot of the Santa Monica Pier, liquefaction of the underlying sands had caused extensive cracking of the pavement and ejection of sand, as shown in Fig. 5.

Fig. 5 Liquefied sand ejected from cracks in the pavement of the parking lot in Santa Monica Beach.

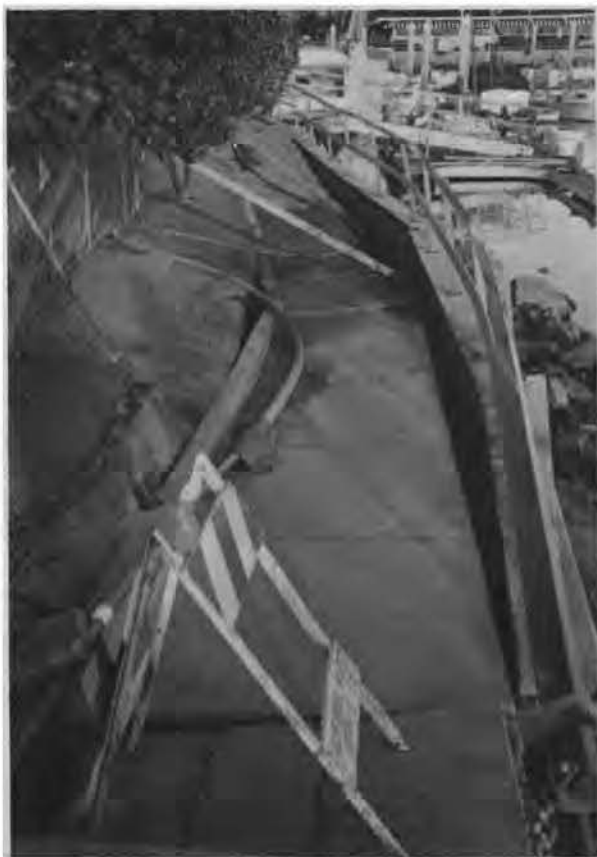
Fig. 6 Movement of the retaining wall of the pier in Redondo Beach.

0.75 m vertically. Evidence of possible liquefaction of the sands, used as the fill material of the pier, was observed. A 1.50 m high retaining wall that was constructed upon a rock berm, as shown in Fig. 6, experienced lateral movements of the order of a meter. The top of the rock berm is estimated to be about 3 m above the mudline. There is evidence of lateral movement at and near the toe of the rock berm as shown by the tilting of the mooring piles (Fig. 7). Furthermore, the ground surface level on the pier experienced significant subsidence. Fig. 8 shows one of the two buildings on the pier that is founded on a concrete slab that experienced about 0.3 m of settlement relative to the section of the wharf that did not move. It is not yet clear as to what the failure mode of this pier was. Further investigations of the geotechnical data and the profile geometry may reveal the mechanism of this failure.

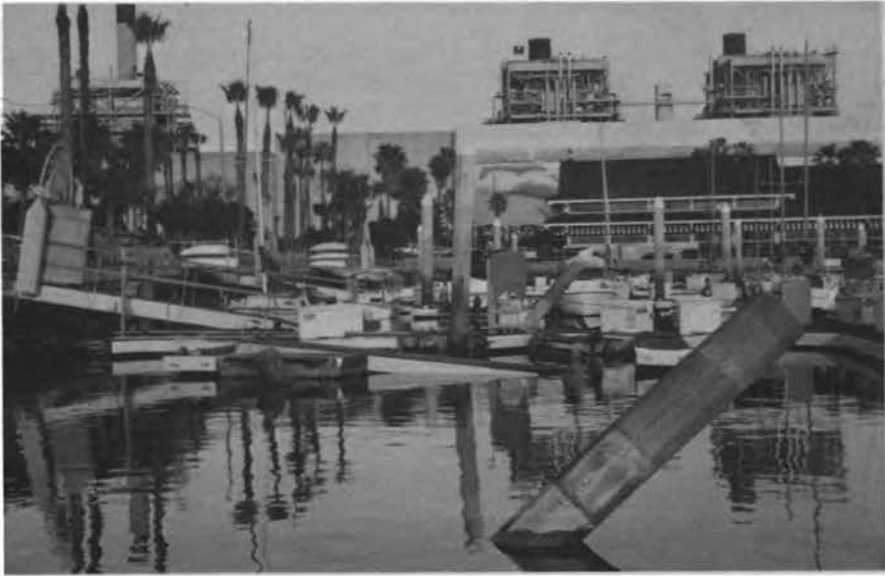
*Fig. 7 Tilting of the mooring piles at the toe of the rock berm of the pier in Redondo Beach.*

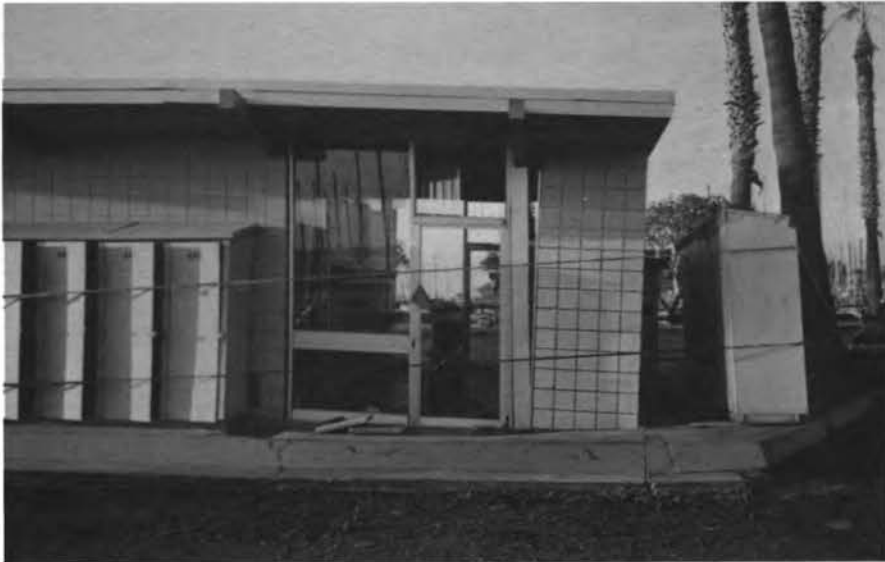
*Fig. 8 Liquefaction-induced settlement of a building on the pier in Redondo Beach.*

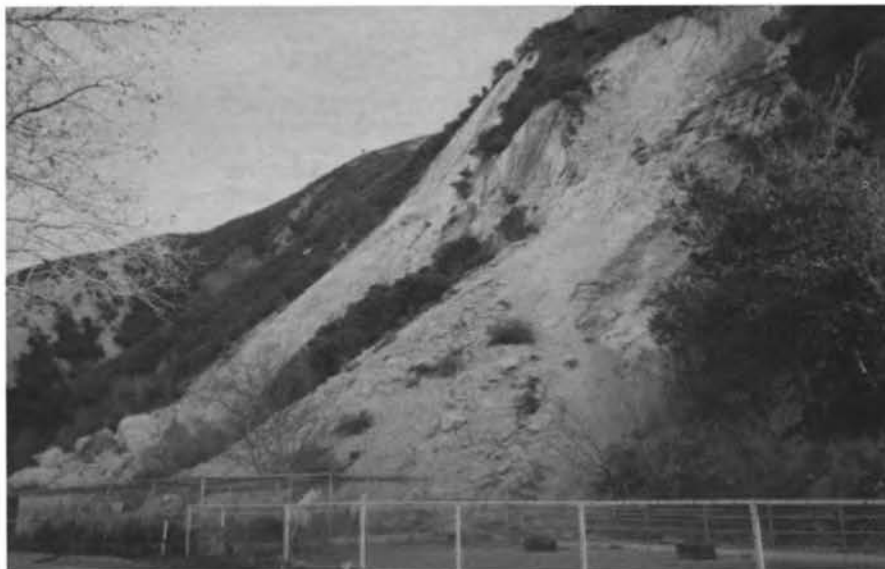
There were a number of rock slides that were observed mostly in the region north of the epicenter. Fig. 9 shows photographs of typical rock slides. In Santa Monica, along the Pacific Coast Highway, spectacular landslides occurred damaging many of the homes built on the cliffs overlooking the Ocean. Fig. 10 shows a section of this landslide. Also, in Simi Valley, a major slide occurred in a slope built with the tailings from a mining operation. Fig. 11 shows the failed slope where lateral and vertical permanent deformations were as large as 1 m and 2 m, respectively. A survey of the slope region revealed that water used in the mining operations is directed through trenches away from the top of the slope towards its toe. The failed slope was observed to be free of ground water. Geotechnical investigations including analysis of the strength properties of the tailing may lead to definitive reasons for this failure.

*Fig. 9 Rock slides in the region north of the epicenter.*

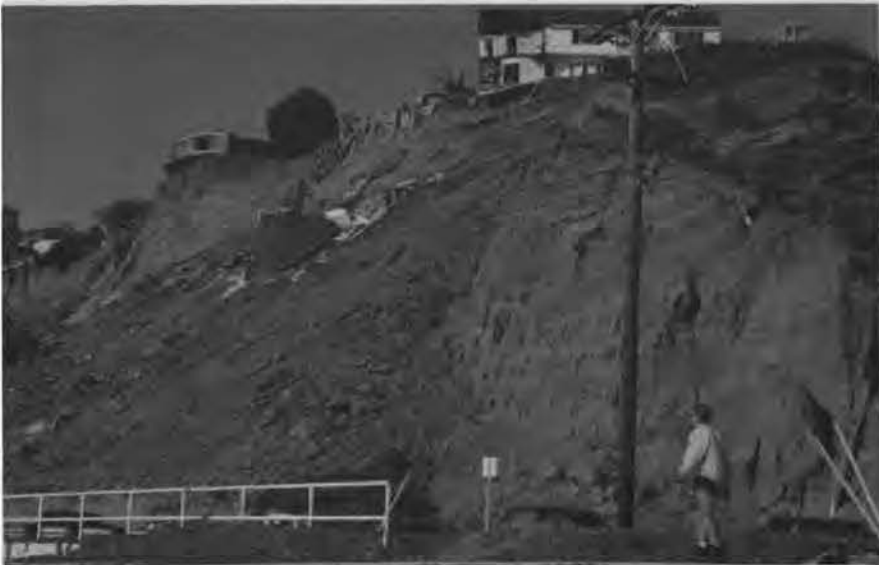
*Fig. 10 Landslides in Santa Monica along the Pacific Coast Highway.*

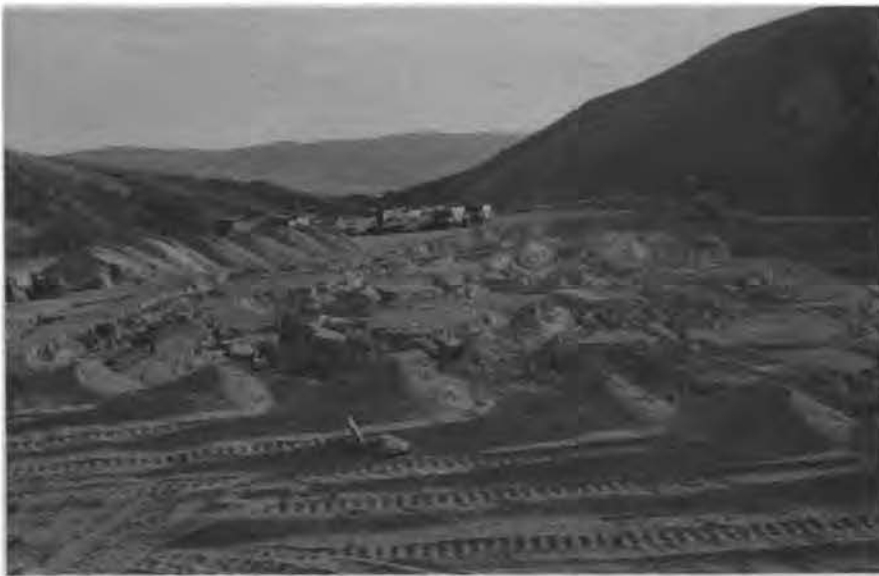
*Fig. 11 Slope failure in Simi Valley at a rock quarry.*

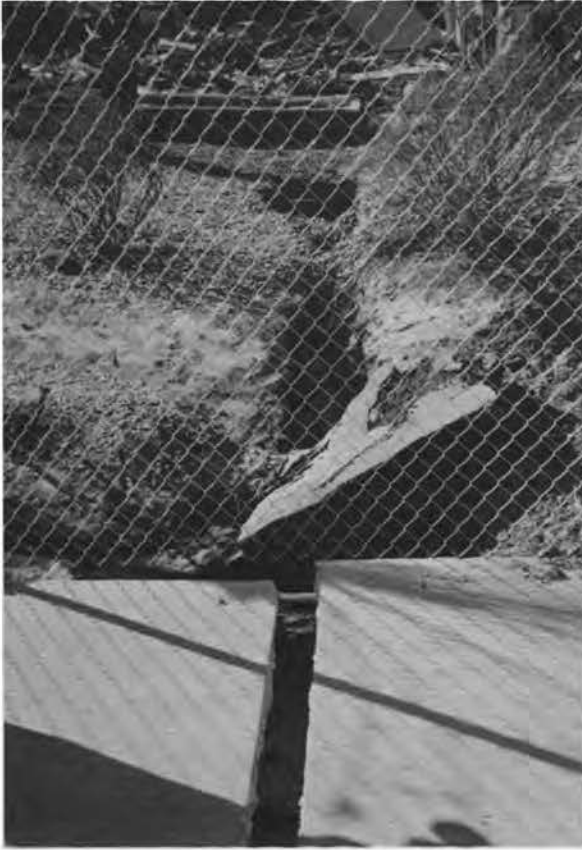
In Granada Hills, on Balboa Street, immediately north of Highway 118, there was evidence of significant permanent ground deformations. About three blocks along this street, and one block on each side of the street, there were many cracks in the ground running perpendicular to Balboa Street. Some of these were tensile cracks with widths as large as 6 to 10 inches, as shown in Fig. 12. Other cracks were of compressive type resulting in ridges in the sidewalks, as shown in Fig. 13. In this section of Balboa Street, there were many ruptures of gas lines leading to fires that destroyed many residential houses. Also, the water main in this section of Balboa Street ruptured causing major floods. The cause of these ground fissures is not well understood yet. Since the fault in this region is closer to the ground surface than anywhere else in the Valley, it is possible that the ground deformations in this region within the San Fernando Valley,

have a more direct connection with the fault rupture. Alternatively, since the cracks in the ground are limited to the section of Balboa Street that is on a hill, shallow slope failures (where blocks of soil moved downhill and relative to one another) can not be precluded as a reason for these cracks.

*Fig. 12 Ground fissures along Balboa Street in Granada Hills.*

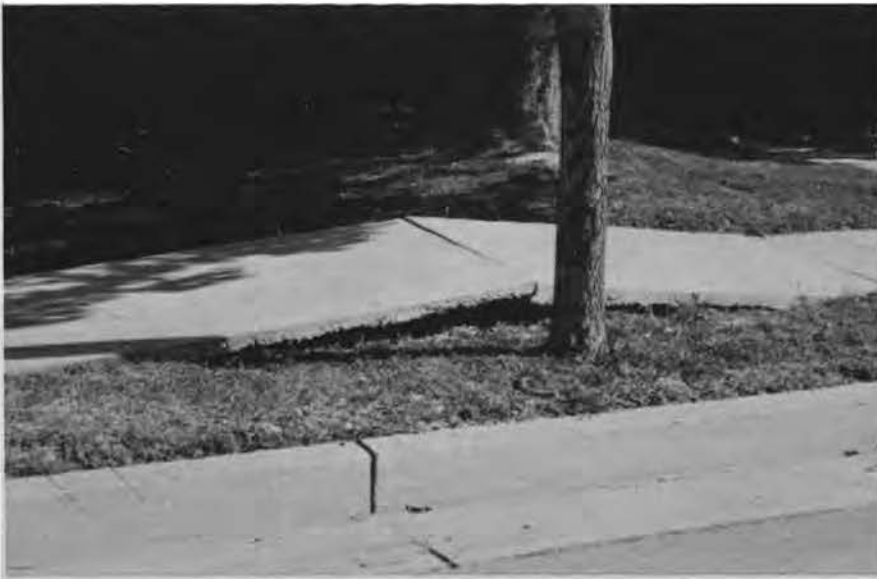
*Fig. 13 Compressive ground deformation along Balboa Street in Granada Hills.*
