River Dike Failure in Japan by Earthquakes in 1993

Paper No. 6.13

SYNOPSIS Hokkaido, Japan was attacked by earthquakes of magnitude 7.8 twice in January and July, 1993. One is the Kushiro-Oki Earthquake and the other the Hokkaido Nansei-Oki Earthquake. River dikes were severely damaged by liquefaction of sand. The former caused liquefaction of subsided dike materials and the latter caused liquefaction of sand of the foundation bed. Relations between dimensional elements of dike and peat bed and stress relaxation within dike were analyzed. Old channels recently filled with sandy materials were distinguished from pointbar zones in ancient river bed covered with silty sediment, based on degree of damage due to liquefaction.

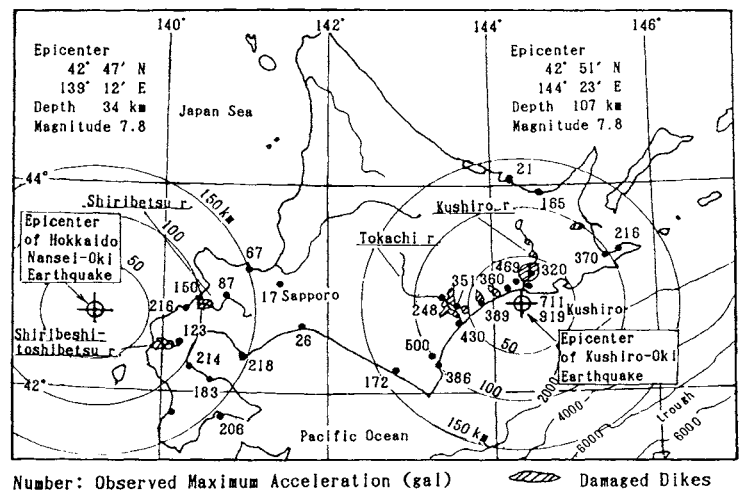
Damage of river dikes caused by the Kushiro-Oki Earthquake reached the total length of 26,306 m through 52 sections. Damage of bank protection was 1,260 m at 11 sections. Damage of river dikes caused by the Hokkaido Nansei-Oki Earthquake was 8,915 m through 24 sections and that of bank protection was 3,511 m at 20 sections.

Fig. 1 Epicenters, observed maximum acceleration and damaged river dikes --- Kushiro-Oki Earthquake and Hokkaido Nansei-Oki Earthquake

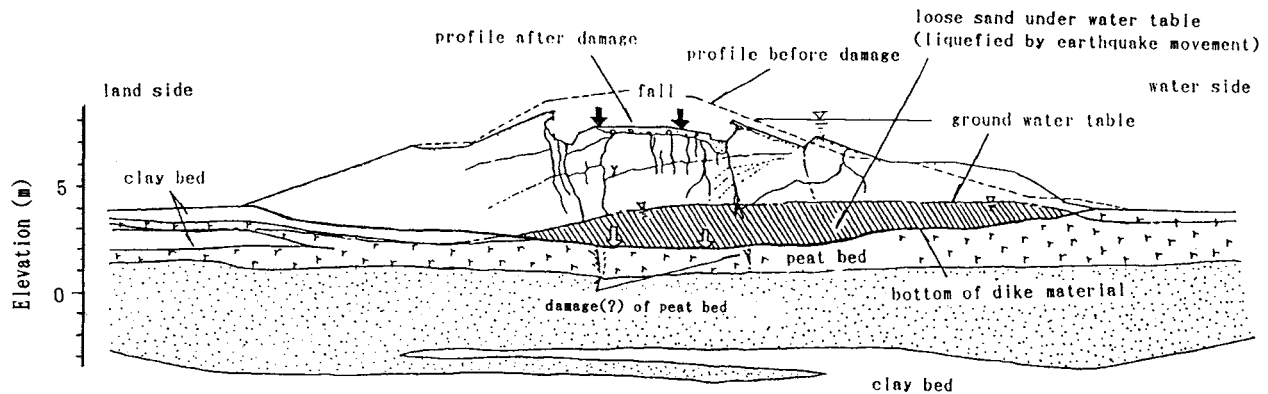
lowlands, dikes were given deadly blows in its long extent, while the peripheral surface (marsh and farmland) showed neither conspicuous breakage nor sand eruption. Namely longitudinal cracks spread along slope shoulders or center of crest of levees, often taking vertical gaps and 2 to 3 m of sinking of crest. Mostly waterside slopes were expanded and disrupted. In order to find out the remaining state in the dike after earthquake, boring in every 50-100 m distance on the crest of dike and 5-7 boring at several sites were practiced on cross sections of dikes, where trench cut were carried out so that vestiges of liquefaction might be found and movements of soil blocks might be interpreted. Cone penetration tests were also tried on the trench bottom.

Peaty bed of 3-6 m thickness spreads over alluvial lowlands of the Kushiro River and the Tokachi River forming marsh or farmland. It is characterized by its natural moisture content (Wn) of 200-1000%. Peat bed was underlain by a sand bed and a thick soft marine clay bed.

River levee with its height of 5-7 m had sank so deep into peaty bed as 2 to 3 m prior to the earthquake. Materials of levee are generally sandy soil originated from volcanic ashes and are rather pervious.

Dike material below the ground surface was submerged under ground water and was potentially liquefied by earthquake. Surface of dike and marsh plane beside levee was frozen to the depth of 50-70 cm and was effective to resist against sand eruption through peat bed from sand layer below through peat bed. Fig. 2 shows a sketch of failure of

Fig. 2 Analyzed sketch of damaged dike at the Kushiro River left bank 9k850

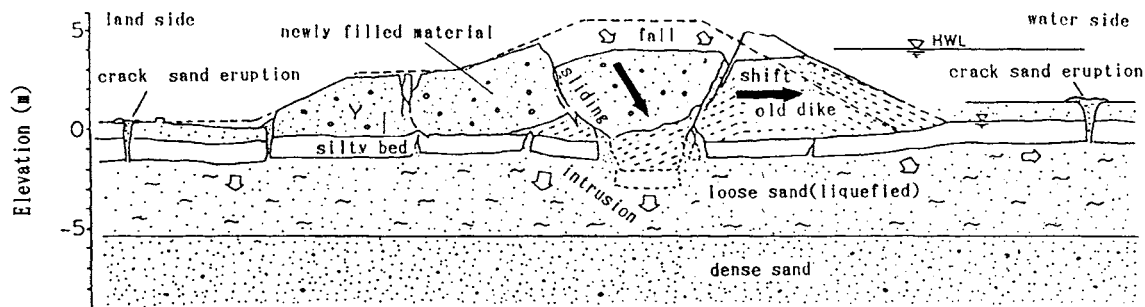
Detailed investigation showed that most heavily damaged sections were underlain by silt bed 2-2.5 m thick. The silty bed seems to be "covering layer on pointbar deposit" inside of meandering old river bed. "Old river channels" were filled

Fig. 3. Analyzed sketch of damaged dike at the Kabutono Bank of the Shiribeshi-toshibetsu river

The silty covering layer is considered resistive to prompt dispersion of excess pore water pressure generated during earthquake movement resulting falls of dike crest.

On the lowest stream of the Shiribeshi-toshibetsu River soil mass under crest fell by 3 m into liquefied sand bed and soil mass under slope was shifted by 3 m horizontally to waterside as shown in Fig. 3.

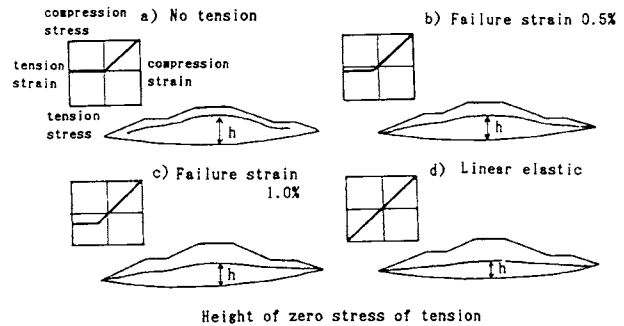
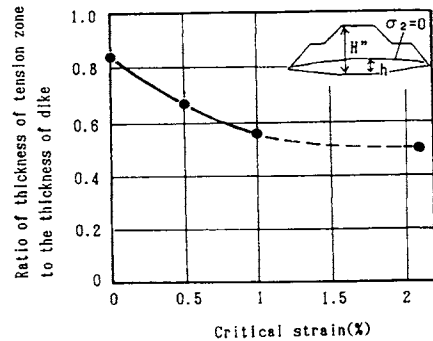
Analytical software was Di-dimensional elastoplastic analysis programme by F.E.M. using EWS. Methodological comparison supposing some failure strains (0%, 0.5%, 1.0% and ∞) in tension quadrant of dike material concluded to adopt linear elastic property both in compressive and tension fields for the sake of simplicity as shown in Fig. 4.

Fig. 4 Critical strain and ratios of thickness of tension zone to the thickness of dike. --- Minimum principal stress ---

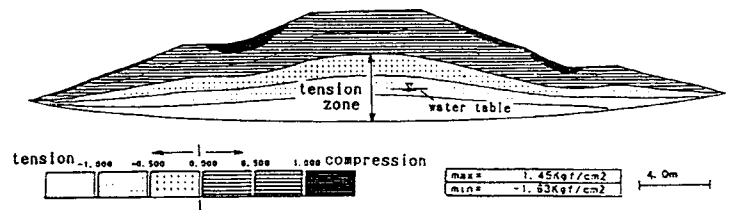
The lower half of dike must have been in tension field as subsidence proceeds and mean principal stress might be negative to be easy to liquefy in spite of certain overburden.

Fig. 5 Stress relaxation Analysis Difference between mean principal stress inside dikes on rigid base and soft base. A case of modelled Kushiro river

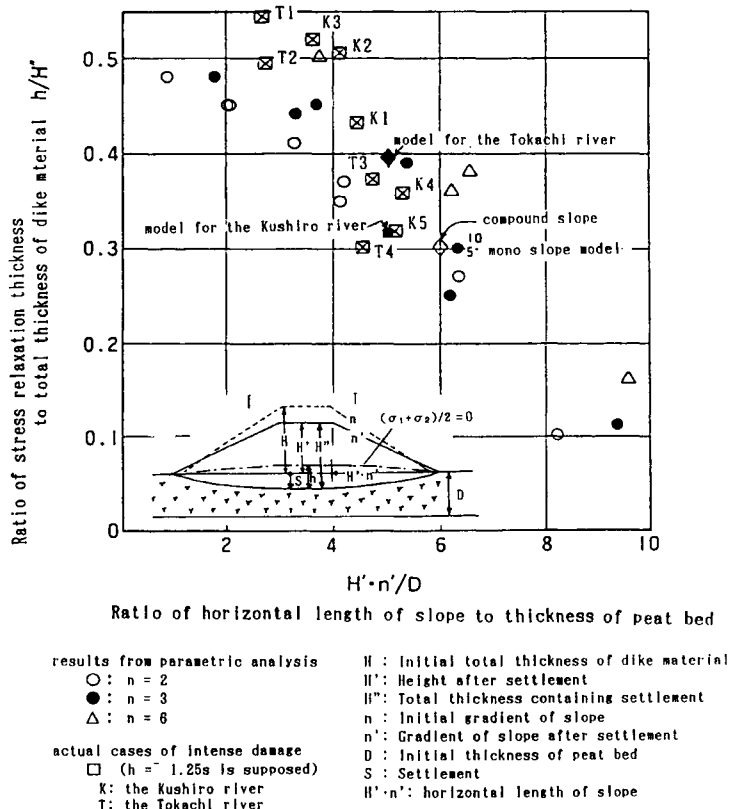
When the ratio of horizontal length of slope (H-n) to thickness of peat bed (D) is less than 7, stress relaxation to lead liquefaction of dike material does not come out also assisted by actual cases.

Fig. 6 gives a comprehensive result of analysis.

Fig. 6 Result of parametric analysis and actual data of damaged dike.
