Performance of Concrete Faced Earthdam to Loma Prieta Earthquake

SYNOPSIS: As a result of the shaking from the Loma Prieta Earthquake of 1989, the concrete lining of an earth embankment suffered cracking at numerous locations on its upstream side and developed in its bed lining, crater-like pot-holes ranging in size up to 10 ft. in diameter. Field investigation and preliminary studies indicated the differential dynamic vibrations of the earth embankment and the concrete lining to be the cause of the cracking, and the liquefaction of the underlying stratum below the bottom of the reservoir to be the cause of the pot-holes formed as a result of the pore pressure bursting through cracks in the lining. This paper presents a summary of the investigation and the related studies.

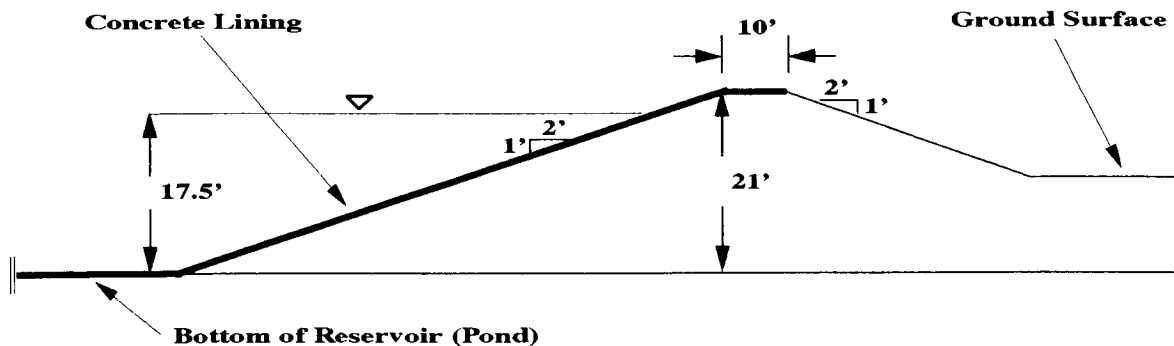
Figure 1: Cross Section of the Dam

The dam embankment was constructed in 1959 by a cut and fill procedure of the native soil which consists of sandy silty clay with some gravels. A test pond reservoir was created by excavating the natural ground and using the resulting material to construct the surrounding embankment. A typical section of the embankment is shown in Figure 1. Each of the upstream

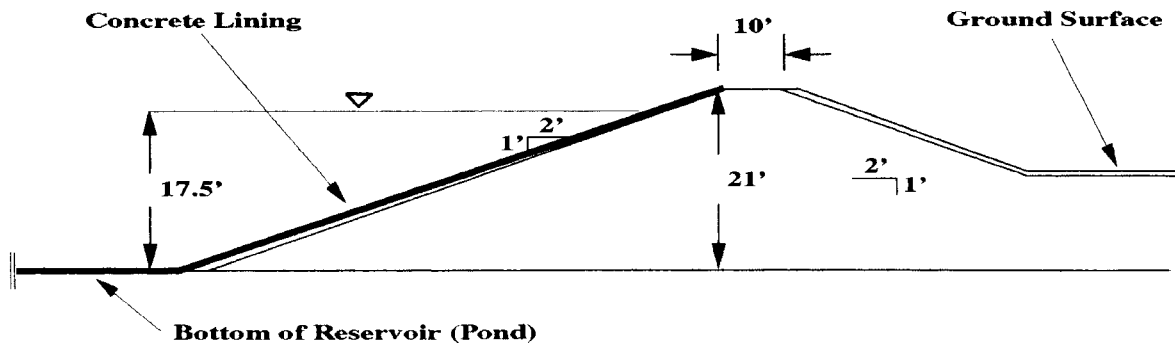
Figure 2: Superposition of As Built Cross Section over the Current Cross Section

A field survey was performed to establish cross sections at pertinent locations where cracking or distress to dam was noticed. When the field measured cross section was superimposed on the original cross section of the dam, a bulging of the dam at the base was noticed (Fig 2).

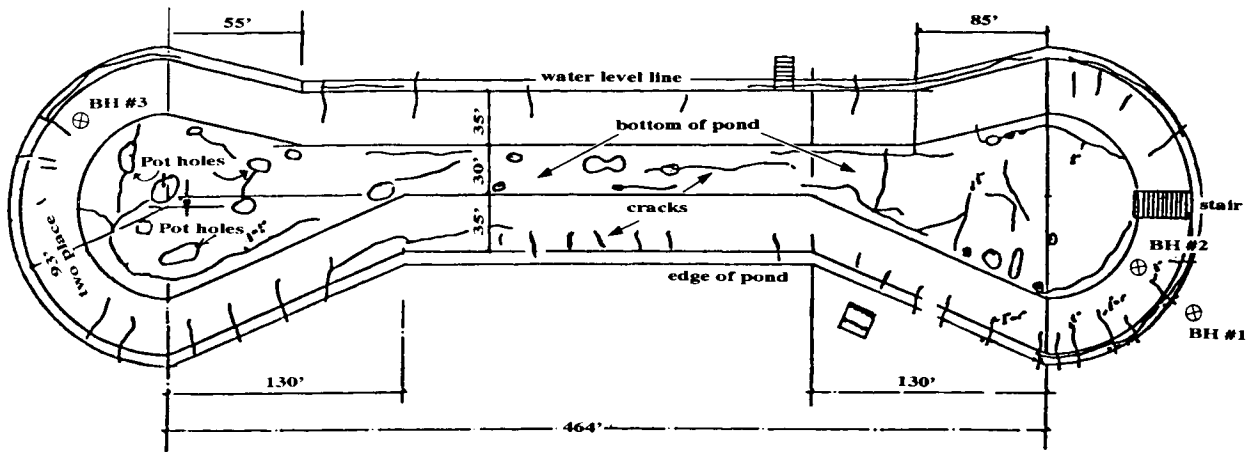
Figure 3: Mapping of Cracks & Craters (Pot-Holes) at FMC Test Pond

A geotechnical field investigation by drilling bore holes and collecting undisturbed samples was carried out. Three bore holes were drilled to a maximum depth of 30 ft. Figure 3 shows the location of the bore holes. Two of these holes were drilled through the crest of the dam. California drive sampler was used for obtaining undisturbed samples. One of the bore holes (bore hole #3), drilled through the crest, was located where tilting of the drainage pipes was observed. The geotechnical investigation indicated silty clay to be the material the entire embankment is made of. Furthermore, laboratory testing indicated this silty clay to be highly plastic ($PI = 41$).

After the reservoir was emptied, a detailed inspection was performed to identify the extent and severity of the damage to the lining and to look for other potential sources of leakage. It was clear that the lining had developed numerous cracks; most conspicuous of which was a continuous crack at the heel almost along the entire length of the embankment. Yet the most striking observation of all was a number of crater like pot holes in the bed lining at the bottom of the reservoir. The maximum size of the crater like pot holes was measured to be approximately 10 feet in diameter (Fig. 3). It appeared that these craters might have been caused by the liquefaction and the high pore water pressure in the foundation soils resulting in a

punching shear failure mode of the existing lining. Field measurements indicated that the existing concrete lining was 5" to 6" deep. Studies were then directed to analyze the cracking in the lining and the development of pot holes.

the soil strat. Whereas a sloping ground or an embankment resting on liquefied strater can undergo undesirable movements until the excess pore water pressure drops sufficiently low and strength regain occurs to arrest the sliding; on a relatively level ground the excess pore pressure often bursts out in the form of a spring carrying with it the liquefied soil and depositing it on the ground surface in the form of a sand boil. Fine sands, silty sands & sandy silts are the types of soils which are most susceptible to liquefaction. As the reservoir at the FMC pond was emptied, three distinct crater-like pot holes with an approximate diameter ranging from 3 ft. to 10 ft. were observed. A careful examination of the sloughed out material in these pot

holes was made. Several grab samples were obtained & washed to examine the type of gravels in the pot holes and the gravels which formed as a constituent of the concrete pad. Three borings were drilled through the pot holes and provided significant information on the nature and strengths of the subsoil. On the basis of all of the foregoing information, it appeared that the clayey fine sand and silty fine sandy clay to clayey silt underneath the concrete pad, liquefied or suffered a loss of strength during the earthquake shaking. Excessive pore pressures generated in these soils created uplift pressures underneath the lining, causing it to fail at the pot hole locations. The reason that such a failure mechanism was not observed at other locations is that at the pot hole locations a water leakage over the years through a possible crack in the concrete pad created an excessively wet condition in the soil immediately underneath the cracks. The seismic shaking generated high pore pressures such that the excessive force immediately underneath the concrete lining burst through it causing it to fail in punching shear. It may be noted that there are inconsistencies in the blow counts and the dry densities data of the liquefiable soils underneath the reservoir, for example boring #4 at ten ft. depth has a relatively high blow count of 14 but the dry density is quite low. Also, this soil has a low PI value of 10. Similarly in the case of boring #5, where as the blow count data of 5 and 7 around 2 ft. depth clearly indicates liquefaction; however, the soil has a relatively high dry density at these locations. We believe that this is due to the nature of the subsoil conditions which contain high percentages of silts with fine sands which

1. The cracks in the upstream face of the lining are believed to have been caused by the differential dynamic vibrations of the earth embankment and the concrete lining. A detailed dynamic analysis is warranted to more clearly define the cause.
2. Possible liquefaction of the underlying soils appears to have caused the bed lining to fail in punching shear due to the uplift pressure.
