Damage to Agricultural Facilities Caused by the 1993 Kushiro-oki and Hokkaido Nansei-Oki Earthquakes

Paper No. 9.15

S. Tani

SYOPSIS Two large earthquakes struck Japan during only a 6 month period in 1993: Kushiro-oki on January 15 and Hokkaido Nansei-oki on July 12. Both caused a lot of damage to facilities, including installations such as farm roads, reclaimed farmland, channels, head works, drainage pump stations, pipelines and fill dams. In this paper, we present an outline of the damage to agricultural facilities and its features.

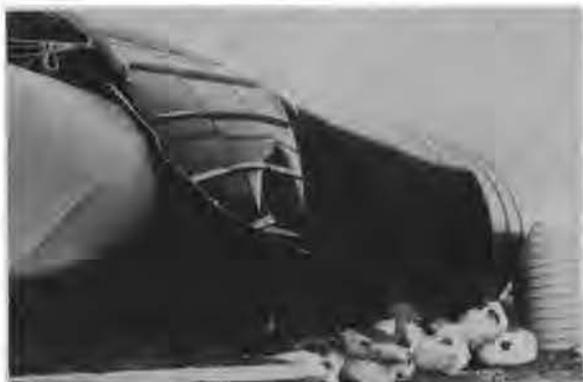
(3) Silos: Three silos in the town of Bekkai were damaged. One was completely destroyed (Fig.3) and in the case of other two, panels on the side walls were damaged and anchor bolts fixing the silos were broken. It is presumed that acid silage had corroded the bolts.

Fig.3. Collapse of Silo in Betsukai City.

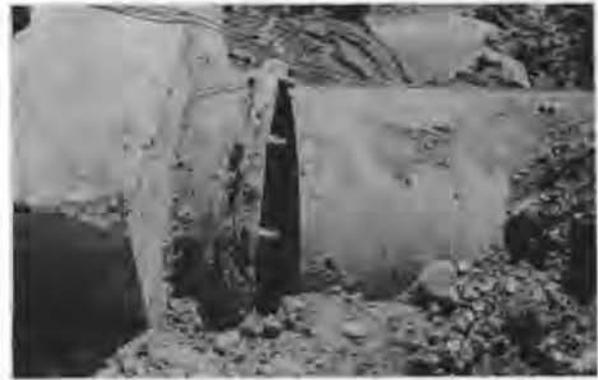
(3) Pipelines: The Makomanai first main pipeline in the Kitahiyama district was damaged. Fig.5 shows the damage of Makomanai pipeline. Mostly, pipes were removed because thrust blocks moved, pipes came up to the surface and joints were dislocated. Large traces of sand boil were observed around

the damaged places. The sand boil seems to have been caused by ground and back-filling sand. Additionally, sand boil occurred when pipes were removed due to high pressure applied to the pipelines. The main cause of damage can be attributed to liquefaction and the accompanying excessive thrust forces working on the blocks, because large damage was observed in the place near the thrust blocks where topographic features suddenly changed.

Fig. 5. Damage of Makomanai pipeline.

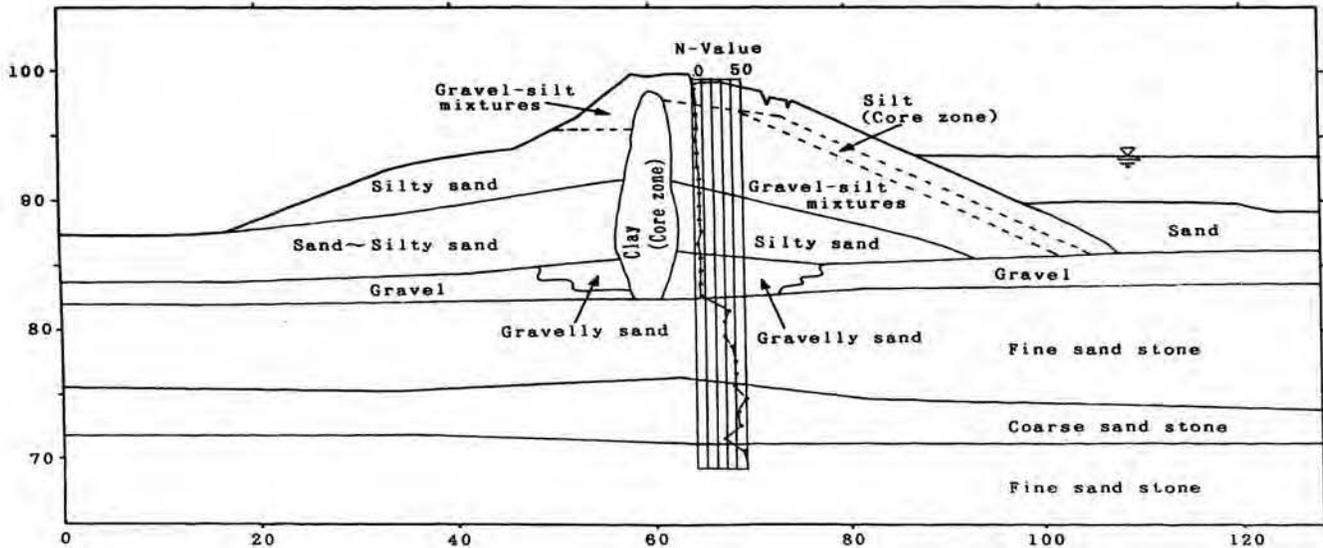
Niwa-ikumine Dam is an earth dam, with the height of the dam being 10 m, and is located about 71 km away from the epicenter. The dam suffered heavy damage, and almost the full length of the crest in the upper stream suffered faulting, which resulted in a 1-1.5 m difference of levels in the direction of the axis of the dam. In addition, a swelling was observed in the bottom part of the slope in the upper stream. This dam was built by settlers at the end of the Taisho era and collapsed once in the beginning of the Showa era and was repaired. A detailed survey of the dam and base ground was conducted after the earthquake. Fig. 7 shows a rough cross section of the dam and base as well as the composition of soil. Although it is basically an earth dam with a core, the composition of soil in the random zone in the down stream and upper stream is complicated. The bank is composed of a mixture of gravel and silt, while the base is composed mostly of fine sand and silty sand with N-values of less than 5. Sandstone with an N-value of more than 40 appears in the layer of -17 m from the crest.

Fig. 7. Cross-section through Niwa-Ikumine Dam Damaged by the 1993 Hokkaido-Nannsei Oki Earthquake.

According to soil test results, it was confirmed that excessive water pressure in the base ground soil easily increases. It is therefore concluded that the major cause of the damage to Niwa-ikumine Dam was the collapse of bank which was brought on by the decrease in the bearing capacity of the ground as excess pore pressure in the ground increased. Analytic study of the cause is now under way. With regard to small earth dam damage, two in Kitahiyama collapsed. 12 other earth dam suffered slight damage, including cracks and sinking. The locations of these earth dam are shown in Fig. 4 with numbers. Most of the damage is concentrated in the town of Setana near the epicenter.

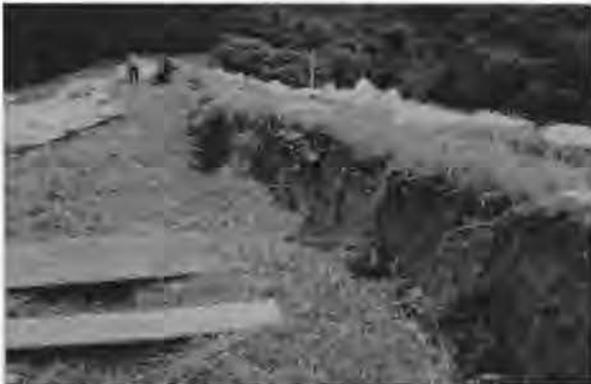
Fig. 8. Damage of Niwa-Ikumine Dam.
