The Observed Building Damage Associated with Fault Movement in 1999 Chi-Chi (Taiwan) Earthquake

H.W. Yang
THSRC
Taiwan

S.M. Lin
National Taiwan Normal University
Taiwan

Daniel Chu
Ninyo and Moore
Irvine, California, USA-92618

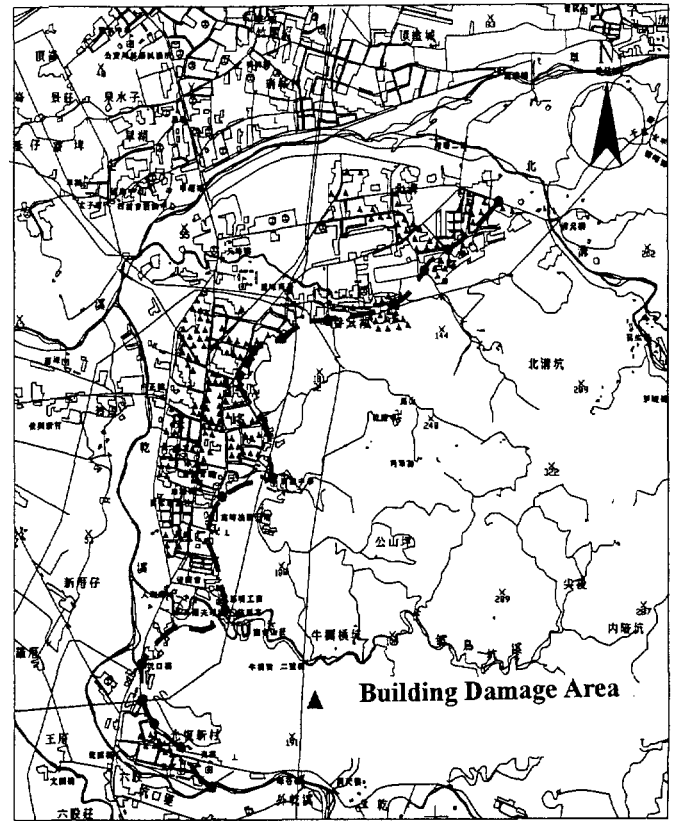
The Chi-Chi earthquake encompassed a primary damage area of 22 townships in Taichung county and Nantou county. The Wu-Fong Township, which is in the primary damage area, was selected for this study due to the extent of damage sustained and the on-site survey data taken in Wu-Fong. Wu-Fong Township was one of the more severely damaged areas in this earthquake due to the fault rupture line passing through most of the downtown area. Figure 2 shows the observed damage spatial distribution in Wu-Fong (Lin, S.M., 2000). In order to study damage patterns along both sides of the fault, three specific locations were chosen from the Wu-Fong Township based on the criteria established. A common trait of these areas includes a ruptured fault passing through the location with buildings on both sides of that fault. Figure 3 provides the three case studies utilized for this study and the location of the fault lines within those three cases.

Fig. 2 Spatial Distribution of Building Damage in Wu-Fong Area (S.M., Lin, 2000)

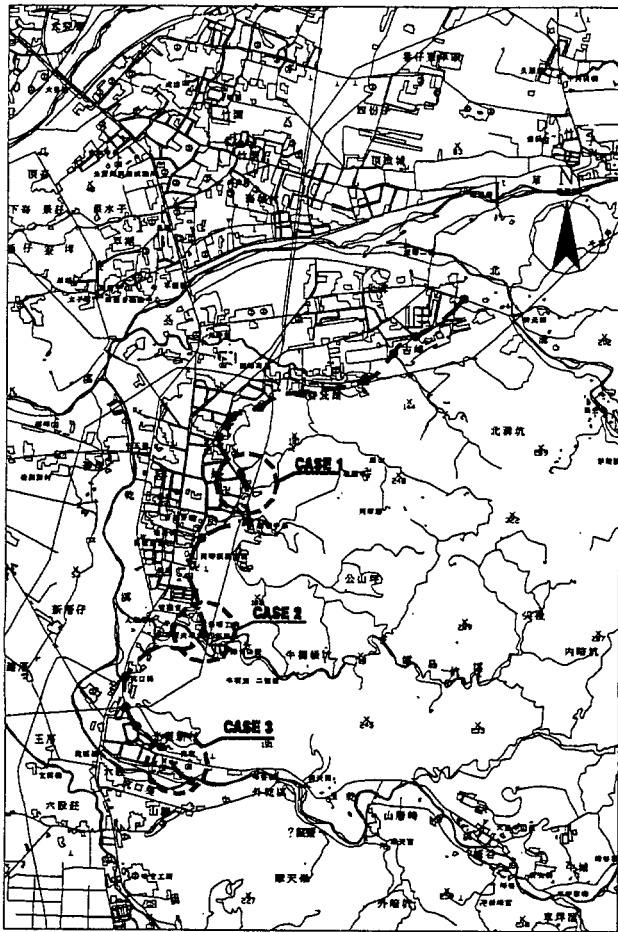
Fault rupture line passes through the east side of the downtown area. The fault rupture caused an approximate 2 meters up-lift. Most of the residential buildings on the up-lift side were totally destroyed. Only minor damage was observed for the buildings on the opposing side of the fault.

A college campus and the Temple of Ten-Thousand Buddha's on the up lifted side of the fault were totally destroyed. The fault rupture is less than 100m south of the Taiwan Provincial Assembly Compound. The Assembly building located on the opposing side of the fault sustained relatively minor damage.

The fault rupture line passes through the Kuangfu High School campus. A thrust fault rupture 2 meters in height is

clearly visible in the sports field. A multi-story building on the uplifted side was severely damaged, while an elementary school approximately 5m from the fault line on the opposing side of the fault experienced only minor damage.

Fig. 3 Case Study Locations in Wu-Fong Area

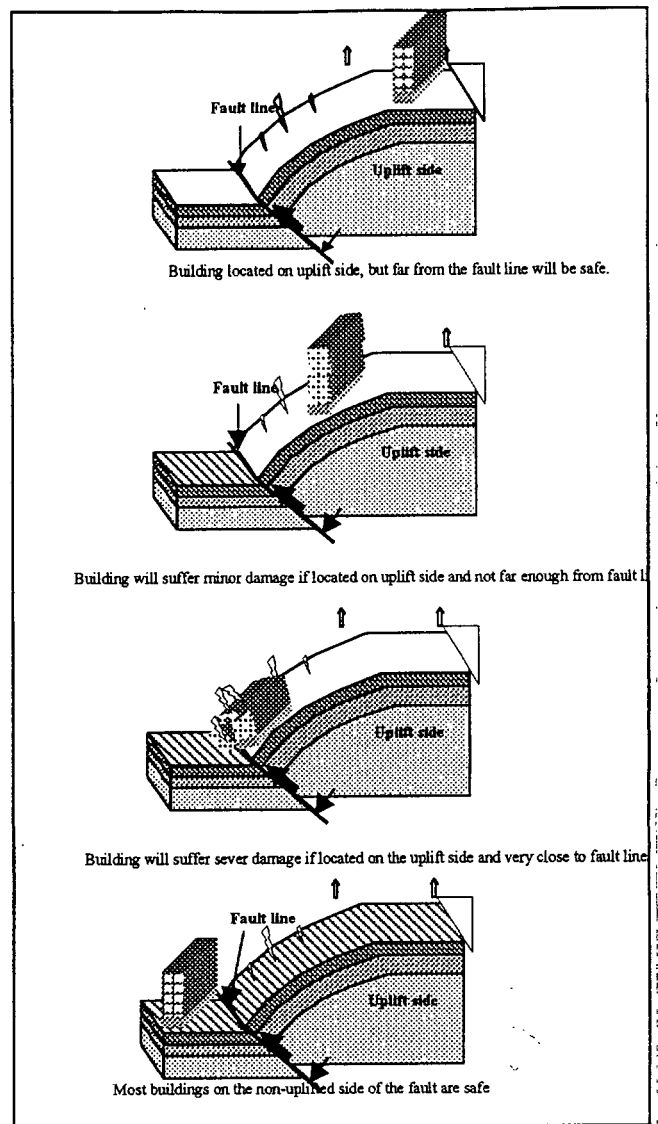
It is readily apparent that the observed damage on the up-lift side of the faults is more severe than that on the opposing side of the faults. A qualitative expression of the failure mechanism (Liu and Chen, 1999) is shown in Figure 4. Careful review and study of the visual inspections and damage assessments carried out after earthquake, lead one to believe that most of damage in the up-lift side was due to ground deformation associated with the up-lift and surface faulting. Buildings located on the opposing side of the fault (West Side) suffered much less ground deformation; therefore, only minor damage was observed.

Fig. 4 Building Failure Mechanism in Chi-Chi Earthquake (Liu and Chen, 1999)

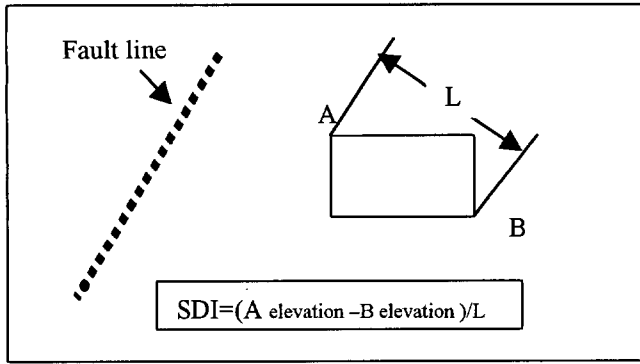
To allow quantification of the observed damage a Structure Distortion Index (SDI) was devised and used for the buildings located on both sides of the fault line. These buildings sustained either total or partial damage. Figure 5 graphically shows the SDI definition. Since the elevation and location survey done after earthquake was for urban planning purposes, it must be understood that the information of elevation may not be accurate and sufficient enough to define differential settlement that is commonly used for building foundation structural design. Higher SDI values equate to a higher damage potential for a building. In addition, it was assumed that the ground elevation was consistent prior to this earthquake. Once the SDI value, damage condition (total or partial), and relative position to the fault line are known, the SDI distribution curve for buildings on both sides of the fault

Fig. 5 Definition of Structure Distortion Index

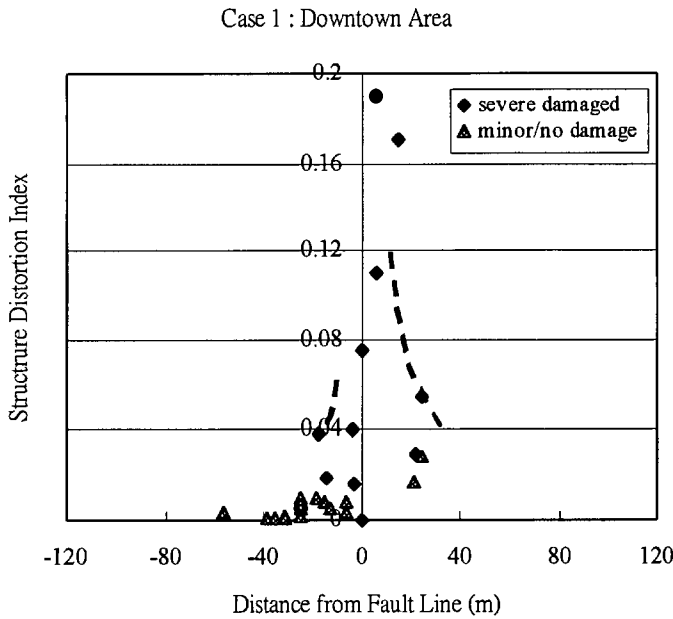
Fig. 6 Damage Distribution for Case 1

Figure 6, 7, and 8 are the SDI data distribution for case 1, 2, and 3 respectively. These three cases demonstrate the same pattern of SDI curves. In cases of buildings located on a fault rupture line, the buildings suffered severe damage and have a SDI value up to 0.2. In general, the damaged building, at roughly the same distance from fault line, has higher SDI value on the uplift side than on the opposing side of the fault. Envelopes of SDI data distribution can be generated for each side of the fault. The damage sustained within the envelope for the up-lift side is clearly higher than the damage sustained within the envelope for the opposing side, which supports the original observation. In addition, severely damaged buildings in case 3 can be found as far as 110 meters from the fault

rupture line. Both case 1 and case 3 demonstrate that many buildings survived with minimal damage on the west side of fault line.

It is readily apparent from the SDI data distribution and resulting envelopes for the case studies that no building is safe when that building crosses a fault that experiences ruptures like those the Chi-Chi earthquake produced. This study demonstrates quantitatively that the damage to buildings was more extensive on the uplifted side of the fault. It is also clear that the nearer a building is to the fault on the uplifted side, the more extensive the damage to be expected. This study reaches conclusions based on the Chi-Chi earthquake data and as such one should exercise caution in extrapolating any similarities to larger magnitude earthquakes. It must be considered that the sample data is limited and more extensive research should be conducted not only from this event, but other large magnitude earthquakes around the world to provide a more comprehensive database, which it is believed would provide a valuable tool for establishing potential risks to buildings. This could reduce the risk of loss of buildings and life not just in Taiwan but across the globe.

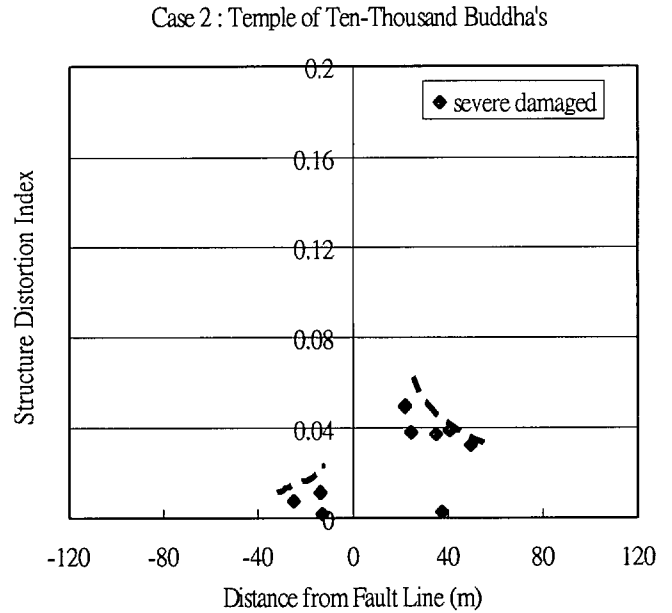
Fig. 7 Damage Distribution for Case 2

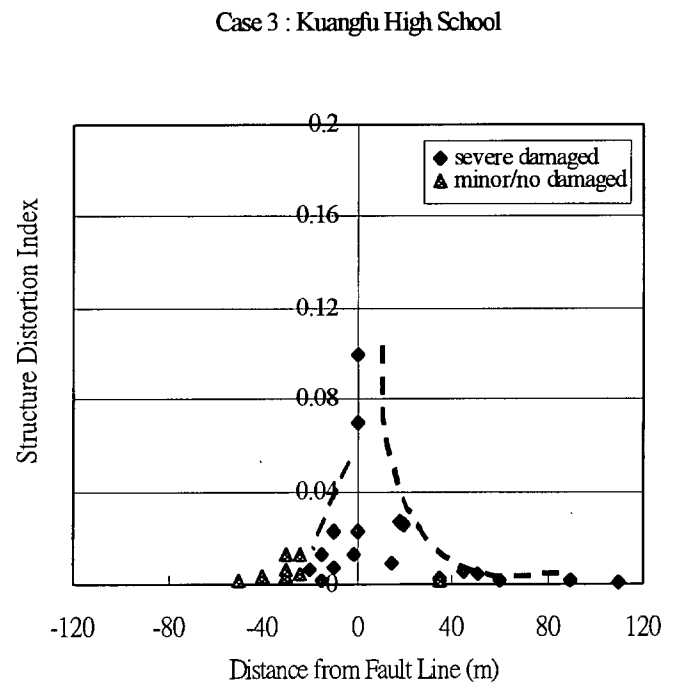
Fig. 8 Damage Distribution for Case 3
