Relevance of Some Damage Factors to Structures Damage in the 1995 Kobe Earthquake

RELEVANCE OF SOME DAMAGE FACTORS TO STRUCTURES DAMAGE IN THE 1995 KOBE EARTHQUAKE

Paper No. 10.27

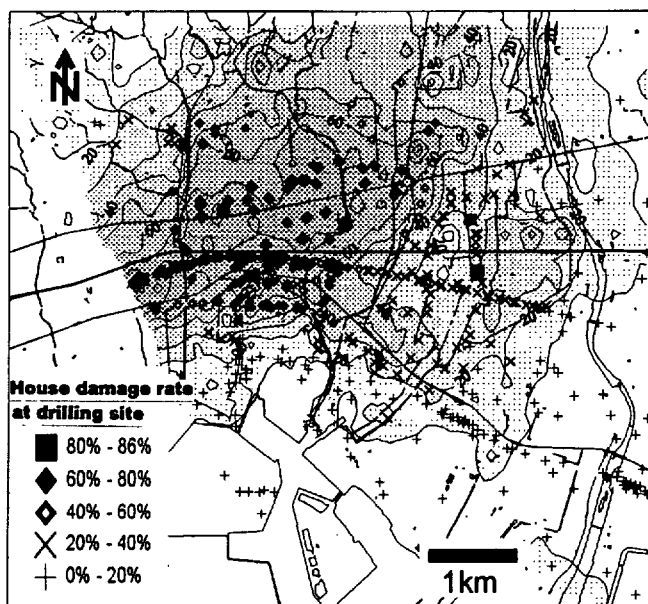
Fig.4 Distribution of houses damage rate

individuals is not published. Iwasaki et al. (1996) reported the detailed collapse rate of wooden houses in each street block of Nishinomiya City. The rate is used for our analysis, as shown in Fig. 4.

The distribution of the collapse rate appears as the accumulation of detached damages. The collapse rate was ranged from 10 % to 80%. The large collapse rate zone (over 60%) distributes in the center and western part of the study area. On the other hand, the coastal area has low collapse rates. Because boiling sands widely appeared, the loose sandy layers in shallow part were liquefied by the main shock in the coastal area. The damping of main shock on the liquefaction causes the distribution of the low rate zone in the coastal area.

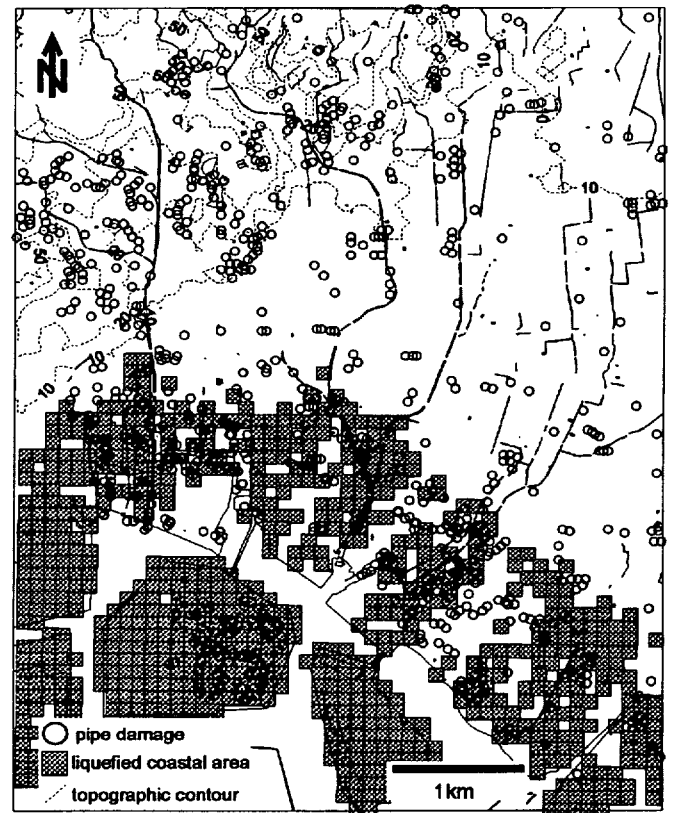
Fig.5 Damage location of the water supply pipelines

Japanese Water Works Association reported the damage location of the water supply pipelines in Nishinomiya City as shown in Fig. 5 (Hamada and Iwasaki, 1997). The degree of pipelines damage at each drilling site was estimated from the total count of damages in a circle area with radius of 200m.

Because water supply pipelines are buried in shallow part of subsurface, it is easy to receive deformation damage by ground displacement. The distribution of pipelines damage in

Nishinomiya City clustered in the coastal and hilly areas. This distribution differs from the houses damage rate. It is suggested that such complex factors, as structure form, ground property and ground motion, cause these differences.

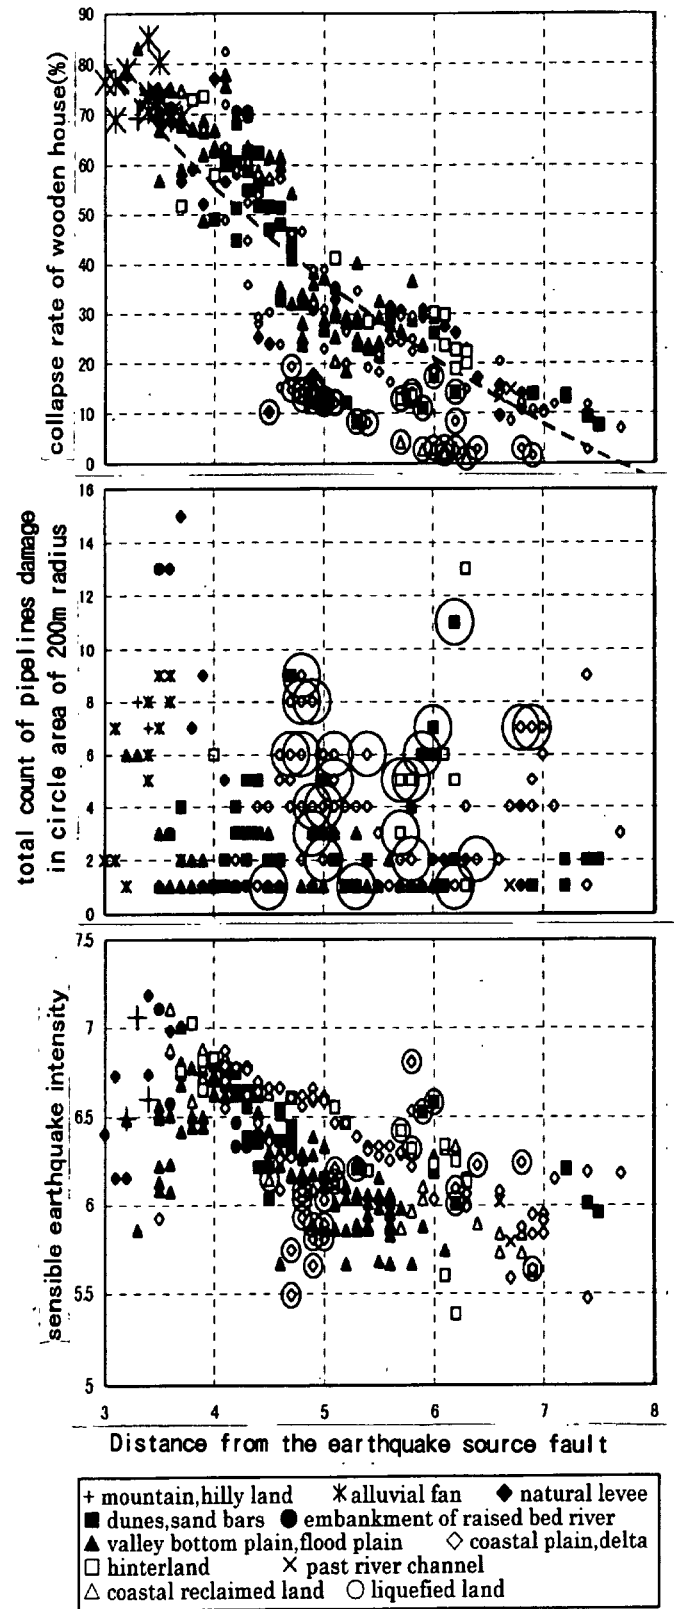
Fig.6 Damage factors correlated with the distance from earthquake source fault

The shortest distance from the drilling data point to the earthquake source fault estimated with the inversion method can be obtained. Fig. 6 shows the correlation between the collapse rate of wooden house and the distance from the earthquake source fault.

The collapse rate is about 80% at the distance of 3km from the earthquake source fault. Then, there is a rapid drop with increasing the distance. The collapse rate decreases to 10 – 20% at the distance of 7-8km. The two factors have a negative interrelation. It is clear that the amplitude of earthquake motion is damped with a logarithmic function of the distance from the earthquake source fault. The relationship between the collapse rate and the distance can also be explained by a logarithmic function as shown in the upper figure of Fig. 6. On the other hand, Iwasaki et al. (1996) reported that the collapse rate is in proportion to the arithmetic distance. There is room for further discussions on this point.

The middle figure of Fig. 6 shows the relationship between the degree of pipelines damage and the distance from the earthquake source fault, in which no clear correlation is confirmed.

As shown in the bottom figure of Fig. 6, the sensible intensity of the earthquake gradually decreases with increasing the distance of the earthquake source fault. Then, beyond the distance of 5 km, it becomes steady about 6.

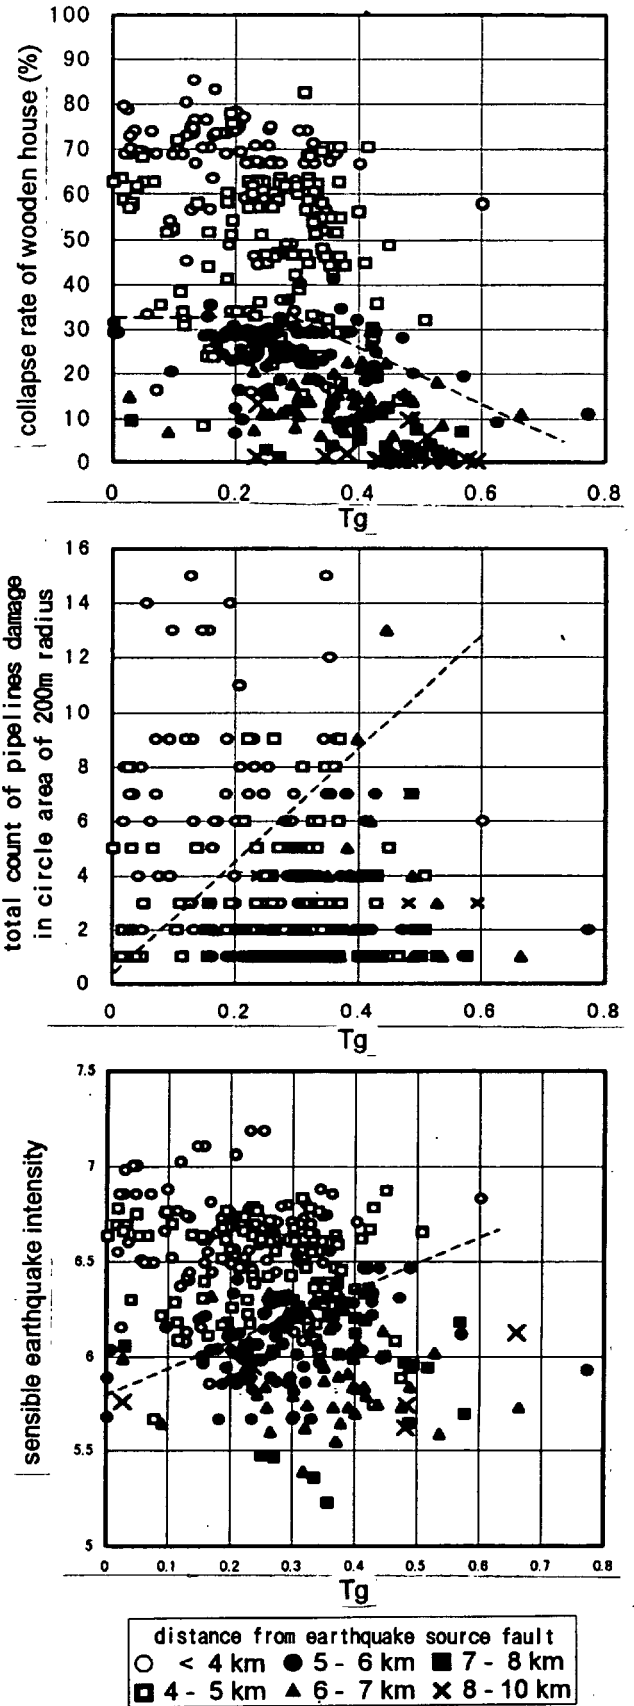
Fig.7 Damage factors correlated with the ground characteristic value

Fig. 7 shows the correlations of collapse rate, pipelines damage, sensible intensity with Tg. In each figure is shown a trend line at the distance of 5-6 km from the fault.

At a distance of less than 5km from the fault, wooden houses damage distributes in higher collapse rate (40-90%) through the difference of Tg. At a distance of over 5km from the fault, it gradually decreases with increasing Tg.

The pipelines damage does not have a significant correlation near the fault, while, at a distance of over 5km from the fault, it increases with increasing Tg. The sensible intensity has a similar trend as the pipelines damage.

As mentioned above, the distance of 5km from the earthquake source fault forms the boundary of trends on the relationship with Tg of the houses damage, pipelines damage and sensible intensity. At a distance of less than 5 km, it is suggested that the impact of amplitude of the main shock to the structure damage exceeds the effect of frequency property of ground.

The effect of Tg is clear at a distance of over 5km from the

fault. In this area, the difference of the frequency property of ground is one of main factors of earthquake damage.
