International Conferences on Recent Advances in Geotechnical Earthquake Engineering and Soil Dynamics 1995 - Third International Conference on Recent Advances in Geotechnical Earthquake Engineering & Soil Dynamics

Northridge Earthquake – Van Norman Complex Ground Movement

C. A. Davis

Los Angeles Department of Water and Power, Los Angeles, CA

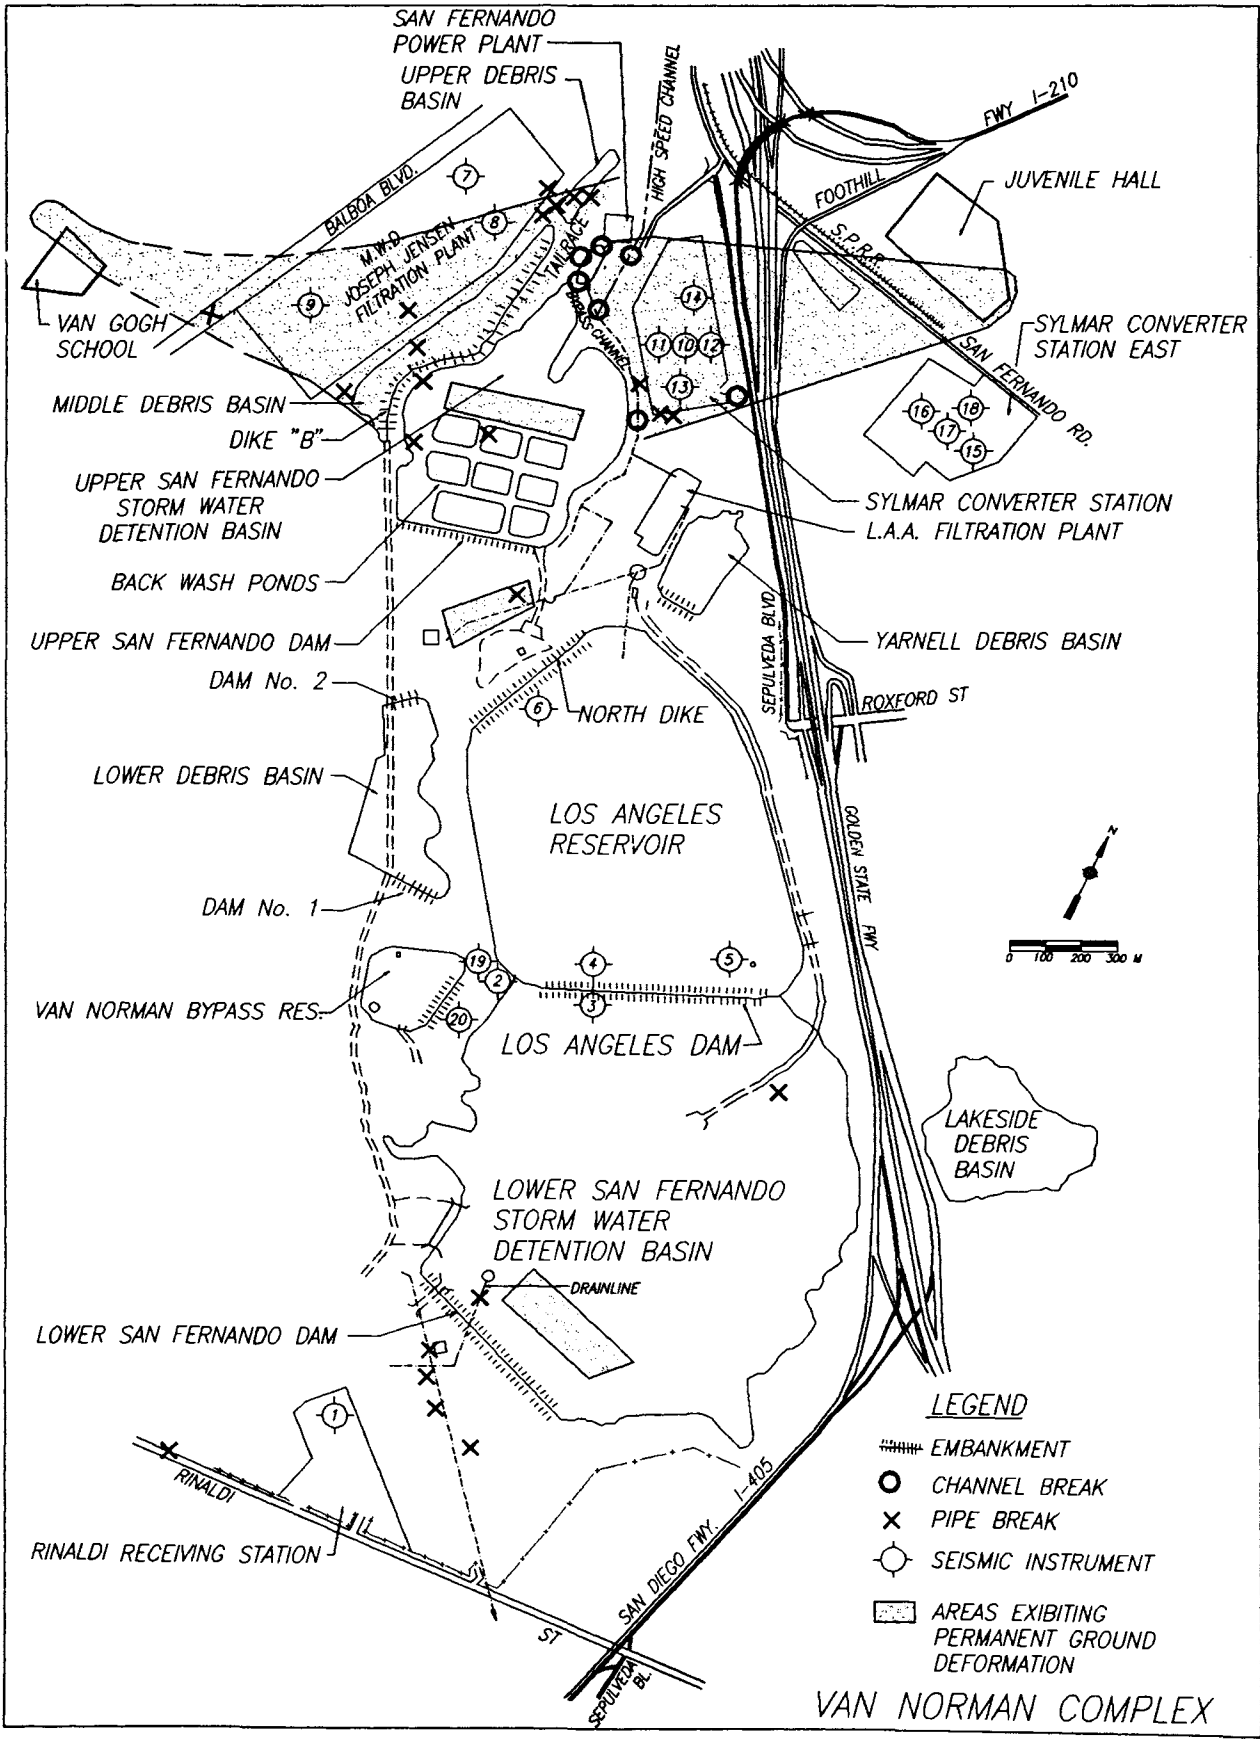
Figure 2. The Van Norman Complex showing location of the main facilities, embankment dams, strong motion recording stations, pipe and channel breaks, and areas of permanent ground deformation.

Figure 2 shows the location for the many cases of ground deformation and liquefaction induced lateral spreading on the Van Norman Complex. Lateral spreading, accompanied by sand boils, was observed below the Upper San Fernando Dam creating tension cracks on the east side of an asphalt road and a compression failure at the west end (Bardet and Davis, 1995b). Compacted fill at the north end of the backwash pond dikes spread northerly creating large scarps (Davis and Sakado, 1994).

As indicated in Figure 2, large zones of lateral spreads occurred on each side of the Upper San Fernando Detention Basin and tailrace channel. These spreads resemble descriptions of ground movements and alluvial slides described by Youd (1971, 1973) following the 1971 San Fernando Earthquake. The Juvenile Hall Slide (Youd, 1971, 1973), extending east, was reactivated causing damage to Interstate 5, San Fernando Road, the Sylmar Converter Station, large water distribution pipes, aqueduct and storm channels, and other important facilities. Much of the Juvenile Hall Slide ground deformation was similar to that reported following the 1971 San Fernando Earthquake, however, during the Northridge Earthquake, lateral spreading covered a wider area and moved less than what was documented in 1971. Surface ruptures on and around the Juvenile Hall Slide, in the area located in Figure 2, were not continuous and did not cause observable pavement failures on Sepulveda Boulevard, the north bound lanes of Interstate 5, or the northern end of the Sylmar Converter Station. Although smaller cracks and pavement fractures were found in Sepulveda Boulevard and the north end of the Converter Station.

On the west side of the Upper San Fernando Storm Water Detention Basin there was evidence of permanent ground deformation and lateral spreading extending west of Balboa Boulevard. This permanent ground deformation was not observed to be continuous throughout the area noted in Figure 2, but, nevertheless, caused damage to the San Fernando Power Plant and Tailrace Channel, pipes, slopes, Jensen Filtration Plant, and other facilities including the Van Gogh Street School west of Balboa Boulevard, all of which are located on the alluvial deposits from Bull Creek which flows easterly from the Santa Susana Mountains. Detailed descriptions of the damage caused to the San Fernando Power Plant and Tailrace Channel are provided by Davis and Bardet (1995a).

As shown in Figure 2, ground deformation resulting from liquefaction and lateral spreading occurred on the upstream berm of the Lower San Fernando Dam. Evidence of liquefaction was provided by the fifty large sand boils which erupted on the ground surface. The liquefaction was found to have occurred within the old hydraulic fill slide debris which was saturated and has remained in place since the 1971 San Fernando Earthquake (Bardet and Davis, 1995b). The area of ground deformation was accompanied with large ground fissures and 100 m of laterally crushed corrugated metal pipe located along the western boundary of the ground movement. Detailed maps of ground cracking and sand boils are presented by Bardet and Davis (1995b) and a discussion of the crushed pipe is presented by Davis and Bardet (1995b).

Within the areas of documented permanent ground deformation and lateral spreading, shown in Figure 2, ground cracking was observed throughout the zones, and sand boils were observed around the tailrace channel, in the Middle Debris Basin located down slope from the Jensen Filtration Plant, on the

Figure 2 shows a map of the Van Norman Complex indicating breaks on pipes and channels used for transporting water by the Los Angeles Department of Water and Power and the Metropolitan Water District. Pipe alignments are not shown for clarity. All of the pipe breaks shown in Figure 2 occurred on 61 cm diameter and larger pipes. For the purposes of this discussion a break is defined as a failure of the conduit or a water leak requiring repair. Approximately 30 breaks were experienced in the many pipes and channels throughout the complex. The majority of trunk line breaks from the Northridge Earthquake occurred on or within 2 km of the complex. Most pipe and channel ruptures north of the Upper San Fernando Dam correlate with the area of observed permanent ground deformation described above.

On the south end of the complex numerous breaks occurred within a concentrated area. However, there was not extensive ground failure observed in the associated region. Erosion from the large pipe breaks may have masked signs of permanent ground displacement. These breaks occurred near the Rinaldi Receiving Station which recorded large accelerations and the highest ground velocities ever noted in any earthquake (Bardet and Davis, 1995a; USGS and SCEC, 1994; Wald and Heaton, 1994).

Pipe and channel breaks provide a good indication of large ground movement. The breaks may result from permanent ground deformation, as observed on the north end of the complex, or from stress induced by strong ground motions. The breaks on the southern end of the complex may be a result of the latter, or a combination of the two effects.

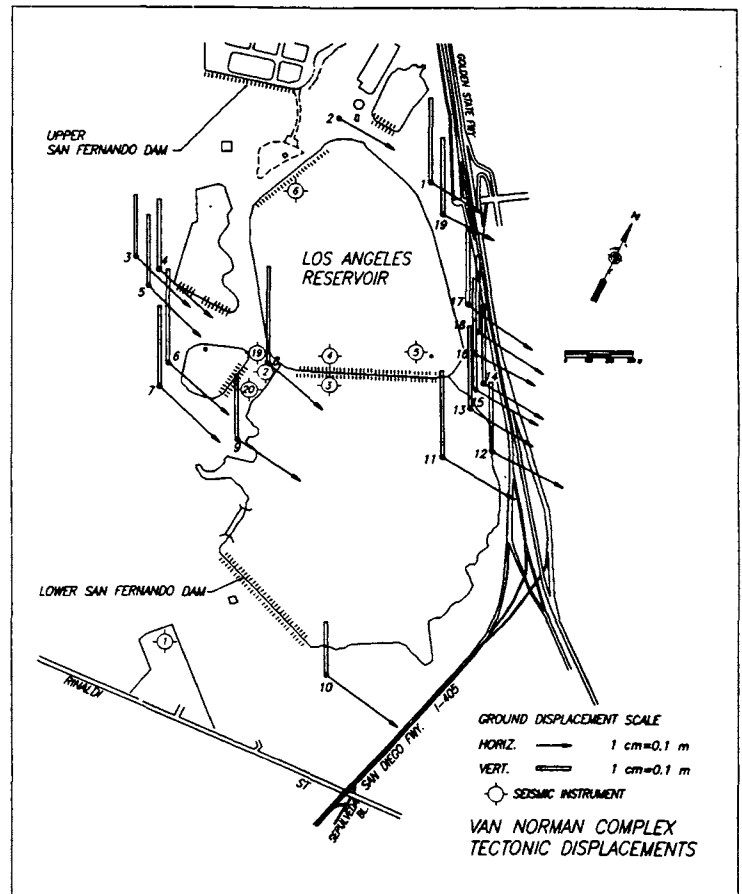
Figure 3 shows tectonic displacements at the Van Norman Complex measured by Global Positioning Systems at 19 monument stations in the vicinity of Los Angeles Reservoir. Most of these displacements were measured on bedrock stations relative to one absolute benchmark point within the complex, the displacement of which was determined by connecting the 1994 post-earthquake leveling networks of the City of Los Angeles and Caltrans. Figure 3 represents the horizontal movement by using vectors and the vertical uplift by using vertical bars. The vertical uplift on the Van Norman Complex ranges from 15 to 30 cm, while the horizontal movement in the southern direction varies from 0.3 to 7 cm and the horizontal movement in the eastern direction ranges from

Figure 3. Horizontal and vertical tectonic movement in the Van Norman Complex.

16 to 24 cm. The vertical uplift increases to the north and west. Movements in the southern direction increase to the west, whereas those in the eastern direction decrease to the north. The tectonic displacement was not consistent throughout the complex. At the Los Angeles Reservoir, the bedrock uplift was found to have a consistent slope with higher elevations to the west across most of the reservoir, and a rapid variation in uplift at the southeast corner (Davis and Bardet, 1995a). Compared to the Santa Susana Mountains, the Van Norman Complex underwent nearly half the vertical uplift, and slightly larger horizontal displacements. Further detail on tectonic displacements can be found in Bardet and Davis (1995a) and Davis and Bardet (1995a).
