Geotechnical Aspects of Recent Japan Earthquakes

Susumu Yasuda
Tokyo Denki University, Japan

Tomohiro Tanaka
Tokyo Denki University, Japan

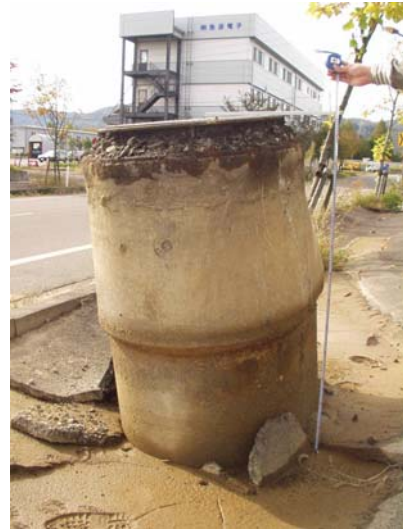
Photo 1. Uplifted manhole in Ojiya City

Sewage facilities were damaged in 22 cities and towns. The maximum distance from the epicenter to damaged towns was about 30 km. The total loss of sewage facilities was valued at 20.6 billion Yen. 152.1 km of pipes were damaged. 1,453 manholes and many buried sewage pipes were uplifted as shown in Photos 1 and 2. The maximum height of the uplifted manholes was about 1.5 m. A car collided with an uplifted manhole in Nagaoka City. Roads caved in at 5,908 sites. Photo 3 shows a road cave-in in Nagaoka City. The surface of the road settled by several tens of cm. Therefore, the damage to the sewage manholes and pipes not only prevented the disposal of waste water but also erected obstacles to traffic and restoration activities.

- compact the sand fill to more than 90 % of degree of compaction ($D_c > 90\%$),
- fill ditches with gravel instead sand,
- mix the sand fill with cement.

In the restoration work, the manholes that uplifted more than about 5 cm and the pipes that uplifted more than 1/4 of the diameter of the pipes had to be replaced in Nagaoka City.

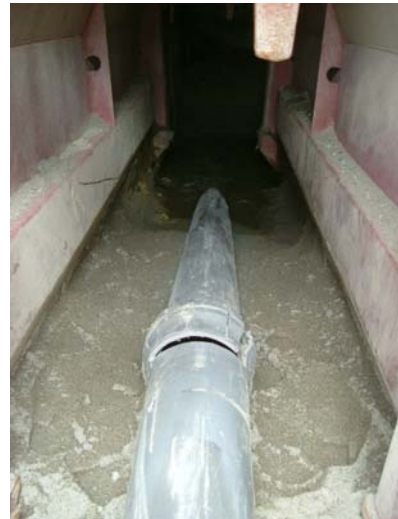
Photo 2. Uplifted pipe found during restoration work in Nagaoka City

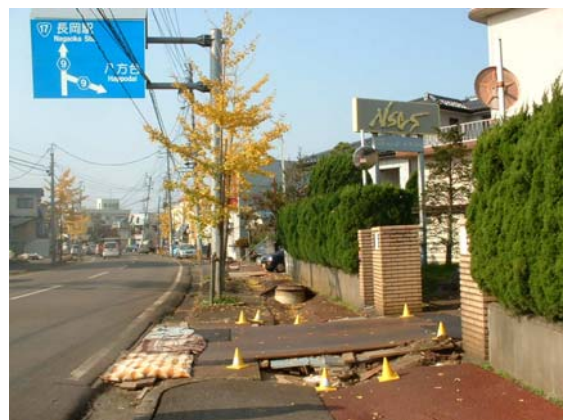
Photo 3. Road cave-in on sewage pipes in Nagaoka City

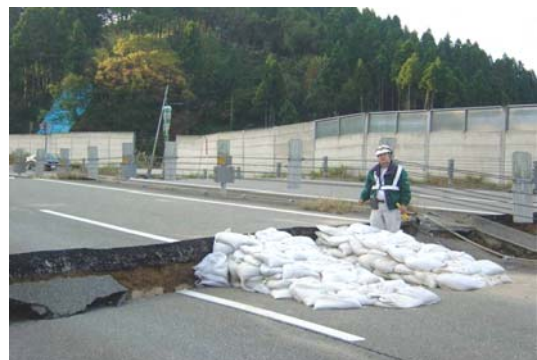
The differential settlements between embankments and culverts, and the settlements of culverts themselves between Yamamotoyama Tunnel and Yamaya PA, were measured. The differential settlement was about 50 to 70 cm near Yamamotoyama Tunnel and the settlements of culverts were about 10 to 20 cm. On the contrary, culverts near Ojiya IC

Photo 4. Differential settlement between embankment and culvert at C-Box Kawaguchi 11 (Yasuda and Fujioka, 2009)

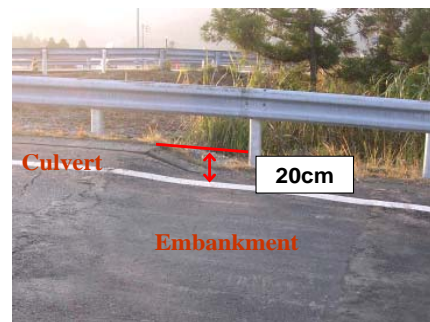
settled much more than this. Around Ojiya IC, differential settlement of several tens cms occurred between embankments and culverts as shown in Photo 5. Moreover, culverts settled several tens cms and stretched as shown in Photo 6 and 7. Embankment soil fell through the opened joints. The deformation of embankments, culvert boxes and ground are schematically shown in Fig.5 (c). Both toes of the embankments spread in a lateral direction and caused the lateral displacement of adjacent ground as shown in Photo 8. The embankment soils at the two sites are clayey soils with 70% to 80% of fines. The SPT *N*-values of the embankment soils are 5 to 10. The heights of the embankments at the two sites were 5.6 to 6.8 m and 5.3 to 5.6 m, respectively. The water levels at the sites were about 3 m higher than the bottom of the embankments, though the embankments were constructed on level ground. At C-Box Kawaguchi 22, thick soft silty layers, with the SPT *N*-values of about 5 are deposited from the ground surface to a depth of 16 m. A thin soft, silt, layer 2 m thick is deposited under the embankment at C-Box Ojiya 2. Then, silty sand, silt, sandy silt and silt layers, with SPT *N*-values of 10 to 20, are deposited to a depth of 24 m.

Photo 5. Differential settlement at C-Box Kawaguchi 22 (Yasuda and Fujioka, 2009)

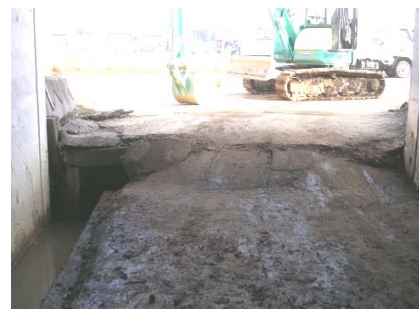
Photo 6. Settlement of culvert at C-Box Kawaguchi 22

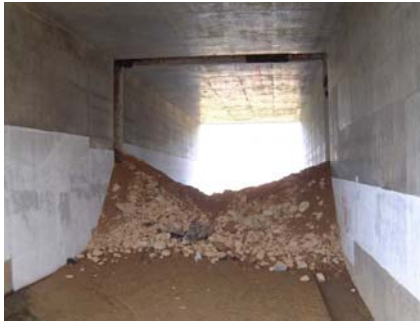
Photo 7. Separation of culvert joint at C-Box Ojiya 2 (Yasuda and Fujioka, 2009)

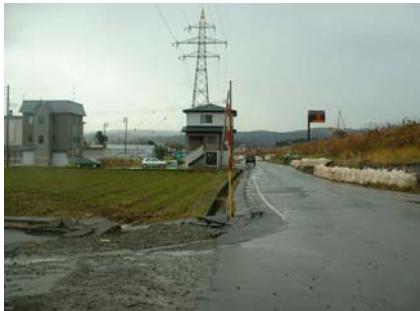
Photo 8. Moved ground adjacent to C-Box Ojiya 2

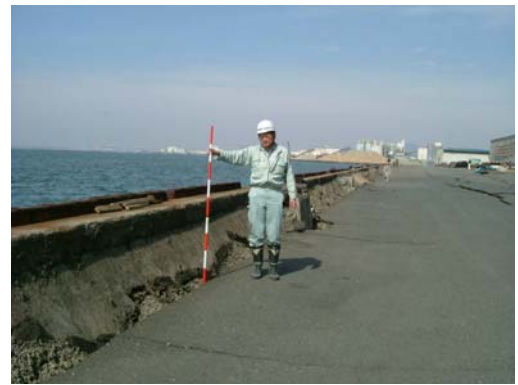
Photo 9. Displacement of a quay wall and subsidence of the ground in Oki-hama

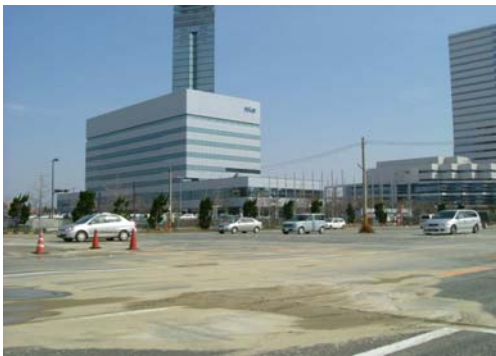
Photo 10. Boiled sand in Momochi-hama

cm due to liquefaction in Aratsu. In Momochi-hama, sand boils were observed at many sites as shown in Photo 10. However, no damage to buildings and timber houses occurred. Obvious ground subsidence did not occur at the liquefied sites. Therefore, it is estimated that liquefied layer was thin.

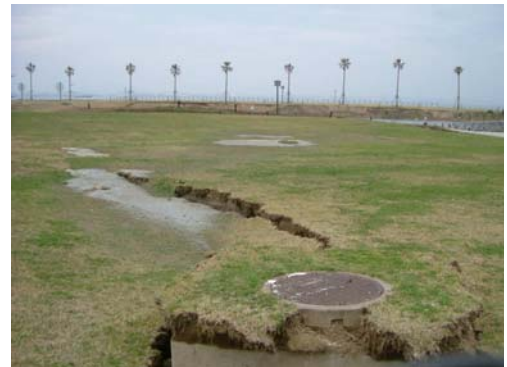
Photo 11. Liquefaction-induced flow at Uminonakamichi Seaside Park

Many boiled sands were observed at Uminonakamichi Seaside Park. This site was newly developed for a park by filling a part of a pond with sand. The filled ground behind a remaining pond has a gentle slope towards the remaining pond. Liquefaction-induced flow occurred on the sloping ground. Maximum horizontal displacement due to the flow was about 10 m. The flow extended to about 80 m. Cracks occurred on the ground surface due to the flow as shown in Photo 11. Simple piers and promenades were damaged due to the flow. A filled sand layer is deposited from ground surface to a depth of about 10 m. The fill was clean and very loose because its SPT *N*-value was very low as 2 to 7. Therefore, it is estimated the fill liquefied due to the earthquake.

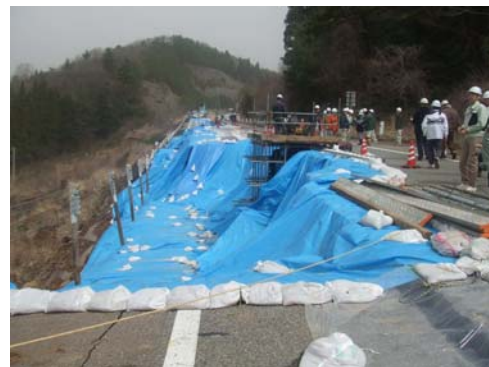
Photo 12. Slide of the embankment of Noto-yuryo road at site No.9

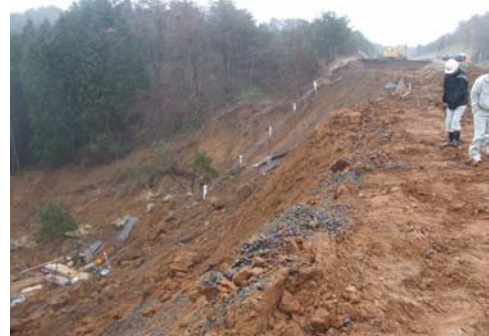
Photo 13. Slide of the embankment of Noto-yuryo road at site No.32

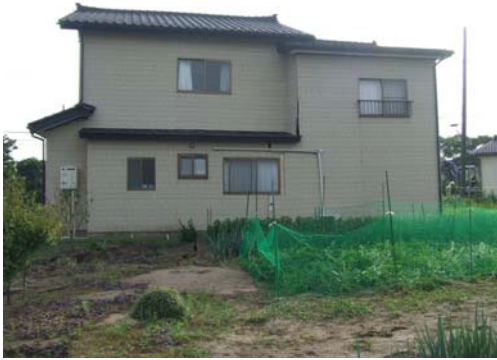
Photo 14. A settled house in Hashiba district

Among the first group, about 20 houses settled due to liquefaction in Hashiba district as shown in Photo 14. The author and his colleagues conducted detailed survey on the damage to houses and grounds. Then, severity of the damage to houses and grounds were graded. Figure 16 shows the relationship between the grade of severity of the damage and depth of ground water table. Severity of damage decreased

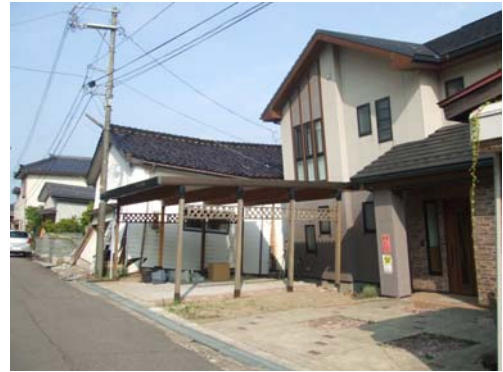
Photo 16. Damaged house due to liquefaction-induced flow in Yamamotodanchi district

In the second group, very severe damage to houses occurred as shown in Photo 16 because not only liquefaction but also liquefaction-induced ground flow occurred at sloping grounds of sand dunes. In Inaba district, liquefaction had occurred during previous two earthquakes: the 1964 Niigata earthquake and the 2004 Niigataken-chuetu earthquake. Several houses settled during the 2004 earthquake were restored by two types of countermeasures. The first type of the measure was to install long steel piles with 5 to 6 m long, then build new houses. No severe damage occurred to the houses though surrounding ground liquefied and subsided about 20 cm. The second type was underpinning of existing houses by short steel piles. The depth of piles were about GL-2 m. Severe damage to the houses with the settlement of about 30 cm occurred as shown in Photo 17. The depth of the piles must be not enough to support the houses because liquefied depth was about 6 to 7 m.

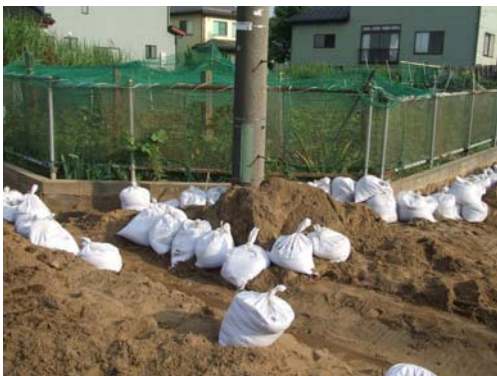
Photo 15. Erupted sand and a settled electric pole in Matsunami district

with the increase of the depth of water table. If the ground water table was deeper than about 1.5 m, no severe damage was observed. Photo 15 shows boiled sand and settled an electric light pole in Matsunami district. Huge amount of water and sand erupted in Matsunami district due to liquefaction. However, only few houses which were located on sloping grounds were damaged. Measured ground water tables at several sites were about GL-2 m to -3 m. Therefore it can be judged that no severe damage to houses occurred because surface unliquefiable layer was thicker than about 1.5 m, though liquefaction induces in the layers below ground water table. This phenomenon is similar as the previous experience during the 2000 Tottoriken-seibu-oki earthquake (Yasuda, et al., 2004).

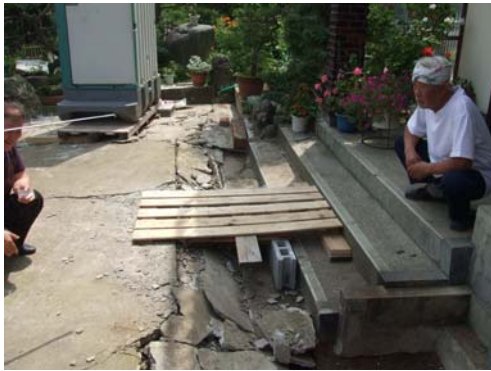
Photo 17. A settled house due to liquefaction though restored by short steel piles after the previous

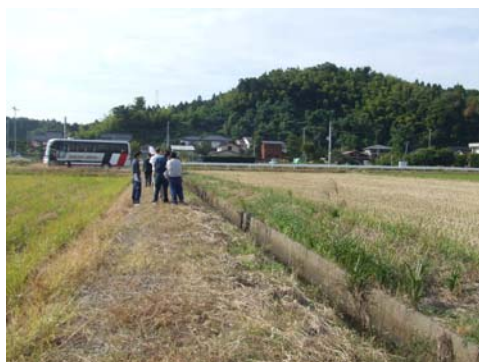
Photo 18. One site where middle pressure gas pipe was damaged due to buckling at the boundary between a valley plain and a surrounding hill

of the plain are surrounded by hills and mountains. As mentioned above, the surface soil in the valley plain is very soft. Moreover, epicenter of the earthquake is fairly close. Then it is estimated that very large compressive strain induced at the boundary between the valley plain and surrounding hills or sand dunes and caused the buckling of the middle and high pressure gas pipes. Photo 18 shows topographical condition of a damaged site.

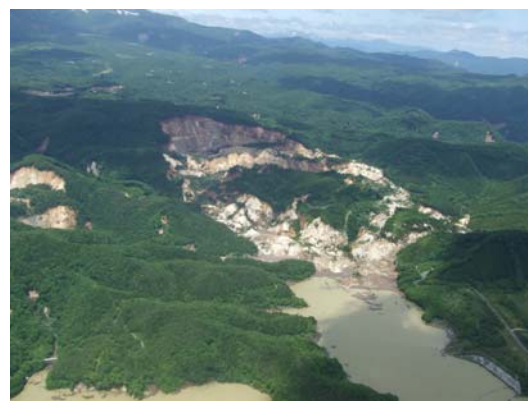
The biggest slide occurred on the slope at the lake of Aratozawa Dam as show in Photo 19. Volume, width, length and average thickness of the slid mass are estimated as 67 million m^3 , 900 m, 1300 m, and 100 m respectively. Slide occurred though slip surface was almost flat as 1 to 2 degree. According the investigation conducted after the earthquake, sandstone and siltstone layers are existed at the depth of the slip surface.

Photo 19. Biggest landslide at Aratozawa

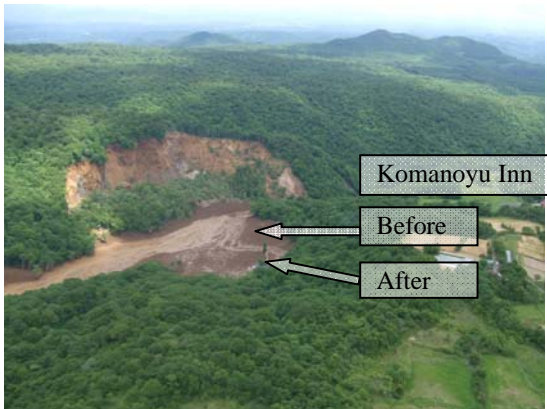
Photo 20. Komanoyu Inn and slide of left slope after the damage by debris flow

blocked the flow. And the right-turned debris flow hit and pushed the Komanoyu Inn about 50 m as shown in Photo 20. Peoples stayed in the inn were buried in the debris.

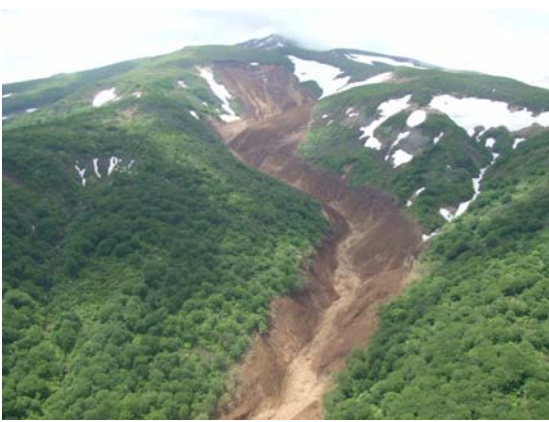
Photo 21. Landslide at the top of Dozou Vally and associated debris flow

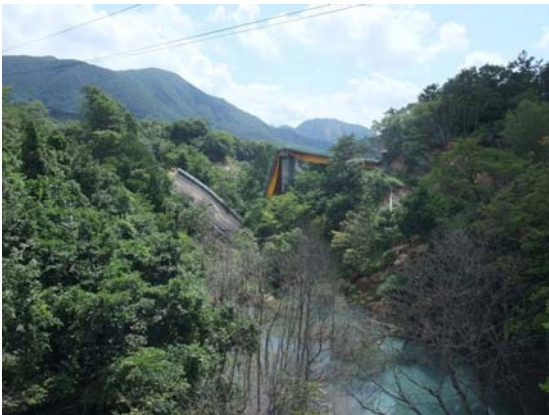
Photo 22. Collapse of Maturube Bridge

One more surprising damage occurred at Maturube Bridge. The bridge fell down due to the lateral force from right side bank as shown in Photo 23. It is estimated that the right slope of the river slide due to inertia force and pushed the abutment of the bridge.
