Behavior and Damage of Dams Under the 1993 Big Earthquakes in Japan

Paper No. 6.23

SYNOPSIS By analyses of the acceleration records at dams during the two big earthquakes which hit in Hokkaido of Japan in 1993, the maximum acceleration at damsite rock, the maximum acceleration amplification ratios at crest and the natural periods of dam bodies were evaluated and were compared the results with empirical equations. Damage to the dams was described, and the mechanism of the deformations was examined.

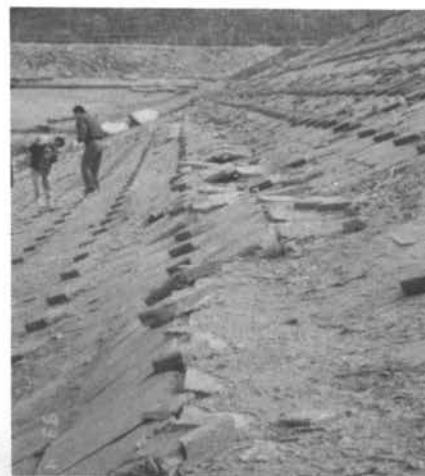
Owing to the earthquake, deformation of the dam body was caused at protective facing blocks which overlapped one another and rose up about 10 centimeters along the entire dam axis directly below the elevation where the gradient of the upstream slope changed, as shown in Fig. 4. The earthquake is thought to have caused the top one-third of the dam body to settle, applying a compressive force in the slope direction on the facing blocks, thus causing them to buckle. When the inspectors removed the deformed facing blocks to check the surface of the embankment body, they concluded that there was no deformation, and that the safety of the dam was not compromised. Undulating deformation was seen on the facing blocks close to the intake pipe on the upstream concrete part of the left bank.

Fig. 4 Raised Facing Concrete Blocks on the Upstream Slope Protection of Mombetsu Dam

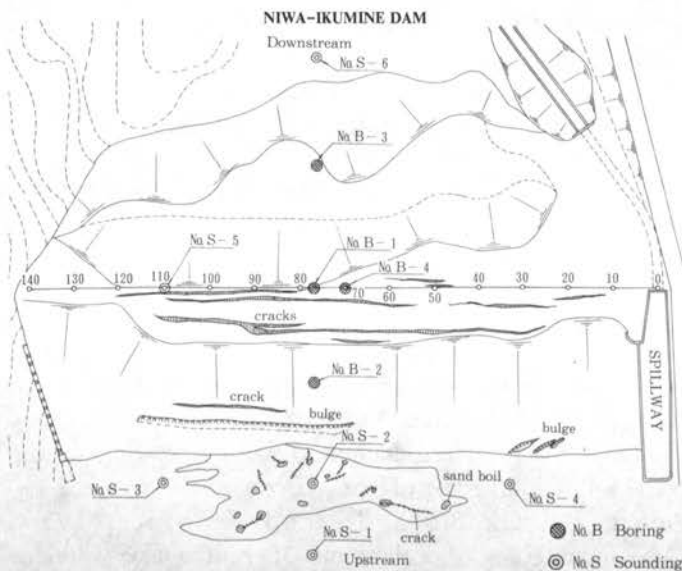
Figure 5 is a plane diagram of the dam showing an outline of the damage. The earthquake caused cracking bulging and on the dam body. As shown in Fig. 5, the cracking consisted of five longitudinal cracks at the crest of the dam; the longest crack extended for a length of approximately 120 meters on the crest at a depth of two meters, and settled on the upstream side with a maximum level difference of about one meter, as shown in Fig. 6. The bulge at the upstream toe of the slope was over 40 meters long and with a maximum level difference of about one meter, as shown in Fig. 7. Several cracks were formed with a sand boil extending from the sand layer in a sedimentary mound at the bottom of the reservoir near the upstream toe of the body.

Fig. 5 Plane of Damage to Niwa-Ikumine Dam

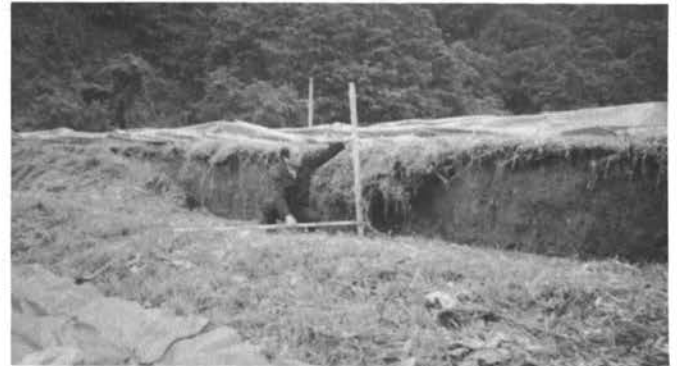
Fig. 6 Settlement of the Upstream Side Body of Niwa-Ikumine Dam

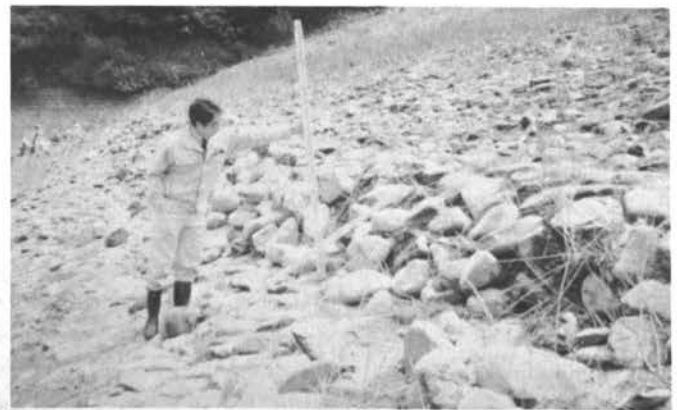
Fig. 7 Bulging on the Upstream Slope of Niwa-Ikumine Dam

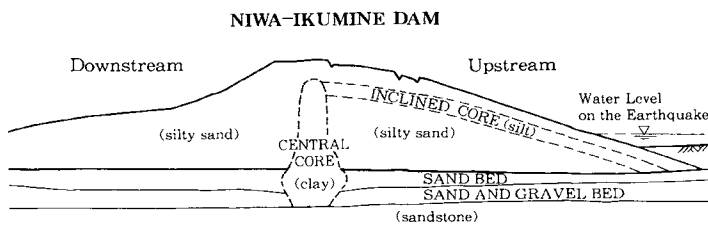
Fig. 8 Cross Section of Niwa-Ikumine Dam

of consolidation existed beneath it. As shown in Fig. 8, the dam body was a zoned type, which consisted of core zones of clay and silt mixed with gravels, and silty sand zones mixed with gravels. Core zones were divided into two zones: a central core and an inclined core. Thus, the embankment of silty sand between two cores was saturated. The silty sand zone was extremely loose with an N value between two to four and with a compaction degree of 81% based on penetration tests, in-situ density tests, and compaction tests. The riverbed deposit consisted of loose sand and gravel with an N value between three to eight and gravel with an N value of about 20.

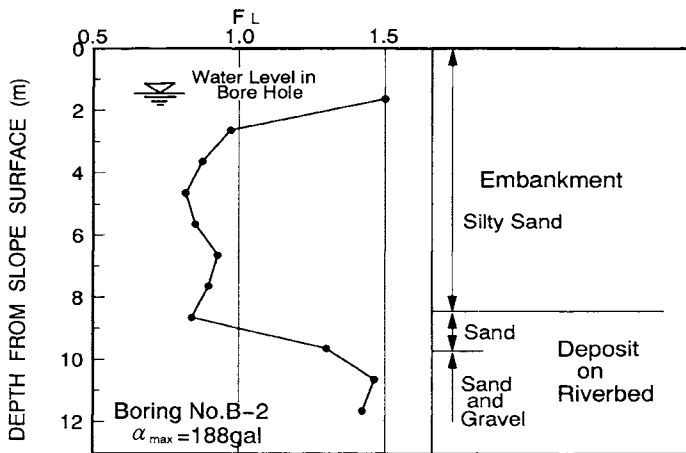
Fig. 9 Liquefaction Resistant Factor at Niwa-Ikumine Dam

reduction coefficient along depth, g is the gravitational acceleration, and α_{max} is the horizontal maximum acceleration, as which we used the value of 188 *gals* from the equation (1). Figure 9 shows the depth distribution of FL in the drilling hole of the upstream side of the dam. The values of FL at the embankment and the upper riverbed deposit are smaller than unity, hence the embankment apparently liquefied and the liquefaction caused the upstream dam body to settle. This liquefaction occurred for two reasons; one is the fact that the dam embankment was badly compacted on the loose riverbed deposit, and the second is that the embankment between the two cores without drainage was saturated.
