June 20, 1990 Earthquake of Northern Iran: An Overview

F. Nateghi and S. Eshghi

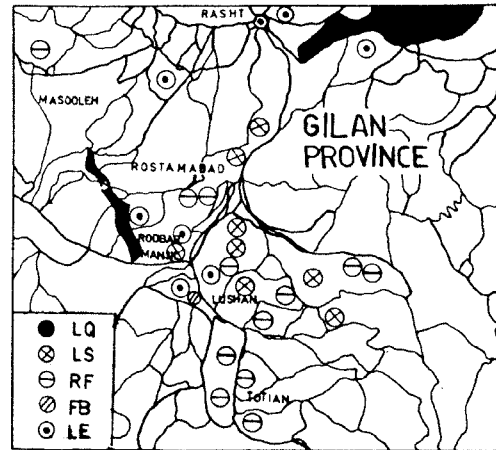
Figure-4 Extent of Geotechnical Failures

A number of geotechnical failures contributed to the destruction in this earthquake such as rock falls (RF), land slides (LS), foundation bearing deficiencies (FB) and liquefaction (LQ). Local site effects (LE) also played a major role in amplifying strong motion and contributed to the structural failures (IIES, 1990). The extent of widespread geotechnical failures are shown in Figure-4.

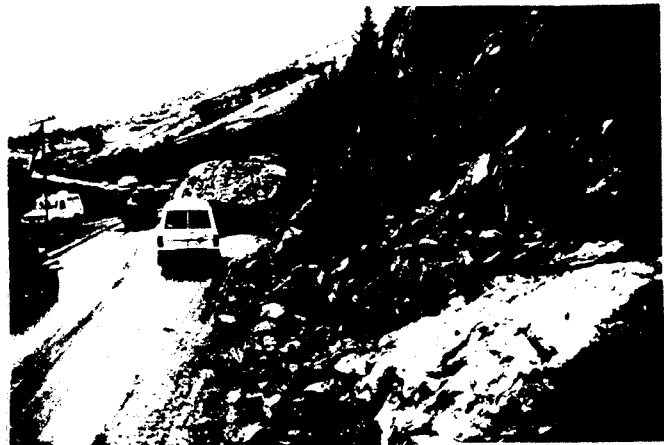
Numerous rock falls and land slides occurred in the region around the epicenter, covering an approximate radius of 60 km. They caused many road closures during and after the main shock and also destroyed many villages and towns in the region. The fallen rocks were some as heavy as a thousand tons or more.

Among the widespread land slides throughout the region, the one near the city of Roudbar (epicentral region) caused earth removal of approximately 10 to 20 million cubic meters. A typical rock fall is shown in figure-5.

Figure-5 Picture of a Typical Rock Fall

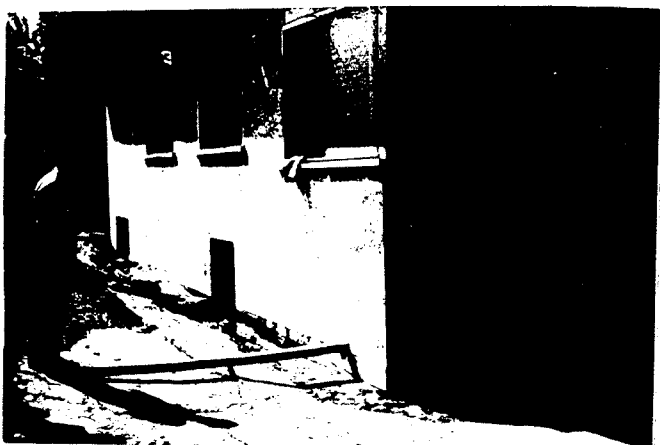
Soil liquefaction has caused extensive damages in a relatively vast area about 80 km to the north-east from the epicenter. It also occurred in an area near the epicentral region in village of Nasir-Mahaleh.

Liquified soil damaged foundations and disposition irrigation canals. It also broke pipelines, cracked pavements, and filled water wells with boiled sand (Eshghi, 1990). Hundreds of houses were unevenly uplifted, or sunken in the region due to liquefaction as shown in Figure-6.

Figure-6 Effect of Liquefaction

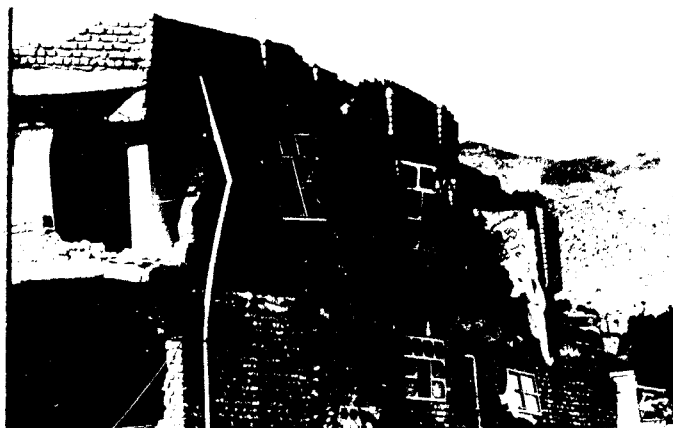
Residential buildings are mostly built as a non-engineered structures while some are built as partially engineered. These are buildings which are not designed in accordance with any seismic code, nevertheless have certain resisting members such as concrete ring-beams. Non-engineered buildings generally performed unsatisfactory resulting in total collapse while partially engineered buildings sustained severe damages but did not totally collapse as shown in Figure-7.

Figure-7 Picture of a Damaged Building

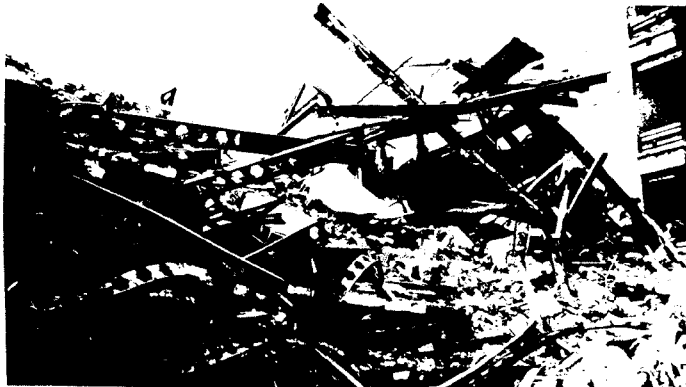
Most of the mid-rise buildings in the area are constructed using steel framing system. These buildings generally performed poorly. A typical damaged steel structure is shown in Figure-8. Lack of a proper seismic resisting system, unavailability of large steel sections, and poor welded connections can be named as the main reasons for unsatisfactory performance of steel structures during this earthquake.

Figure-8 Damaged Steel Structure
