2001 - Fourth International Conference on
Recent Advances in Geotechnical Earthquake
Engineering and Soil Dynamics

A Study on Failure Mechanism of Embankment Dams for Irrigation Damaged by the 1995 Hyogoken-Nanbu Earthquake

A STUDY ON FAILURE MECHANISM OF EMBANKMENT DAMS FOR IRRIGATION DAMAGED BY THE 1995 HYOGOKEN-NANBU EARTHQUAKE

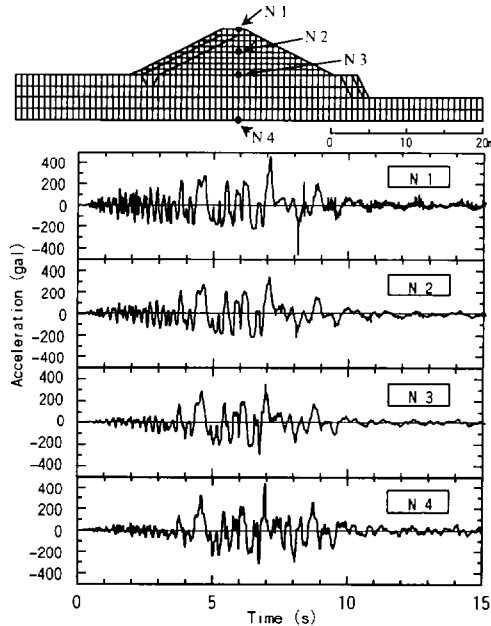
- Until about 3.5 seconds passing from the beginning of the earthquake, amplification of acceleration from the bottom to the crest is about two times as shown in Fig.7 and the liquefaction doesn't occur in all elements (as seen in Fig.6).
- During 3.5-4.0 seconds, the element E1 (see Fig.8) near the upstream slope is liquefied, then elements in the downstream side are liquefied. The liquefaction area expands in nearby areas in the subsequent large pulse at about 4.5 seconds.
- Liquefied area expands to the center part until 7 seconds when input acceleration shows peak values. At 7 seconds, liquefaction area form upstream to downstream sides jointed,

Fig. 7. Acceleration time history

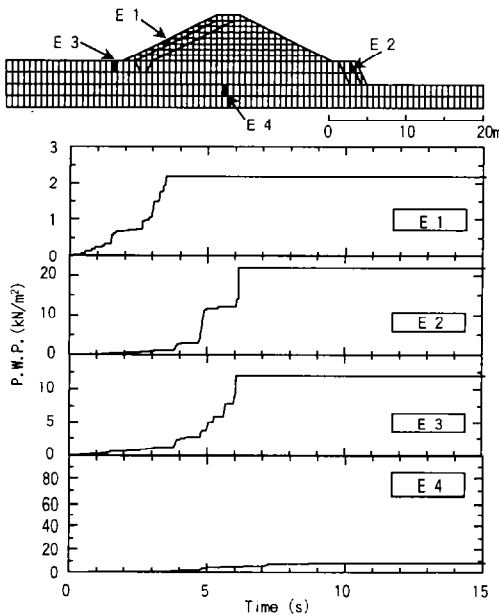
Fig. 8. Pore water pressure time history
