Corrosion of Galvanized Fasteners used in Cold-Formed Steel Framing

RESEARCH REPORT RP04-4

FINAL REPORT

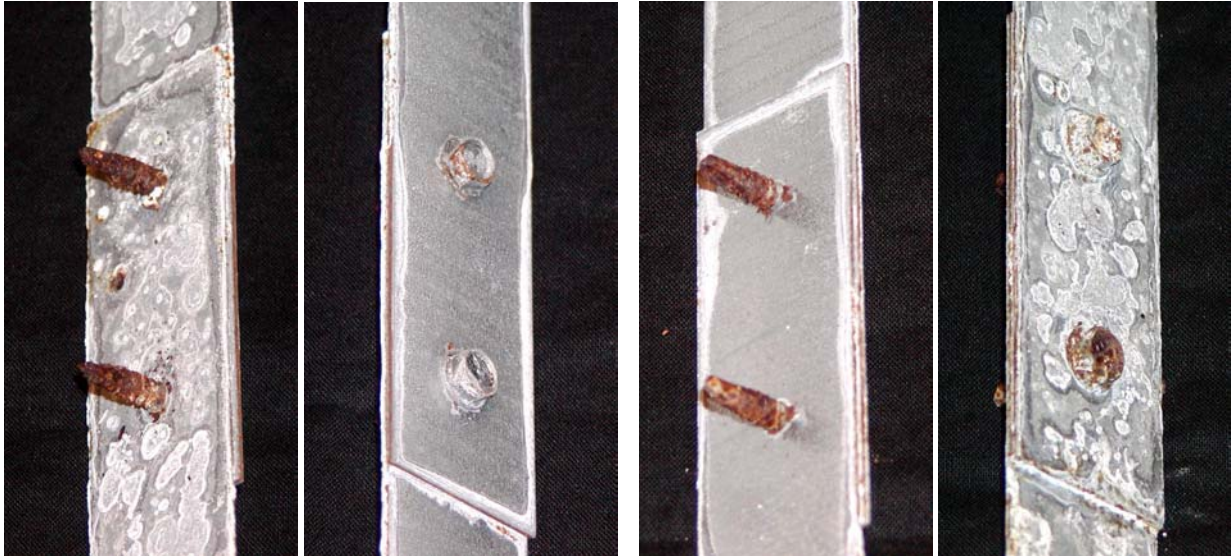
After 2772 cycles in the corrosion chamber, the galvanized screws showed significant surface corrosion (Figure 6.32). Nevertheless, the average connection strength had not decreased, regardless of whether the threads were oriented up or down in the corrosion chamber (Figure 6.35). However, the average specimen elongation at the peak load had decreased to around 80% of that for the control specimen (Figure 6.36). This decrease was larger for the connections stored with threads up. It appears that the connection ductility is affected by this level of corrosion, though the strength is not. Figure 6.37 to Figure 6.40 show microscopic images of the screw threads for control and 1537 cycle test specimens before and after testing. Although the surface corrosion appears significant, it has not yet penetrated the shaft of the screw, and hence has not affected the screw failure strength (Figure 6.40).

Figure 6.32: Test connections after 2772 cycles – Threads up (left) and down (right)

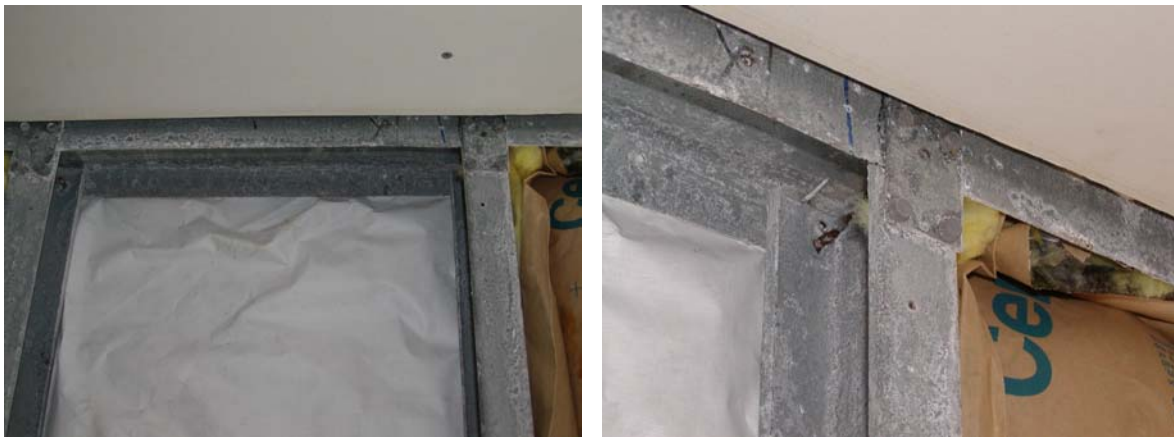
After 16 months of exposure, there was evidence of corrosion of both the CFS members and framing fasteners at the top plate of the wall with vapor barrier (Figure 7.16). This corrosion appeared limited to the top plate and top section of the studs. There was considerably less corrosion further down the stud. This condition worsened after 21 months (Figure 7.17) and 28 months (Figure 7.18), by which time most of the framing fasteners in the top plate connections showed signs of ferrous oxide. There was still very little sign of corrosion on the studs at mid-height of the wall. It appeared that humid, chloride rich air was passing from the vented attic to the top plate connections, resulting in the localized corrosion. No seal had been provided between the top plate and the attic space. For the first 16 months, the interior drywall had also not been taped, so humidity could also have entered the wall cavity through the drywall joints. It was noted that the ETF pins used to secure the Hardie Board had less ferrous oxide corrosion than the framing screws (Figure 7.16).

Figure 7.16: Wall framing with lap siding and vapor barrier, MCBH Coastal after 16 months.
