**Corrosion of Galvanized
Fasteners used in Cold-
Formed Steel Framing**

RESEARCH REPORT RP04-4

2004

FINAL REPORT

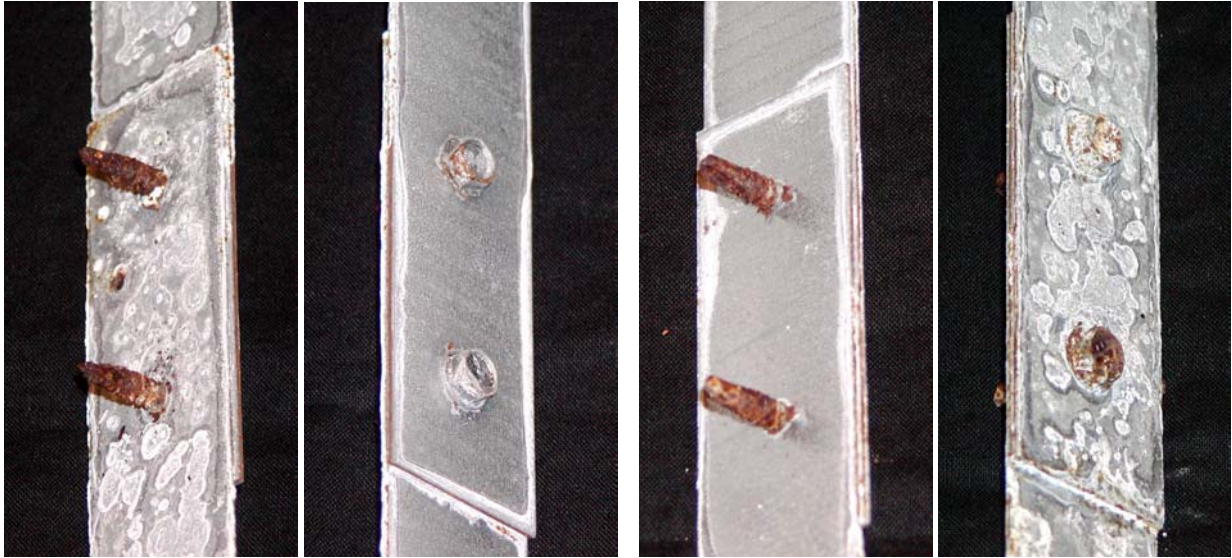
After 2772 cycles in the corrosion chamber, the galvanized screws showed significant surface corrosion (Figure 6.32). Nevertheless, the average connection strength had not decreased, regardless of whether the threads were oriented up or down in the corrosion chamber (Figure 6.35). However, the average specimen elongation at the peak load had decreased to around 80% of that for the control specimen (Figure 6.36). This decrease was larger for the connections stored with threads up. It appears that the connection ductility is affected by this level of corrosion, though the strength is not. Figure 6.37 to Figure 6.40 show microscopic images of the screw threads for control and 1537 cycle test specimens before and after testing. Although the surface corrosion appears significant, it has not yet penetrated the shaft of the screw, and hence has not affected the screw failure strength (Figure 6.40).

Figure 6.32: Test connections after 2772 cycles – Threads up (left) and down (right)

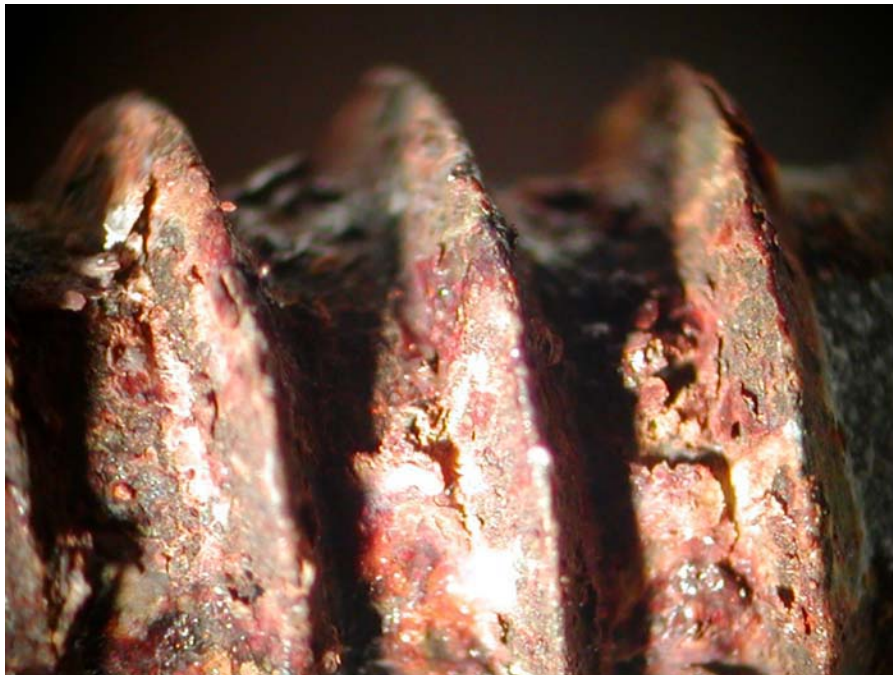
Figure 6.38: Screw threads after 1537 cycles in the corrosion chamber.

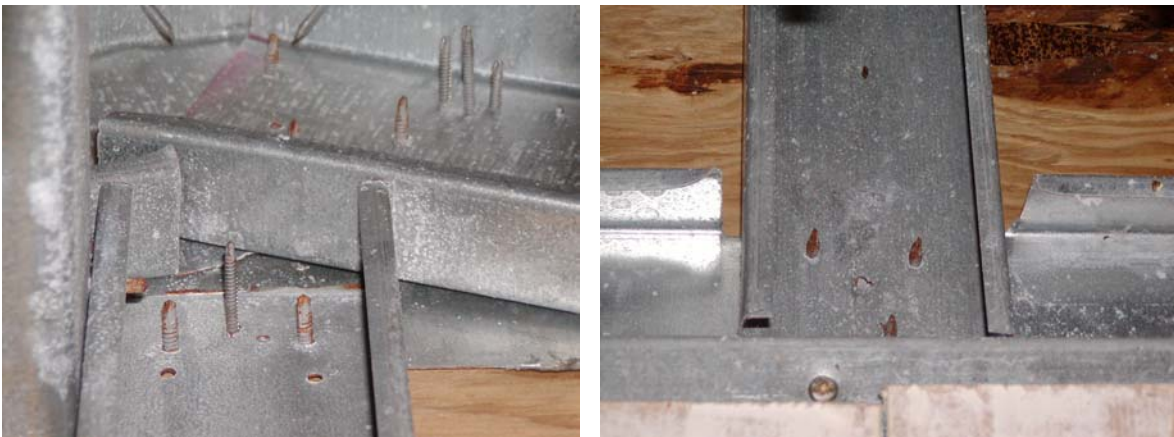
Initiation of corrosion was evident at the cut edges of the CFS framing and on some of the fasteners in the vented attics of the two Iroquois sites as shown in Figure 7.2. The fasteners in the vented attic at the Wheeler site showed no corrosion as seen in Figure 7.3.

Figure 7.2: Attic framing at Iroquois Coastal site after 20 months exposure.

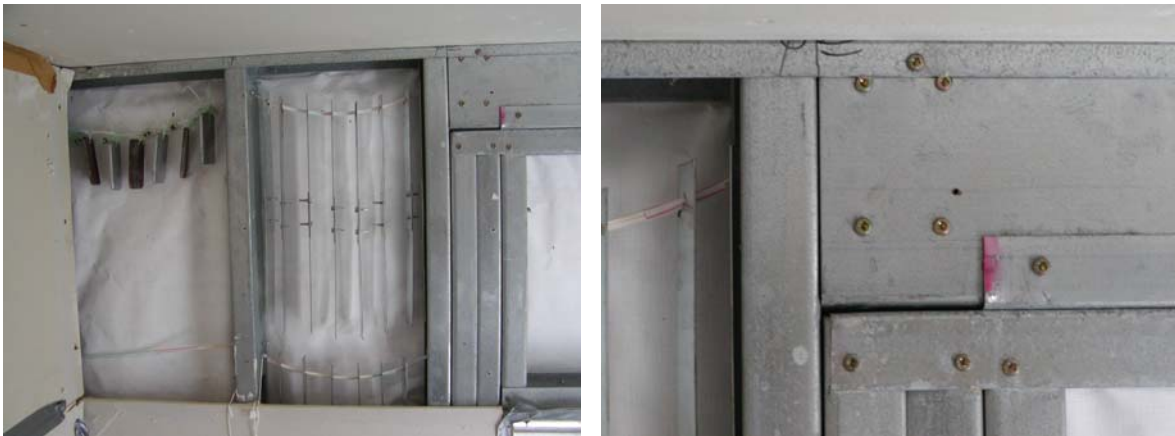
After 28 months of exposure, no evidence of corrosion was noted on the framing members or fasteners in the wall framing with vapor barrier (Figure 7.6).

Figure 7.6: Wall framing with vapor barrier at MCBH Inland after 28 months exposure.

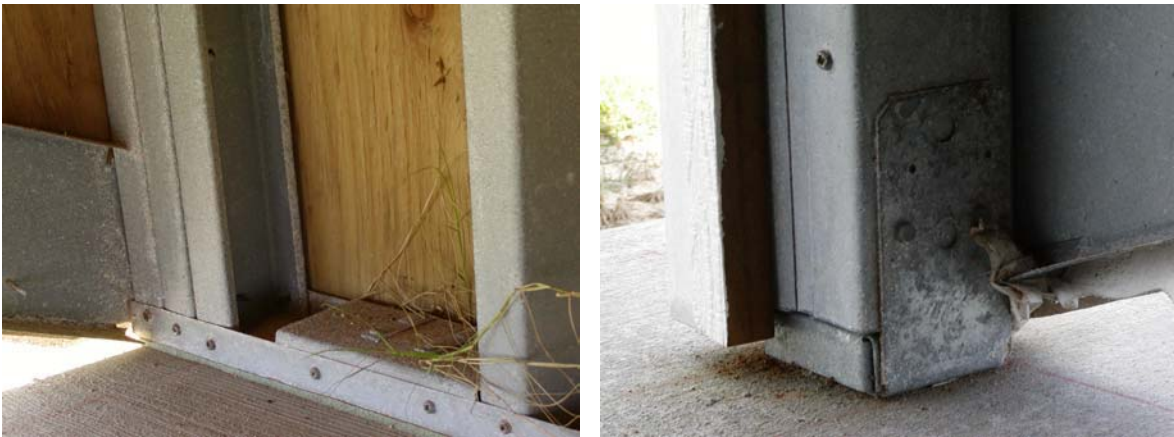
Figure 7.28, Figure 7.29, Figure 7.30 and Figure 7.31 show a progression of the corrosion on the cripple wall and post supports in the crawl space of the MCBH Coastal enclosure. After 5 months there were signs of tarnishing of the zinc galvanizing, and ferrous oxide on some of the fastener heads or threads, and cut ends of the CFS members (Figure 7.28). By 16 months, the zinc coating on portions of the CFS framing had corroded completely and ferrous oxide was forming on end regions of the CFS members and galvanized anchor hardware. There was also significant ferrous oxide on the exposed fastener heads (Figure 7.29). At the 21 month inspection it was clear that this corrosion had progressed rapidly (Figure 7.30) and after 28 months there was clear indication that the corrosion had compromised the integrity of the CFS studs, post and post base hardware (Figure 7.31). The corrosion appeared to concentrate in regions exposed directly to through flow of chloride laden air from the nearby coastline.

Figure 7.28: Crawl space cripple wall and post, MCBH Coastal after 5 months.
