Johnston City School, Mine Subsidence or Shallow Foundation Problem?

Alphonse C. Van Besien
Dept. of Geology & Geological Engineering, University of
Mississippi, USA

Nolan B. Aughenbaugh
Dept. of Geology & Geological Engineering, University of
Mississippi, USA

SYNOPSIS: Johnston City, a small community in southern Illinois, lies above the Herrin (Illinois No. 6) coal seam. The community has experienced sporadic episodes of surface subsidence due to the collapse of underground mines since the 1930's. Although the mining company left a large block of coal beneath the town's elementary school to prevent subsidence damage to the structure, large cracks appeared in the school building in December, 1971. After the building was razed, construction of a new school was initiated in 1974. Approximately six months after the start of construction, new evidence of structural distress was observed in the still-uncompleted structure. Construction was suspended indefinitely while site investigations were conducted. These investigations, along with recent air photo studies, indicate that renewed mine collapse and the resulting downward displacement of the surface, were the cause of this second i

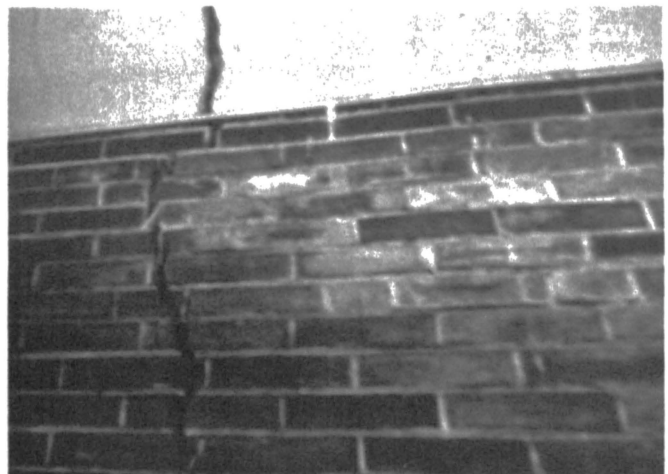
The initial subsidence damage to Johnston City's Washington Elementary School was first observed during the Christmas school holidays. Janitors working during this break discovered cracks in the walls and ceilings of eight school rooms (Figure 3). Door frames were misaligned (Figure 4) and large fractures were visible on outside foundations, sidewalks, and school playgrounds (Figure 5). Damage was so extensive that the building was declared unsafe and was demolished shortly thereafter.

Figure 3. Cracks in classroom walls and ceilings.

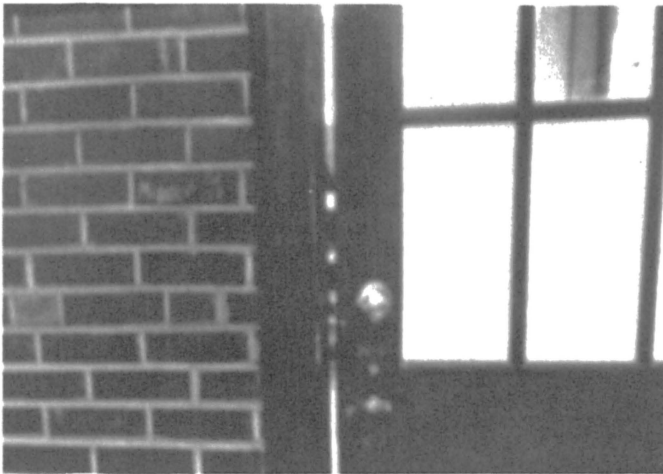
Figure 4. Misaligned door frames.

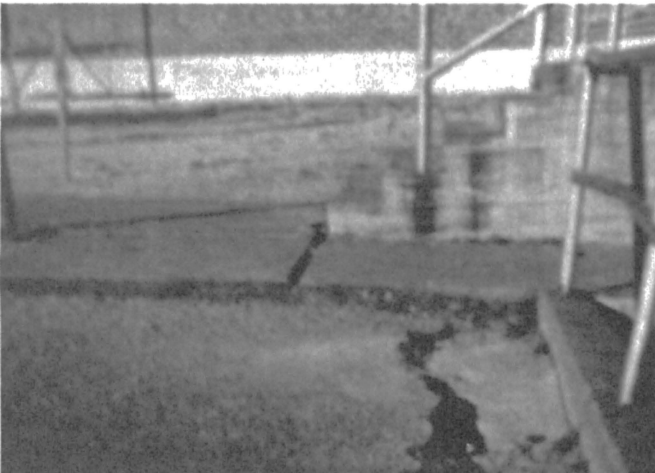
Figure 5. Crack in playground.

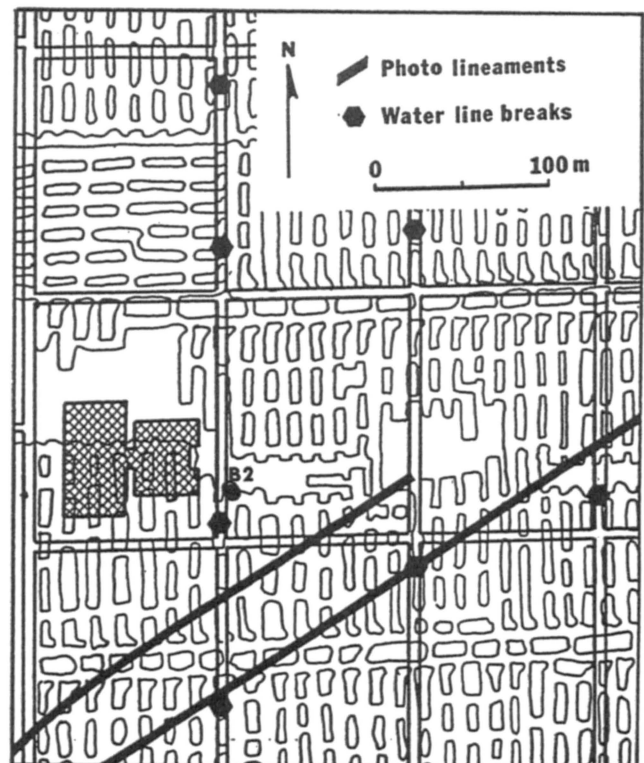
Ten borings were drilled in the vicinity of the school during these investigations. Two of the borings encountered coal, while eight borings encountered collapsed, or partially collapsed, mine workings. Where the mine was partially collapsed, openings ranging in height from 6 inches to 2.2 feet (0.2 to 0.7 m.) were encountered. Boring B-2 (Figure 6) followed a vertical fracture from near the surface to a depth in excess of 190 feet (58 metres).

Figure 6 Mine layout and indications of subsidence.

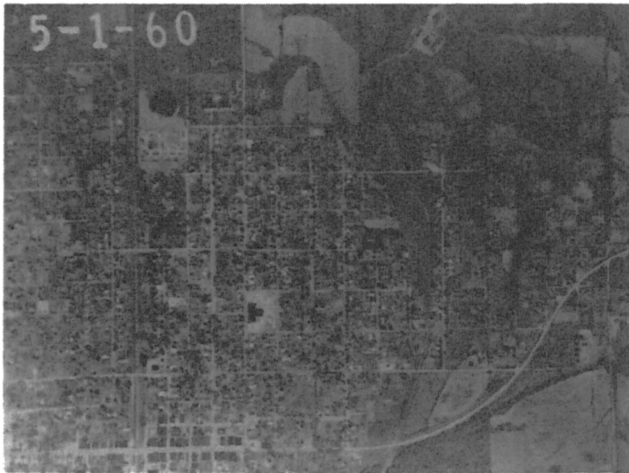
Recently, air photos taken of the site in May, 1960, and December, 1974, were examined for evidence of subsidence. No evidence of subsidence was observed in the 1960 air photos (Figure 7). Digital image processing applied to the 1974 air photos revealed a lineament trending NE-SW and corresponding generally with the reported water-main breaks (Figures 6 and 8). The light-colored lineament is interpreted as a narrow zone of soil which has dried, and become lighter in color, due to the presence of an underlying fracture in the bedrock. The fracture is believed to be a tension fracture associated with the mine subsidence. Once the lineament was observed in the enhanced image, it could be observed in the original 1974 photo, although only very faintly.

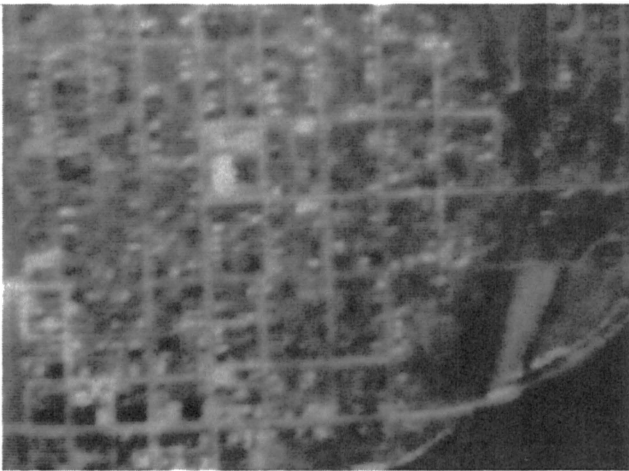
Figure 8. Air photo of Johnston City in 1974.
