Phase 1 Inspection Report: National Dam Safety Program. White River Basin. Ozark Lead Tailings Dam, Reynolds County, Missouri

OZARK LEAD TAILINGS DAM
REYNOLDS COUNTY, MISSOURI
MO 30166

PHASE 1 INSPECTION REPORT NATIONAL DAM SAFETY INSPECTION

APRIL 1981

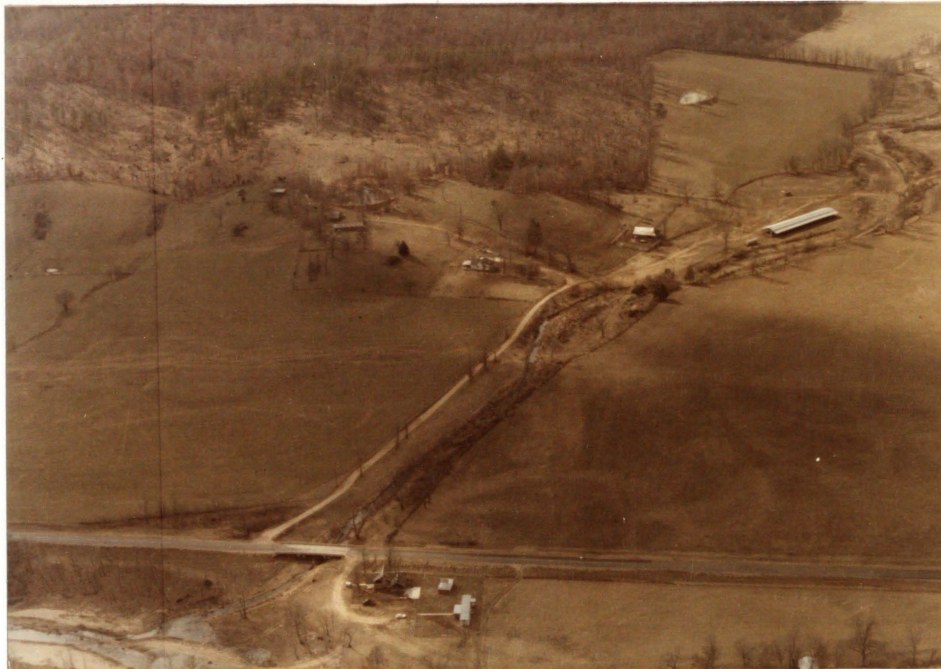
1. Typical contents of downstream hazard zone. Dam is approximately 1.5 miles upstream, out of picture to the upper right.

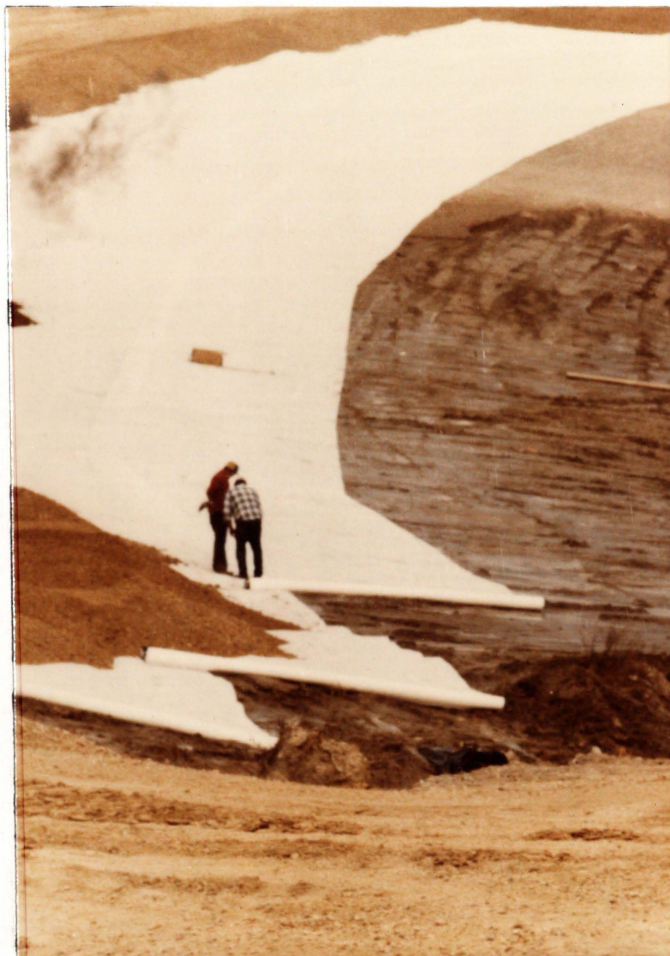
2. Filter fabric and gravel drain being installed during modifications to dam. Note abundant seepage (dark area below fabric) and erosion due to seepage water. Looking east from right abutment. Photo by Ozark Lead Company (1979 or 1980).

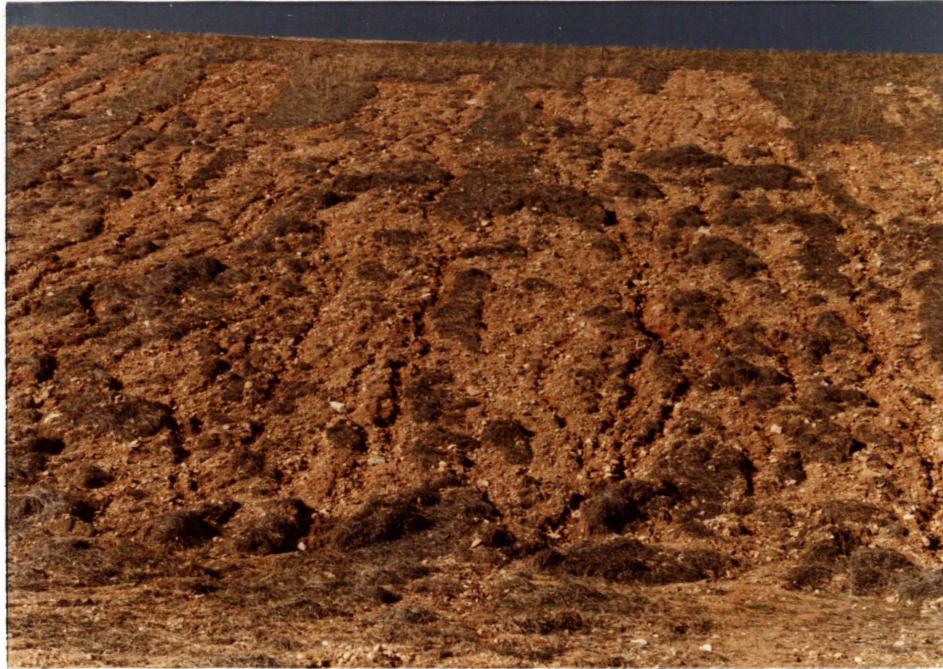
3. Minor surface erosion on downstream slope of dam. Looking north, upstream, from toe of dam.

1. Continue efforts to vegetate the downstream slope of the embankment. Replacement of the mulch will likely be necessary.
2. Inspect the embankment for evidence of slope instability such as cracking or slumping, detrimental settlement or piping.
3. Inspect discharge from the various drain outlets to identify turbidity (soil or tailings) in the water. This should include any areas of seepage identified along the toe of the slope or in the abutments.
4. Maintain the decant inlet, storm drain inlet, and spillway channel free of obstructions to flow.
5. Inspect the 60-in. diameter storm drain beneath the dam for evidence of settlement, cracking or leakage.

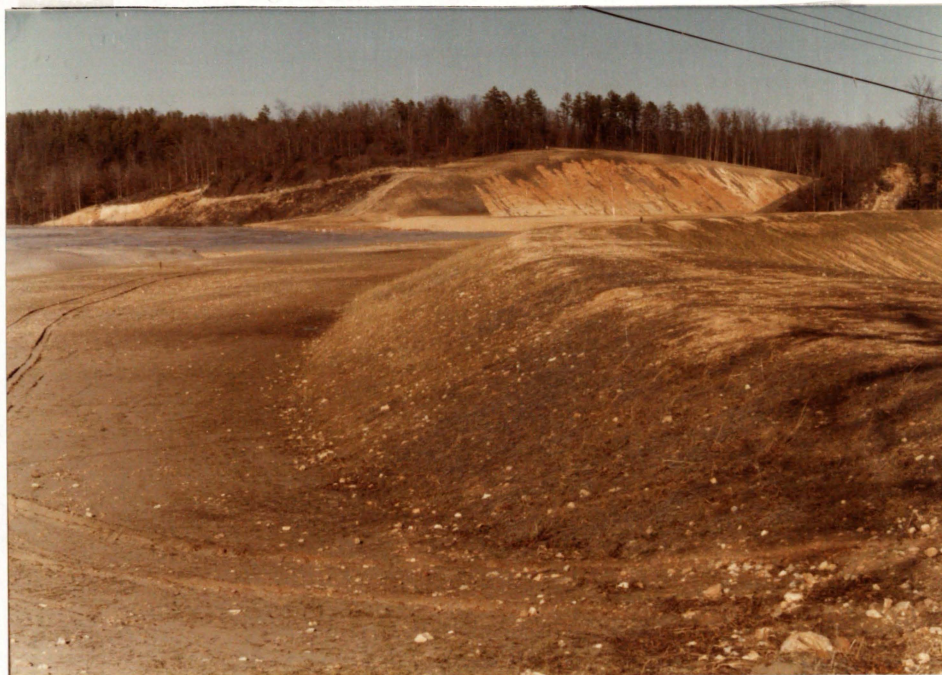
4. Upstream slope showing well developed vegetation cover. Spillway in the distance. Looking east from right abutment.

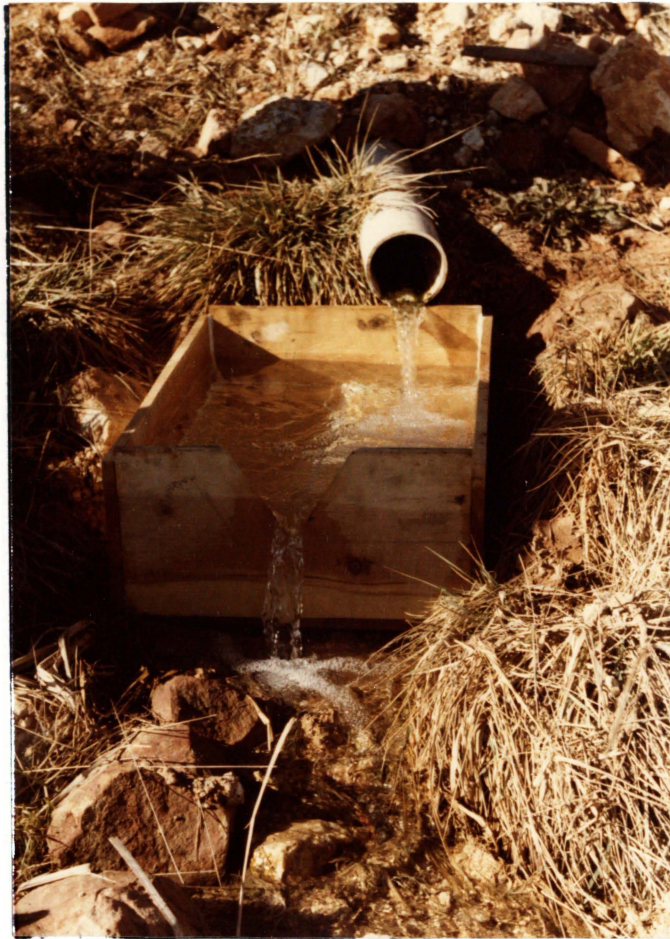
Three outlet pipes for a blanket drain system were noted near the toe of the embankment. These consisted of 6-in. diameter PVC pipes, and were each flowing at an estimated rate of 15 gal/min (Photo 5). The pipes discharged into wooden weir boxes to allow measurement of flow. The total flow was described by Ozark personnel as being nearly constant at the observed rate.

5. Discharge pipe and weir box for blanket drain. Flow estimated at 15 gal/min at time of inspection.

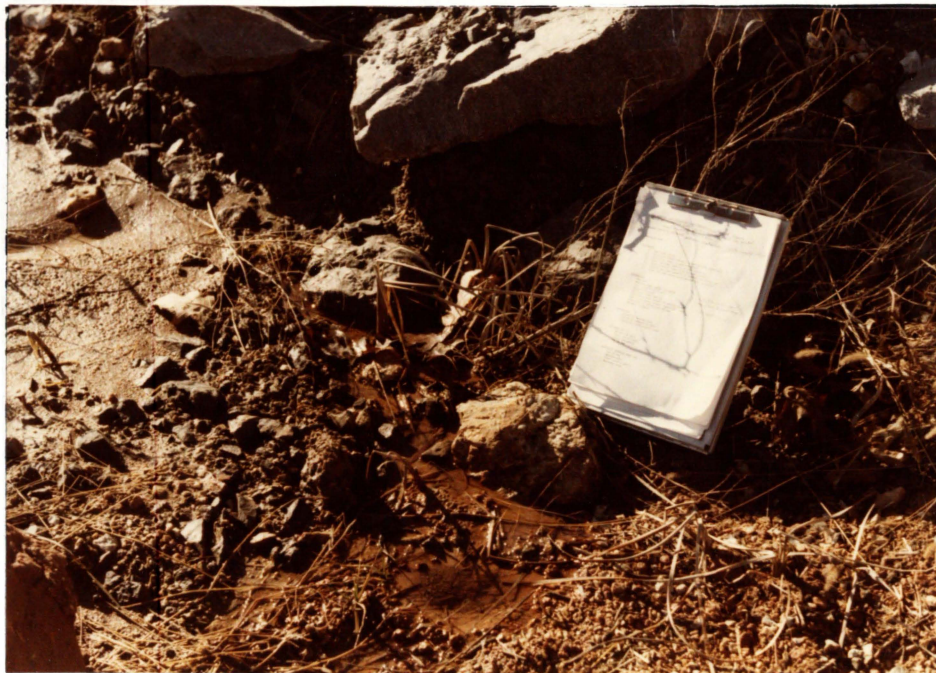
One area of seepage and spongy ground was noted near the center drain (Photo 6). Seepage was estimated at approximately $\frac{1}{4}$ gal/min and was not transporting any soil.

6. Seepage area near toe of right abutment. Flow estimated at less than $\frac{1}{4}$ gal/min.

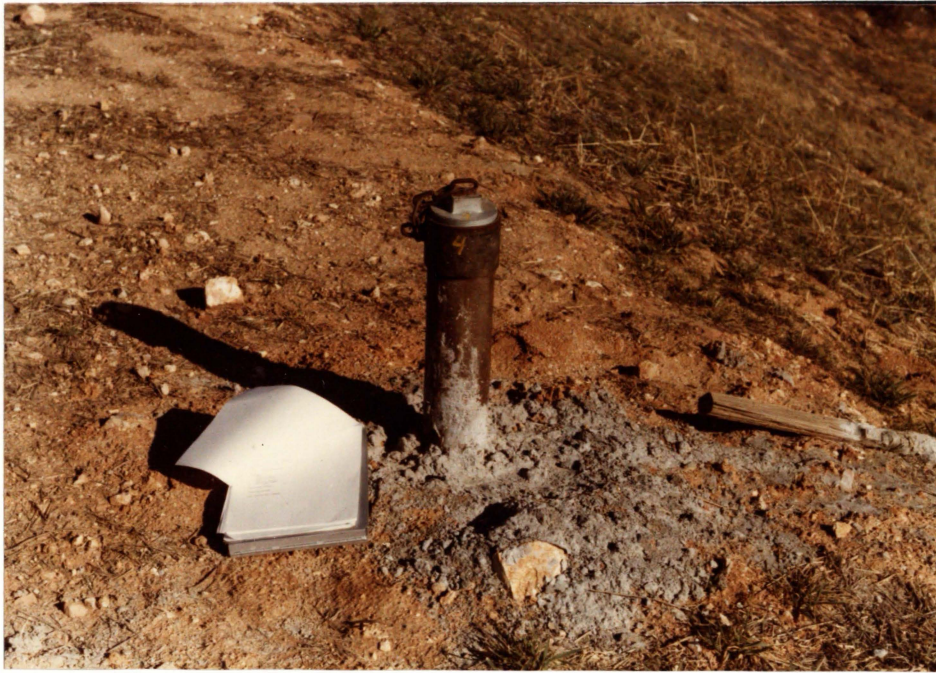
7. Piezometer installed at crest of dam. Similar piezometers are installed on upstream and downstream slopes.

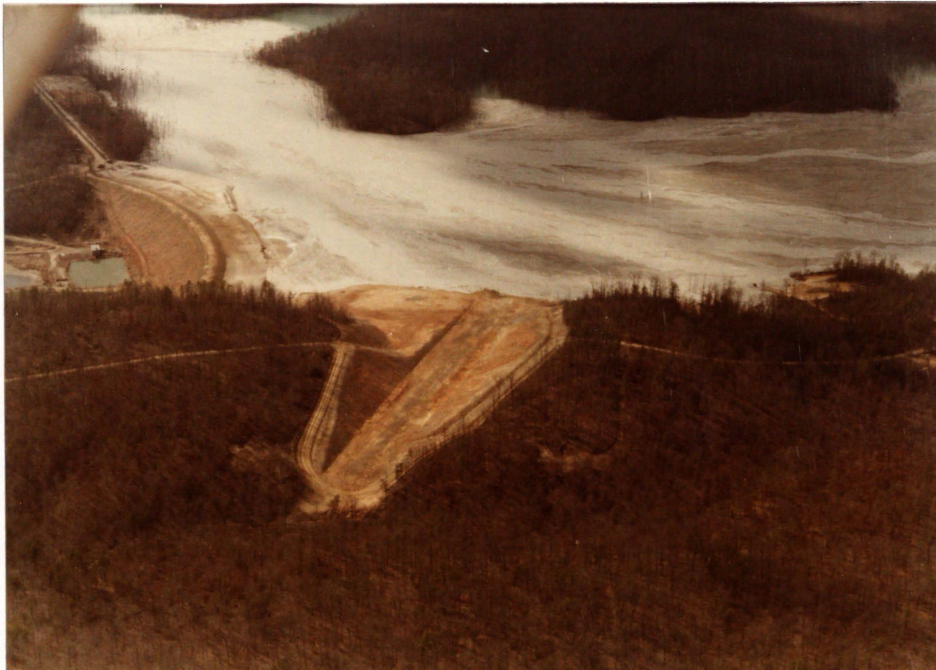
1. Spillway. A broad, unlined, uncontrolled open channel spillway has been cut through the hillside northeast of the dam (Photo 8). The floor of this spillway cut is approximately 110 ft wide; the sides of the trapezoidal cut are approximately 2(H) to 1(V). The excavation was made in soil and weathered bedrock. Attempts to vegetate this area were hampered by a period of drought in 1980. Some erosion may occur in this area during high flood flows, but will not pose a hazard to the dam due to the distance from the embankment.

8. Spillway cut through hillside east of reservoir. Floor of spillway is 110-ft wide. Looking west.

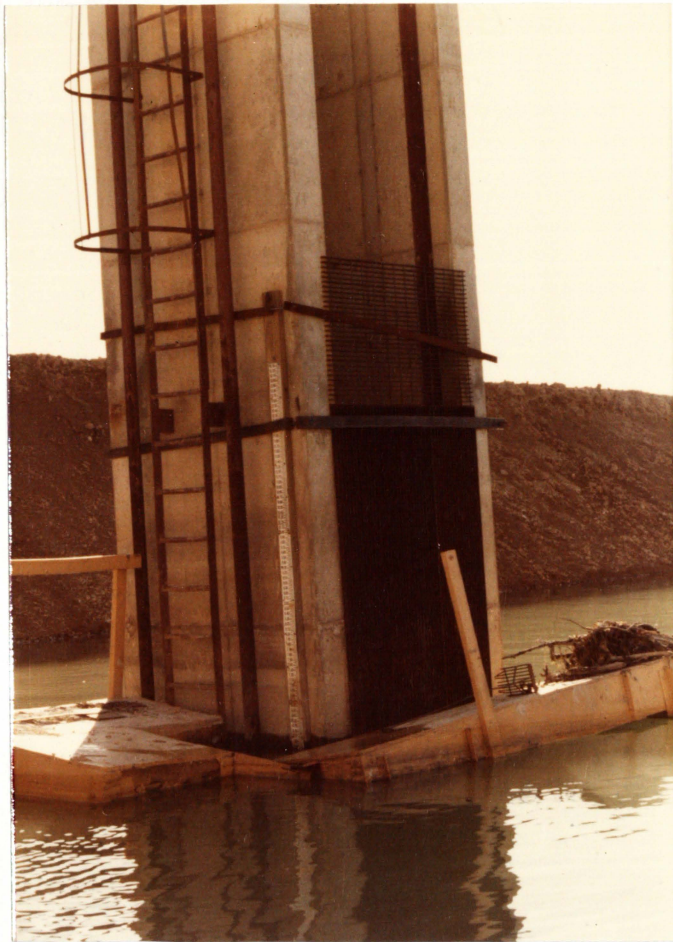
9. Inlet tower for decant line.

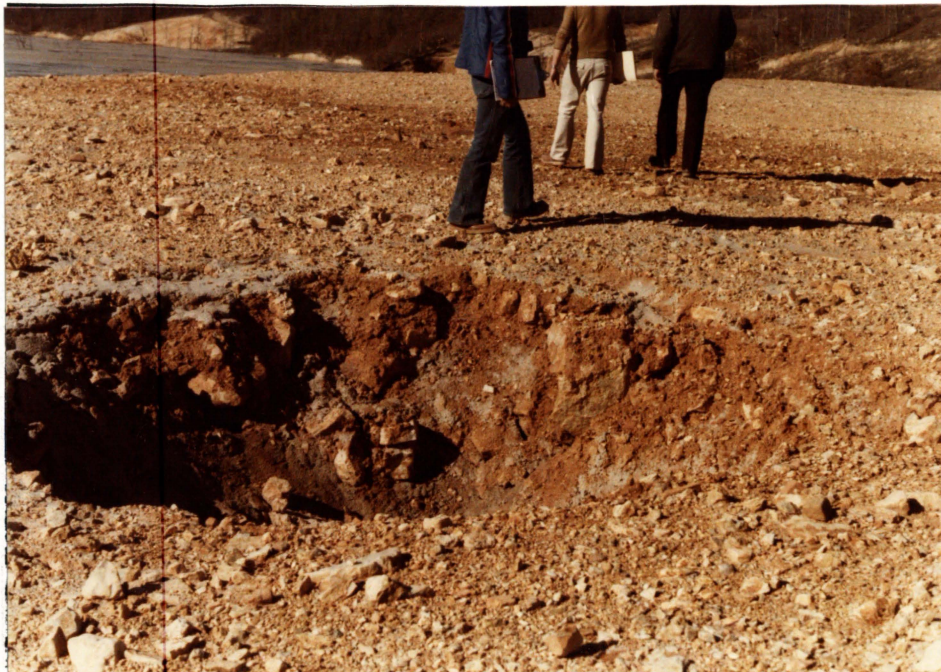
- d. Reservoir area. The reservoir for this dam is nearly filled with fine sandy to silty tailings (Overview Photo). Portions of the reservoir at the upstream end have water covering the tailings deposits. The tailings appear quite soft when first deposited. In the area of the reservoir adjacent to the spillway, some of the spillway excavation spoil was pushed out onto the tailings surface. A crater-like feature, approximately 6 ft in diameter was noted, apparently where a boulder in the spoil material sank into the unconsolidated tailings (Photo 10).

The other possible item of concern is the crater-like feature noted on the spoil pushed onto the tailings surface adjacent to the spillway excavation. It appears this crater-like depression is where a boulder in the spoil sank into the unconsolidated tailings. However, the 60-in. diameter storm drain pipe runs along the floor of the reservoir in this area. If settlement, corrosion or overburden pressure has

deformed or damaged this pipe, some loss of material could be occurring in the overlying tailings. Some sedimentation was described by Lagergren and Griffith in the settling pond - stilling basin at the discharge end of this pipe at the downstream toe of the dam. Loss of materials in the tailings reservoir would not represent an immediate hazard to the dam but could indicate this conduit is deteriorating which could affect the dam. Periodic inspection of this 60-in. diameter pipe is recommended to assess its condition and any necessary remedial measures.

10. Crater-like feature on surface of spoil from spillway excavation. Apparently a result of boulder in spoil sinking into soft tailings underneath. Located about half of the way between left end of dam and spillway.
