Bridge Lessons Learned from the Wenchuan China, Earthquake

Bridge Lessons Learned from the Wenchuan, China, Earthquake

W. Phillip Yen, Genda Chen, Mark Yashinsky, Youssef Hashash, Curtis Holub, Kehai Wang, and Xiaodong Guo

A strong earthquake of M7.9 occurred in Wenchuan County in Sichuan Province, China, on May 12, 2008. This paper presents the field observations on various types of bridge damages, including unseating of girders, longitudinal and transverse offset of decks, pounding at expansion joints, shear key failure, bearing displacement, column shear, and flexible cracks. Plausible causes of damages and collapses are discussed and the lessons learned from this event are briefly summarized. Some of the postearthquake temporary constructions are also reported.

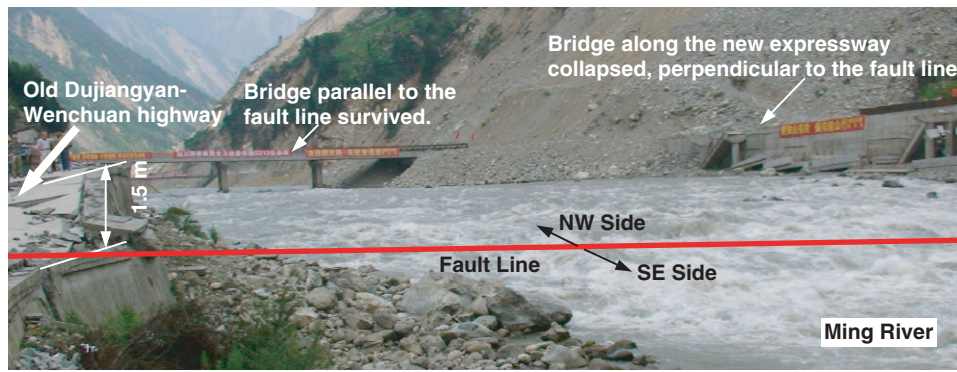
The surface rupture of the center fault in the Longmen–Shan thrust zone was observed in Yingxiu as illustrated in Figure 1. The thrust fault appeared to cross the Ming River at a right angle. As shown in Figure 1, the earthquake left behind a distinct dislocation on the river bed. The northwest (NW) side of the fault on the upstream of the river moves upward against the southeast (SE) side of the fault. The fact that one deck panel along the new expressway elevated bridge was still supported by one pier in Figure 1 indicated a sudden push by a near-field pulsing effect. On the other side of the Ming River was the old Dujiangyan–Wenchuan highway. Because of surface rupture, the vertical dislocation of the old highway was approximately 1.5 m, as illustrated in Figure 1.

Figure 1 also shows that the bridge in parallel with the fault line suffered damage in one side span only due to landslides. The significant difference in damage pattern between the two elevated structures at right angle suggests a strong directivity effect. The bridge perpendicular to the fault line experienced substantial motion in a longitudinal direction due to the thrust fault movement, dropping off all spans.

FIGURE 1 Surface rupture near Yingxiu Town.

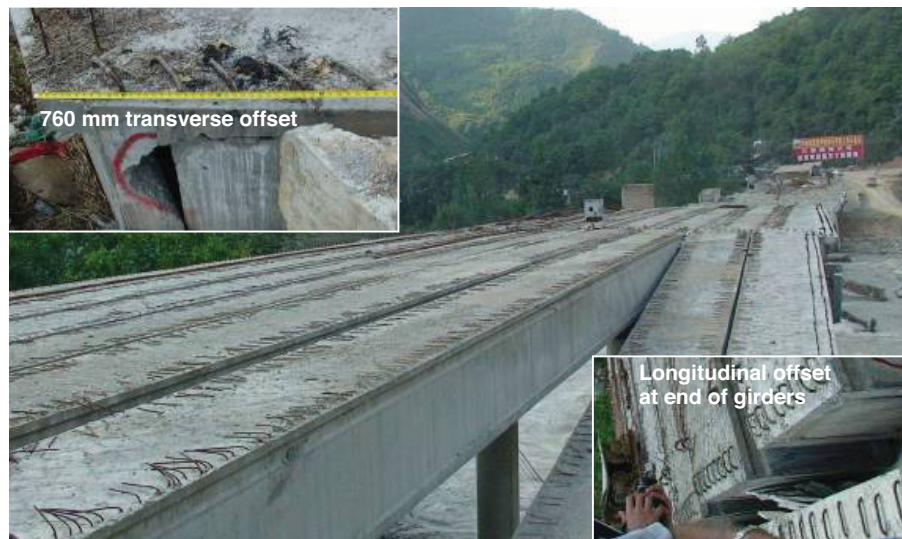
As shown in Figures 3 and 4, most of the box girders of the new bridge dropped into the river and the two-column bents were distorted. The end box girders were transversely displaced by approximately 760 mm. Most of the shear keys were cracked or knocked off. Many of the bents were leaning or distorted, but with no damage visible above the waterline. At the time of the earthquake, the bridge deck had not been poured, and the slightly skewed girders were loose and not tied together into a bridge superstructure as a system. In addition to strong shaking at the site, these factors contributed to the collapse of the 10-span bridge.

bents. The reconnaissance team was not able to discern what type of foundation system supported the bents, but apparently they were not sufficiently embedded into good material.

FIGURE 4 Damage to 10-span bridge under construction.

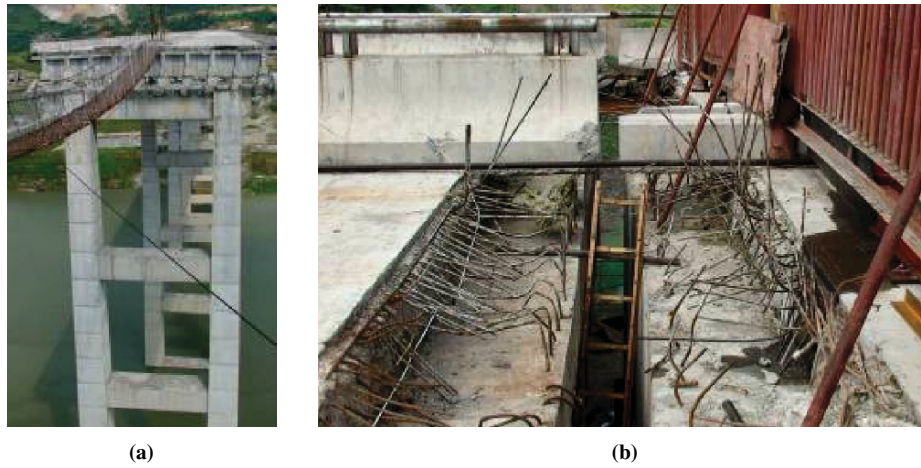
The construction of the bridge was near completion except for the installation of expansion joints at the time of the earthquake. The most severe damage was to the end span of a five-span T-girder segment that became unseated at the expansion joint end as illustrated in Figure 9, fractured in the continuous deck at the other end due to gravity load, and fell off the supporting bent caps during the earthquake. The bent seats were approximately 300 mm in length but the bridge experienced at least 500 mm of longitudinal movement due to earthquake shaking. Since the columns of each bent are approximately 105 m tall, the accumulated displacement at the bent cap was likely significant during the earthquake. There were other indications of large longitudinal movement. As shown in Figure 10, the barrier rails were overlapped by about 300 mm at the southeast expansion joint. The barrier also moved transversely for approximately 250 mm. Divers found cracks at the bottom of the main span columns due to earthquake shaking. Shear key failure was also observed as shown in Figure 8. After the earthquake, the bridge deck was jacked back into place with hydraulic jacks.

FIGURE 9 Dropped-off span and construction details between two spans.

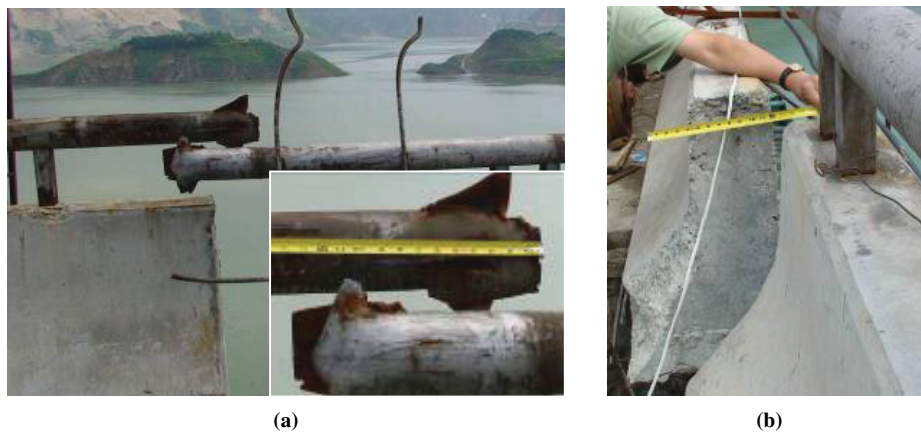
FIGURE 10 Longitudinal and transverse offset of bridge deck.

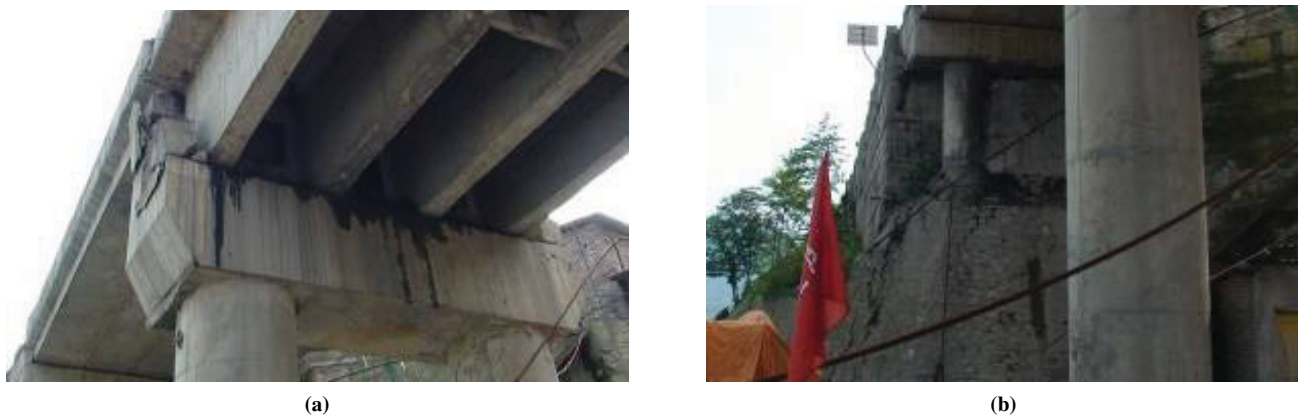
alignment with the twin tunnels as indicated in Figure 7. Over the southeast approach is a four-span RC girder overpass built in 2004. The overpass supports the old highway from Dujiangyan to Wenchuan and Juzhaigou. The old highway was built along the mountain terrain, perpendicular to the Zhipingpu Highway at Zhipingpu Town. The bridge showed shear key failures and embankment cracking,

as seen in Figure 11. In the vicinity of Miaozhiping Bridge there are several RC girder bridges, as shown in Figure 12. These bridges appeared to suffer little damage. No weight limits were posted on these bridges.

FIGURE 11 Damage to shear key and embankment of the overpass.

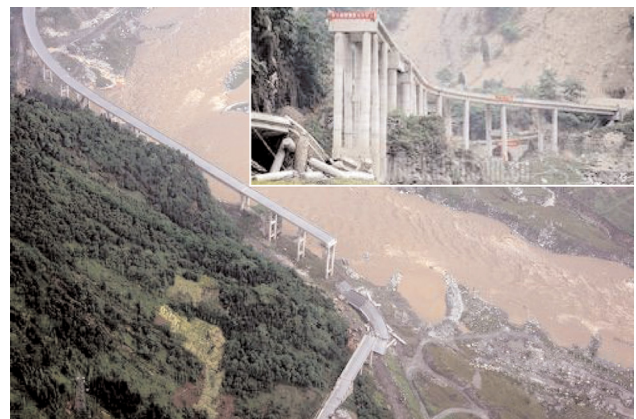
During the earthquake, the more highly curved section of the bridge collapsed, as illustrated in Figure 14. The rest of the bridge suffered varying degrees of damage, including shear cracks and failure at columns and struts and shear and key failure, as shown in Figures 15a to 15c for Bents 3, 9, and 18, respectively. At Bent 3, typical damage occurred between the strut and columns in the form of spalling and cracks. At Bent 9 with expansion joints, the superstructure had significant transverse displacement, knocking off the shear key. At Bent 15, the bridge section was collapsed, likely resulting from a combined effect of large deformation in tall columns and the presence of the expansion joint at Bent 14 and the in-span

hinge near Bent 18. As illustrated in Figure 14, the full-width cracks in the superstructure at Bents 15 and 17 support the suggested collapse mechanism. At Bent 18, in addition to cracks between column and strut, significant spalling occurred underneath the bridge deck.

At the curved part of the bridge, the bridge is likely subjected to higher deformation and stress under the earthquake, resulting in collapse. Even for the straight part of the bridge, because of tall columns,

FIGURE 14 Postearthquake damage. (Source: CNS.)

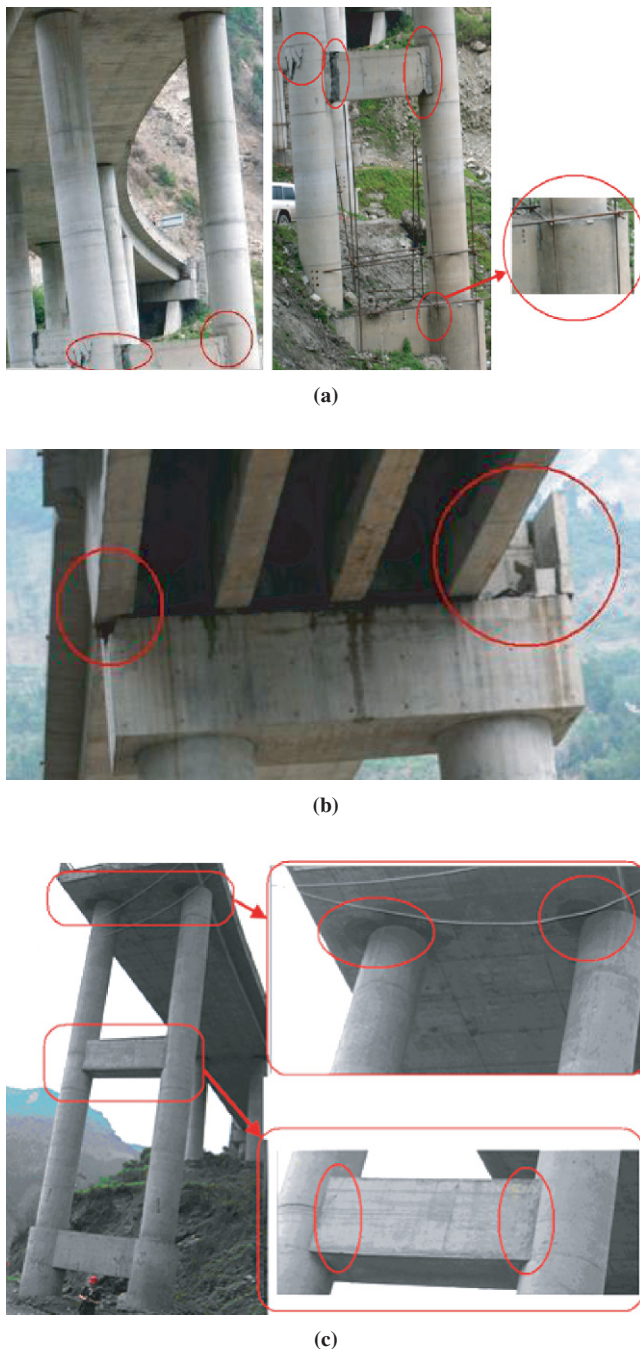
FIGURE 15 Damage at various bents: (a) Bent 3, (b) Bent 9, and (c) Bent 18.

the damage in various sections under the earthquake results in tilting of the columns that would push the superstructure almost off its support at several locations.
