China Earthquake Reconnaissance Report: Performance of Transportation Structures during the May 12, 2008, M7.9 Wenchuan Earthquake

China Earthquake Reconnaissance Report: Performance of Transportation Structures During the May 12, 2008, M7.9 Wenchuan Earthquake

PUBLICATION NO. FHWA-HRT-11-029

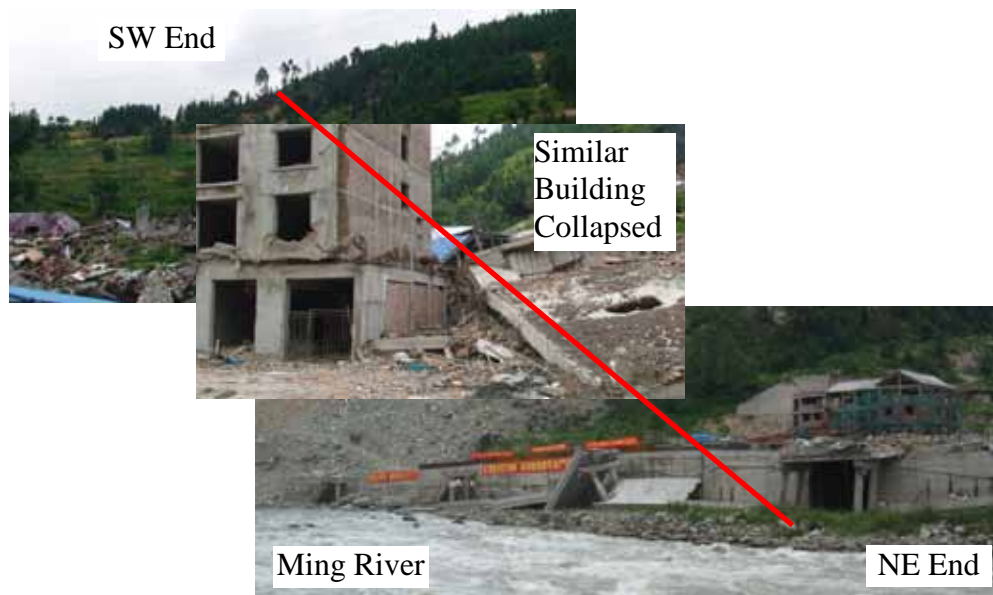
The epicenter of the earthquake was located near Yingxiu in Wenchuan County, Sichuan Province. The surface rupture of the center fault in the Longmen-Shan fault zone was observed in Yingxiu, as illustrated in figure 5. The thrust fault appeared to cross the Ming River at a right angle. The earthquake left behind a distinct dislocation on the river bed at the northeast end of the surface rupture. The northwest side of the fault, on the upstream of the river, moved upward against the southeast side of the fault. The fact that one deck panel along the elevated expressway bridge was still supported by one pier indicated the sudden push by a near-field pulsing effect. The line on figure 5 traces the surface rupture features: a sudden slope change in the mountain, buildings that were damaged next to collapsed buildings, and dislocation across the river bed.

Figure 5. Photo. Surface Rupture of the Earthquake Fault.

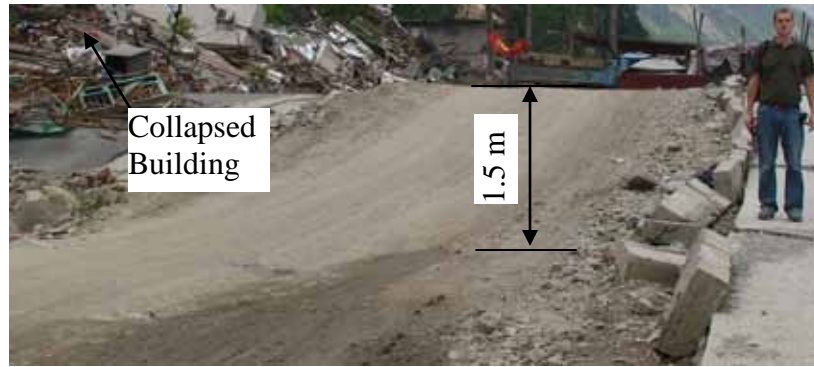
On one side of the Ming River was a five-story building with a construction joint between two similar parts. The right side of the building was completely collapsed while the left side of the building only lost the second story and suffered structural damage in the walls. A sudden change was also apparent on the slope of the mountain behind the building. A closer look at the Dujiangyan-Wenchuan highway in front of the building indicated that the vertical dislocation was approximately 4.92 ft (1.5 m), as shown in figure 6.

Figure 6. Photo. Surface Rupture Along the Old Highway Near a Collapsed Building.

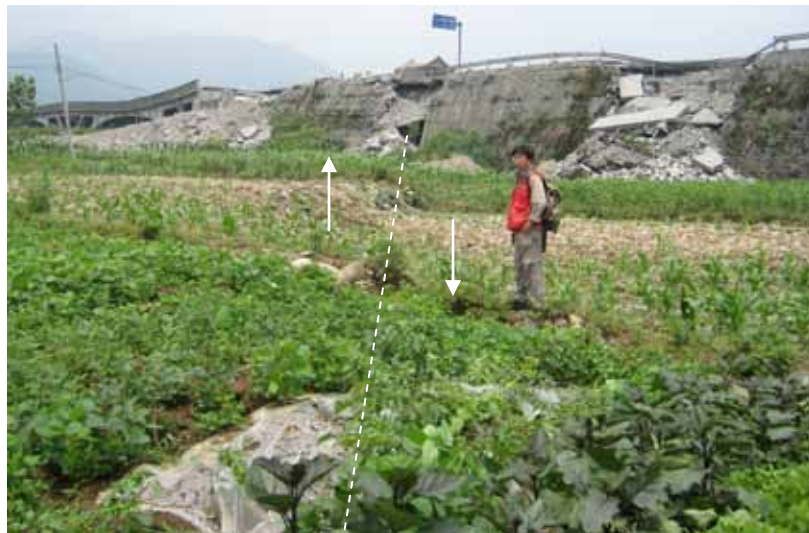
Xiaoyudong Bridge is located at 31.1859 °N, 103.7677 °E between the front and center faults in the Longmen-Shan fault zone. Part of the bridge structure collapsed, and the rest suffered significant damage. According to Xie et al., surface rupture was observed at the bridge site, as shown in figure 7 and figure 8. The vertical offset was more than 3.28 ft (1 m). The highest peak ground acceleration recorded during the Wenchuan earthquake, 0.65 g (6.37 m/s^2), was measured near Xiaoyudong Bridge, at a point to its northeast.

Figure 7. Photo. Surface Rupture Near Xiaoyudong Bridge.

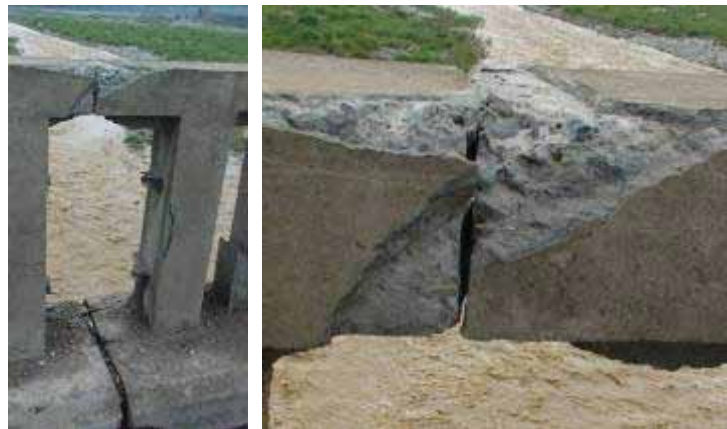
Tongji Bridge is a nine-span stone arch structure on reinforced concrete (RC) pier walls spanning a river, as shown in figure 13. Built in 1999, the bridge is located in the northwest of Chengdu Metropolitan Area and has a span arrangement of 29.5 to 110.5 ft (9 to 33.7 m). The abutment of the bridge on the river side was retrofitted to increase its strength against hydraulic forces, as indicated in figure 13. During previous floods, water rose to the arch level. It was observed that water leaked through the first arch from the bridge deck due to rains. Minor pounding damage at railing joints and approach settlement were observed, as illustrated in figure 14.

Figure 14. Photo. Pounding Damage at Railing Joints.

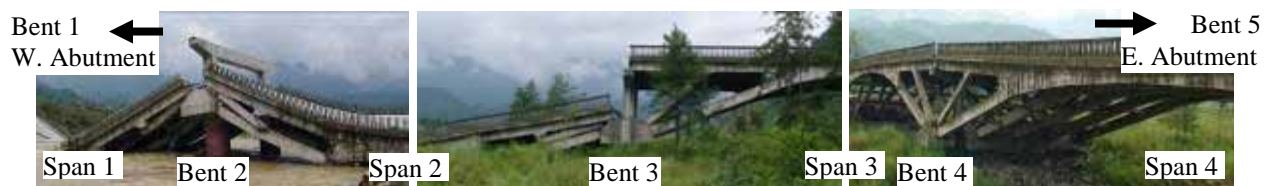
The two spans on the west side of the bridge had collapsed, and the eastern most span was severely damaged, as shown in figure 17. The remaining span suffered little damage. As shown in figure 17, bent 2 is located in the middle of the river, with the longest pile shafts exposed above ground. Bent 2 was significantly tilted while the other intermediate bents appeared to have little rotation. The difference in the stiffness of the various bents most likely contributed to the collapse of the two western spans. Under severe shaking around the bridge site, as indicated by landslides shown in figure 18, bent 2 rotated, resulting in unseating of the two spans. The bent cap was approximately 33.15 inches (850 mm) across, and the seat length of each girder was approximately 11.7 inches (300 mm), which is very limited for strong shaking at the bridge site.

Figure 17. Photo. Overall View of the Remaining Arches.

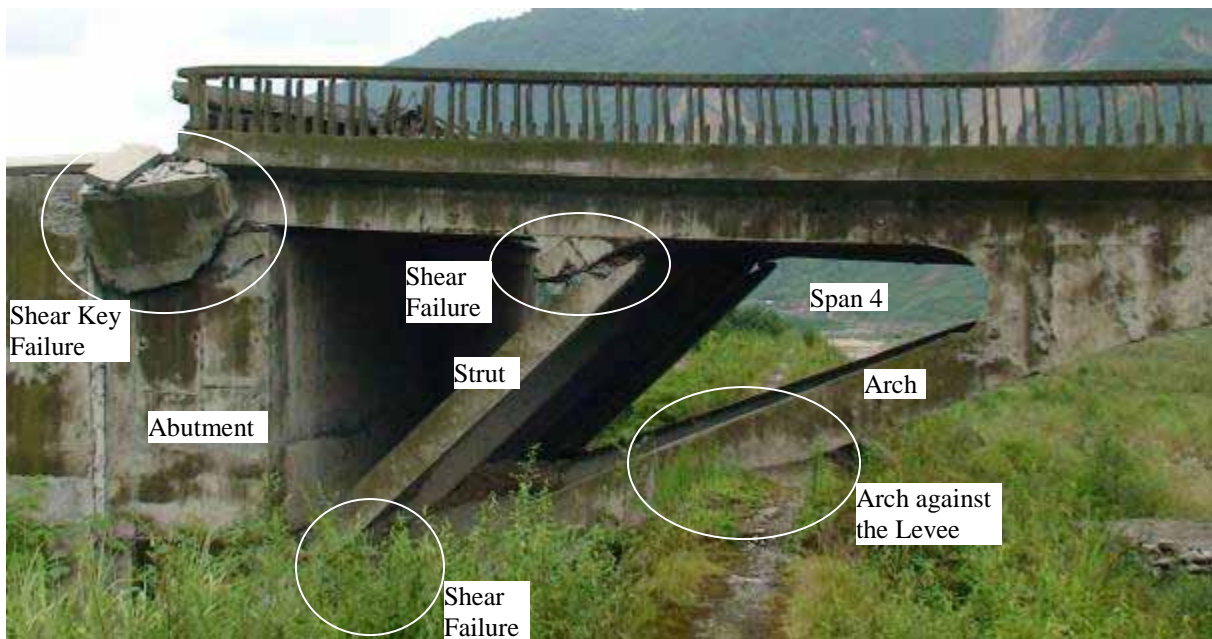
The easternmost span also suffered significant damage. As shown in figure 19, shear failures were observed on the top end of the struts and on the bottom end of the arches. The shear key on the east abutment was damaged. The shear failure is shown in figure 20. At the top end, each strut seemed to be reinforced with 15 #25 (metric) bars. Some of them were fractured.

Figure 19. Photo. Damage in Easternmost Span.

The damage to the easternmost span was likely caused by the surface fault near the east abutment, as shown in figure 7. Figure 21 presents a schematic of the interaction between the fault rupture and the east abutment of the bridge. When the hanging wall of the thrust fault moved up and right, relative to the foot wall supporting the east abutment, the levee began to bear on the arches and added significant shear forces and bending moments, especially at the east ends of the arches. Designed for axial forces, the arches failed in shear at their east ends. The top end of the arches remained intact due mainly to its larger section. Due to the shear failure in the arches, the east span deflected downward significantly, as shown in figure 19, and added more loads to the strut, resulting in its shear failure as well. At the same time, span 4 pushed toward bent 4 and caused flexural cracks at the pile shaft, as indicated in figure 22.

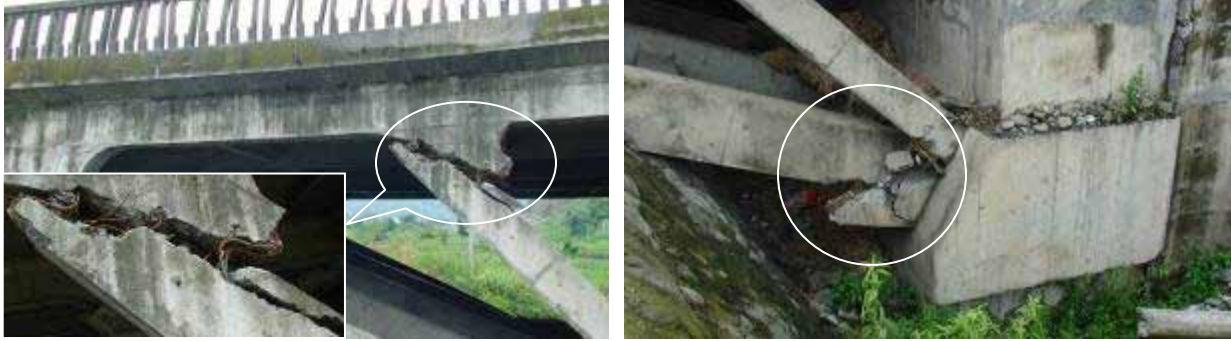
Figure 20. Photo. Details of Shear Failures in Easternmost Span.

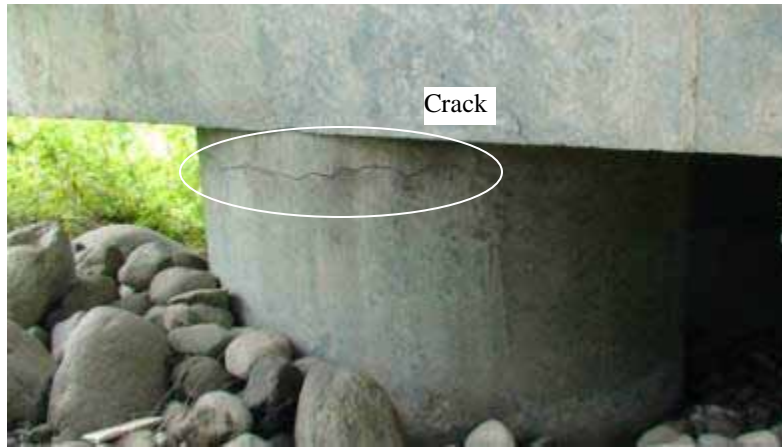
Figure 22. Photo. Flexural Crack on Pile Shaft at Bent 4.

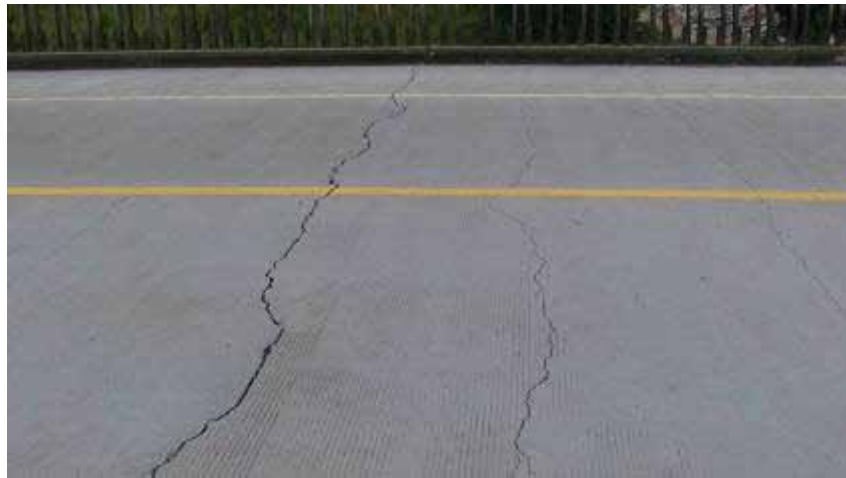
Span 3 suffered little damage. In addition to the flexural crack on the pile shaft at bent 4, the bridge deck cracked near the location where the arch element was connected to the bridge deck on the east side of the span, as shown in figure 23. At midspan and at the west side of span 3, there was no cracking. Therefore, the damage was most likely caused by a significant horizontal earthquake force in the west direction. In this case, the bending moment in the bridge deck exceeded its capacity at the crack location.

Figure 23. Photo. Transverse Crack on Top of the Bridge Deck in Span 3.

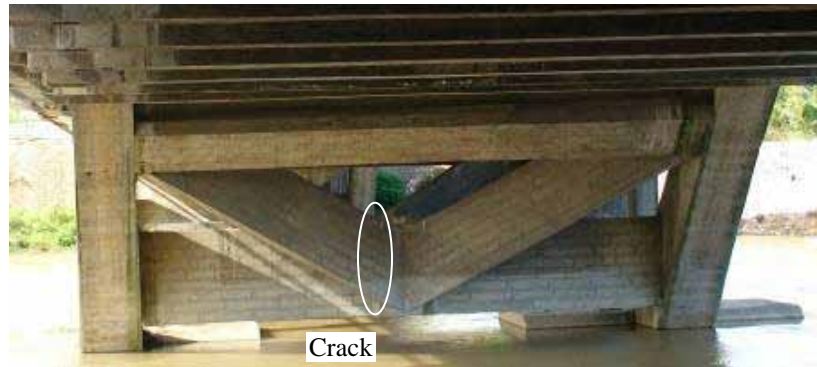
Figure 26. Photo. Cracks on Diagonal Members/Transverse Bracings.

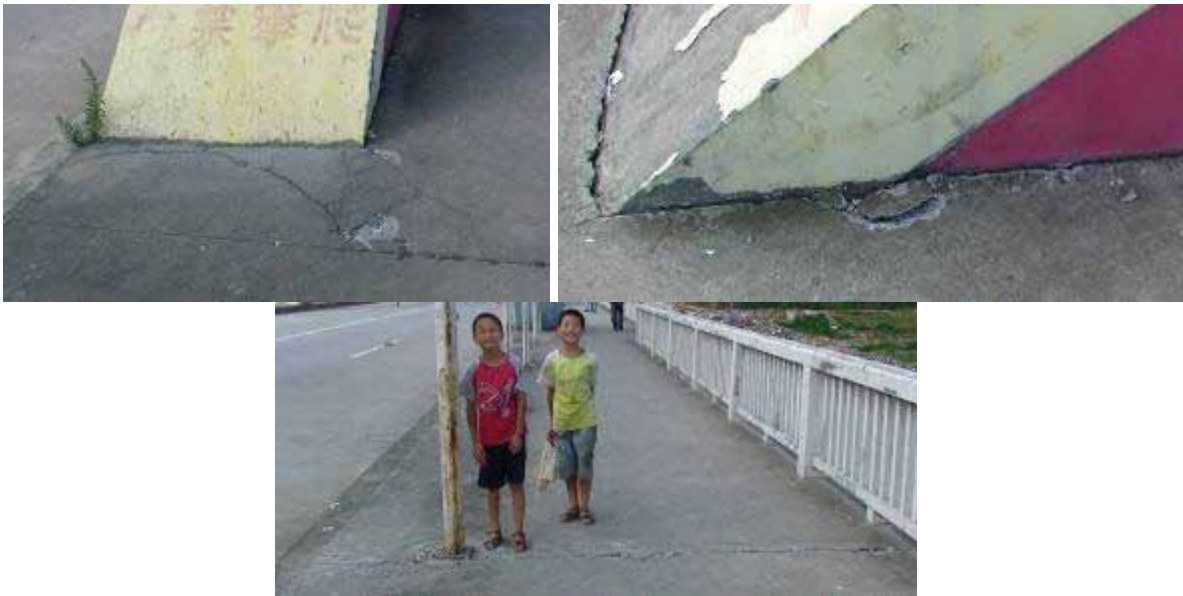
Figure 27. Photo. Damage in Bridge Deck Around Arch and Suspender.

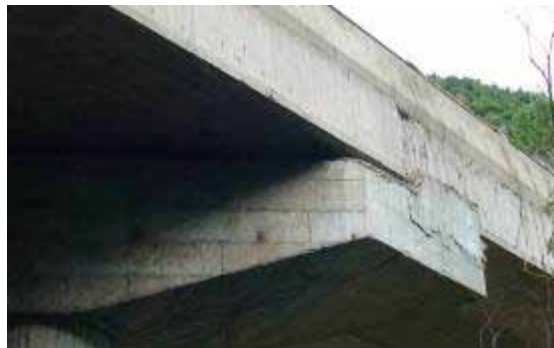
Figure 31. Photo. Damage in Shear Key.

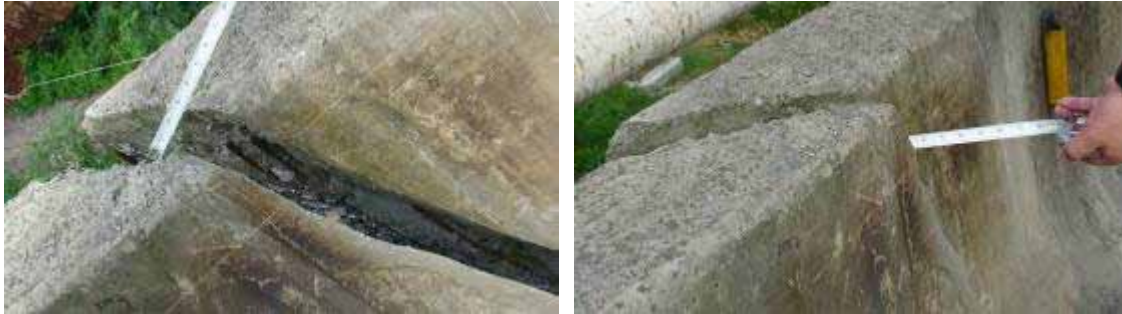
Figure 32. Photo. Measurement of Expansion Joint Offset.

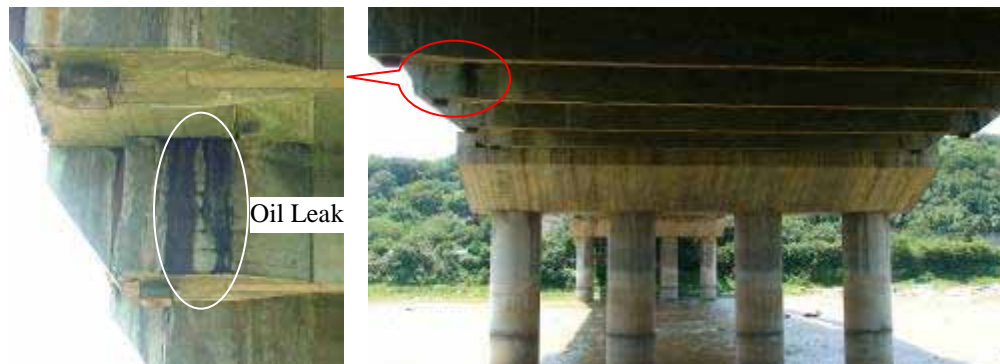
Figure 36. Photo. Oil Leakage Underneath the Bridge Deck.

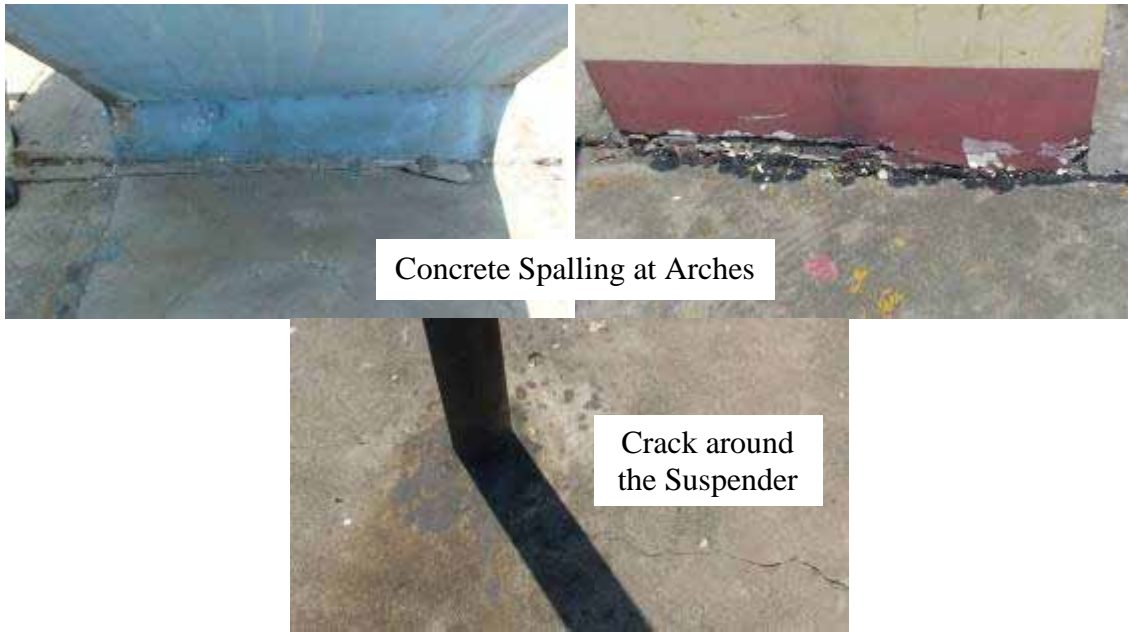
Baiyun Bridge was built in 2001 and spans the Anchuang River in the northwest-southeast direction. It is a three-span simply supported tied-arch structure, as shown in figure 34. As illustrated in figure 35, the three spans of the bridge are 223, 262.4, and 223 ft (68, 80, and 68 m). The height-to-span ratio is approximately 1:5. The arches are supported on four-column bents and seat-type abutments. To protect ties from corrosion, the tendon duct of each tie was filled with oil. Both the tie and the oil duct were embedded in the RC bridge deck. After the earthquake, oil in the tendon ducts began to leak, as shown in figure 36, suggesting that the ducts developed cracks during the earthquake or that the anchorages were damaged. In addition, concrete spalling and cracking were observed on the bridge deck around the arches and cables, as shown in figure 37.

Figure 37. Photo. Concrete Spalling and Cracks on Bridge Deck.

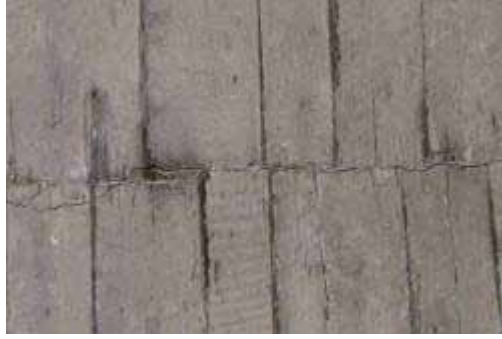
Built in 1989, Nanhe Bridge is a five-span open-spandrel arch structure with an additional slab bridge at the north end, as shown in figure 38. The bridge is oriented north-south. Six secondary arches (haunch soffit) are supported by the spandrel columns on each of the five main arches. As shown in figure 39, transverse cracks were observed at the crown of all secondary arches. The cracks covered the entire width of the secondary arches but did not penetrate the deck thickness. The damage pattern indicated that two adjacent secondary arches and their common supporting column may have rotated slightly during the earthquake.

Figure 39. Photo. Transverse Crack at the Crown of Secondary Arch.

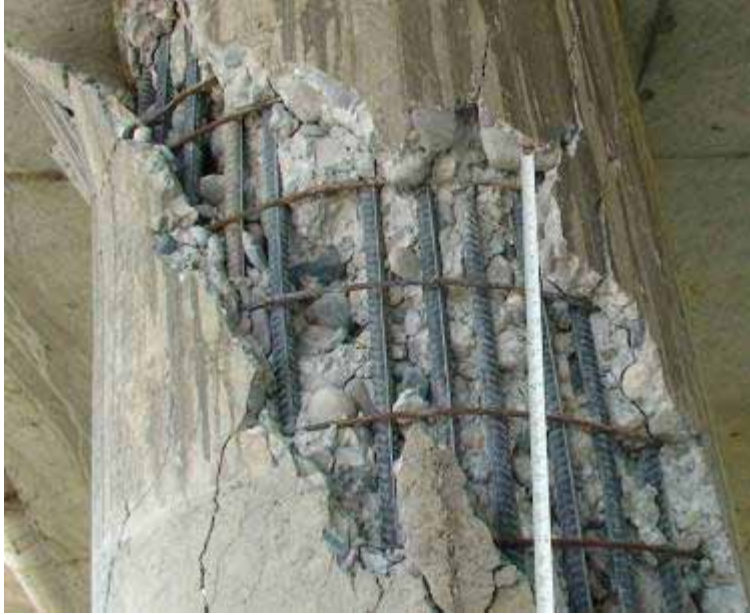
The two short, stiff columns at bent 5 of the northwest approach had severe shear cracks that exposed the aggregate and reinforcement as well as minor diagonal shear cracks, as shown in figure 42 and figure 43. The damage probably resulted from large gravels used in the concrete mix (approximately 3.9 inches (100 mm), illustrated in figure 42) and loose tie bars, as well as from the relatively rigid wall effect, which lead to irregular stiffness distributions. Torsion resulting from the asymmetry in stiffness of the structure probably caused the different levels of shear damage in the two columns at bent 5. In the vicinity of bent 5, the retaining wall underneath the northwest approach had a diagonal crack, as shown in figure 44. In addition, there was spalling of the superstructure concrete at the expansion joint next to bent 5. The southeast approach structure had minor flexural cracks at the lower portion of the columns at bent 4.

Figure 42. Photo. Shear Failure at West Column of Bent 5 of the Northwest Approach.

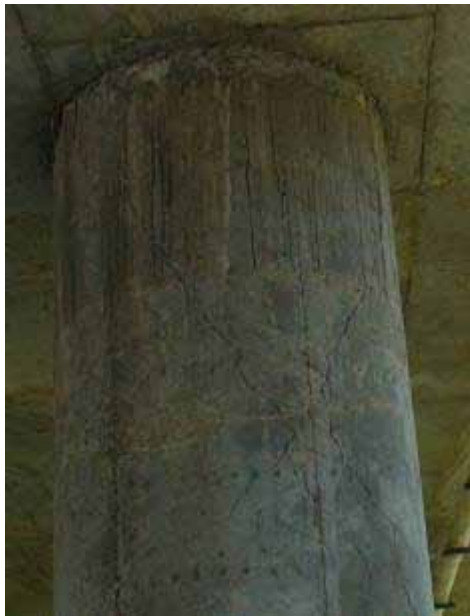
Figure 43. Photo. Shear Crack at East Column of Bent 5 of the Northwest Approach.

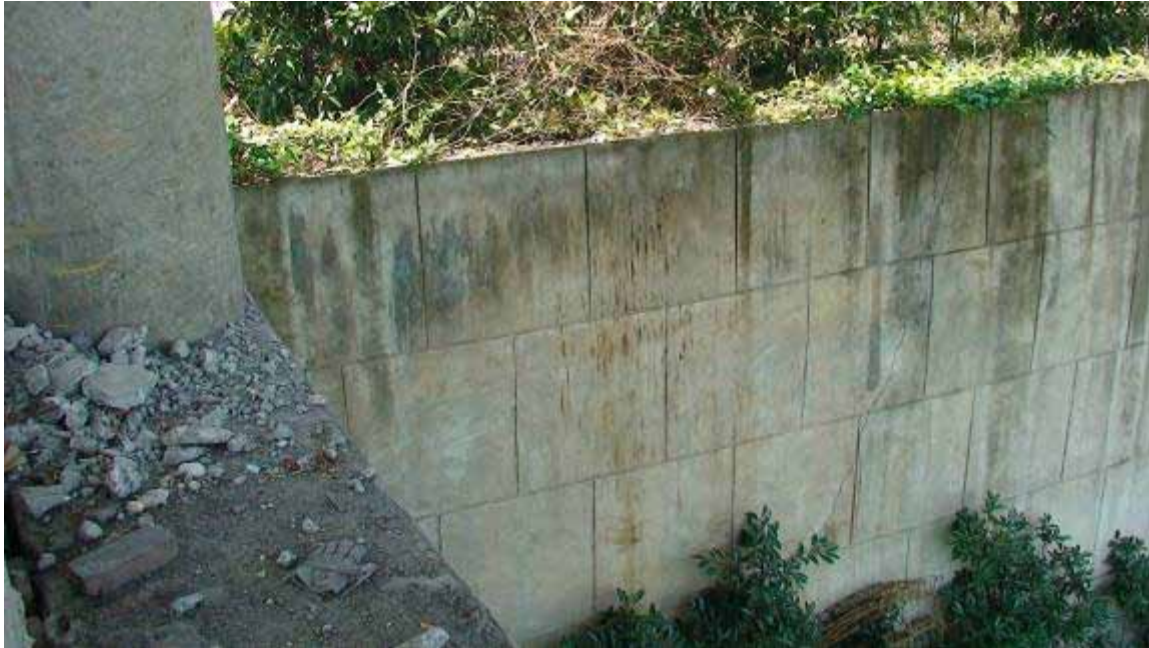
Figure 44. Photo. Crack on Retaining Wall Underneath the Northwest Approach.

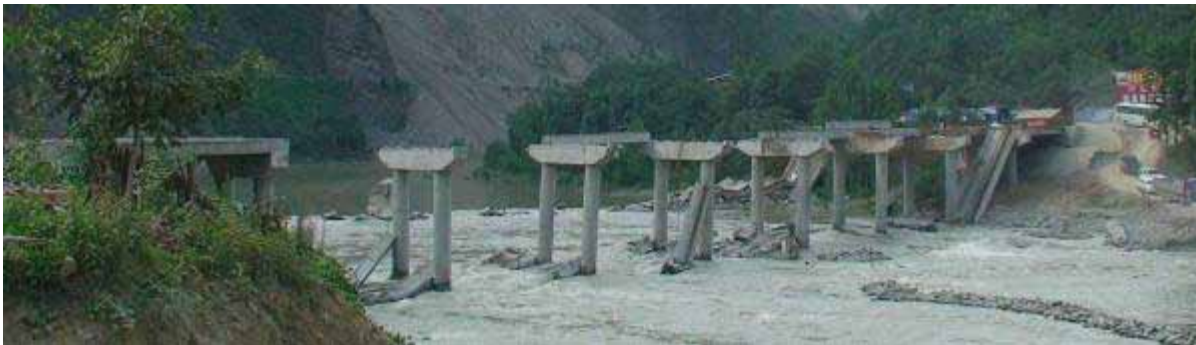
Figure 47. Photo. Damage Scenario of 10-Span Bridge Under Construction During the Earthquake.

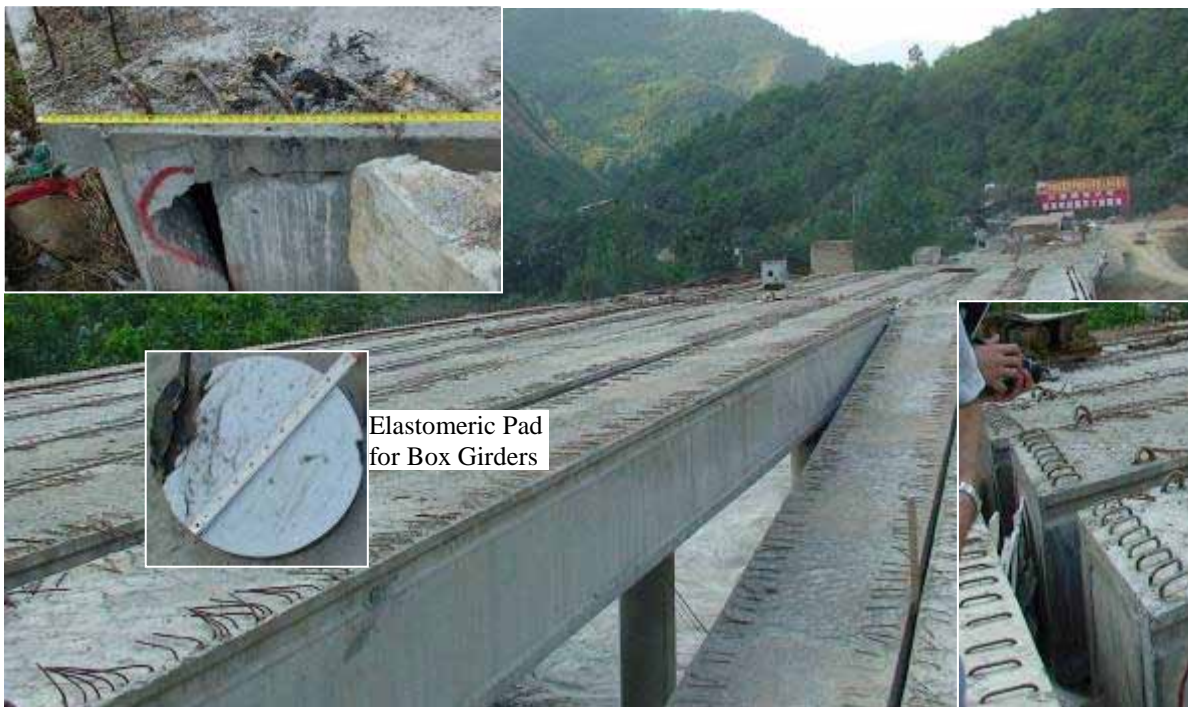
Figure 48. Photo. Damage to the 10-Span Bridge Under Construction.

by approximately 29.64 inches (760 mm). The deck had not been poured, there were no real transverse bracing or shear keys, and girders were on a slight skew, all of which contributed to the damage. Also, many of the bents were leaning or distorted, but no damage was visible above the water line.

There was no indication that the 10-span bridge suffered any damage due to a fault crossing. As such, the three-span arch bridge must have been damaged by ground shaking, perhaps exacerbated by soil movement. Liquefaction, lateral spreading, or other soil movement also may have been responsible for the distortion of the two-column bents. The reconnaissance team was not able to discern what type of foundation system the bents were supported on, but apparently they were not sufficiently embedded in good material.

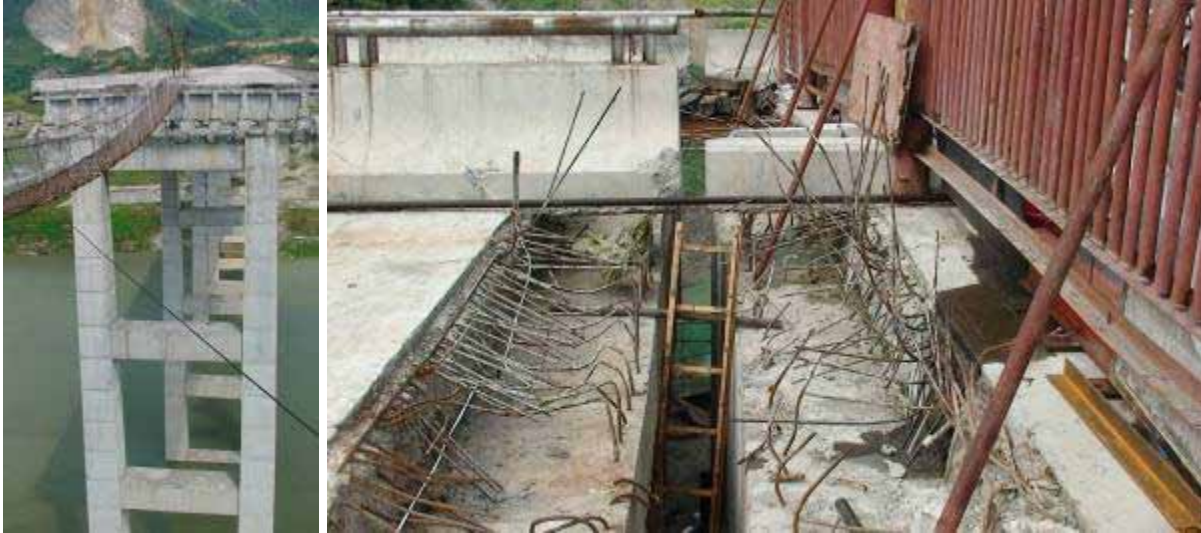
As shown in figure 55, the approach near the tunnel is a two-span, RC girder structure with a 164-ft (50-m) span length. The bridge deck is supported on five RC girders and two-column bents with several cross struts. The bridge deck is continuous, but the girders are simply supported on the bents. As shown in figure 51 and figure 54, the main bridge is a continuous, non-prismatic, three-span structure supported on two intermediate wall piers with span lengths of 410, 722, and 410 ft (125, 220, and 125 m). The superstructure is a single-cell box girder structure. The depth of girders varies to a maximum depth of 13.1 to 14.8 ft (4.0 to 4.5 m).

Figure 55. Photo. Drop-Off Span and Construction Details Between Two Spans.

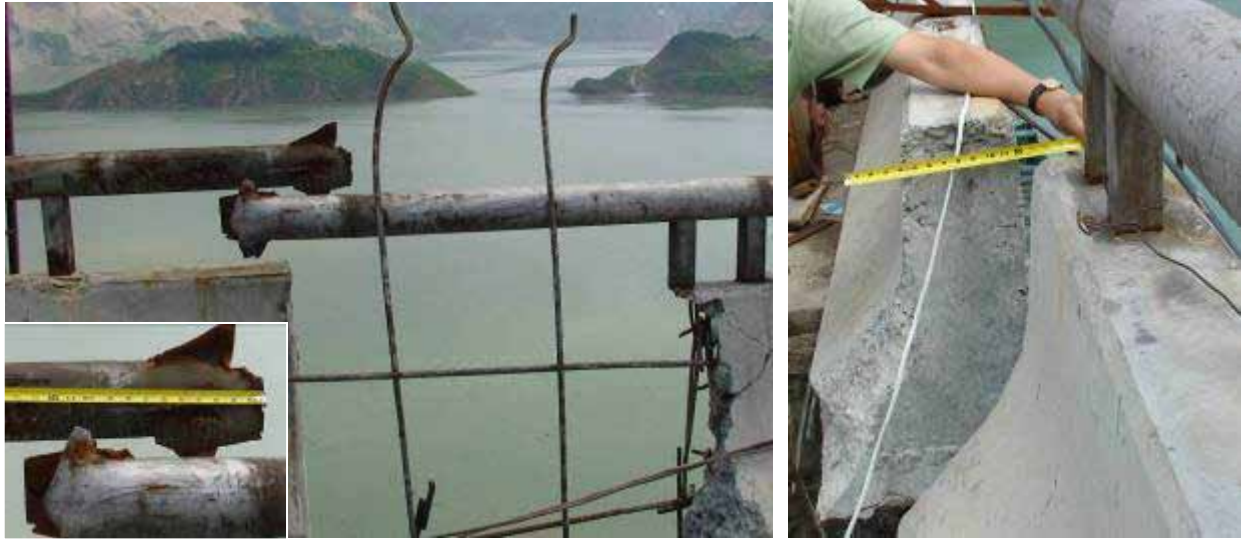
The construction of the bridge was near completion at the time of the earthquake, with only the installation of expansion joints remaining. The most severe damage was to the end span of a five-span T-girder segment that became unseated at the expansion joint end, fractured in the continuous deck at the other end due to gravity load, and fell off the supporting bent caps. The bent seats were approximately 11.7 inches (300 mm) long, but the bridge experienced at least 19.5 inches (500 mm) of longitudinal movement due to earthquake shaking. Since the columns of each bent are approximately 344.4 ft (105 m) tall, the accumulated displacement at the bent cap was probably significant during the earthquake. There were other indications of large longitudinal movement. As shown in figure 56, the barrier rails overlapped by about 11.7 inches (300 mm) at the southeast expansion joint. The barrier also displaced transversely by approximately 9.75 inches (250 mm). Divers found cracks at the bottom of the main span columns due to earthquake shaking. Shear key failure was also observed, as shown in figure 57. After the earthquake, the bridge deck was put back into place with hydraulic jacks.

Figure 56. Photo. Longitudinal and Transverse Offset of Bridge Deck.

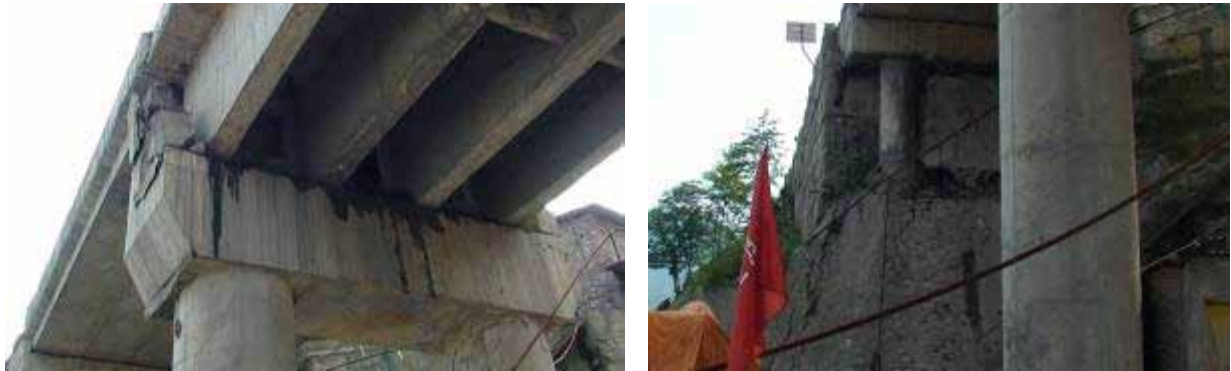
The end of Miaozhiping Bridge near the tunnel is divided into two parallel elevated structures to guide traffic in two directions through the twin tunnels, as shown in figure 58. Over the southeast approach is a four-span RC girder bridge built in 2004. The bridge supports the old highway from Dujiangyan to Wenchuan and Juzhaigou. The old highway was built along the mountain terrain perpendicular to the Zhipingpu Highway at Zhipingpu Town. The bridge showed shear key failures and embankment cracking (see figure 59).

Figure 59. Photo. Damage to Shear Key and Embankment of the Overpass.

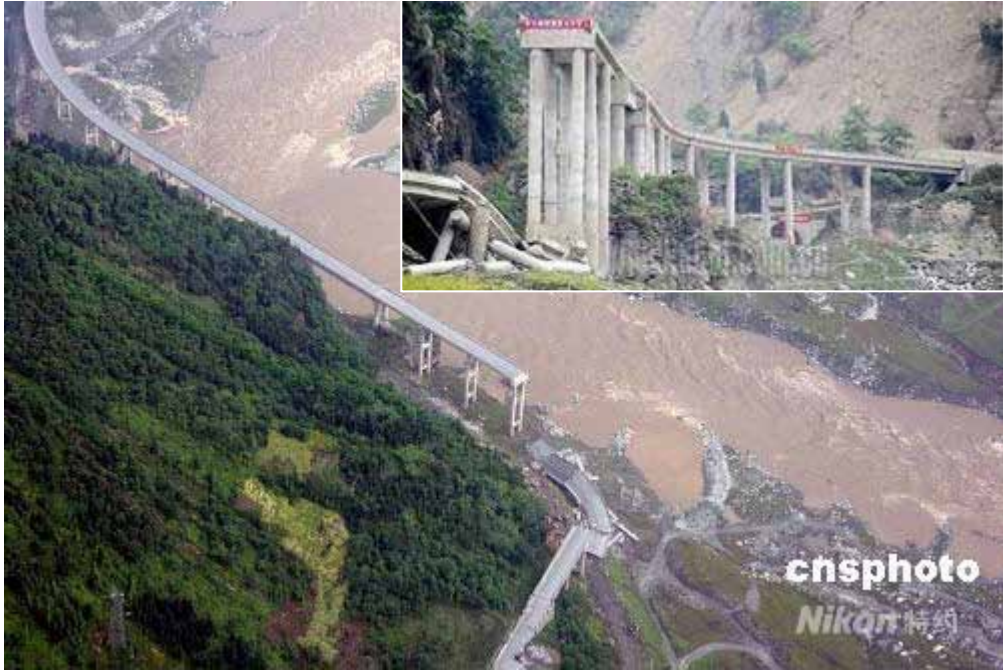
During the earthquake, one curved section of the bridge completely collapsed, as shown in figure 64. The rest of the bridge suffered varying degrees of damage, including shear cracks and failure at columns and struts, shear key failure, and bearing failure as shown in figure 65 through figure 69 for bents 3, 9, 15, and 18. At bent 3, typical damage occurred between the strut and columns in the form of spalling and cracks. At bent 9, with expansion joints, the superstructure had significant transverse displacement, knocking off the shear key. At bent 15, the bridge section was completely collapsed, probably due to the shear and flexural failure of the columns. At bent 18, significant spalling occurred underneath the bridge deck in addition to cracks between the columns and the strut.

Figure 64. Photo. Postearthquake Damage.

The curved part of the bridge was probably subjected to higher deformation and stress during the earthquake, resulting in collapse. Due to the tall columns, the earthquake caused tilting that pushed the superstructure almost off its support at several locations in the straight part of the bridge. A detour was graded along the side of the damaged bridge. Considering the high risk of further collapse during an aftershock, the bridge was demolished with dynamite, as shown in figure 70 and figure 71.

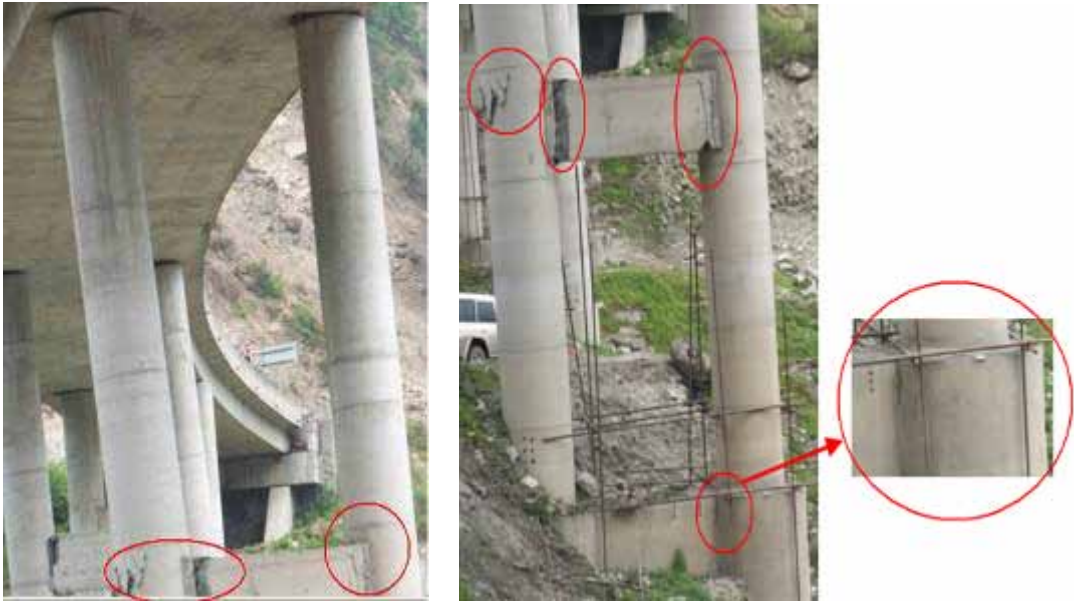
Figure 65. Photo. Damage at Bent 3.

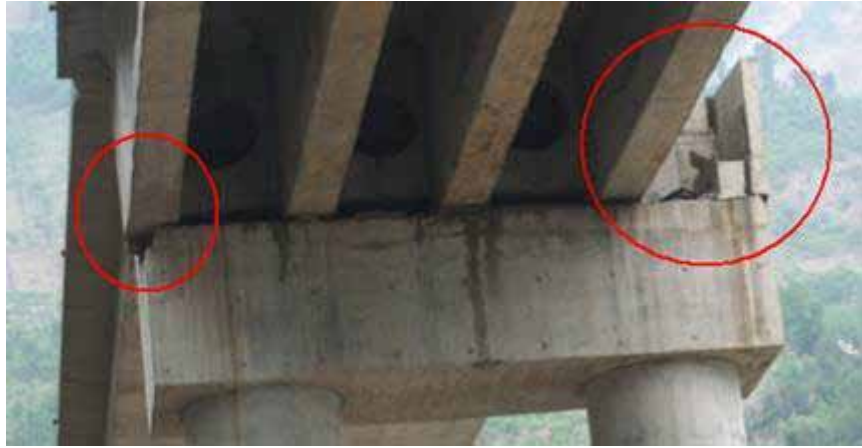
Figure 66. Photo. Damage at Bent 9.

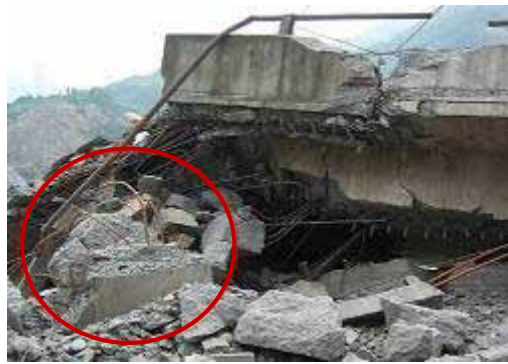
Figure 67. Photo. Column Shear and Flexural Failure at Bent 15.

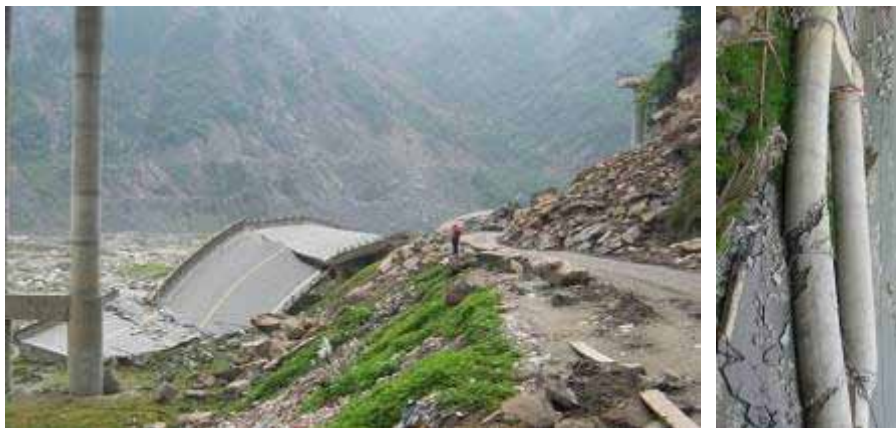
Figure 68. Photo. Column Shear Failure and Section 5 Collapse at Bent 15.

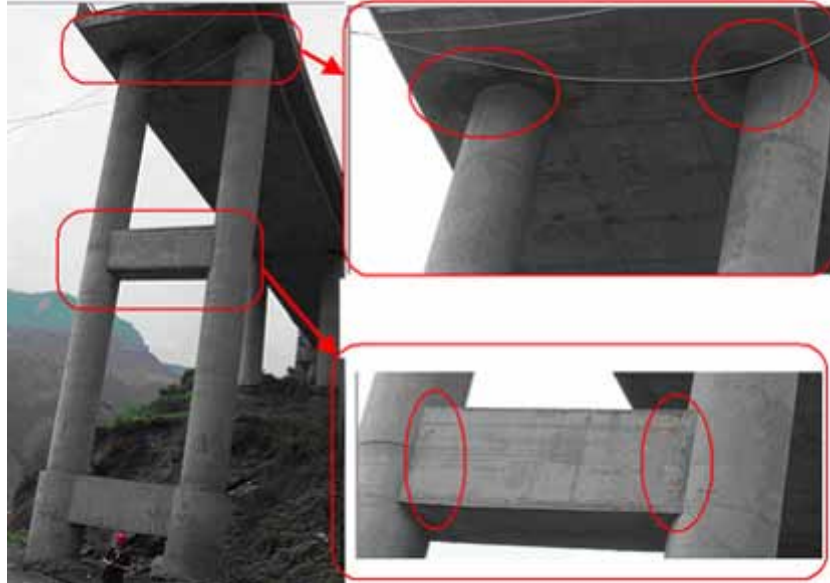
Figure 69. Photo. Damage at Bent 18.

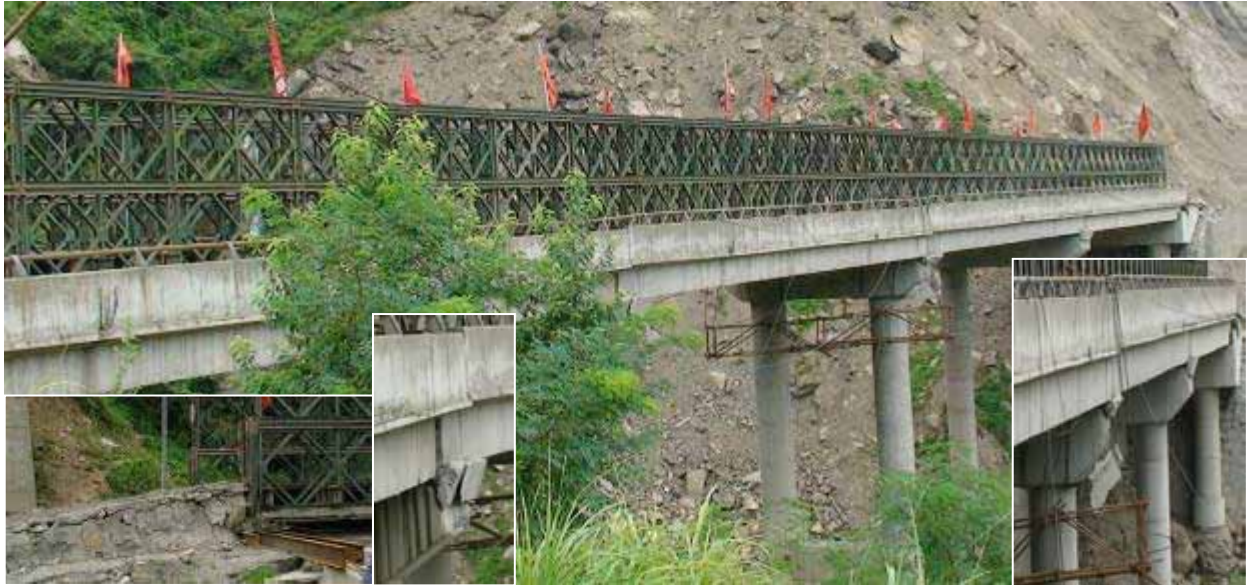
Zhima Bridge has four spans of 65.6 ft (20 m) and is an RC T-girder structure, as shown in figure 72. It is supported on very tall RC two-column towers. The bridge is a river crossing link across the deep canyon shown in figure 73. The bridge suffered significant movement both longitudinally and transversely. Most shear keys were damaged, as shown in figure 73. As a result, a long Bailey bridge was launched over the existing superstructure to support traffic. It appeared that the north span may have almost dropped.

Figure 73. Photo. Bailey Bridge Over the Existing, Damaged Bridge.

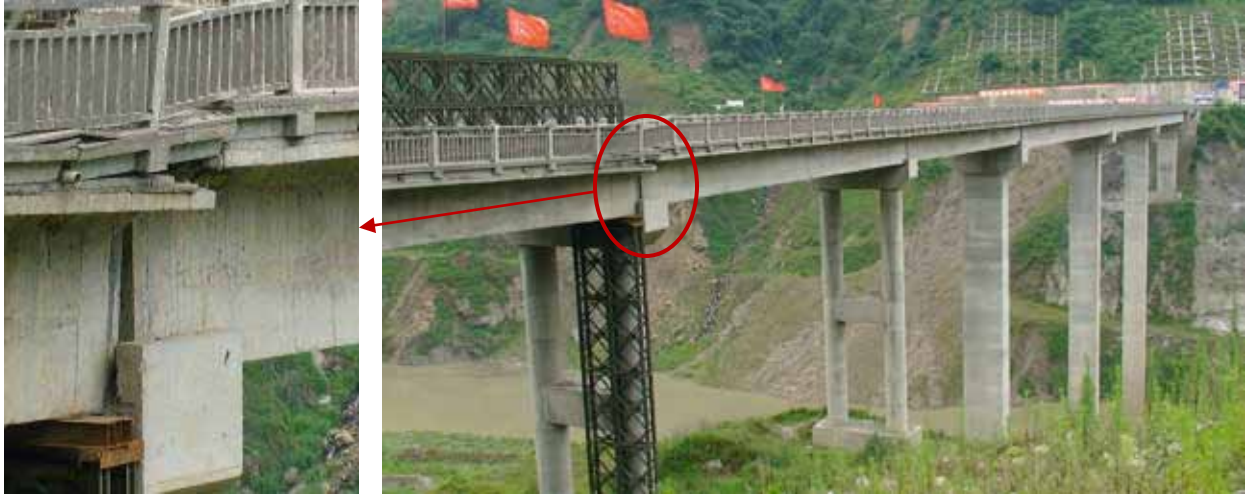
As shown in figure 75, the north span almost fell off the north tower and was supported on a steel tower with a Bailey bridge over the last span to carry traffic. The north approach embankment showed evidence of ground failure and movement. The west side showed evidence of ground failure, but the east side looked stable. There was a shear failure of the north abutment.

Figure 75. Photo. Overview of the Bridge Structure and Damage Location.

The entire structure shifted north and then back, leaving the girders of the first span pushed onto the approach and almost unseated from the first two-column tower. Damage was the result of ground shaking and insufficient seat to accommodate the resulting movement.
