# Forensic Investigation of Failed Mast Arms of Traffic Signal Supported Structures

Genda Chen, Michael Barker, D. Scott MacKenzie, Christopher Ramsay, Joe Alderson, Lokeswarappa Dharani, and Jiaqing Yu

**In Missouri, 11 traffic signal mast arms fractured at the arm-post weld connection in 7 years. To reduce this fatigue failure, the Missouri Department of Transportation developed a fatigue-resistant weld profile that increases the weld leg and reduces the slope of the weld at the toe. This study investigated causes of the failed arms, compared performance of new and old weld profiles, and suggested retrofitting measures for further investigation. The scope included a metallurgical investigation of one failed field mast arm, laboratory fatigue testing of five prototype mast arms (two new and three old profiles), and laboratory failure analysis of one arm tested to cracking. Metallographic and fractographic analyses indicated that the fatigue crack in the failed mast arm initiates near the weld toe of the arm due to undercutting, creating a sharp local toe angle. Location of undercutting at the heat-affected zone of the base material, where the material is softest, further contrib

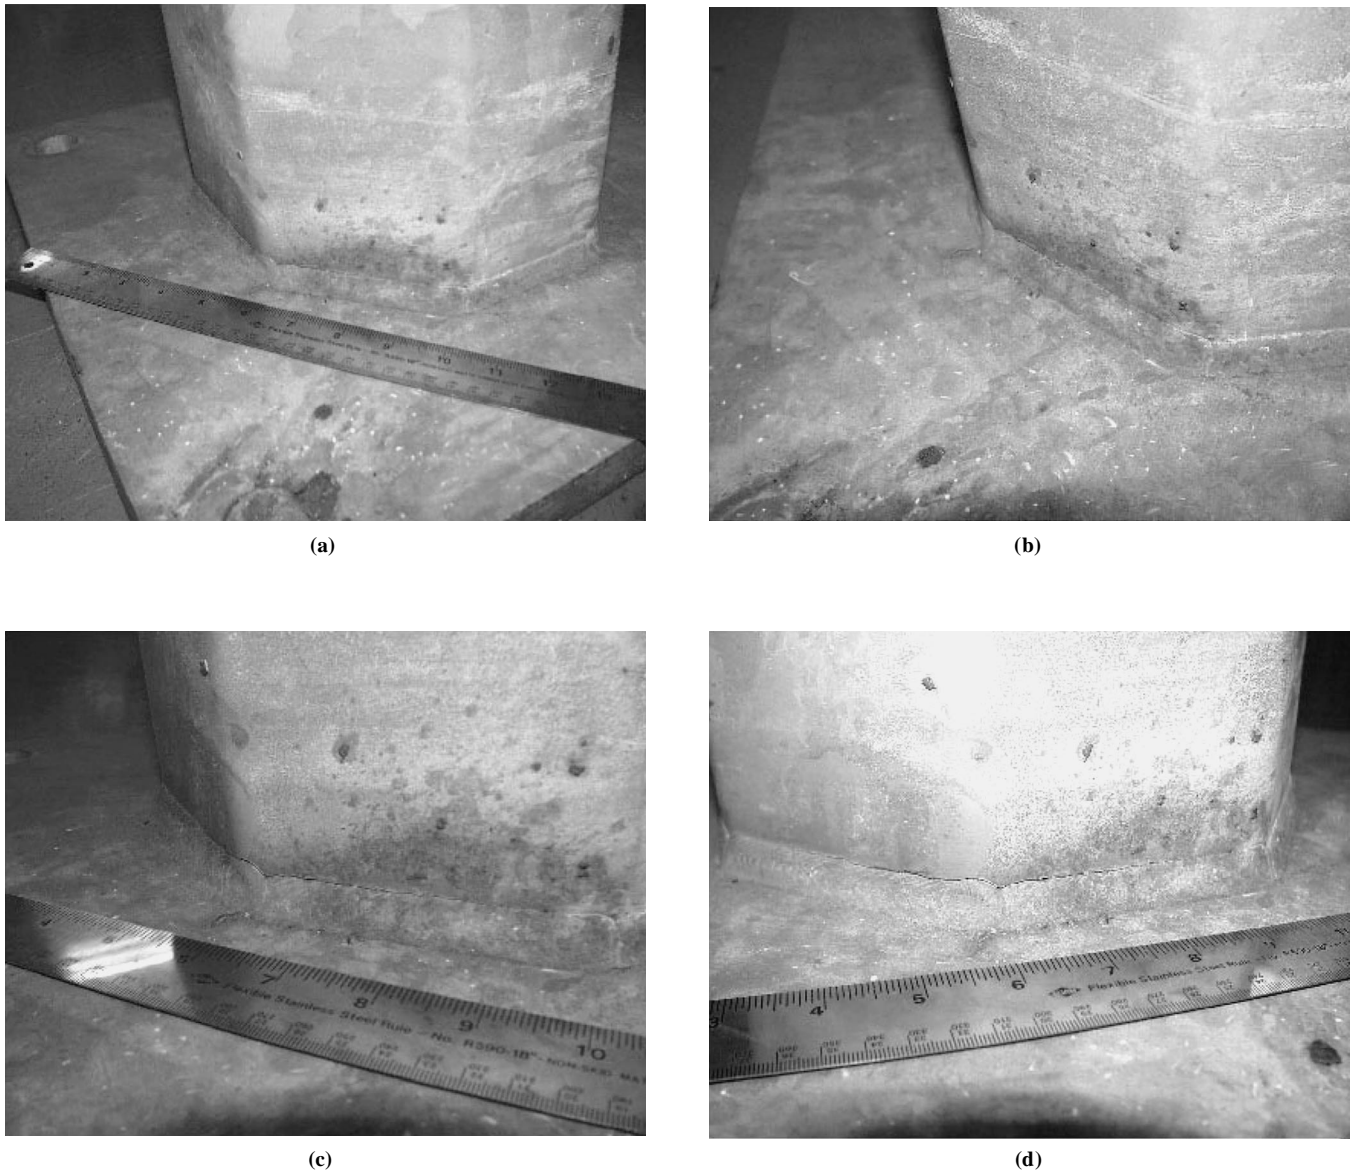
The mast arm examined is octagonal and similar to the one shown in Figure 1. Close-up views of the arm from various angles are shown in Figure 3. The appearance of the weld bead indicated that welding was discontinuous, with each flat of the mast arm tube welded individually. There was some attempt to tie in the welds on the other flats.

The progression of the weld solidification pattern indicated that welding was performed in a single direction. The weld on each flat ended at the corner of the flats. No evidence appeared of “buttering back” to prevent crater cracks. At the toe of the weld, undercutting was evidenced on both the signal mast arm and the base plate, as seen in Figure 3. It appeared to be more severe on the side of the mast arm. The shape of the weld bead was convex in relation to the fillet.

**FIGURE 3** Views of the typical outside weld on the luminary stanchion: (a) overall view of the stanchion, (b) and (c) views showing extent of undercut on multiple faces, (d) cracking evident at the undercut of the weld.

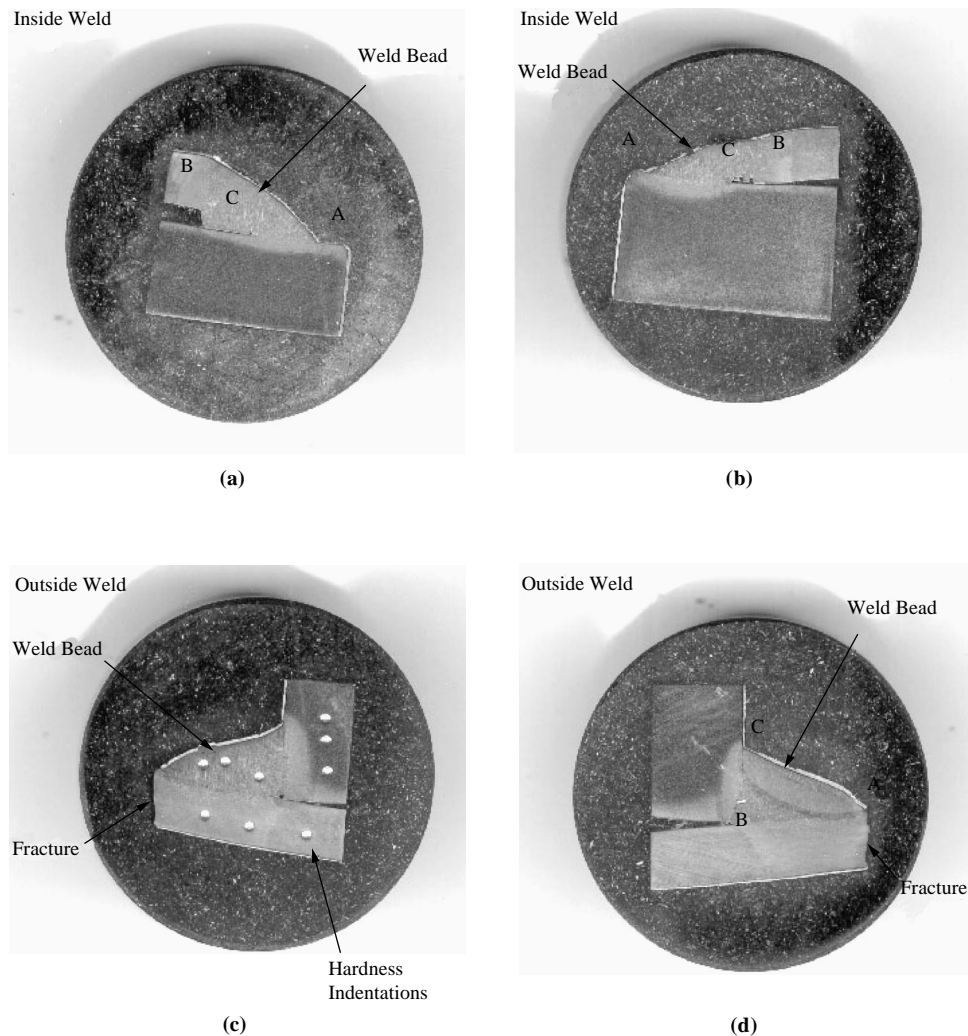
Examination of these sections showed a lack of fusion in all metallographic sections. There was no evidence of any weld preparation. On the inside weld (Specimen BE), the weld beads at three locations presented in Figure 5 show a typical microstructure of acicular ferrite. The zone-in picture at location A<sub>1</sub> gave a more detailed view of the microstructure. The heat-affected zone showed evidence of banded spheroidized pearlite. The base material was also banded and exhibited distinct regions of very fine pearlite. This structure is not unusual for A36 steel that has been cold formed. The radius at the toe of the weld is sharp. A sharp undercut of the weld is also evident. The undercut is approximately 50 to 100  $\mu\text{m}$  ( $1.97 \times 10^{-3}$  to  $3.94 \times 10^{-3}$  in.) deep and 200  $\mu\text{m}$  ( $7.87 \times 10^{-3}$  in.) wide. This is a very sharp notch and occurs where the base material is the softest and least resistant to fatigue.

FIGURE 4 Metallographic specimens examined: (a) Specimen BC, (b) Specimen BE, (c) Specimen CT, and (d) Specimen ET.

It is clear that the weld quality is poor, with a lack of fusion and lack of penetration. This can be improved by proper joint preparation and preheating the weld. Better penetration of the weld could be achieved by creating a small, 45° bevel at the edge of the base plate where the mast arm meets the base plate. This bevel could readily be achieved by grinding immediately before welding. This would improve the amount of weld fusion and penetration. It would also provide a concave weld-bead shape that is more conducive to fatigue service. This would reduce the sharp radius produced by the convex weld shape, decreasing the high stress concentration.

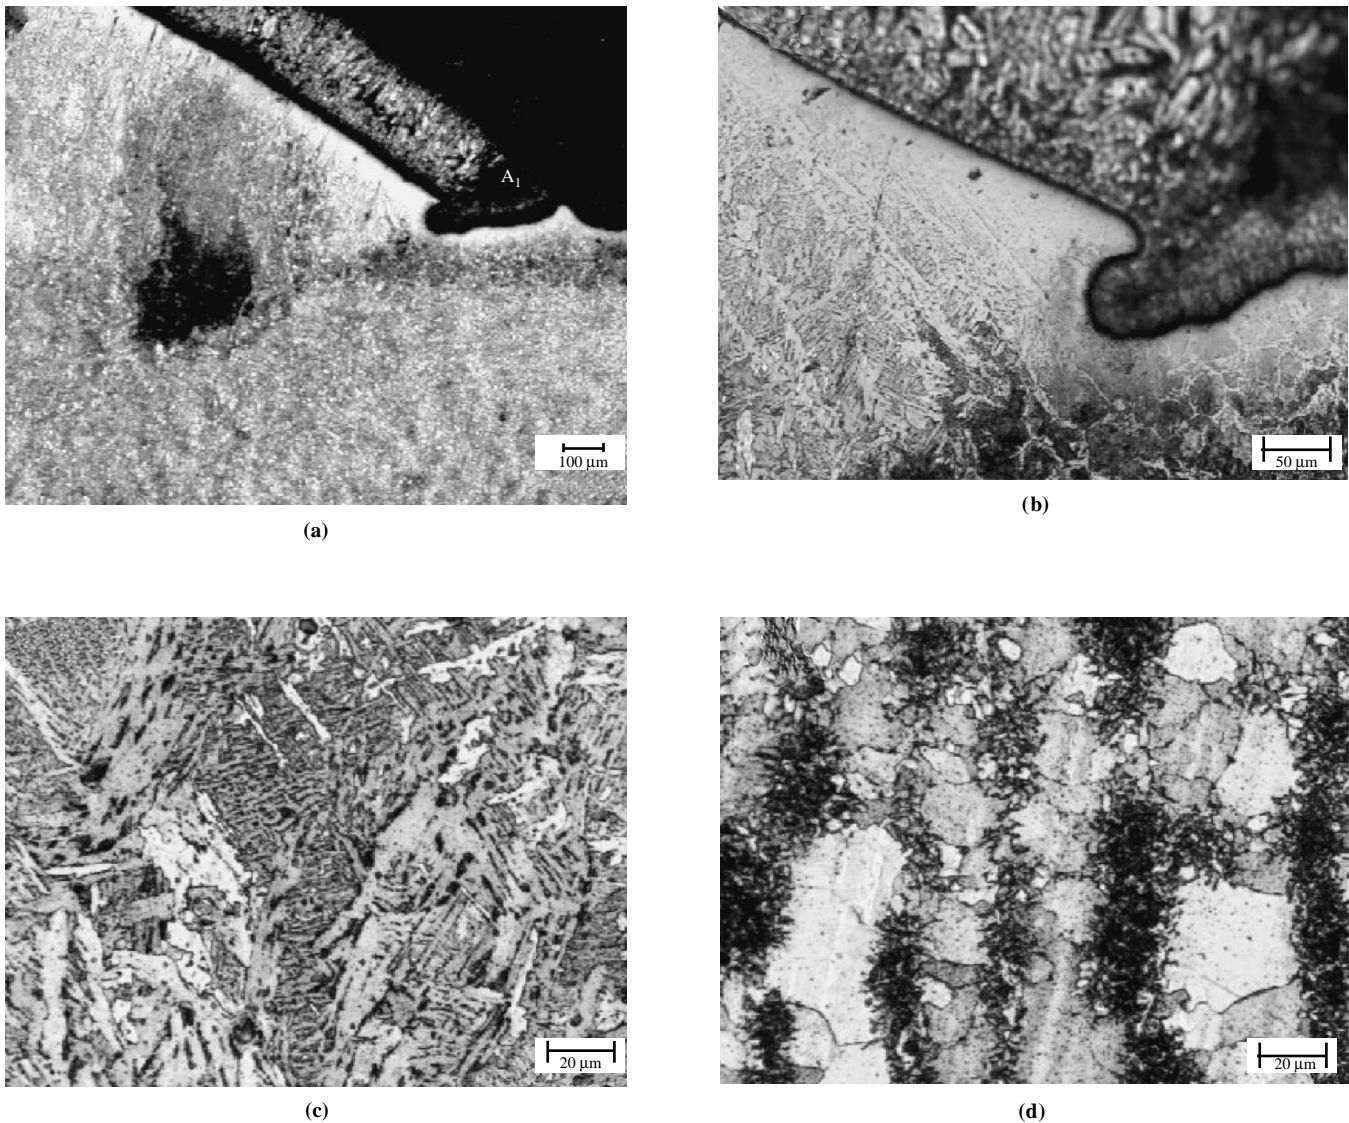
FIGURE 5 Selected photomicrographs from Specimen BE: (a) Location A, (b) Location A<sub>1</sub>, (c) Location B, and (d) Location C.

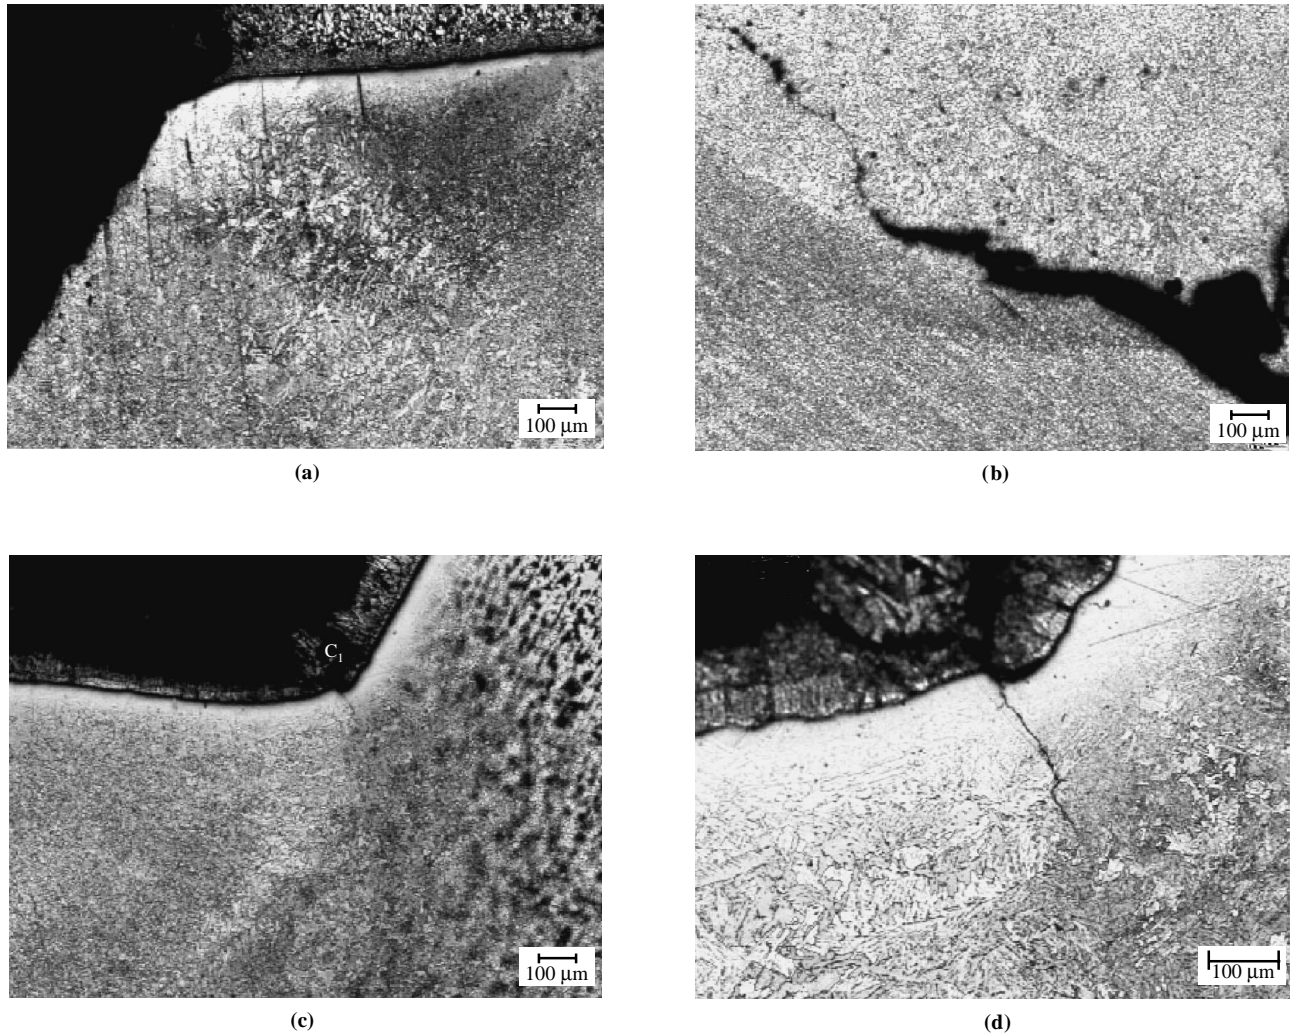
On the outside weld (Specimen ET), the weld beads at three locations, shown in Figure 6, presented evidence of undercutting at the

site of crack initiation of the fracture surface. The close-up view at location C<sub>1</sub> confirmed the cracking. The small size of the shear lip indicates that the stress levels were small in comparison with the overall section size. At the region of the root of the fillet, evidence of porosity, and cracks linking regions of porosity, were observed. This probably occurred by overload, possibly during the final failure. This is indicated by the direction of cracking, perpendicular to the fracture. However, this also could have occurred because of residual stresses in the weld.

FIGURE 6 Selected photomicrographs from Specimen ET: (a) Location A, (b) Location B, (c) Location C, and (d) Location C<sub>1</sub>.

of the weld. This was aggravated by the undercutting in the region of the heat-affected zone, where the base metal is softest and least able to resist fatigue. The presence of undercutting and the resultant large stress concentration factor are likely the source of premature fatigue-crack initiation. Several factors—including excessive current, too long an arc, too large an electrode, and the incorrect electrode angle—cause undercutting at the toe of a weld bead. It is symptomatic of poor welding procedures or inexperienced welding operators. Pinning is suggested to reduce the undercutting effect.

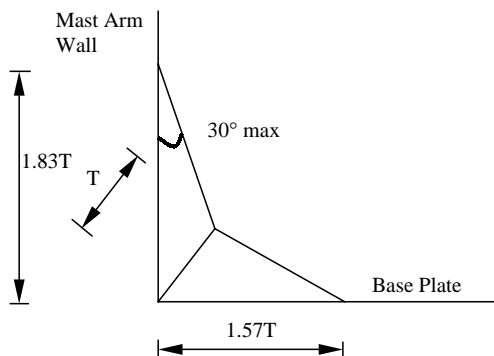
FIGURE 7 Fatigue-resistant weld profile.

To determine the fatigue strength of a typical weld connection as shown in Figure 1, five prototype mast arms were tested in the laboratory. They include products from three manufacturers and two arms with a new fatigue-resistant weld, as sketched in Figure 7. Clearly, the new weld profile extends the weld leg and reduces the slope at the toe of the weld. Numerical simulations in Chen et al. (1) demonstrated that the new weld profile may extend the crack propagation life because of the longer leg of the weld. The question of whether

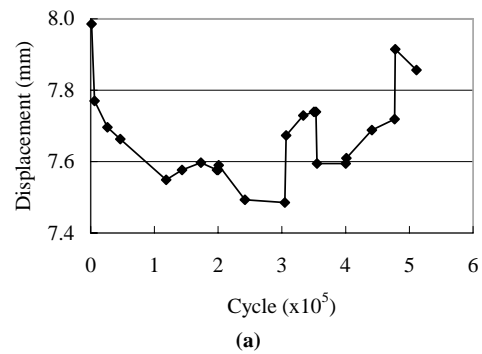
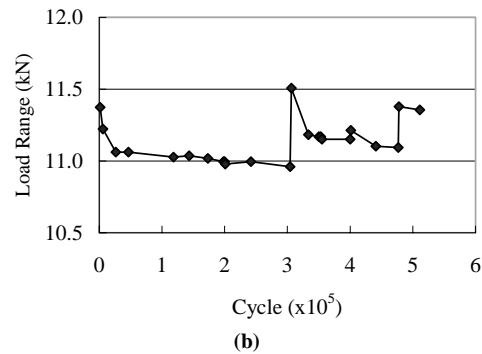
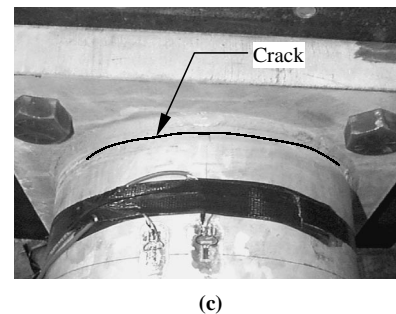
Specimen CB12917 failed at 0.4 million cycles. This was 75% earlier than anticipated. Figures 8a and 8b show the variation in displacement and load range for this arm. These two figures suggest crack initiation between 0.3 million and 0.4 million cycles, which was confirmed by magnetic particle testing at 0.5 million cycles. Figure 8c shows the crack on the outside of the arm.

**FIGURE 8 Specimen CB12917 test results: (a) maximum displacement versus number of cycles, (b) applied load versus number of cycles, and (c) fatigue crack on outside of the mast arm.**
