## A study on environmental corrosion of gilded heritage structures of Royal Palace Patan, Nepal

This article presents the results of corrosion study carried out on 17<sup>th</sup> century gilded sample procured from the metallic golden window of Patan Royal Palace, Nepal. The characterization techniques employed in the study provide the detailed information about the environmental pollutants responsible for the corrosion and degradation of gilded window. The analytical results have revealed that the window has been made of pure copper sheet on which traditional mercury-amalgam gilding technique has been used. Particulate matters like elemental carbon, sulphur dioxide, chlorine and organic matter have been found to be the main factors responsible for the corrosion and degradation of gilded surface. The information obtained from the present study is expected to be the source of understanding and solution for the protection and conservation of the gilded heritage of Nepal.

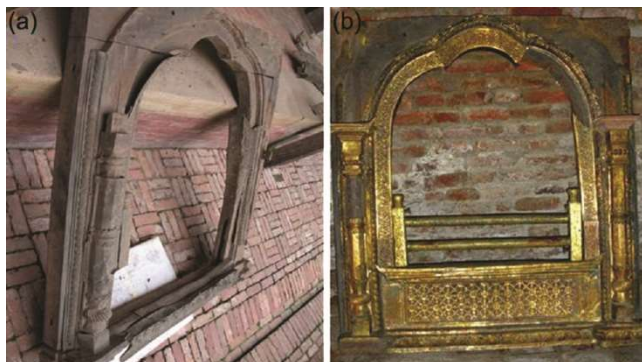
The surface layer presents various alterations, typically appearing as superficial formations and

encrustations due to both products of metal corrosion and exogenous materials. Photos of before and after conservation of 17<sup>th</sup> century gilded window from Royal Palace Patan, Nepal is shown in Fig. 2. Today Nepal's mountainous and challenging topography and socio-economy make it a highly vulnerable country to climate change. Degradation to the environmental qualities in the valley is seriously hampering the national economy particularly the tourism sector and damaging these invaluable archeological and heritage site.

Fig. 2 — Photos of 17<sup>th</sup> century gilded window from Royal Palace Patan, Nepal (a) before and (b) after conservation.

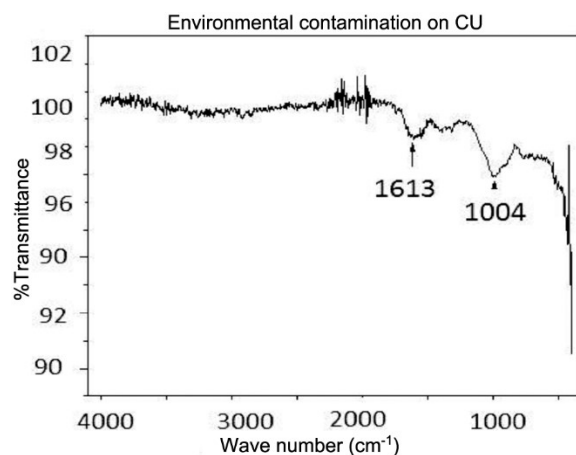
Fig. 5 — FTIR spectra of gilding sample showing C-C stretch and C-H bending.

Noise is observed in the data due to air gap. However, according to the standard IR frequency table, the peak at  $1613\text{ cm}^{-1}$  corresponds to C-C stretch and peak at  $1004\text{ cm}^{-1}$  corresponds to C-H bending on the surface of the sample. A little broadness can be seen in the higher side of wavenumber (i.e.,  $3500\text{--}3200\text{ cm}^{-1}$ ) which can be attributed to presence of moisture. Presence of large amount of carbonaceous material revealed in the SEM image and EDS spectra are confirmed by the existence of C-C stretch as depicted in FTIR spectra.

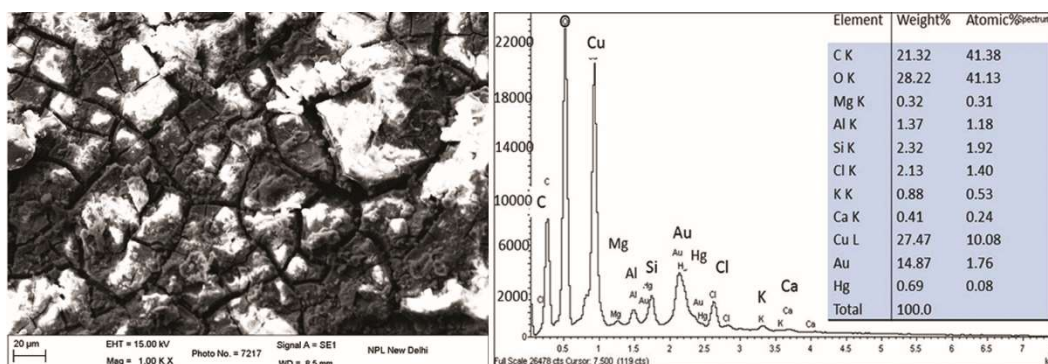
Scanning electron microscopy investigations can show the sample superficial texture at nanometric level, revealing shape and dimensions of particles that constitute the surface layer. Figure 4 represents the secondary electron (SE mode) SEM micrograph of the sample as procured from golden window of Patan Royal Palace, Nepal. The surface of the sample was not cleaned before putting into the scanning electron microscope (SEM) specimen chamber. SEM image revealed that the surface of the sample is composed of bright and some dark areas. The bright area in the micrograph represents the amount of dust particles containing carbonaceous compounds deposited as contaminants from the environment on the surface of the sample during the course of time. Large fraction of area of the sample consists of micro cracks throughout on the top surface of sample which may be developed

due to the exposure to varied atmospheric conditions over the years. As per the gilding process used in the Nepal in the ancient years are concerned, very thin layer of gold (Au) used to be deposited on copper sheets by a long and cumbersome gilding process<sup>7</sup>. Thickness of the Au gilding depends on the amount of Au available<sup>1</sup>. This is further to mention here that the initiation of micro and nano cracks on the gilding surface may be created due to the variation in coefficient of thermal expansion of Cu ( $16.6 \times 10^{-6} \text{ m/(mK)}$ ), Au ( $14 \times 10^{-6} \text{ m/(mK)}$ ), and Hg ( $61 \times 10^{-6} \text{ m/(mK)}$ ). If the body is constrained so that it cannot expand, then internal stress will be caused or increased by an increase in temperature resulting in the localized stress and the strain at the gilding surface which are evident from the SEM image.

Fig. 4 — SEM micrograph of the gilding sample without cleaning its surface and EDS spectra.

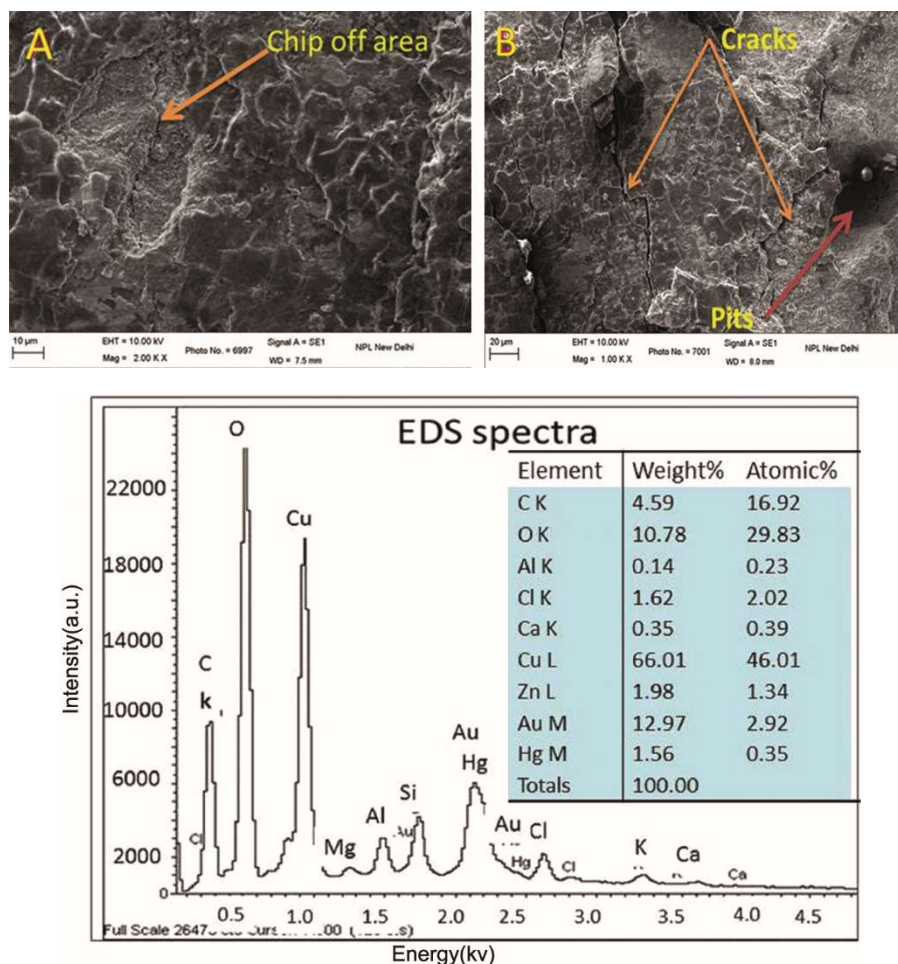
Prior to SEM imaging the same sample was cleaned in the acetone followed by the ultra-sonication to remove the environmental contaminants on the sample's surface. Images A and B shown in Fig. 6, represent the SE mode SEM micrographs of the cleaned gilded sample. SEM image marked as A shows the chipped off areas at certain places in the sample which may be due to the exposure to different atmospheric conditions during time. SEM image

marked as B revealed the presence of micro and nanocracks along with the evidence of pits at some places which are clearly indicated in the image. These pits may have been created due to the reaction of chloride or sulphate ions present in the environment as pollutant after forming the acids. The figure also shows the elemental compositional details of the corresponding areas of the sample.

Presence of various elements is depicted in the table shown as an inset of EDS pattern and also marked on the spectra peaks corresponding to different energies. Presence of elements like C, O, Si, Cl, Ca may be due to contaminants present in the atmosphere and the elements such as Mg, Al, K are expected due to the impurities in the copper sheet used for the gilding process. However, the presence of Au and trace amount of Hg proves that mercury-amalgam process was used in the making of golden window. This is further to be noticed here that the high amount of C in the EDS spectra still persists even after

Fig. 6 — SEM images (A and B) of the chip off area and the EDS spectra of the corresponding area of the cleaned sample.

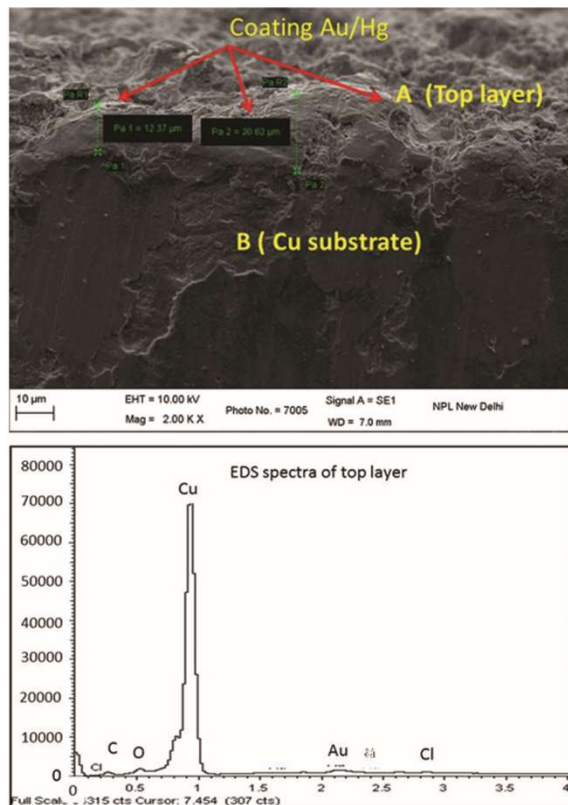
An effort has been made to identify the thickness and the uniformity of thin layer of Au coating during the gilding process (Fig. 7). Cross sectional SEM image as depicted in Fig. 8 clearly revealed that the gilding layer is not uniform. Thickness of the gilding layer is found to vary between 12 to 20 micrometers. Presence of Hg is not revealed in the EDS spectra (Fig. 7) as expected as per the traditional gilding technique in the Nepal is concerned, since the Hg was supposed to be sublimed during the repeated heat treatment.

Fig. 7 — SEM image of cross sectional view and the EDS spectra of same area.

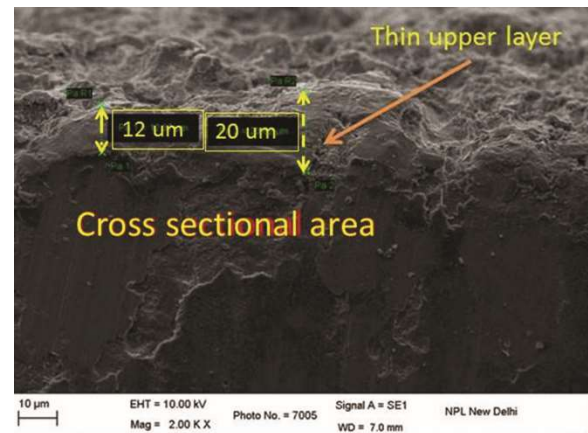
Fig. 8 — SEM image of cross sectional view of the sample indicating the variation in thickness.

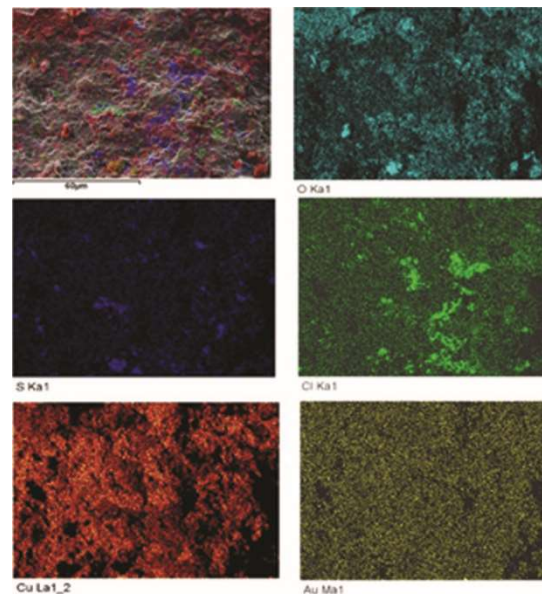
X-ray mapping of gilded sample is presented in Fig. 9. Distribution of various elements like oxygen, sulphur, chlorine, copper and gold has been revealed in the mapping originated from different energy levels of the element present in the sample. It is evident from

the X-ray mapping images that a sufficient amount of sulphur and chlorine is present on the top surface which is responsible for the initiation of corrosion and degradation (chipped off) of the gilded surface during the course of time.

Fig. 9 — X-ray mapping of gilding sample showing maps of different elements.

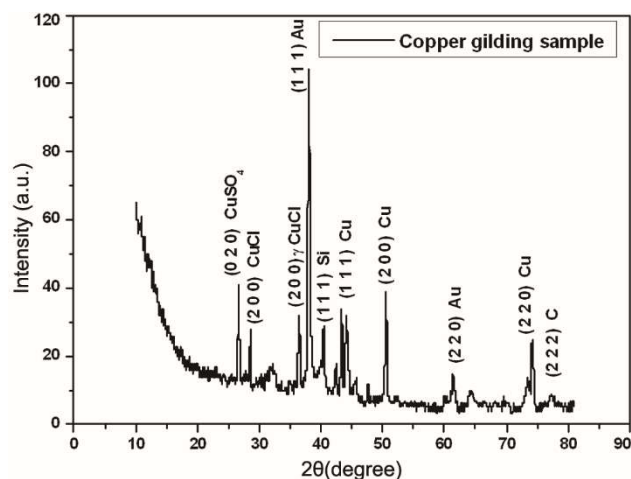
X-ray diffraction technique was used to further characterize the gilded sample for the identification of various elements and the different phases of the compounds present in the sample. A typical diffraction pattern of the gilded sample has been shown in Fig. 10. From the XRD data it is observed that the sample mainly composed of copper and gold present due to gilding process used in ancient times in Nepal. Diffraction peaks oriented along (111), (200), (220) direction found to be of copper matching with the

Fig. 10 — XRD pattern of the gilding sample showing various elements on the surface.

standard data JCPDF file No. 892838. However, the peaks of Au oriented along the (111) and (220) direction are found to be in good agreement with standard data of JCPDF file No. 893697. Presence of carbon and silicon reflection peaks in the diffraction pattern may be in the form of contaminants from the environment. Detailed analysis of the diffraction data also revealed the existence of  $\text{CuSO}_4$  (JCPDF file No. 721248) along (020) plane,  $\gamma$  CuCl (JPDF file No. 811841) along (200) plane and CuCl (JCPDF file No. 822117). Presence of  $\text{CuSO}_4$  and CuCl phases in the diffraction pattern may be due to the presence of sulphate and chloride ions as contaminants from the environment and responsible for the corrosion or degradation in the form of pits on the surface of the gilding sample.
