Rapid Repair of Severely Damaged RC Columns with Different Damage Conditions: An Experimental Study

Ruili He¹⁾, Lesley H. Sneed^{1),*}, and Abdeldjelil Belarbi²⁾

(Received December 31, 2012, Accepted February 13, 2013)

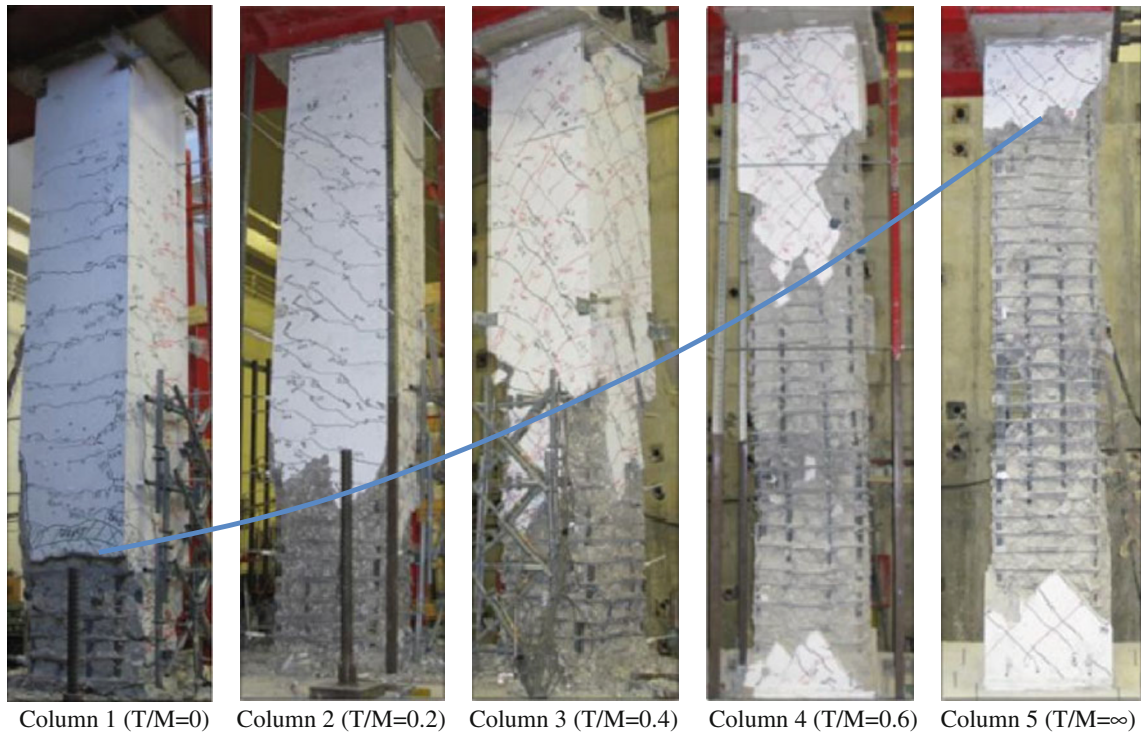
Fig. 2 Damage conditions of the original columns after previous tests.

The damaged columns after the original tests are shown in Fig. 2, which illustrates the difference in the visible damage extent and the plastic hinge location. Generally, the damage region extended farther along the column height and the plastic hinge location shifted away from the base with increasing torque-to-moment ratio. For instance Column 1, which was tested under cyclic shear and bending, sustained cover concrete spalling 25 in. (635 mm) above the column base, and the plastic hinge was located approximately 10 in. (260 mm) above the base. Column 5, which was subject to cyclic torque moment, exhibited concrete damage that extended almost the entire column length, and the core concrete crushed through the cross section 64 in. (1,620 mm) above the column base. The damage to Columns 1, 2, and 3 was concentrated near the base of the column at the location of maximum moment due to flexure-dominant behavior in columns with low T/M ratios ($T/M < 0.5$). Columns 4 and 5 were torsion-dominant with high T/M ratios ($T/M > 0.5$), which resulted in higher plastic hinge location and larger damage extent as illustrated in Fig. 2.

A detailed description of the damage to the original columns is summarized in Table 1. Damage to each column included concrete cracking, cover concrete spalling, and core concrete crushing, as well as longitudinal reinforcement yielding. Damaged ties failed by yielding and, in some cases, subsequent straightening of the end hooks. Additionally, longitudinal bars buckled in Columns 1–4, and two longitudinal reinforcing bars fractured in Column 1 near the base of the column at the northwest and southeast corners of the cross-section (see Fig. 1).

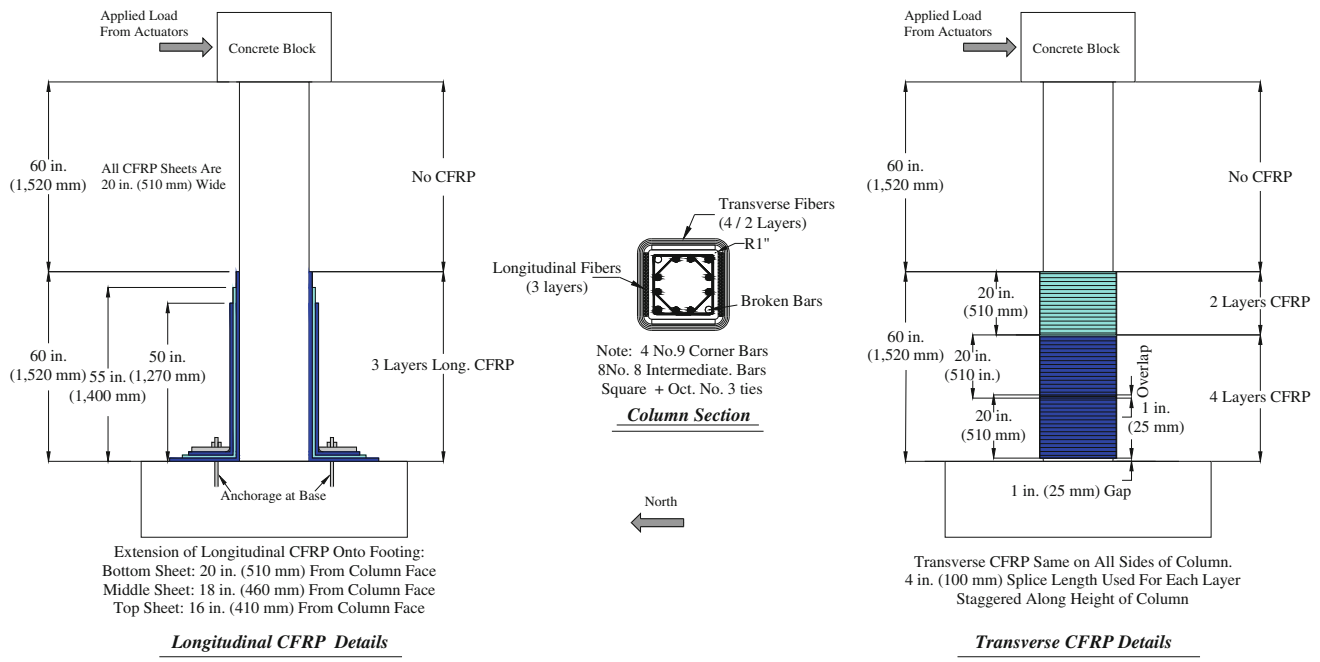
Fig. 4 CFRP layout for Column 1-R.

The failure modes of the repaired columns are summarized in Table 3. Column 1-R experienced premature failure due to the detailing of the anchorage system used to anchor the longitudinal CFRP sheets to the base of the column (Grelle 2011). During testing, the top of the quarter-pipe section of the anchorage system came into contact with the CFRP system, which led to CFRP rupture on both the south and north sides of the column due to the bearing of the corner of the anchorage

The measured lateral load and displacement in Column 1-R did not reach that of Column 1, which is due to premature failure associated with longitudinal CFRP anchorage as discussed in the previous section. A moment–curvature analysis of the repaired cross-section confirms that the lateral load associated with the predicted moment capacity after failure of the longitudinal CFRP was close to the peak lateral load measured during the test. It must be noted that anchorage of externally bonded longitudinal CFRP sheets is a crucial issue to ensure that the tensile force can be developed at the critical section. When the plastic hinge is located near a joint, the situation is even more complicated by the interaction between the column and the anchorage system, which was the situation of Column 1-R. Therefore careful attention must be paid to detailing of both the FRP and its anchorage system.

The CFRP layout for each repaired column is shown in Figs. 4 to 8. Repaired columns are denoted in this paper with the extension “-R”. The CFRP layout for each column was designed and detailed considering the nature of damage to the column, the damage location, and the peak applied loading. As a result, each column had a different repair region and CFRP layout. To maximize the time efficiency, only the regions of the column at and adjacent to the plastic hinge were repaired. Adjustments were made to the designs based on lessons learned during testing of previous repaired columns within the series as discussed below. (Repaired columns were repaired and tested in sequential order from Column 1-R to 5-R).

For Columns 1-R, 2-R, and 3-R, the repair regions were located in the lower half of the columns since the damage

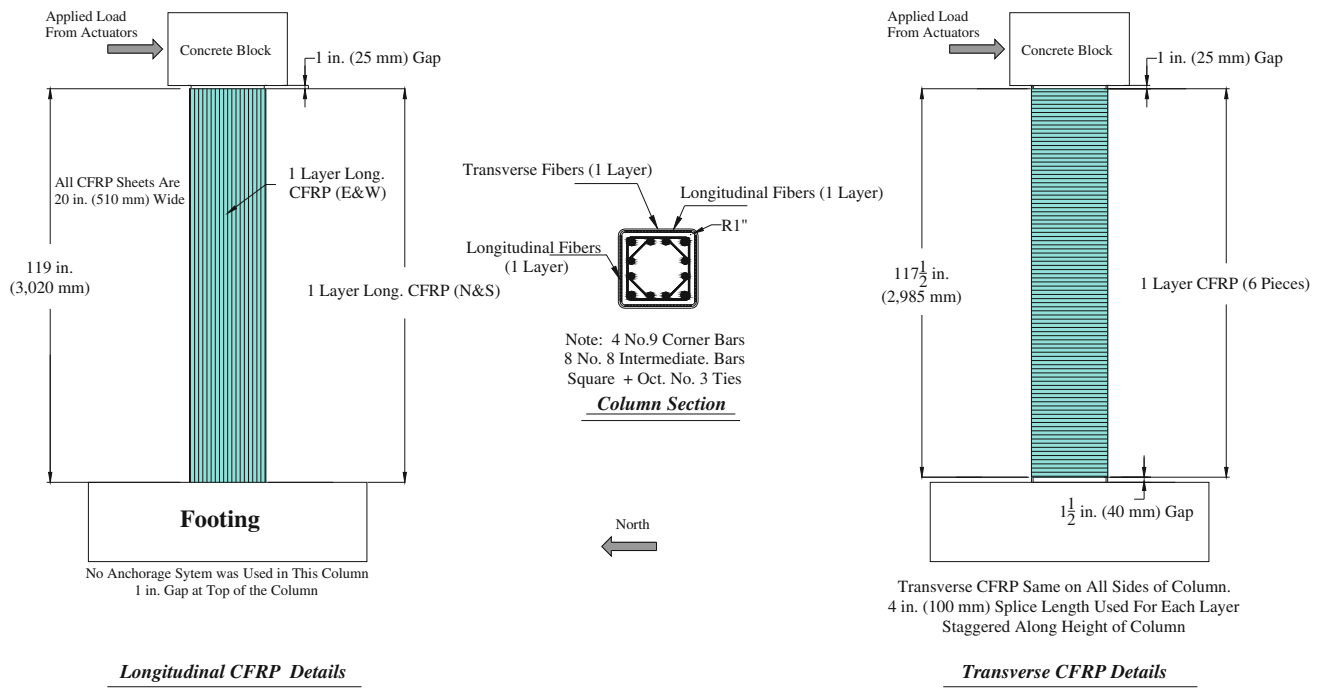
Fig. 8 CFRP layout for Column 5-R.

crushing in the unrepaired region followed by CFRP rupture near the unrepaired region. The failure mode of Column 5-R was rupture of the CFRP. Rupture of the external CFRP on Column 5-R first occurred at the south-west corner of the column approximately 65 in. (1,650 mm) above the column base, which coincides with the interface of the unrepaired concrete and the newly placed repair mortar. Rupture progressed to the upper west side of the column, and then to the lower south side. Finally, the ruptured CFRP peeled away with a thin layer of concrete bonded underneath, and crushed mortar fell out.

For Columns 4-R and 5-R, the repair regions extended along most of the column length. Column 4 was repaired along most of its height except for the top 12 in. (305 mm) because of lack of damage in the top region as well as difficulty of applying formwork and placing the repair mortar along the full height of the column. However, shifting of the plastic hinge location of Column 4-R prompted the full height repair of Column 5-R.
