On the breakage of rock drill steel

Muir Luken Frey

MASTER OF SCIENCE IN METALLURGY

1923.

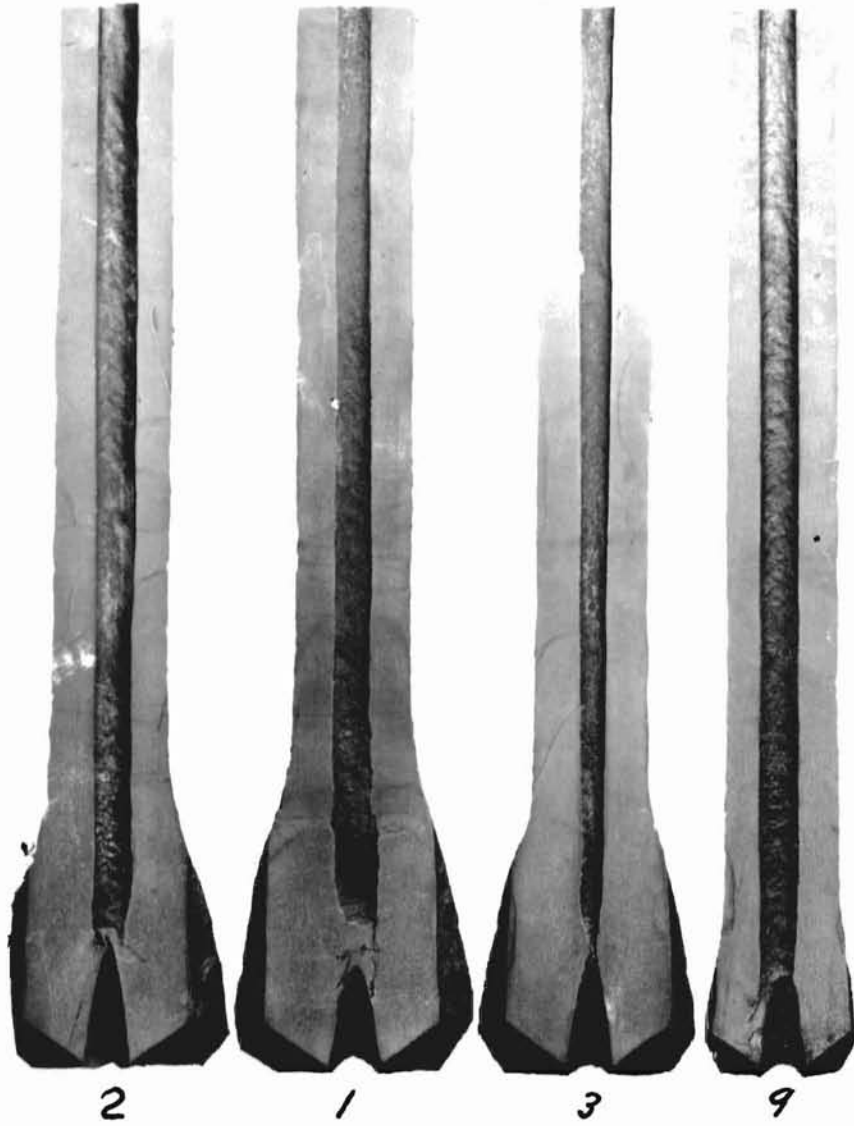
FIG. 2.

Bits 1, 2, 3, and 9. Macro etch, 7/10 actual size.

In bit No. 1 there are numerous crack areas a considerable distance above the metallurgical break but the deepest cracks occur in that latter region. Area No. 6, which is in the region of structural change, has the deepest cracks, two of which are 1.848 and 1.344 mm. deep and can be seen easily with the unaided eye.

In bit No. 2 there is apparently little relation between the cracks and the metallurgical break. This may be considered a relatively good piece of drill steel.

Bit No. 3 is very similar to No. 2 in that it has few cracks and may be considered relatively sound. Such unsoundness as exists is in the region of metallurgical break.

A similar condition to that of bit No. 7 is found in bit No. 9. There are few deep cracks in any portion of the specimen. The deepest one, 0.924 mm., is distinctly in the as-rolled section. The bit may be classed as passable.

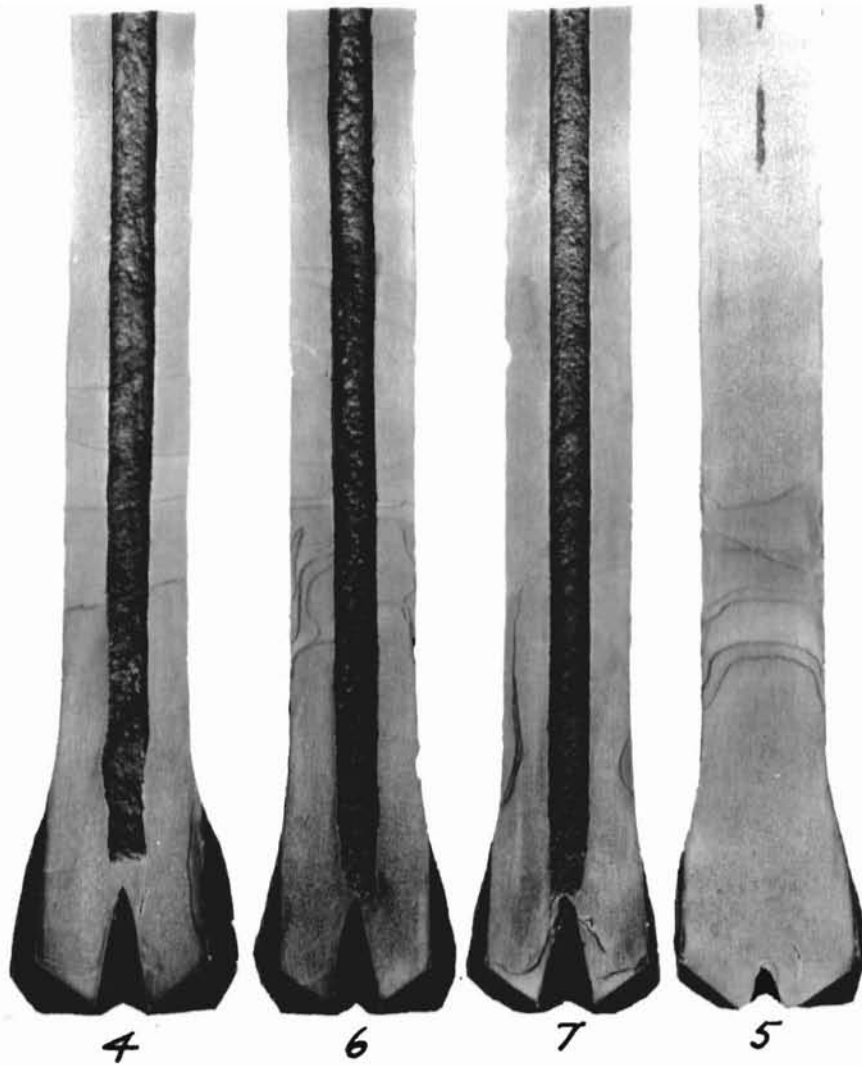
FIG. 3.

Bits No. 4, 5, 6, and 7. Macro etch, 7/10 actual size.

In bit No. 4 is found once more the semblance of a relation between the metallurgical break and the area of most cracks. However, the deepest cracks occur just beyond the region of structural change.

In bit No. 5, the worst condition with respect to cracks is in the region of structural change. There are five zones embracing areas in which there are numerous cracks, and four of these five zones are in that region. Practically all of the deepest cracks, also, are in this region. The bit is relatively in very poor condition. It may be cited as the poorest of the lot.

Bit No. 6 is poor but not as poor as No. 5. Here, too, the region of deepest and most numerous cracks coincide with the region of structural change.

As regards cracks, No. 7 is a fairly good specimen. There seems to be no connection between the metallurgical break and the location of the deepest crack. However, there are numerous small and incipient

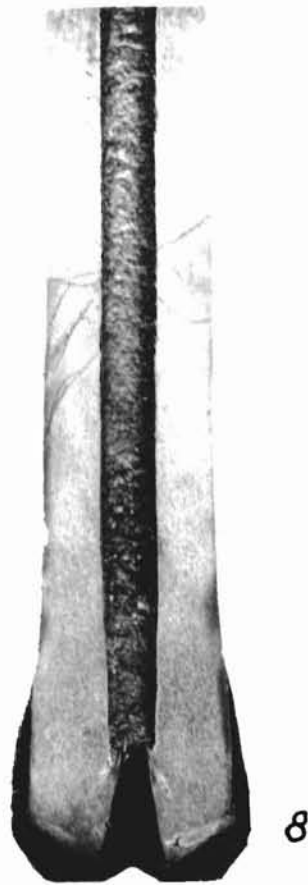
FIG. 4.

Bit No. 8. Macro etch, 7/10 actual size.

The most serious cracks in bit No. 8 are, generally speaking, not within the region of structural change, but are in the as-rolled section of the bar. The bit would be classed as poor.

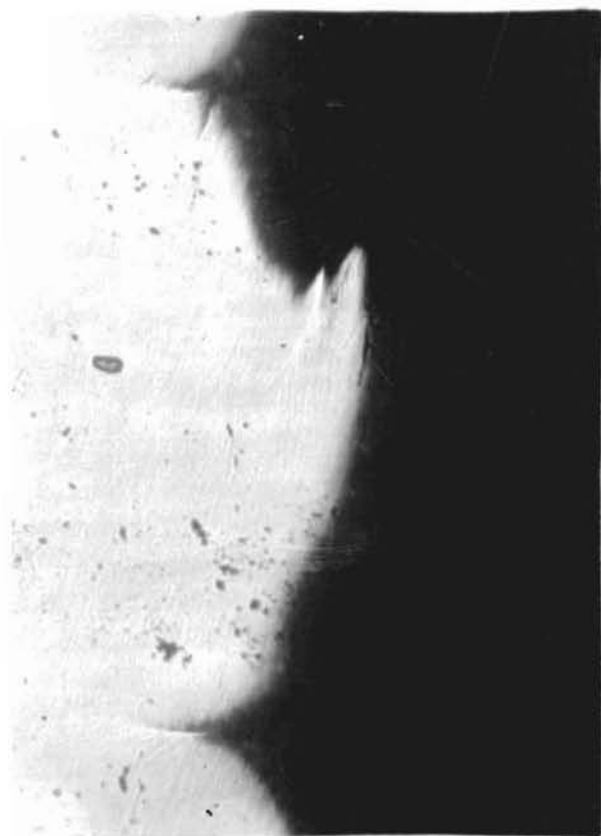
FIGURE 5.

Representative Cracks from Bit No. 1.
X 140.

Figure 5 shows two shallow cracks from bit No. 1. These two cracks are representative of one of the two classes found -- the first being those not filled with any foreign material. A deeper crack of the same class is illustrated in Fig. 6, with both an unetched and an etched view.

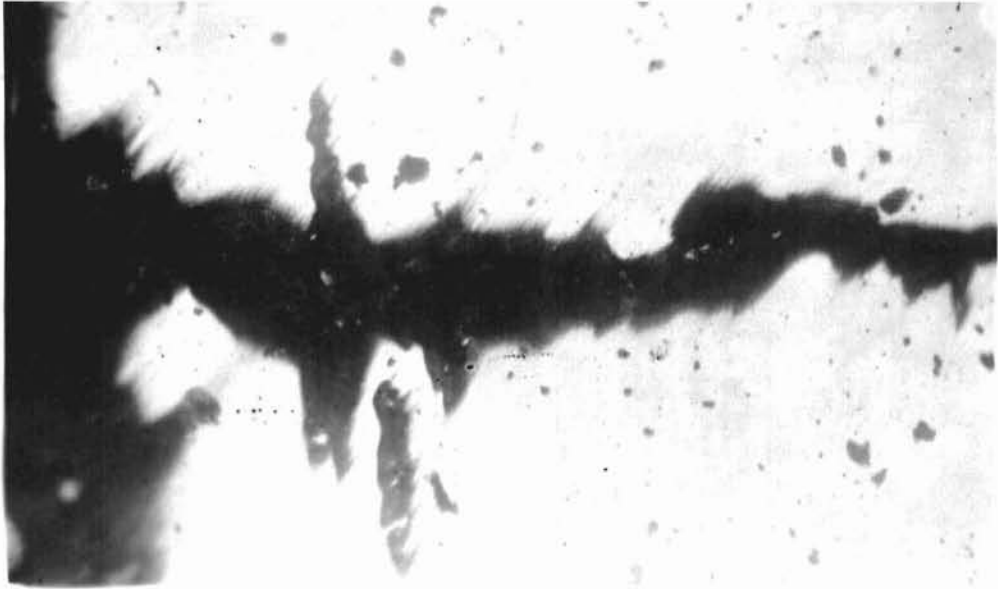
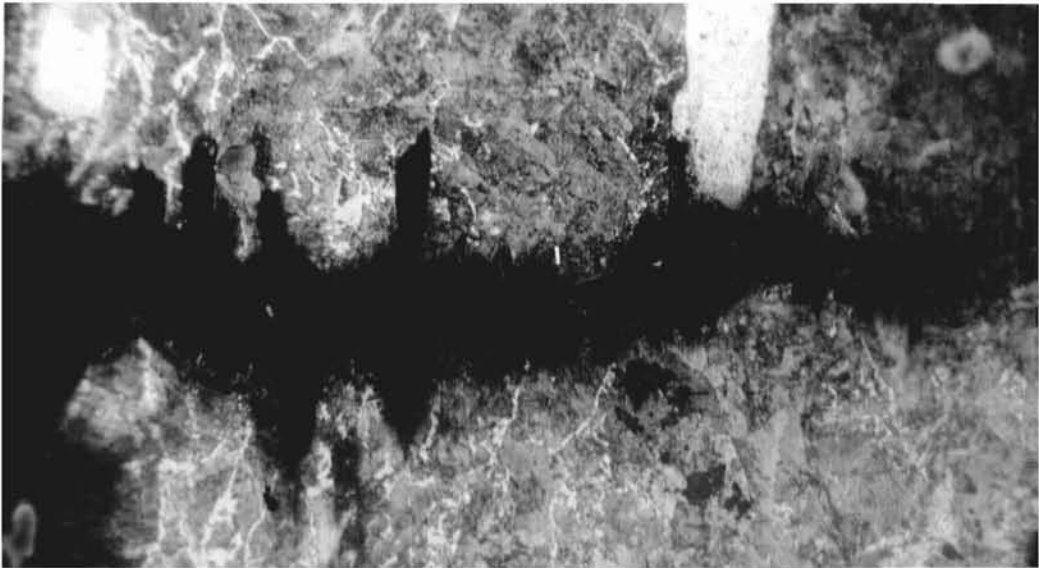
FIGURE 6.

- A -- Deep crack from Bit No. 9, X 140, unetched.
B -- View of same crack etched, X 140. Etched with
10% HNO_3 in Amyl Alcohol.

crack might have grown with subsequent service of the steel. The etched view shown in Figure 6 illustrates this point.

Figure 6 shows, in addition to the crack at right angles to the direction of rolling of the bar, several lateral cracks extending

from the larger one at right angles, parallel to the direction of rolling. Such additional defects, though not common, are worthy of mention since they seem to show the action of another deteriorating factor. The presence of these cracks is most probably due to the corrosive action of mine water. Once admitted to the unprotected surface of a crack, the water will very readily attack certain segregated portions of the steel.

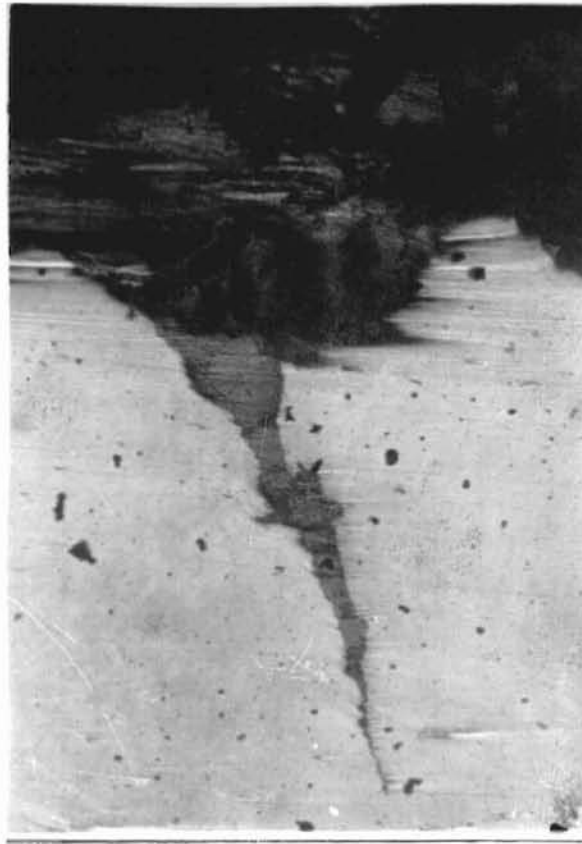
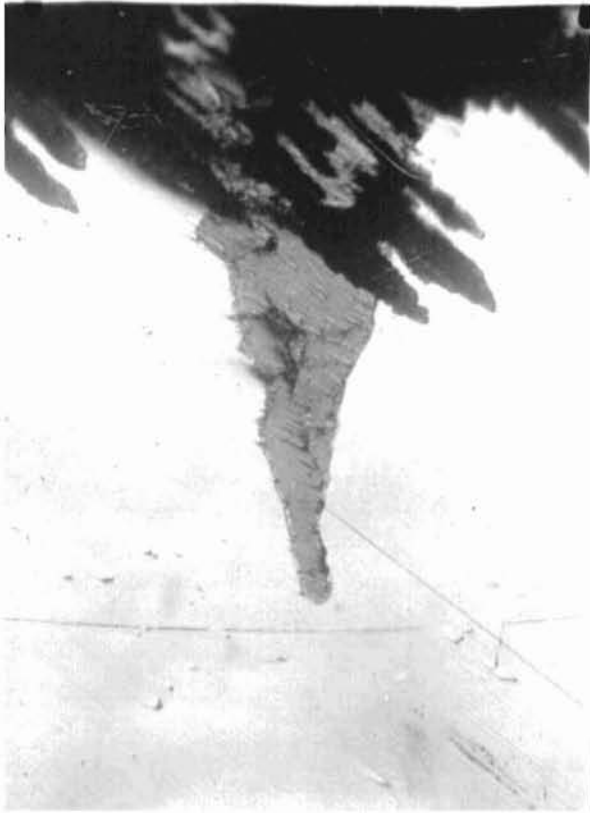
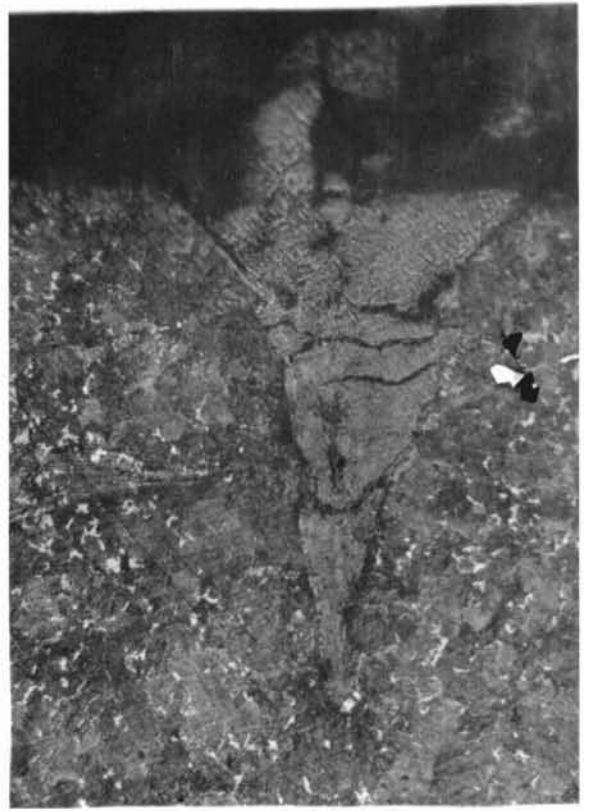
FIGURE 7.

A and B -- Two cracks from Bit No. 9, X 140.
C -- Etched view of B, X 140. Etched with 10%
HNO₃ in Amyl Alcohol.

The second class of crack, that filled with some foreign material, is illustrated in Fig. 7. The foreign substance may be either iron oxide, rock dust, or dirt and sediment from mine water. In all probability, rock dust and sediment is the filling material in most cases, since as will afterward be shown, such cracks form after the steel has been put into service. Such filled cracks are slightly more prevalent in the region heated for working and so the oxide filling, when such is present, could come from a slight oxidation of the steel when it is heated.

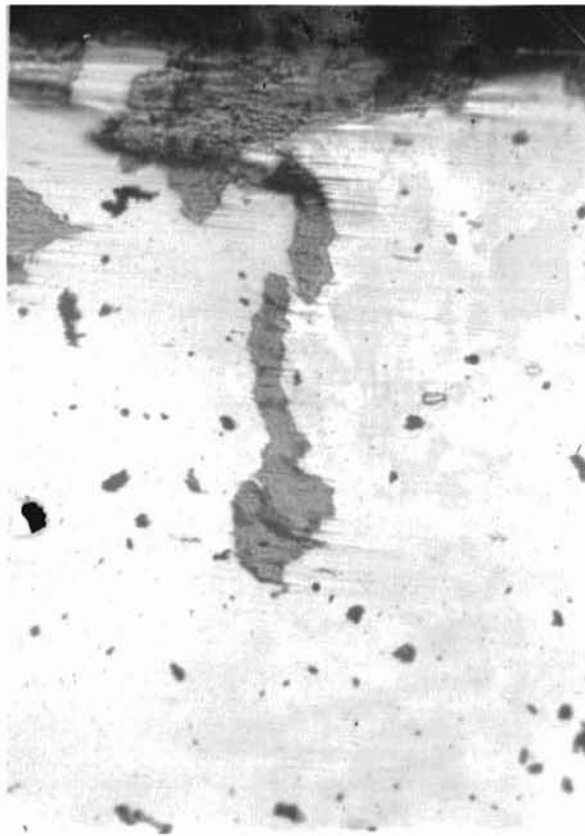
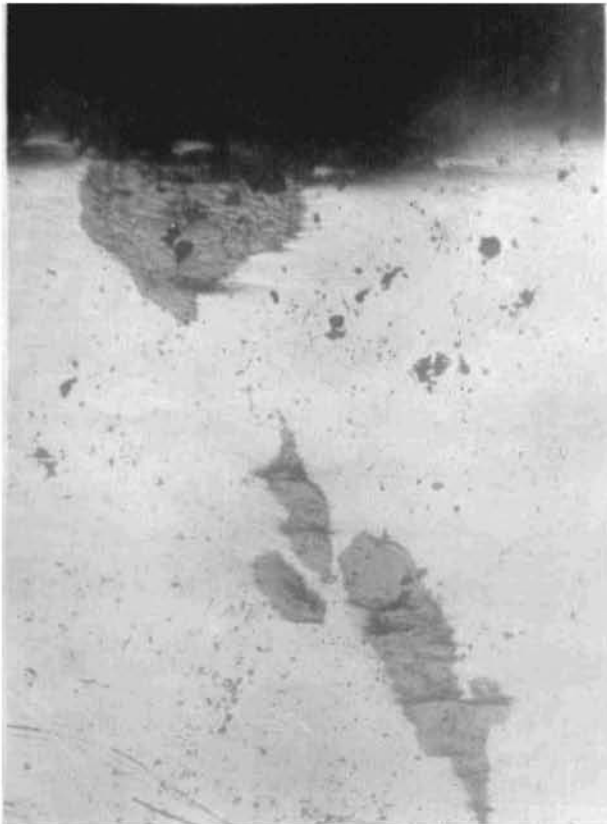
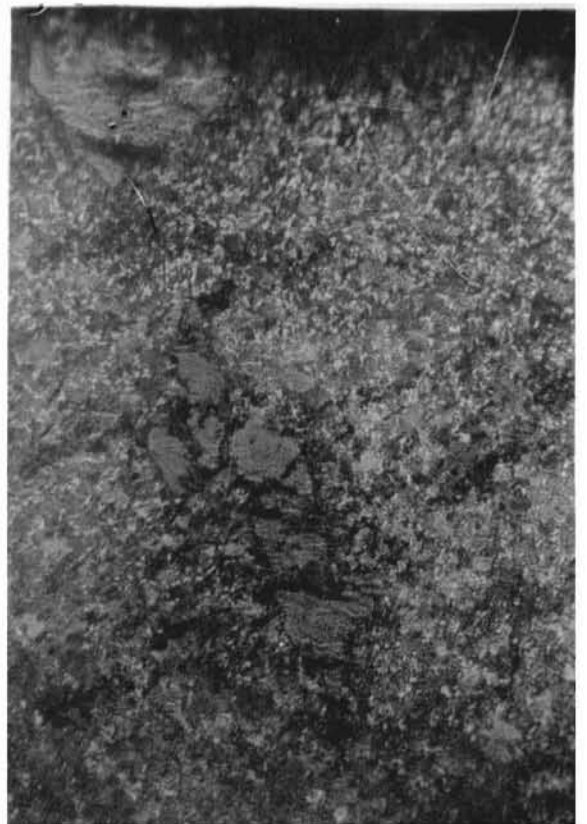
FIGURE 8.

Figure 8 shows what are apparently inclusions near the edge of the steel, but which undoubtedly are cracks. In the first place, these "inclusions" are elongated at right angles to the direction of rolling of the bar. Any inclusion in the steel would necessarily show elongation in a direction parallel to that of rolling. Second, cracks in steel almost invariably follow a tortuous path. From these two facts it seems logical to conclude that what may at first sight appear to be inclusions are, in reality, cracks

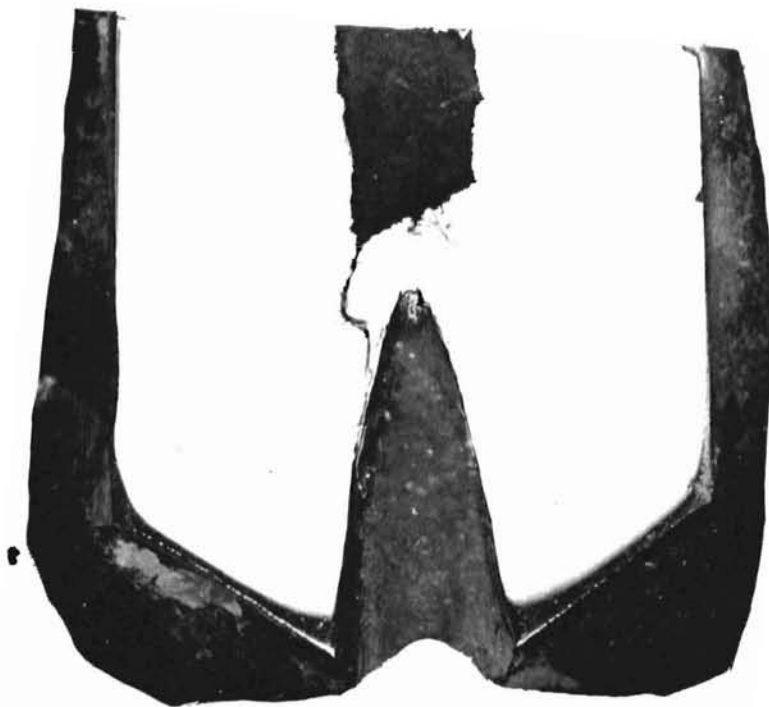
FIGURE 9

Bit No. 1 as polished.

half-sections of the different bits. Figure 9 shows bit No. 1. In this case the water hole is completely plugged with metal forced into it during the process of upsetting and shaping the bit and punching the water hole. This bit shows no cracks that may be considered of a very serious nature. Figure 10 shows bit No. 2, the water hole of which is also completely plugged. This bit has one large crack which would undoubtedly in time cause rupture. Figure 11 shows bits Nos. 4 and 5. The water hole of No. 4 is not completely plugged, but there are no doubt some cracks which would in time become detrimental to the bit. It is impossible to tell from the photograph of No. 5 whether or not the water hole was closed, but some cracks of a serious nature are in evidence.

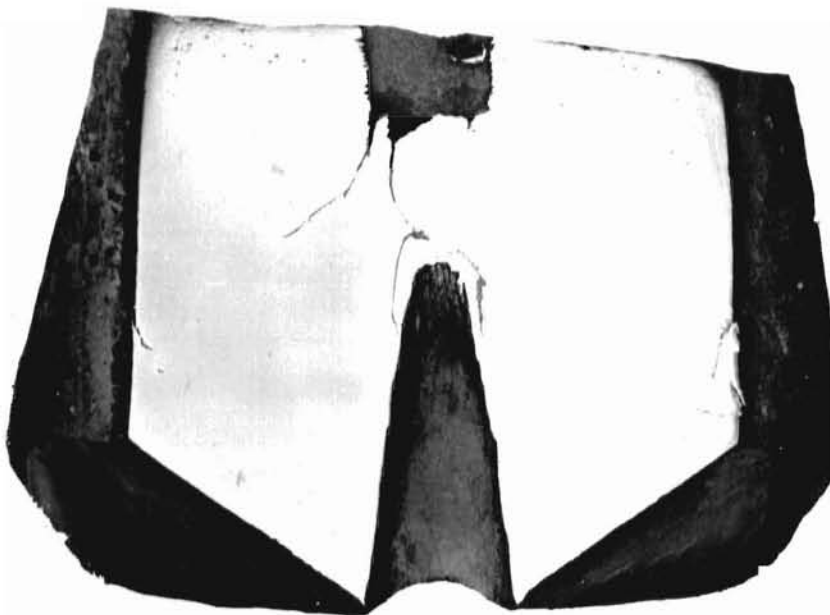
FIGURE 10.

Bit No. 2 as polished.

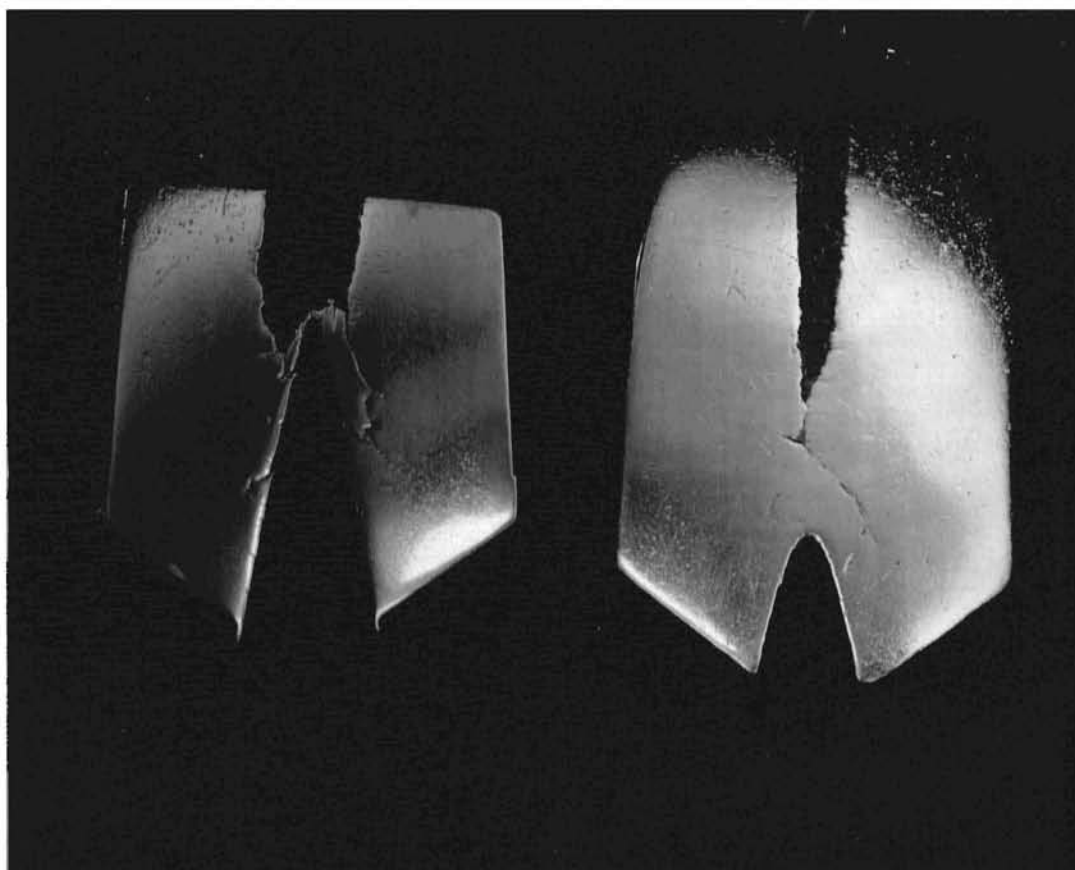
FIGURE 11

Bits No. 4 and 5 as polished.

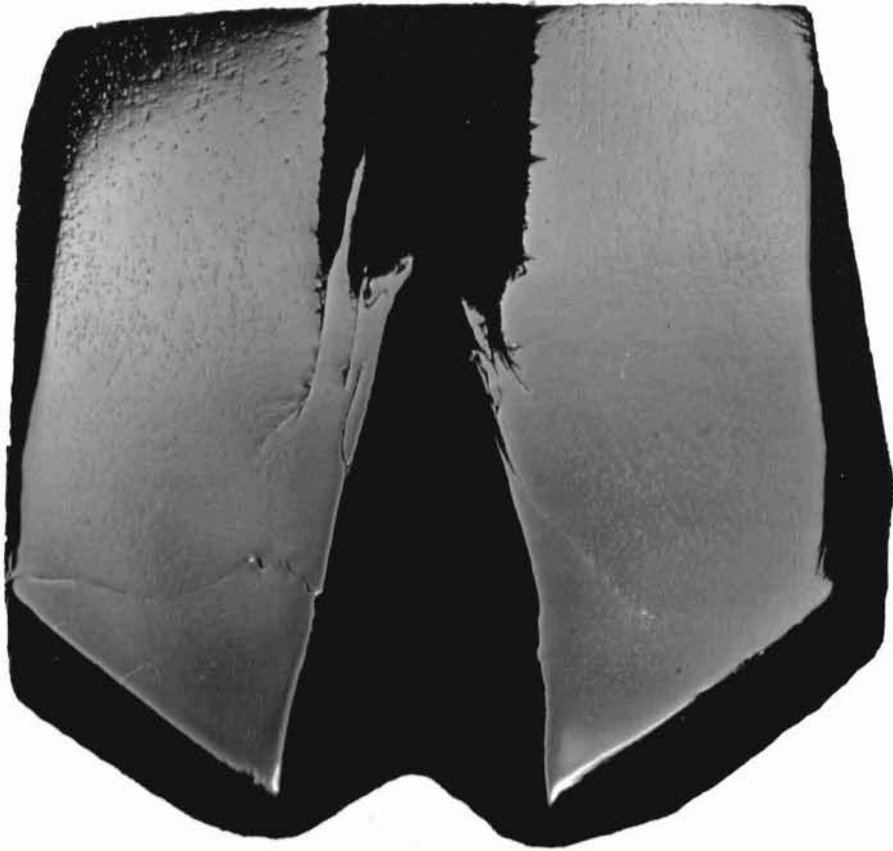
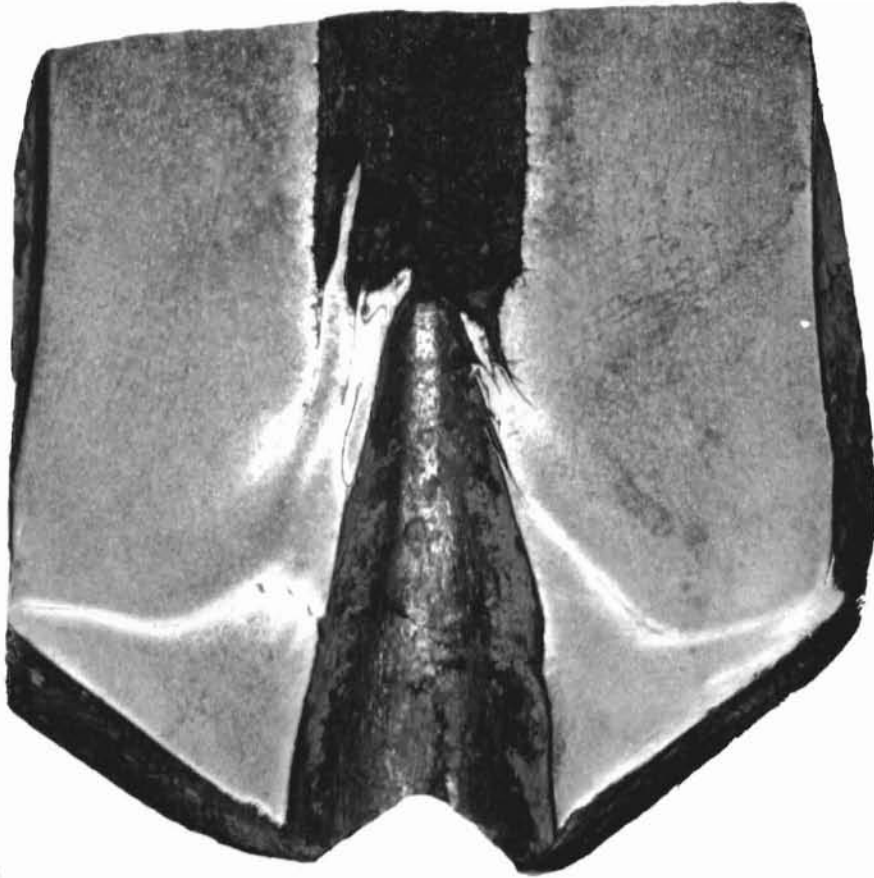
FIGURE 12.

Bit No. 7 as polished.

Bit No. 7, etched with 10% HNO_3 in Amyl Alcohol.

Figures 12 and 13 respectively show unetched and etched views of bit No. 7, which ^{bit} may be considered worthless from the start. In this bit the water hole remains open but there are cracks extending entirely through each wing of the bit. The white on the photograph of the specimen etched shows that there is decarburization all along the crack. The microscope showed that in general the crack was filled with oxide.

That in itself, is a defect of some consequence in the method but there is another still more potent. The punch, being of the shape it was, had a tendency to carry up with it tongues of metal which, upon subsequent heating, were decarburized and later oxidized so that they would not weld to the walls of the water hole. Upon a second upsetting or sharpening of the bit, these cracks which at first were in the form of an inverted V with nearly vertical legs, spread, increasing the angle between the legs of the V. This process continued until the extreme case illustrated in Figures 12 and 13 was the result.

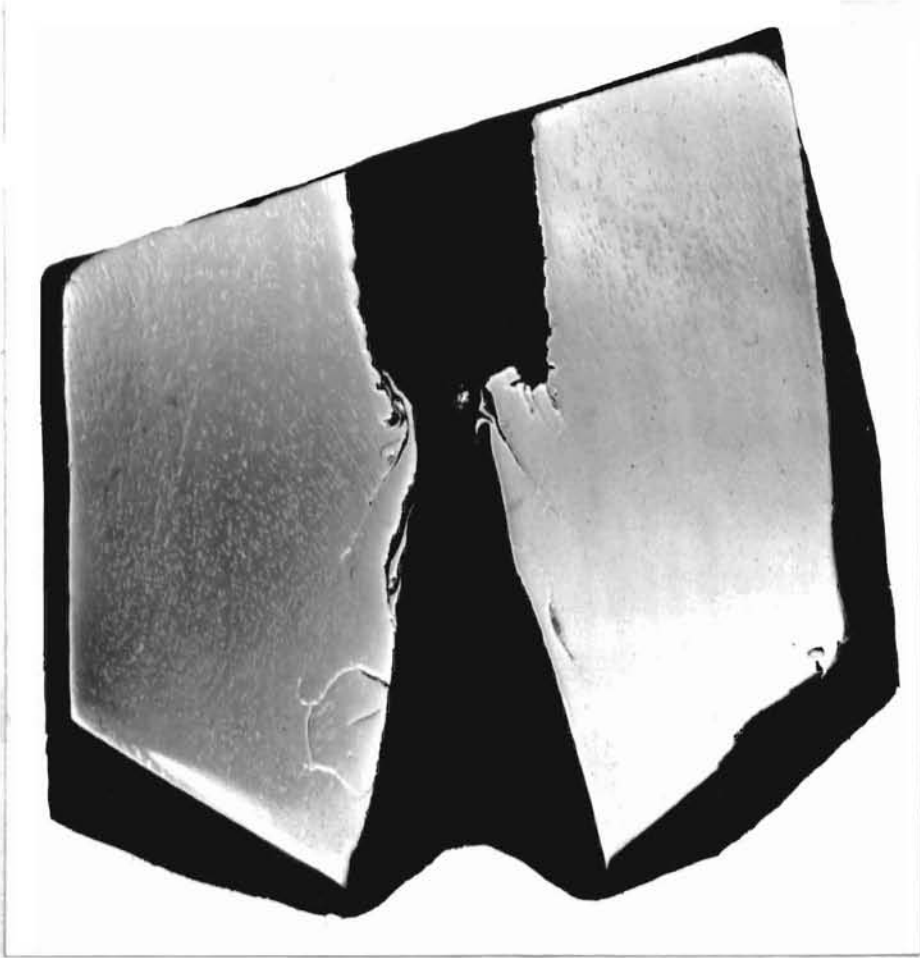
FIGURE 14.

Bit No. 8 as polished.

Figure 14 shows bit No. 8. The water hole in this bit is not plugged but there are cracks which, with another upsetting of the end, would produce the condition shown in Figures 12 and 13. There is also a large defect near the lower end of the bit.
