Merepoint Boat Launch Facility Eelgrass Mitigation Measures: Final Project Assessment

MER Assessment Corporation

18 December 2013

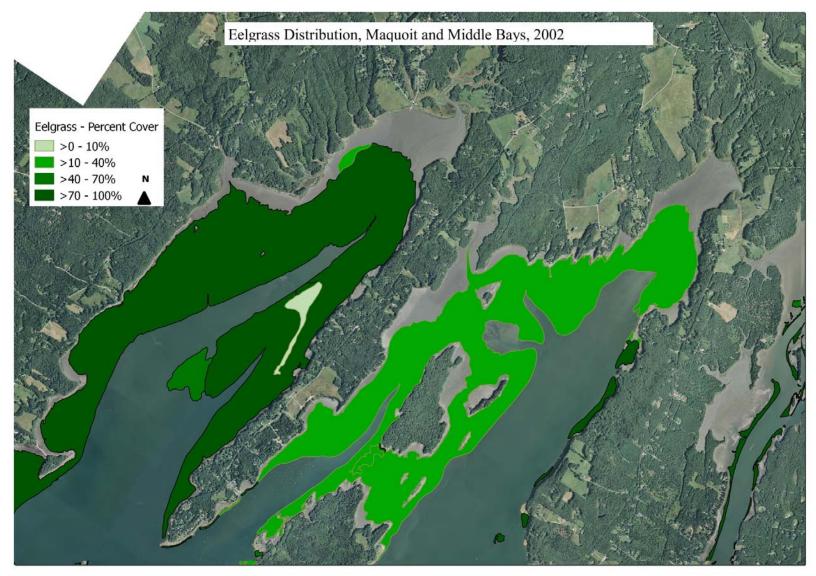
Figure 3. 2013 Sewall aerial photo Maquoit Bay and Middle Bay area in 2013 showing photo-interpreted eelgrass distribution in 2002 per Seth Barker (formerly with Maine DMR).

The most striking results were those of the aerial photography of Maquoit, Merepoint and Middle bays done by Sewall Company with photo-interpretation by Seth Barker, formerly of the Maine DMR conducted as a collaborative effort between the CBEP and the Maine DEP. The comparison of coverage between the dense and expansive meadows seen in 2002 and the limited eelgrass observed in Maquoit Bay and essentially barren condition of Merepoint and Middle Bays seen in 2013 clearly shows the catastrophic loss that has occurred.

The video monitoring at the mooring scars and vicinity of Simpson Point revealed a near catastrophic loss of eelgrass in Maquoit Bay and Merepoint Bay. These observations were confirmed by aerial photography conducted by Sewall Company as part of a collaborative effort by the Maine DEP and DMR and Casco Bay Estuary Partnership (CBEP) with photo-interpretation of eelgrass distribution done by Seth Barker, formerly with the Maine DMR.
