## Casco Bay Stream Barrier Surveys (2010 State of the Bay Presentation)

Alex Abbott  
*U.S. Fish and Wildlife Service*

Alex Abbott  
U.S. Fish and Wildlife Service  
Gulf of Maine Coastal Program

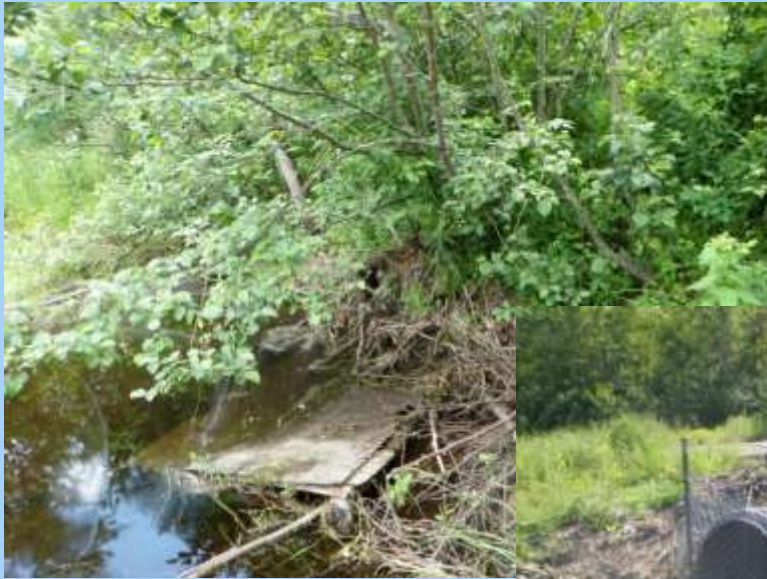
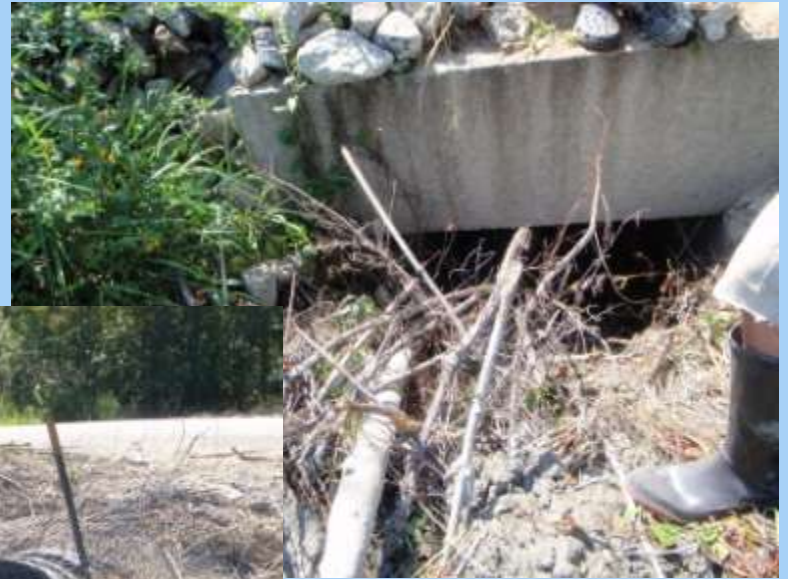
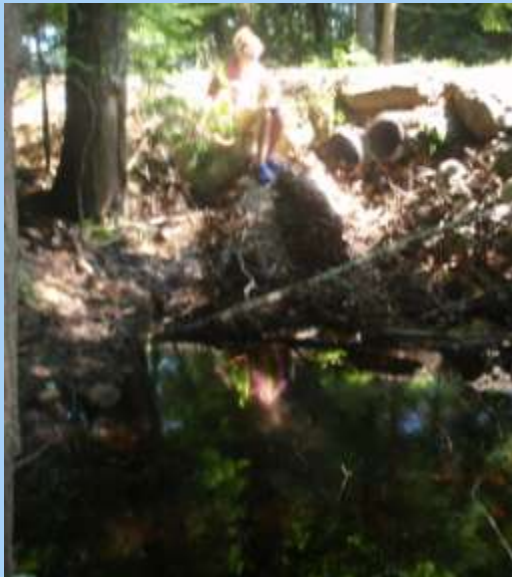
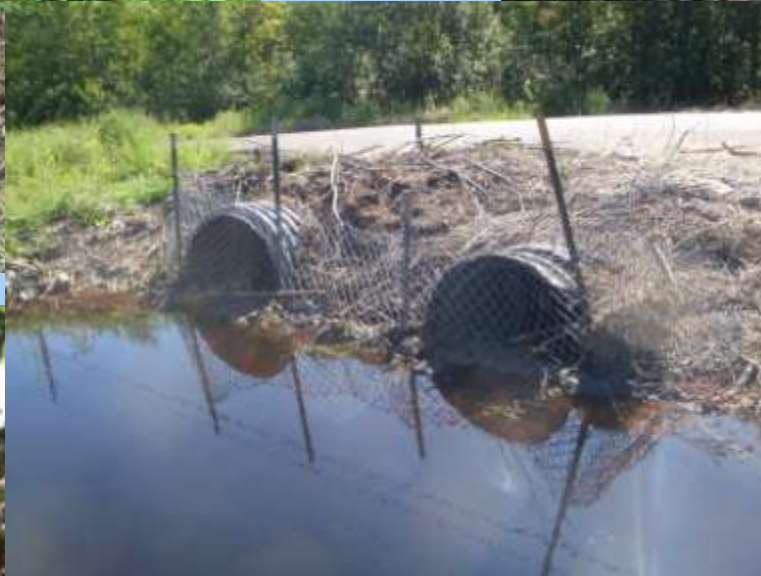
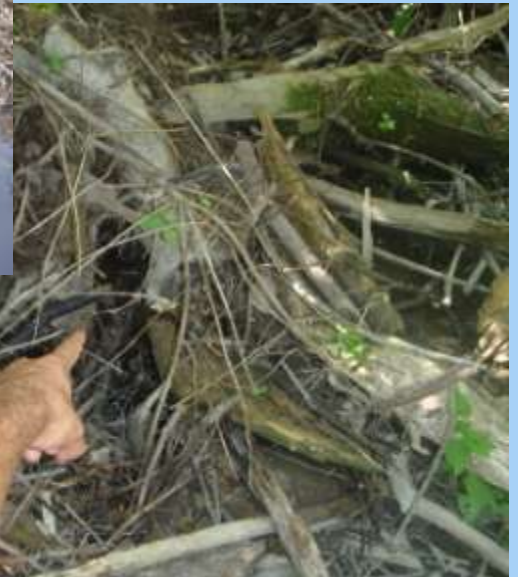
# 64 Blocked Inlets

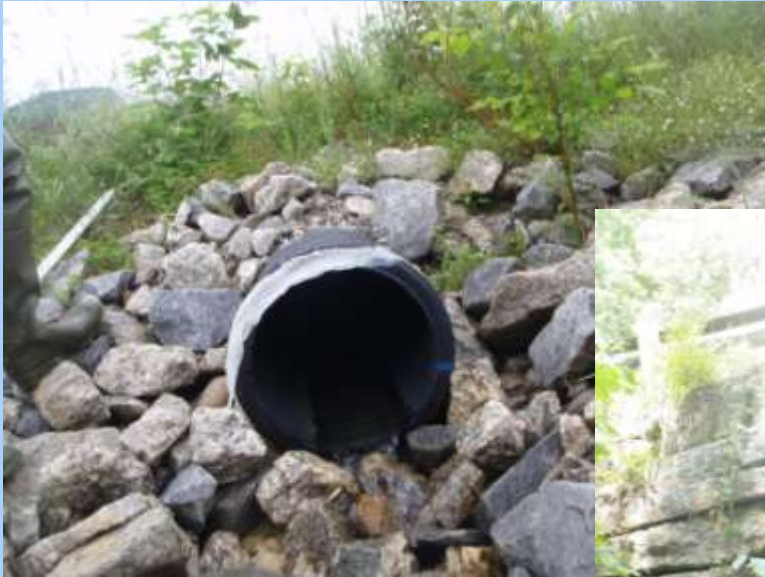
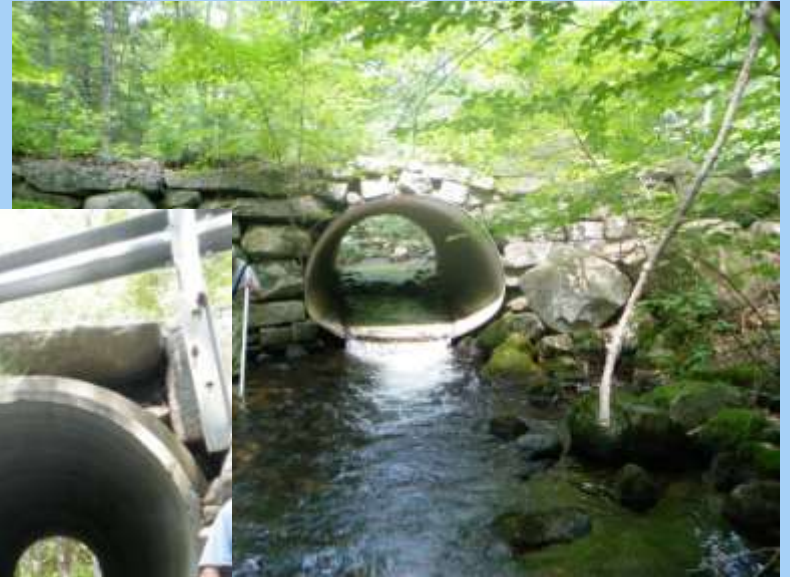
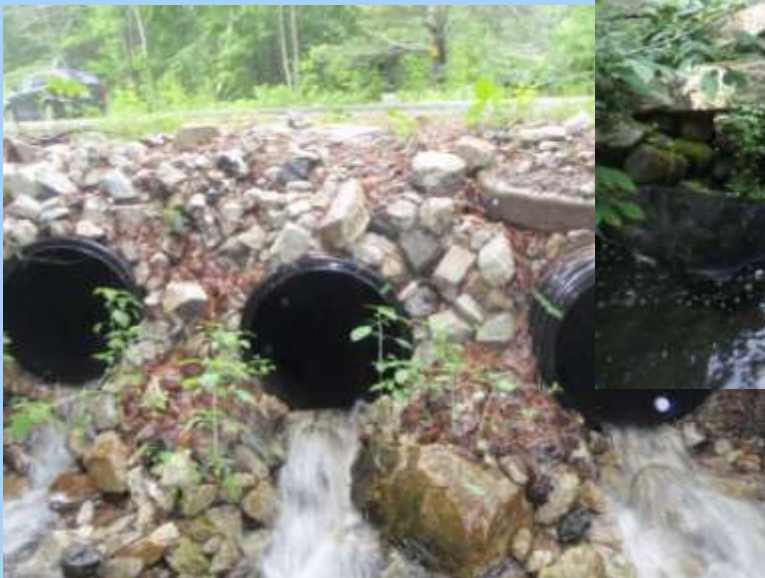
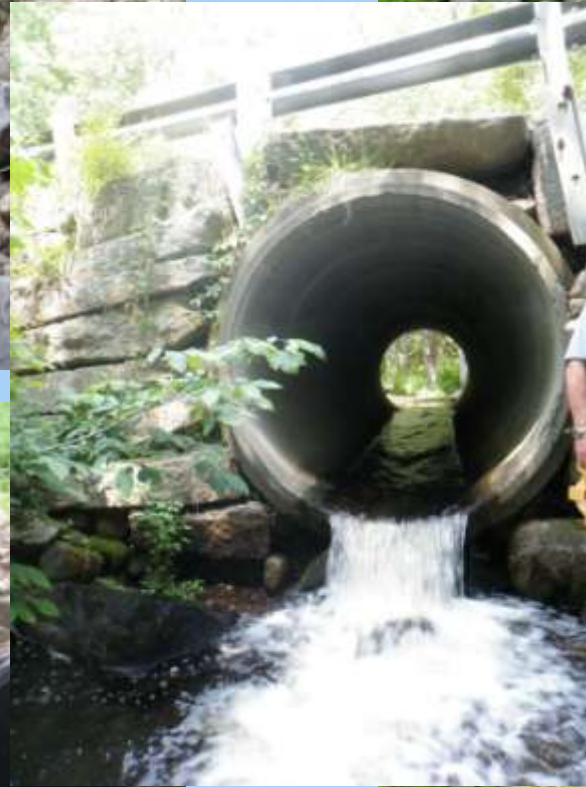
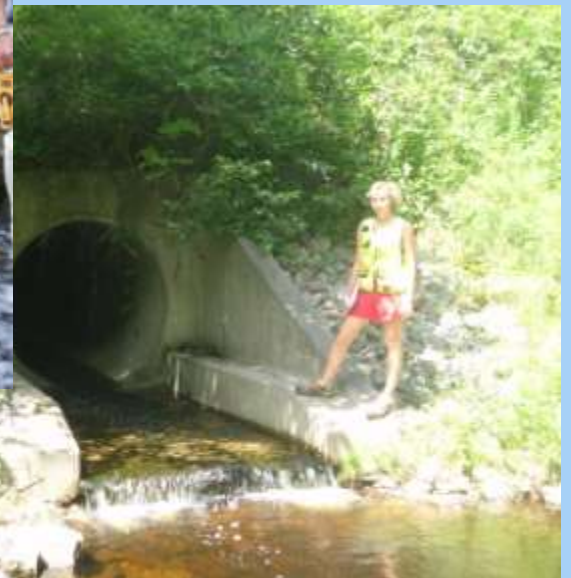
# 182 Perched Outlets

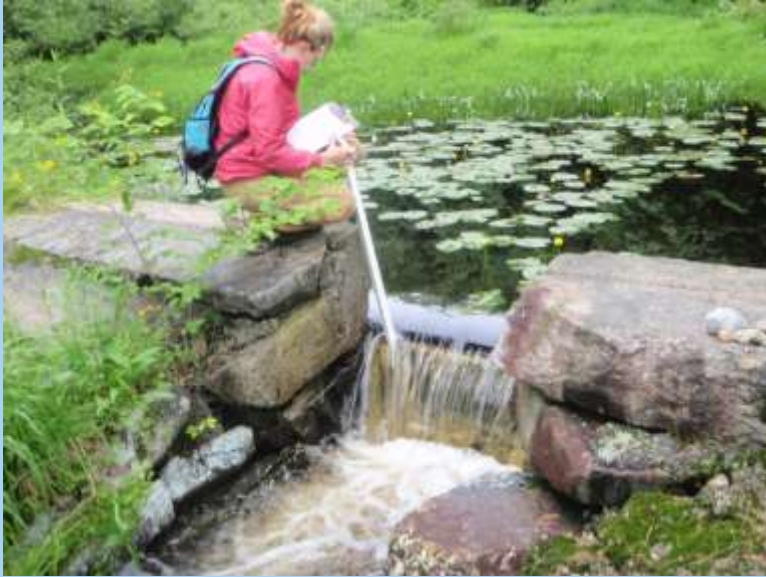
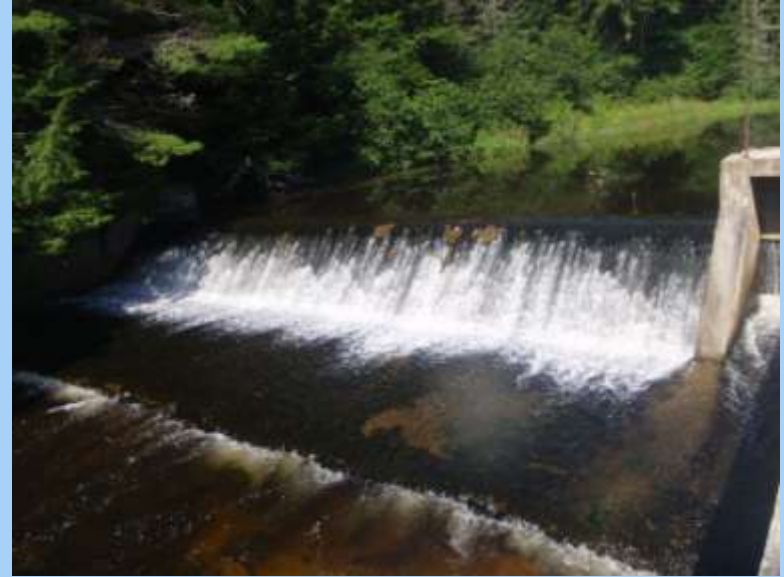
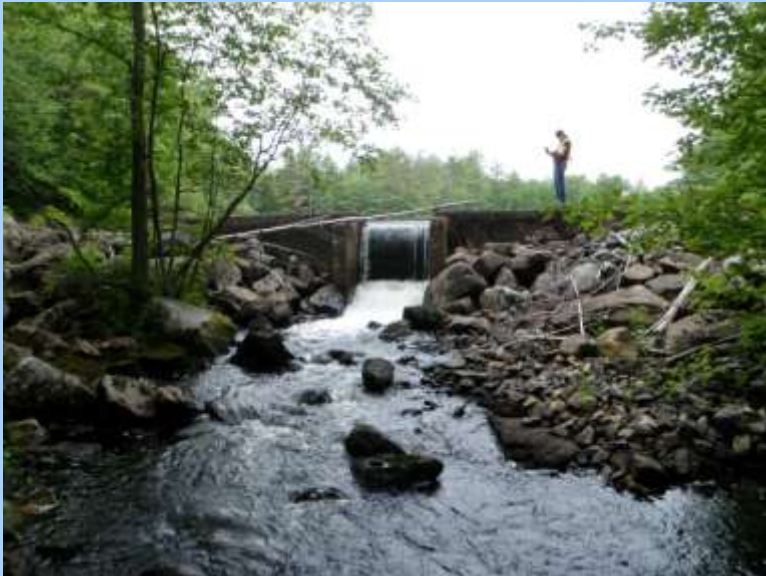
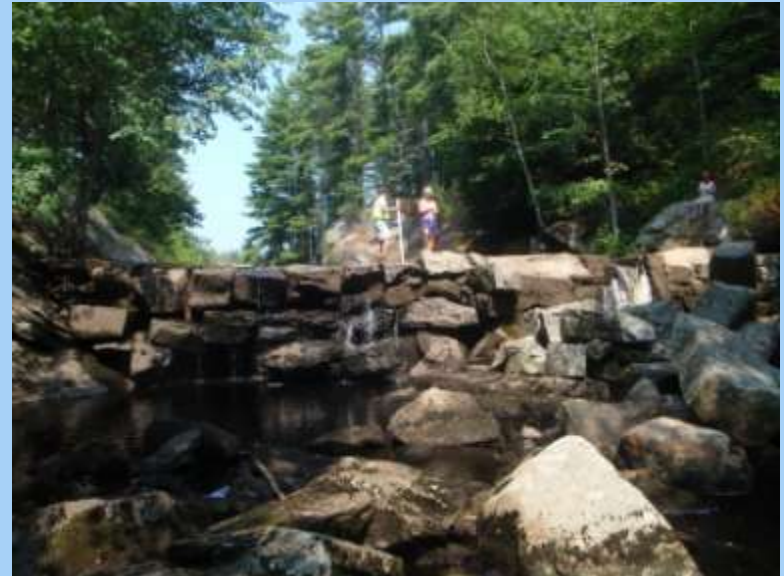
# 45 Severe Dam Barriers
