**Fishway Assessment and Cost Analysis Report, Royal River,  
Yarmouth, ME**

# Fishway Assessment and Cost Analysis Report

ROYAL RIVER, YARMOUTH ME

**PREPARED FOR THE NATURE CONSERVANCY  
FINAL – JULY 2017, REVISED JANUARY 2018**

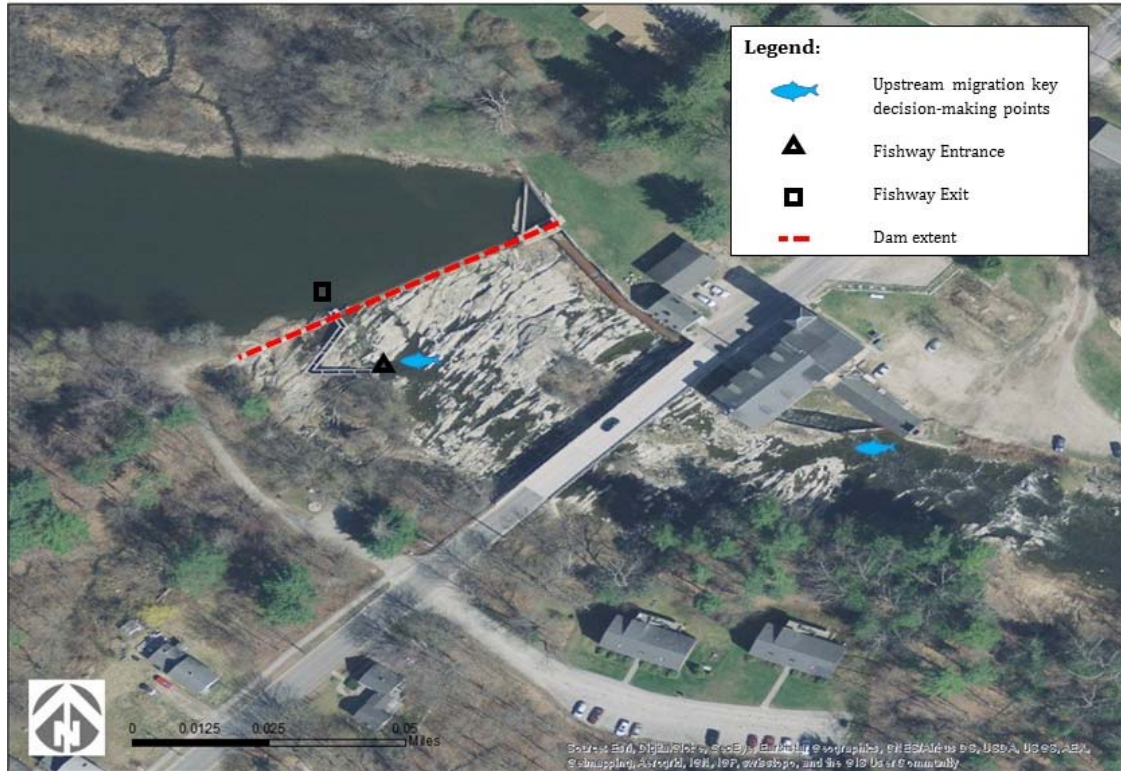
As upstream migrating fish approach the zone of passage, they first encounter the tailrace of the Sparhawk hydroelectric facility (Figure 7). During periods of operation, with maximum diversion capacity of approximately 250 cfs, this outflow could cause a competing signal for upstream passage as it equates to a substantial proportion of the total river flow over much of the fish passage operational range (Table 6 and Figure 6). However, the current operational status and future plans are unknown. At the time of the field assessment, the hydroelectric facility did not appear to be in active generation. If only modest generation were to occur, this competing attraction signal will be less of a concern.

Upstream of the tailrace, fish encounter the beginning of the ledge outcrop and the bridge. Based on the review of the available high resolution aerial photography and previous topographic survey results (Titcomb 2013), the predominant flow patterns downstream of the spillway over the ledge outcrop tend to orient to the river right margin, with several primary streams converging in the vicinity of the fishway entrance (Figure 8). During the highest flows, there is a secondary flow pathway on river left but based on review of the aerial photos, this appears to be a shallower, less substantial flow alignment. As fish migrate closer to the fishway entrance, however, they will encounter several competing signals during many flow conditions, with the exception of the lowest flows (Figure 7 and Figure 8). These patterns may present challenging far-field attraction conditions for upstream migrating fish over a notable portion of the fish passage operational range. This trend is exacerbated by the relatively modest discharge that is able to be passed through the fishway while still operating in the target flow condition for upstream passage (discussed in more detail below).

**Figure 7:** Site map of the Bridge Street site indicating key decision points for upstream migrating fish. Date of imagery is March 31, 2012. Flow direction is left to right.

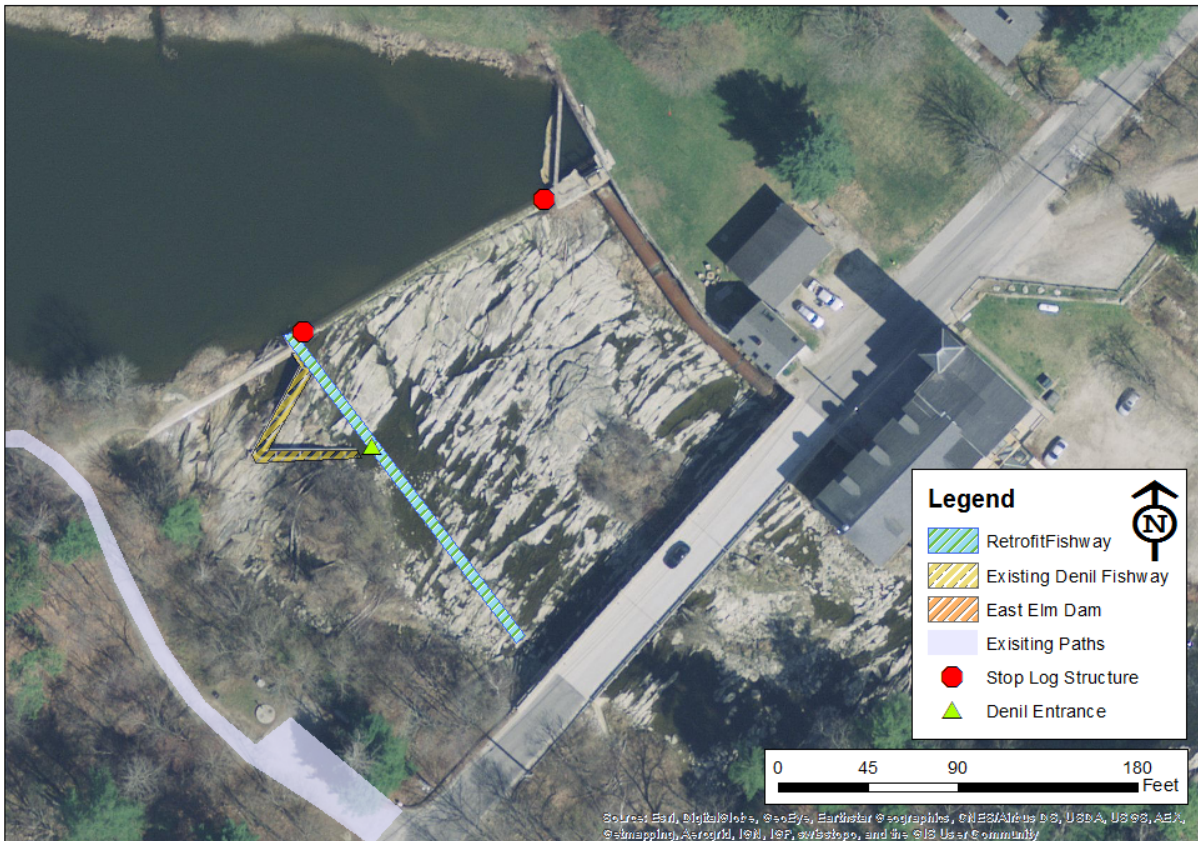
**Figure 11: Possible Bridge Street dam site alignment and dimensions of new Denil fishway to meet USFWS criteria (Table 4).**

The new Denil fishway would follow the design criteria established by the USFWS (2016). Specifications for the new fishway include 4-foot standard width, 1:8 slope, straight alignment, greater depth than the current structure, and increased resting pool length to meet EDF requirements. This alternative would also include installation of an eel ramp to facilitate passage by juvenile eels, selected dam and ledge modifications to facilitate safe downstream passage, and selected ledge modifications in the primary channel leading to the fishway entrance to facilitate upstream migration. The new fishway would be 45 feet longer than the existing fishway. One possible alignment for the new Denil fishway is shown in Figure 11.

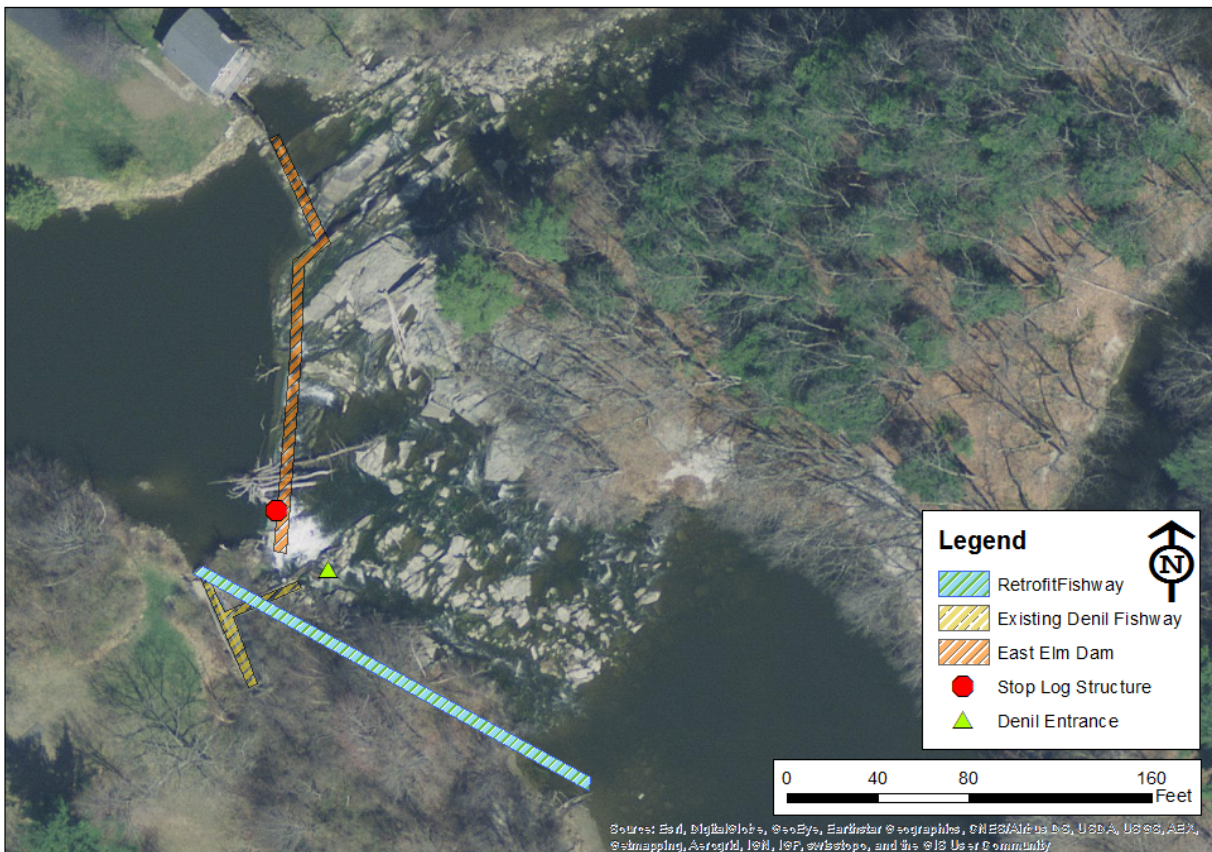
**Figure 14: Location and dimensions of proposed retrofit of existing East Elm Street Denil fishway to meet USFWS criteria (Table 4).**

upstream migration. The new fishway would be 70 feet longer than the existing fishway. One possible alignment for the new Denil fishway is shown in Figure 14.

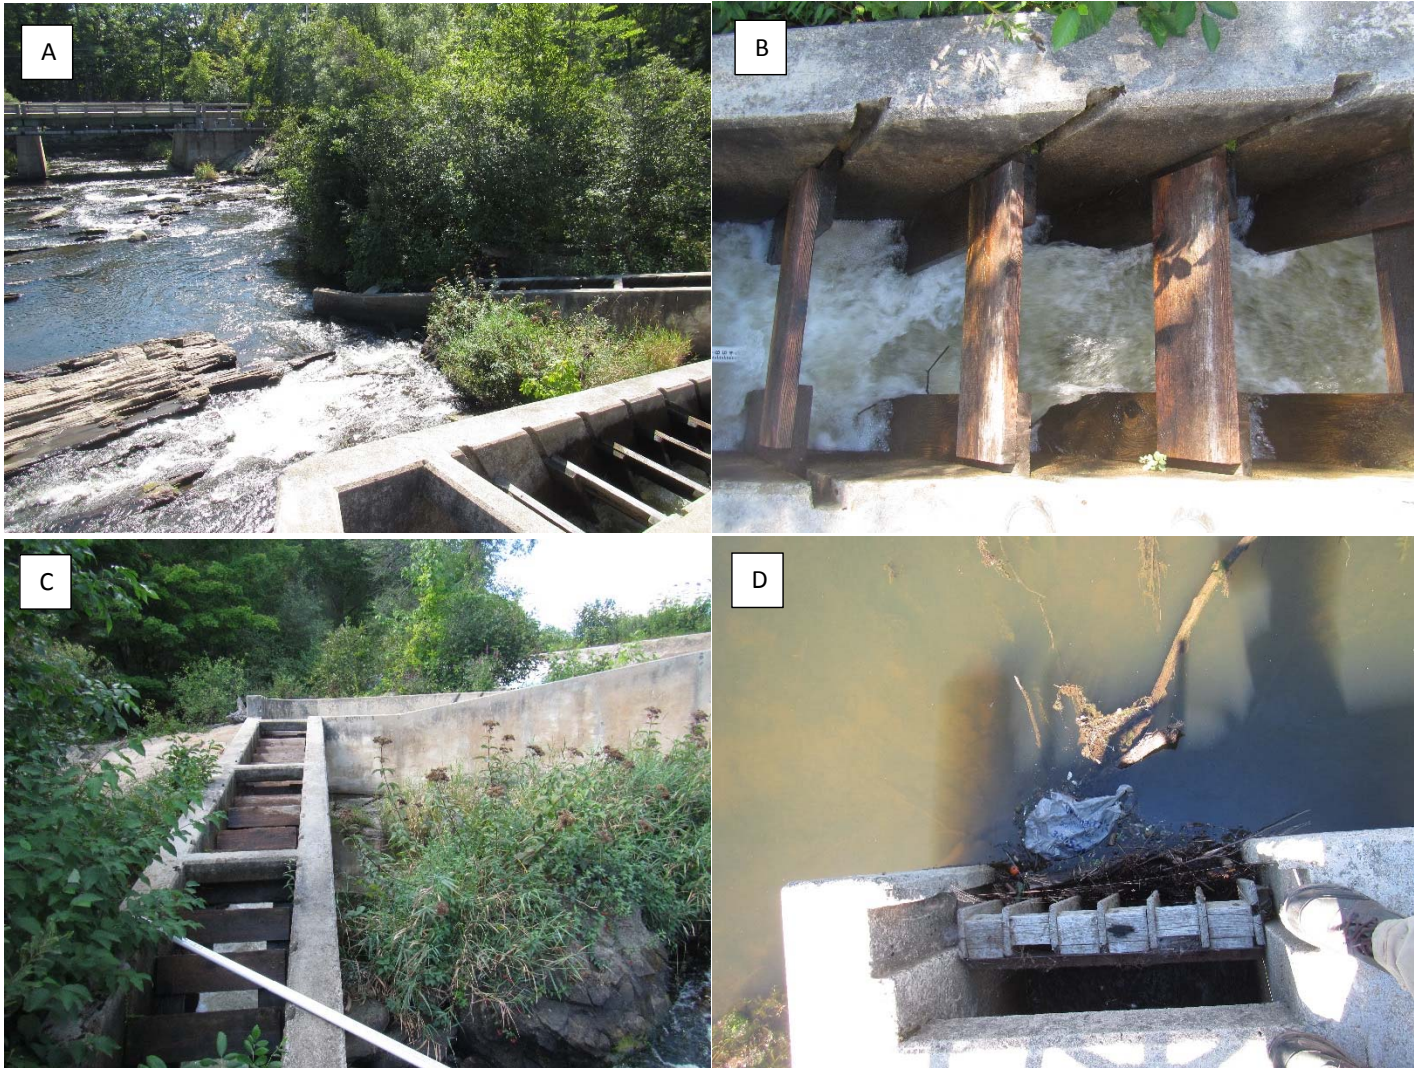
- Qualitative Assessment of Denil Fishway:
  - *General Condition:*
    - Presently operational but requires maintenance and continuous upkeep to successfully provide passage for target species at target populations, and thus regain full functionality. Repairs may lead to improved passage for a subset of the target fish community such as river herring as an interim measure. Does not match current design recommendations for American shad. Status of headgate operability is unknown.

- *General Comparison to prevailing design standards:*
    - Steeper, narrower, and angle of turning pool more acute than recommendations.
    - Shad Passage: several deficiencies– does not meet recommended minimum width or maximum slope, contains turning pools angled greater than 90 degrees.

**Figure 17: Selection of photos of Bridge Street Dam Fishway. (A) View is downstream at fishway entrance on river right. (B) View at a sample baffle section showing turbulent streaming flow. Flow is from right to left. (C) View is upstream towards first baffle section, with second baffle section extending towards the right. (D) Exit of fishway into impoundment showing trash and debris blockage.**

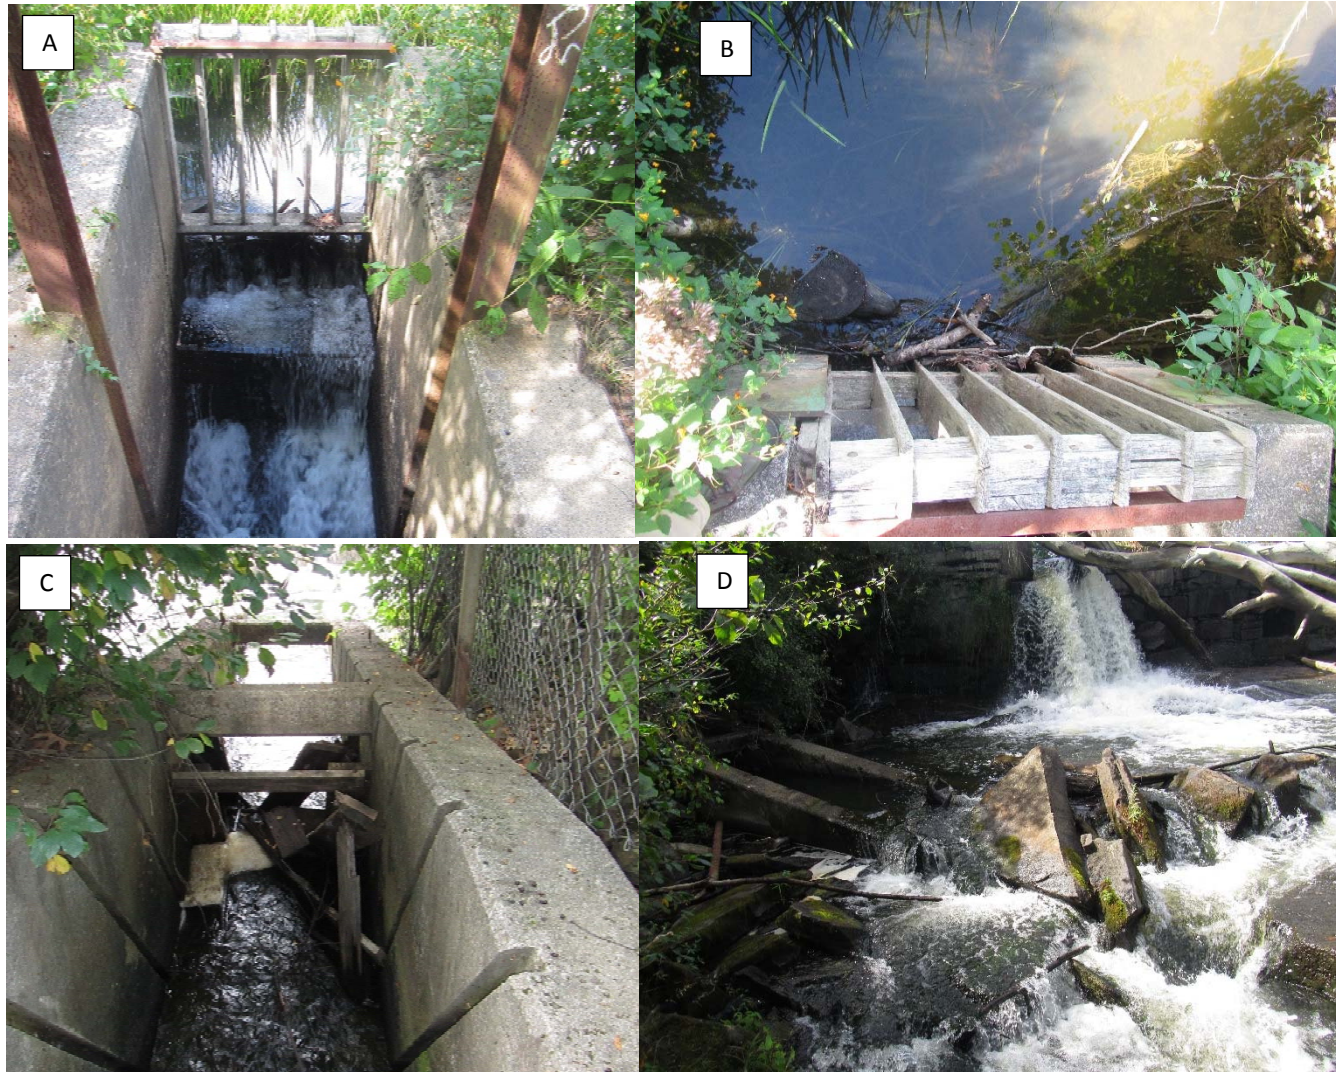
Very poor condition, very difficult entrance location and condition. See report

**Figure 18: Selection of photos of East Elm Street Dam Fishway. (A) View is upstream at fishway exit into impoundment; (B) view of trashrack blocked by debris; (C) view is downstream at second baffle section blocked by broken baffles and debris; (D) entrance to fishway blocked by large wood and rubble.**
