Nondestructive evaluation of concrete bridge columns rehabilitated with fiber reinforced polymers using digital tap hammer and infrared thermography

Nondestructive Evaluation of Concrete Bridge Columns Rehabilitated With Fiber Reinforced Polymers Using Digital Tap Hammer and Infrared Thermography

**Master of Science
in
Civil Engineering**

**Department of Civil and Environmental Engineering
Morgantown, West Virginia**

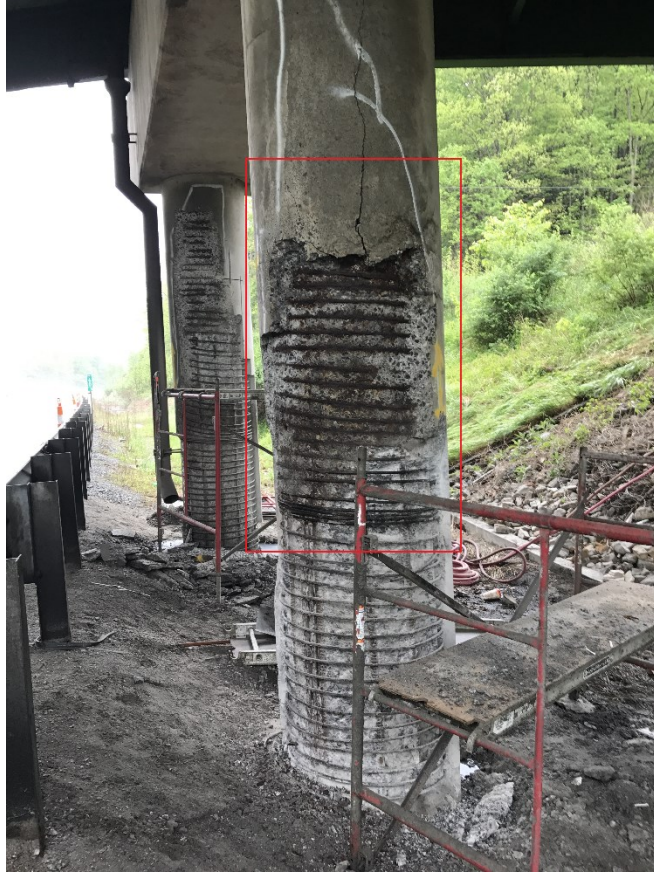
Figure 3.2: Extent of original concrete spalling.

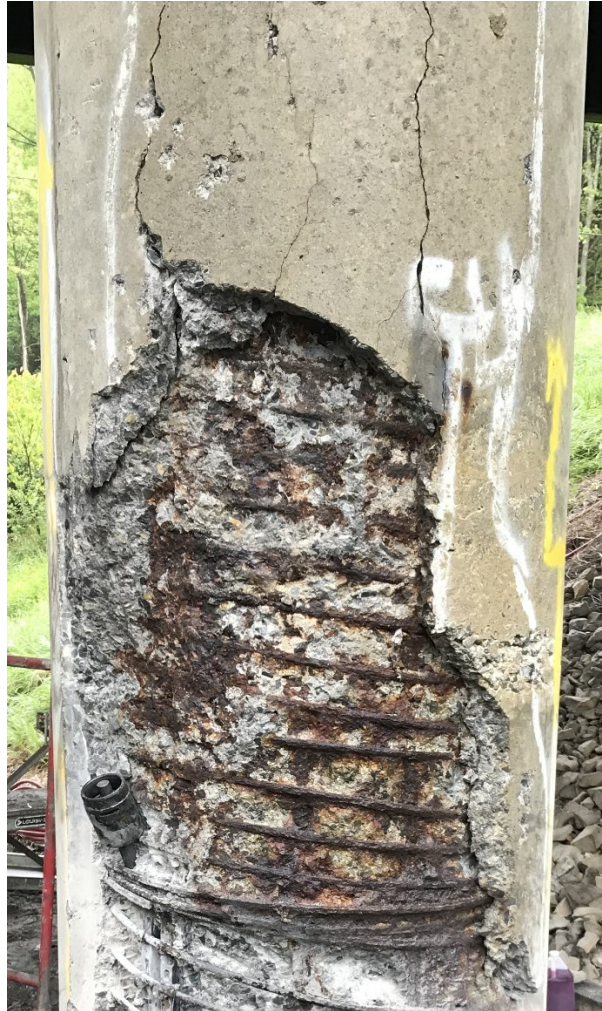
Figure 3.3: Concrete spalling on pier 3.

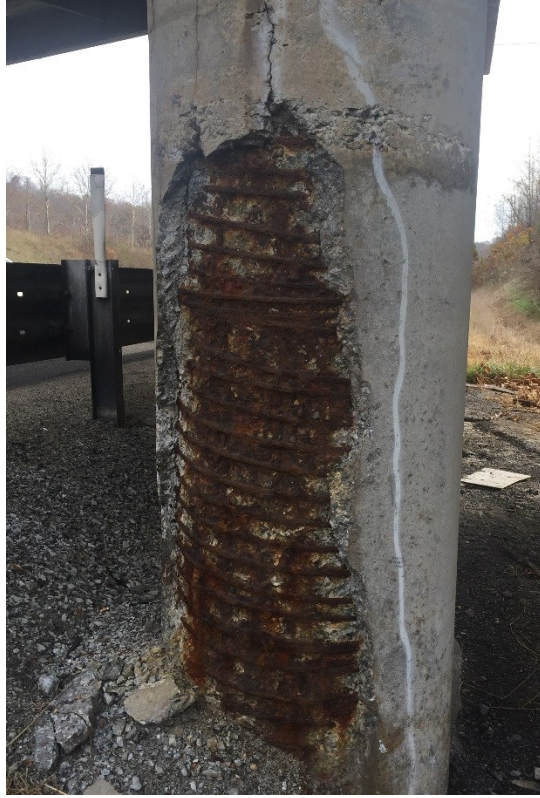
Figure 4.3: Concrete spalling prior to rehabilitation.

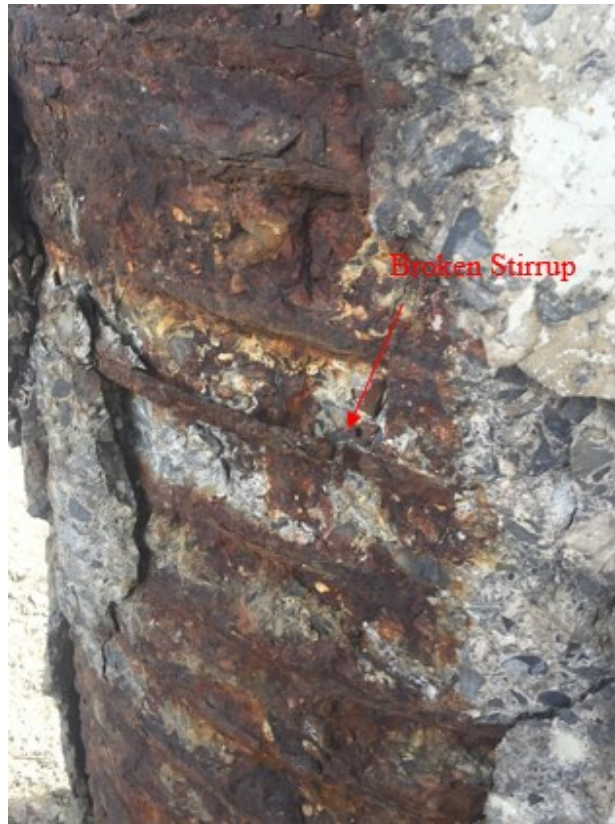
Figure 4.4: Corrosion of the stirrups on one of the columns.

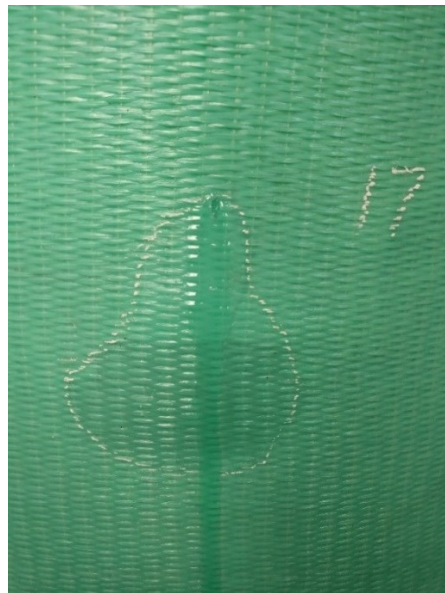
Figure 4.7: Example of a debond found using digital tap hammer techniques.

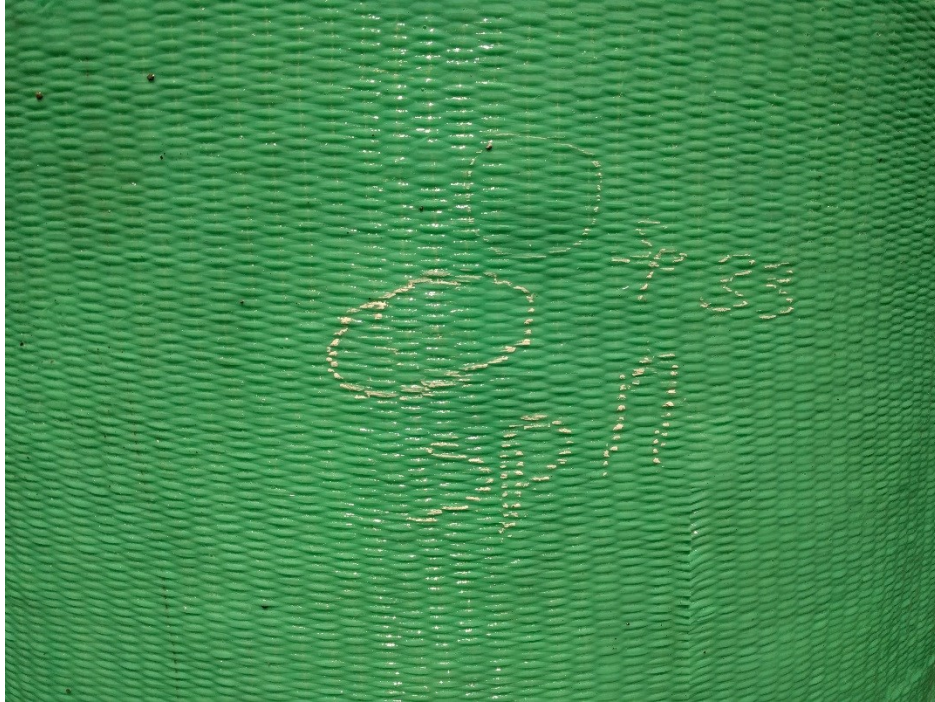
Figure 4.8: Elevated tap hammer readings on the east column of pier 3.

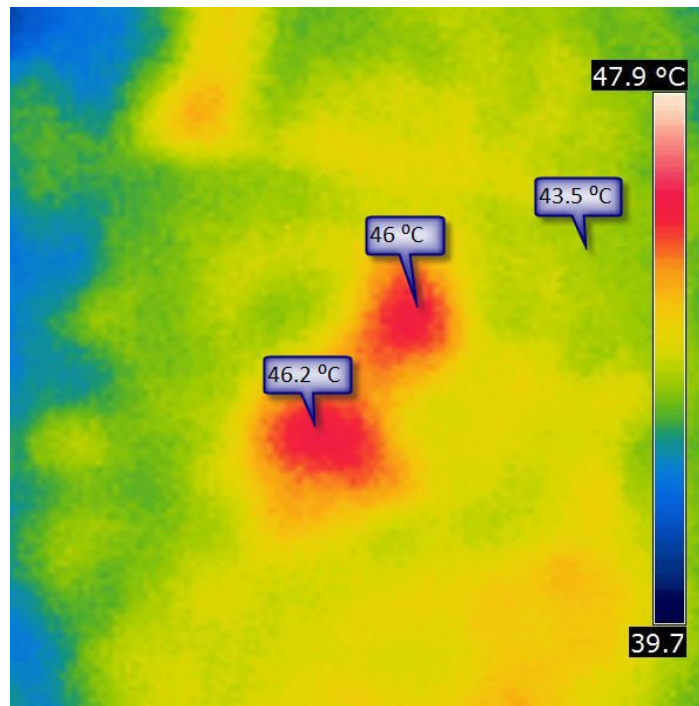
Figure 4.9: Infrared images associated with Figure 4.8.

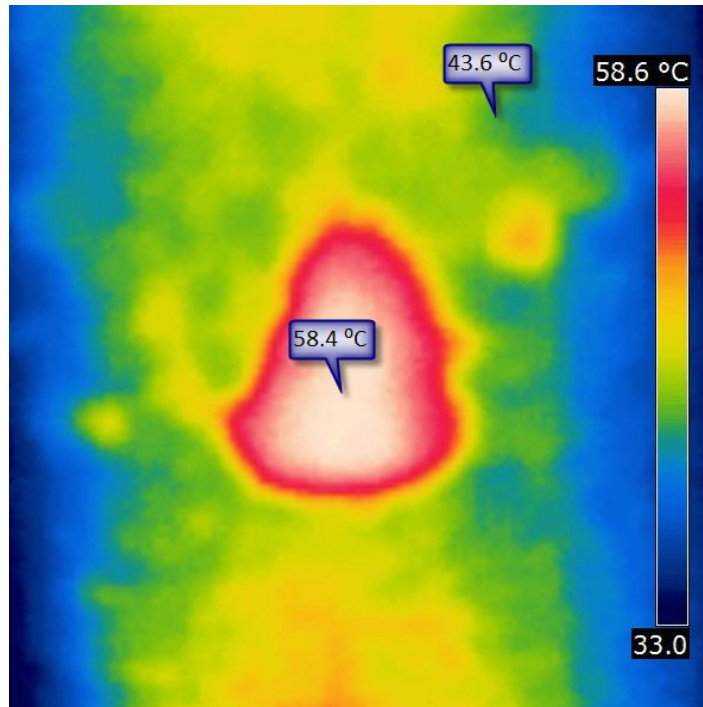
Figure 4.10: Infrared image of region 17 in Figure 4.7.

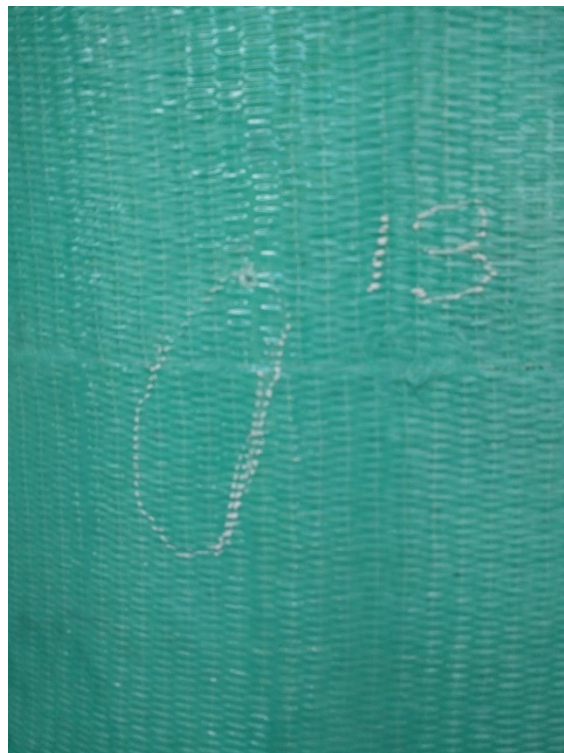
Figure 4.11: Area 13 on the center column of pier 3.

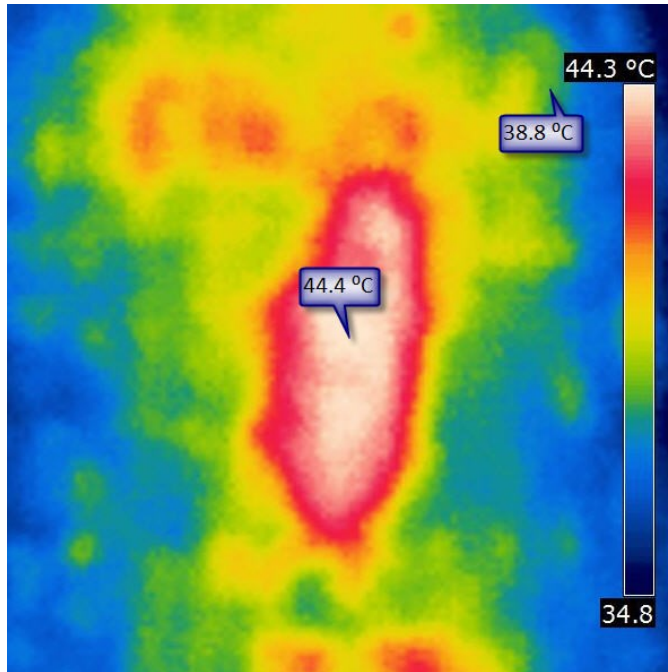
Figure 4.12: Area 13 debond.

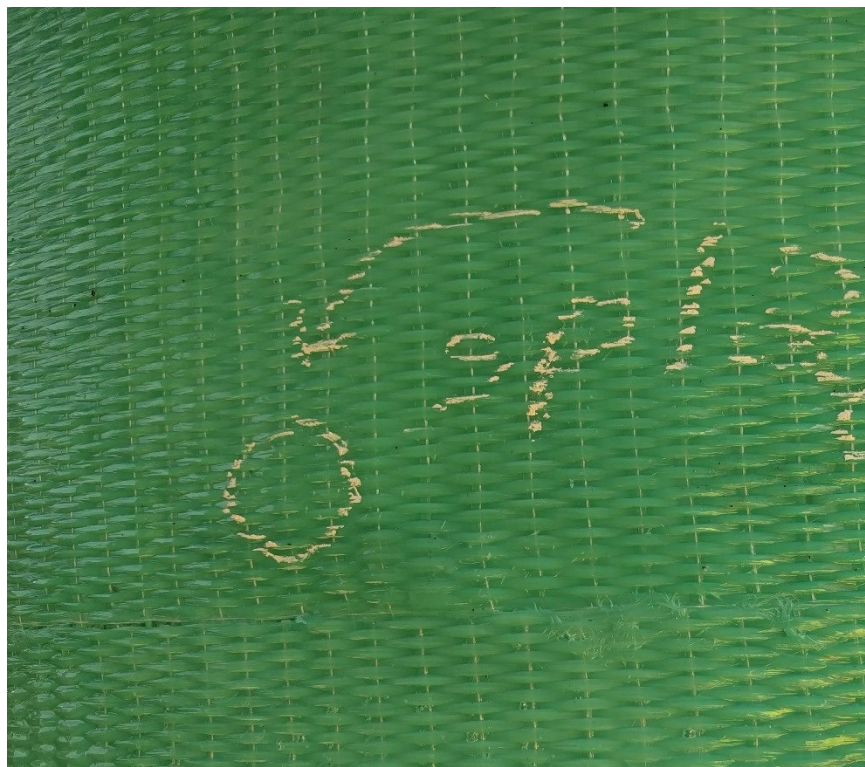
Figure 4.13: Digital tap hammer region 12 on west column of pier 3.

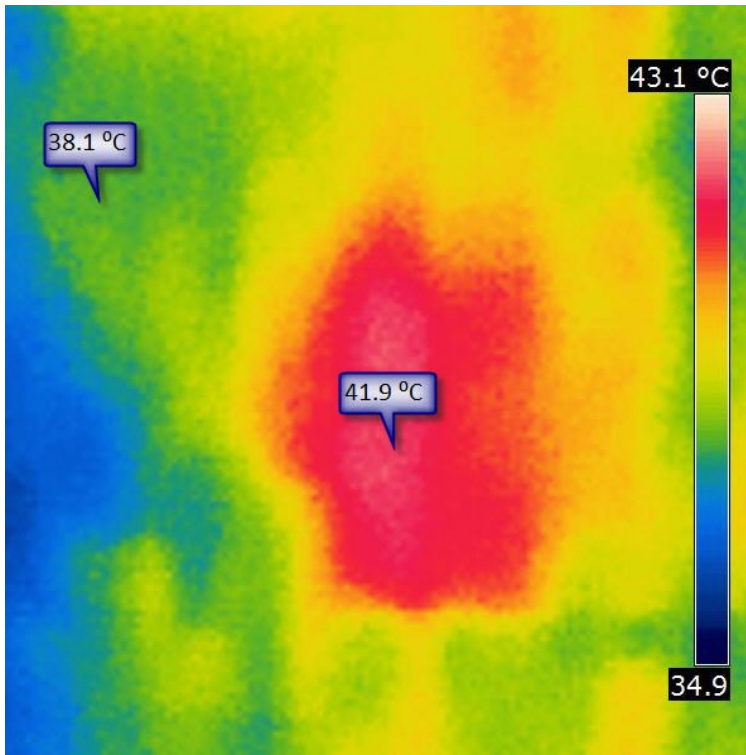
Figure 4.14: Denotes the infrared image for Figure 4.13.

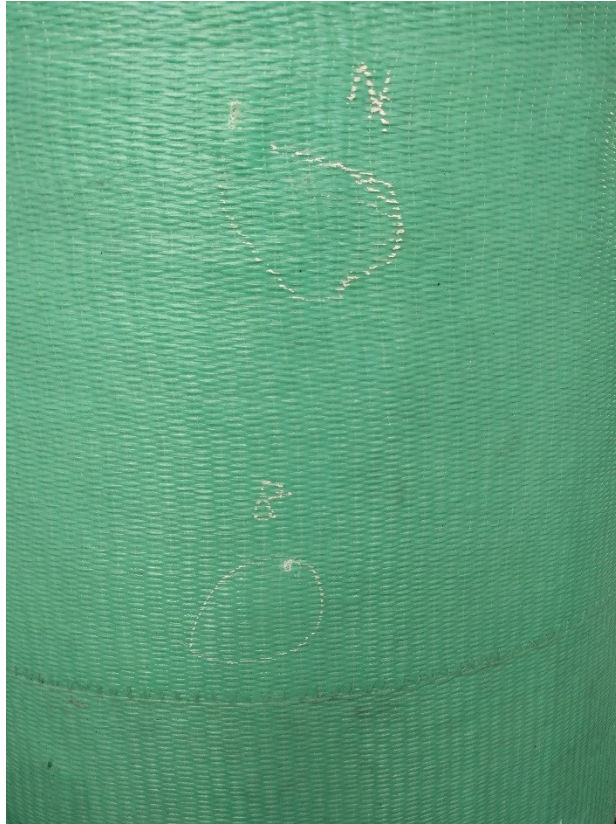
Figure 4.15: Regions 7 and 8 of center column in pier 3.

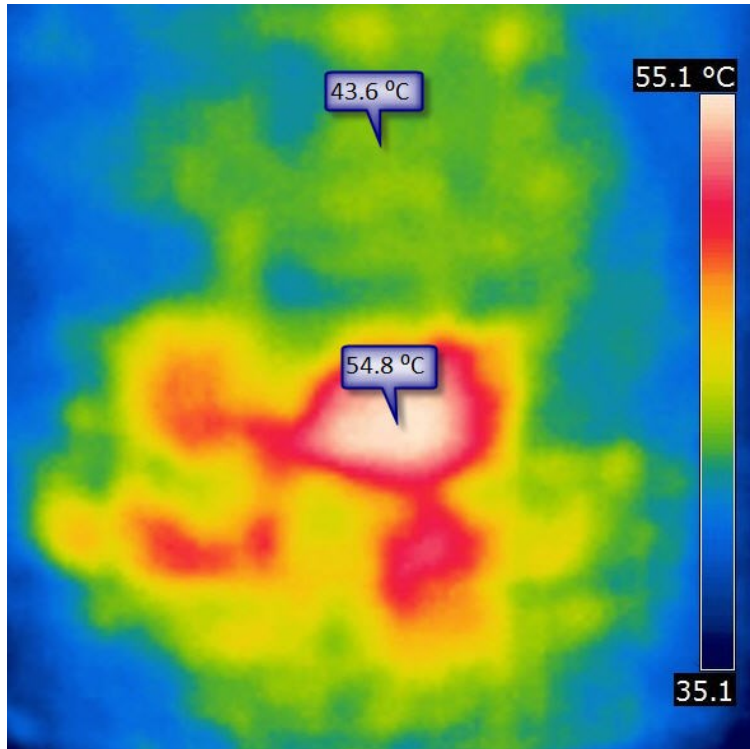
Figure 4.16: Infrared image correlating to region 7 in Figure 4.15.

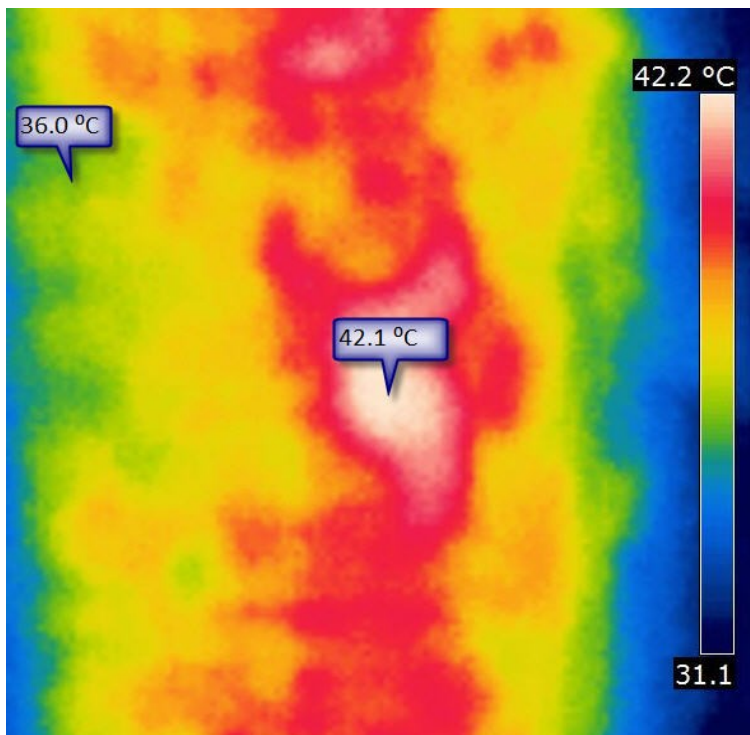
Figure 4.17: Infrared image for region 8 in Figure 4.15

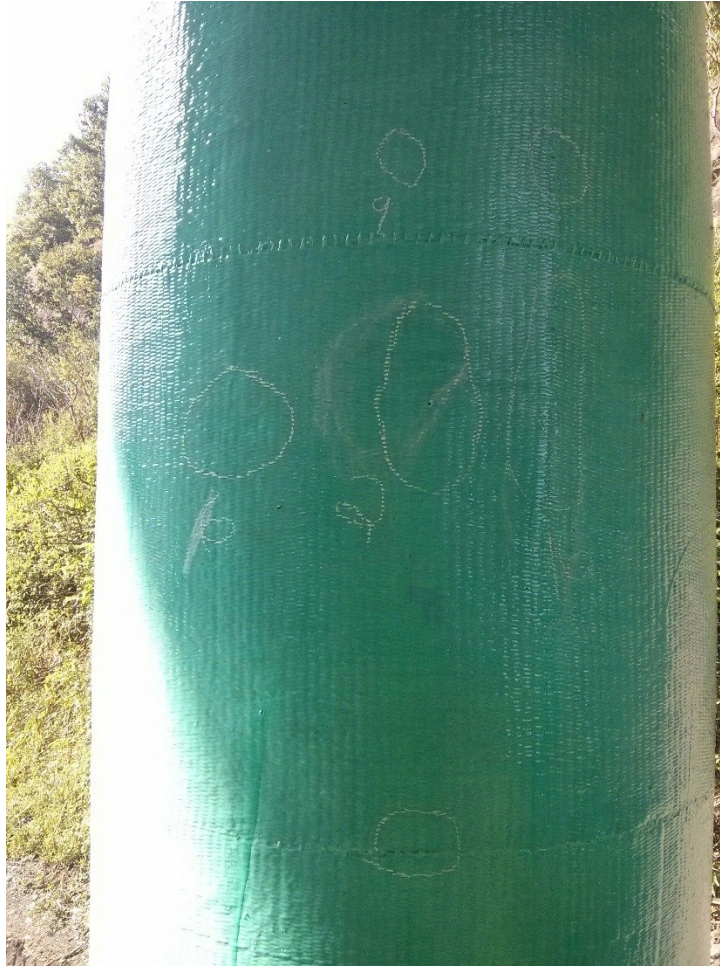
Figure 4.18: Debonds found in the west column of pier 1.

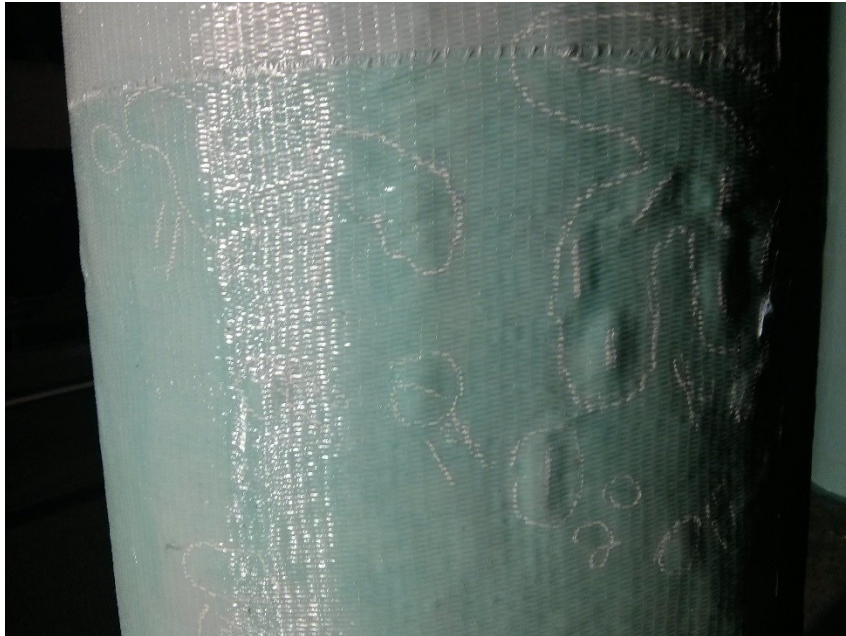
Figure 4.22: An example of the amount of debonds found while testing columns pier 2.

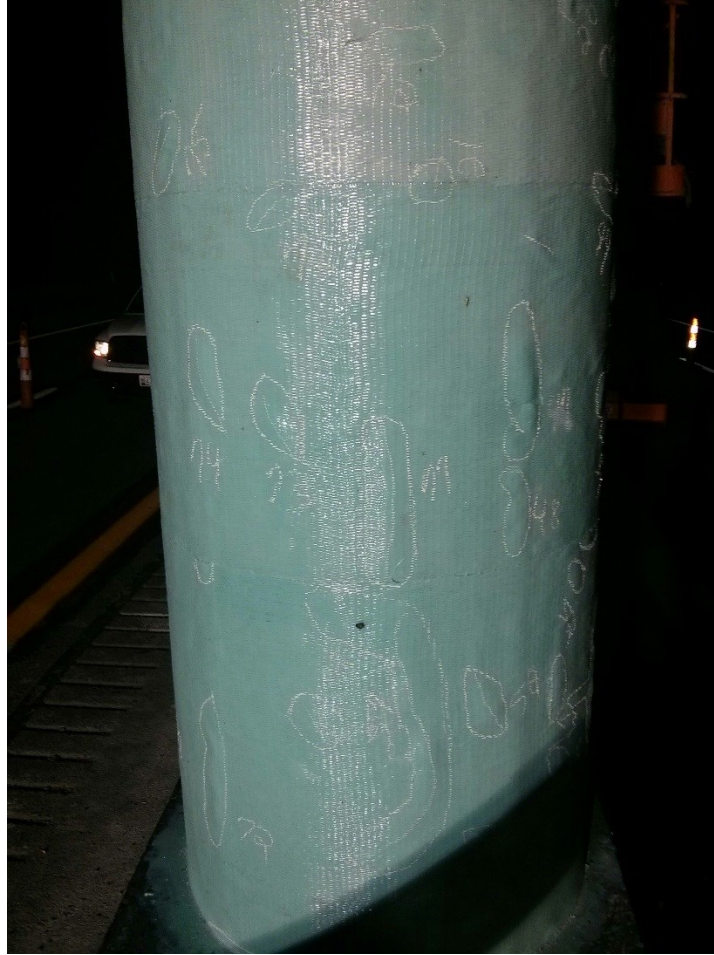
Figure 4.23: The lower half of the west column on pier 2 and debonds that were found.
