Nondestructive evaluation of FRP composite bridge componenets using infrared thermography and digital tap tesing

Ruben Mangal Joshi

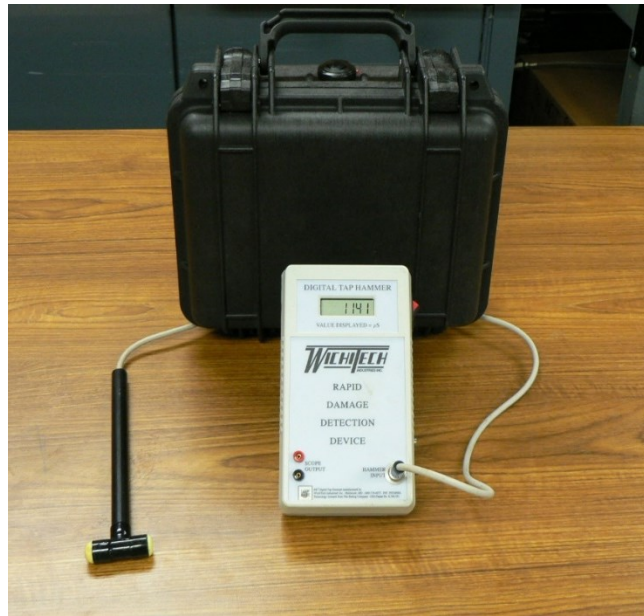
Figure 2-4: Digital Tap Hammer – Rapid Damage Detection Device (RD³)

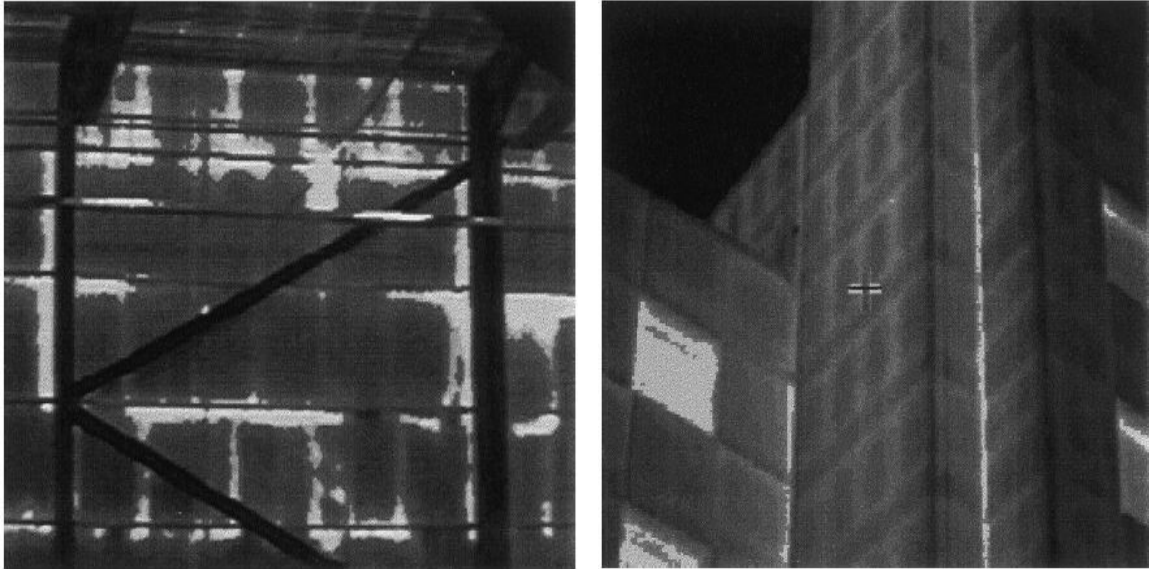
Figure 3-1: Thermal image of poor insulation system in the walls (left) and thermal image of precast RC building showing heat loss at joints (right) (Titman 2001)

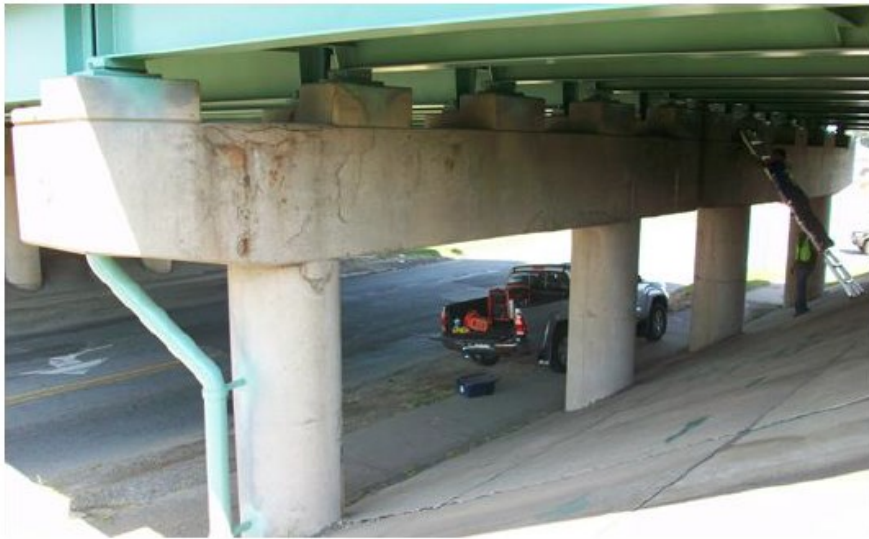
Figure 3-3: Close-up view of the damaged piers and pier cap on the south side of the bridge (Halabe et al. 2012)

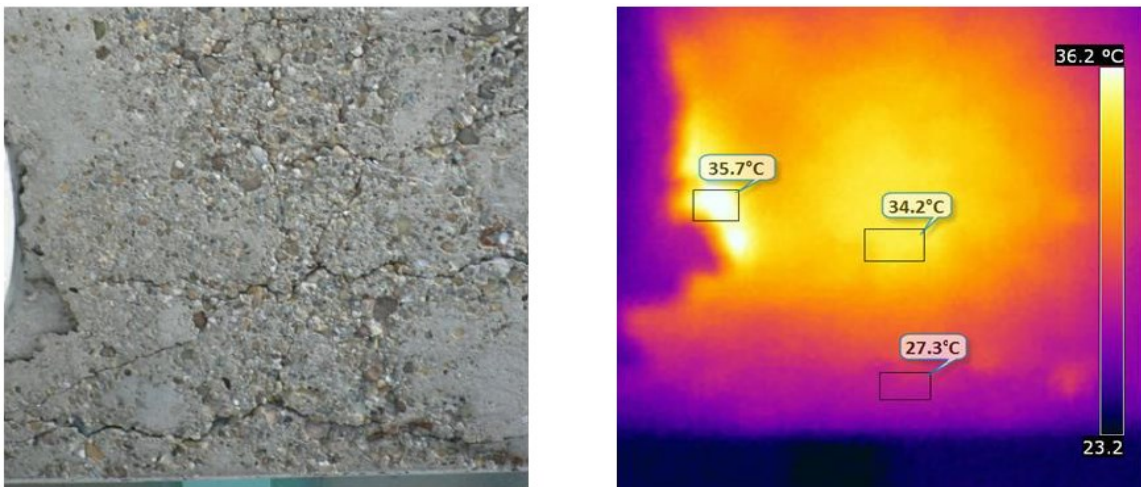
Figure 3-2: Another pier cap in the RC bridge (left) and thermal image of the surface showing defect as hot spot (right) (Halabe et al. 2012)

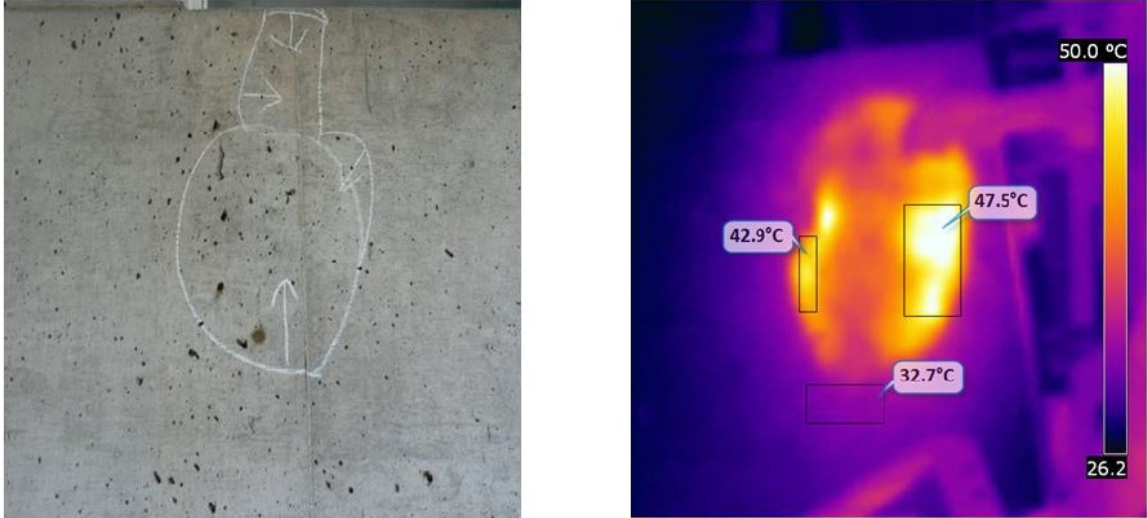
Figure 3-4: Damaged pier cap in the RC bridge (left) and thermal image of the surface captured by infrared camera after heating (right) (Halabe et al. 2012)

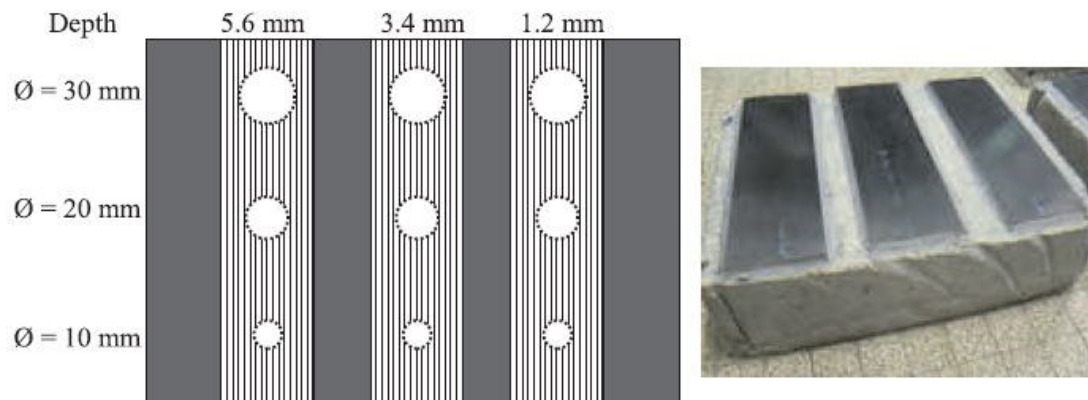
Figure 3-8: Concrete Slab Reinforced with Bonded FRP Plates along with Defects (Taillade et al. 2012)

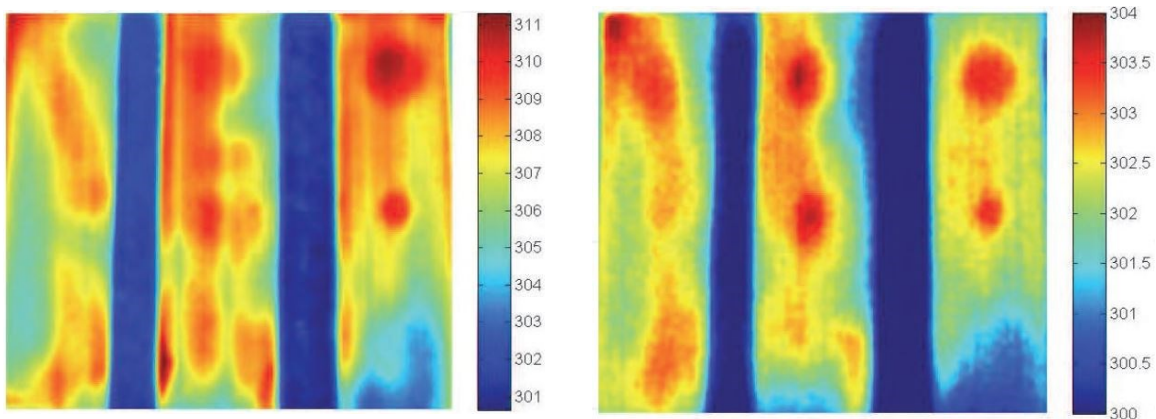
Figure 3-9: Thermal Image at the beginning of thermal relaxation (left) and after 52 seconds after heating (right) (Taillade et al. 2012)

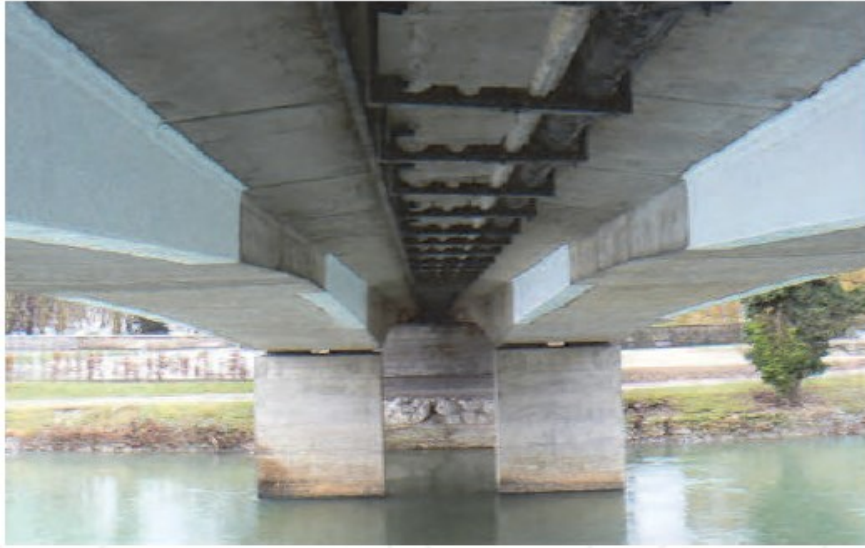
Figure 3-10: FRP Strengthened Box-Girders of the Bridge (Taillade et al. 2012)

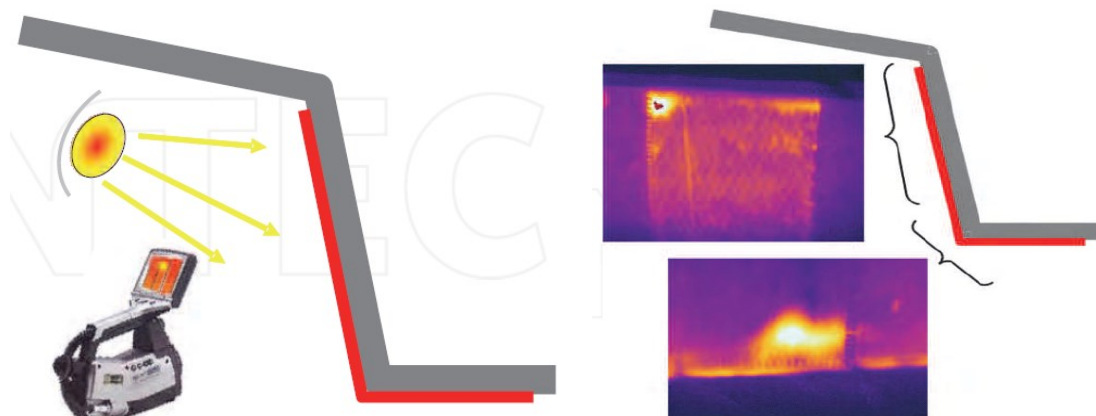
Figure 3-11: Schematic diagram of infrared thermography on the bridge (left) and thermal images showing defects on the wrap (right) (Taillade et al. 2012)

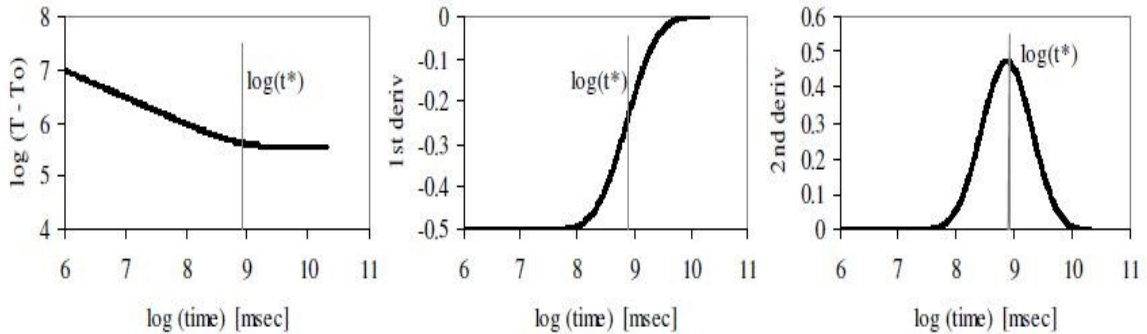
Figure 3-12: Logarithmic Surface Temperature vs Time plot (left), first derivative (center) and second derivative (right) with respect to logarithmic time (Shepard 2013)

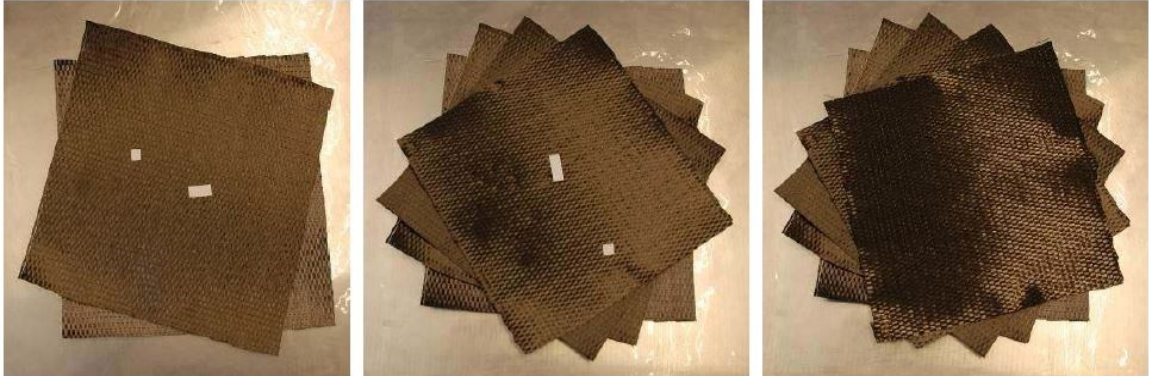
Figure 3-15: CFRP layers with Teflon inserts in the sample before applying vacuum infusion molding process (Oswald-Tranta et al. 2014)

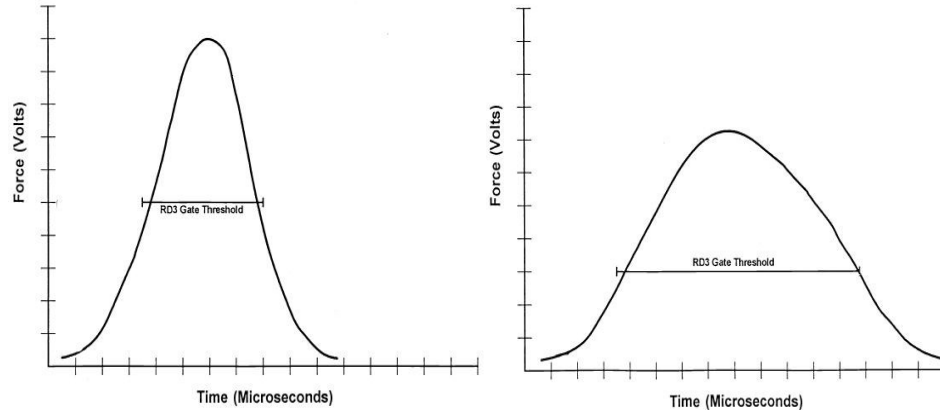
Figure 3-18: Typical RD³ force-time pulse for good area (left) and debond (right) (Georgeson et al. 1996)

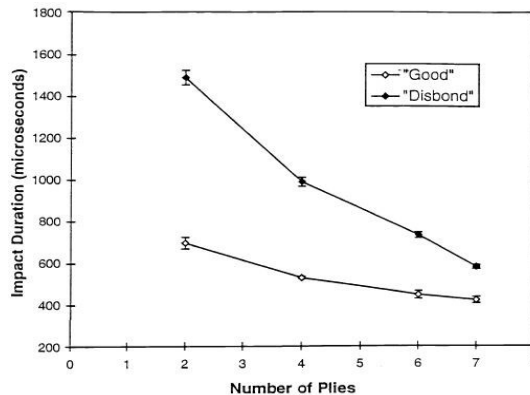
Figure 3-19: RD³ results on fiberglass/epoxy skin, Nomex honeycomb core test panel (Georgeson et al. 1996)

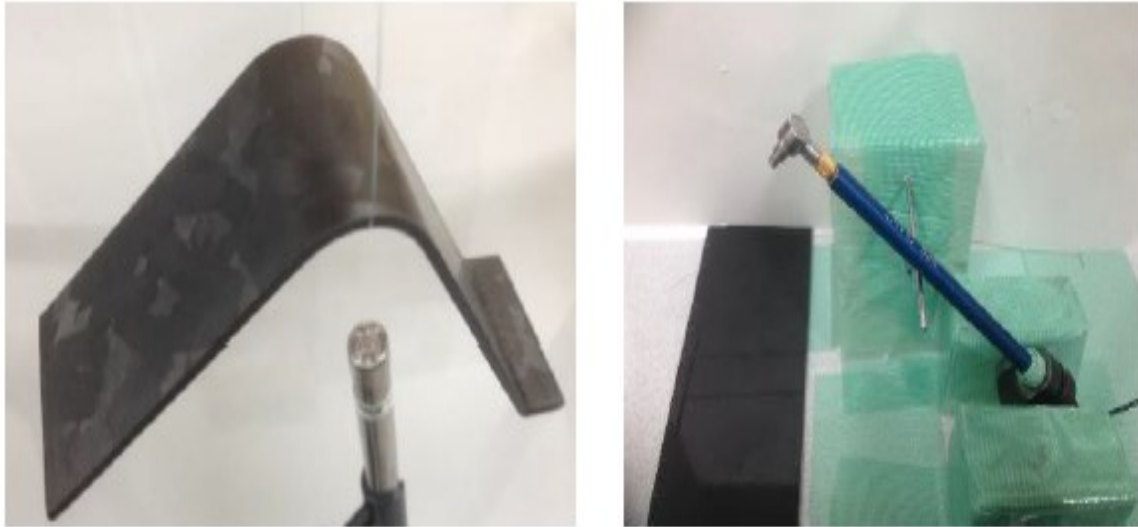
Figure 3-20: Experimental setups for tapping method: Global method (left) and Local method (right) (Lyu et al. 2015)

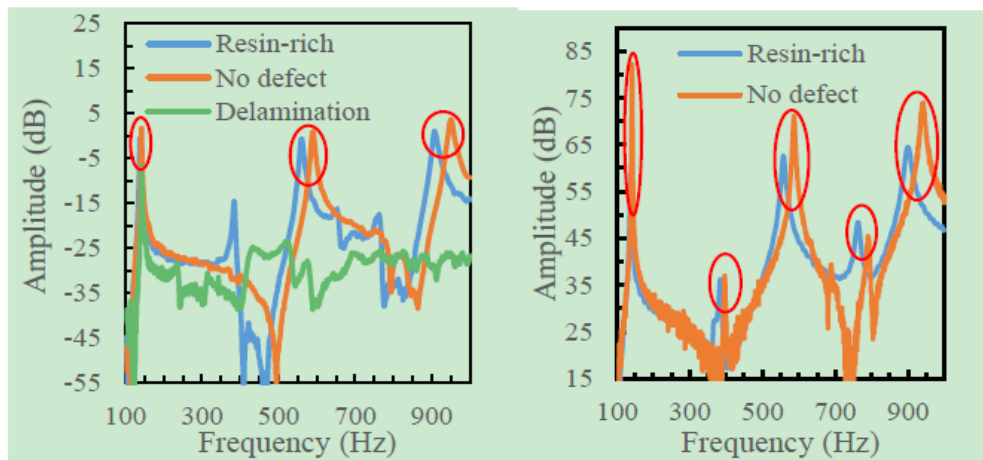
Figure 3-21: Damping and frequency analysis of the specimens for global method: Signal form microphone (left) and accelerometer (right) (Lyu et al. 2015)

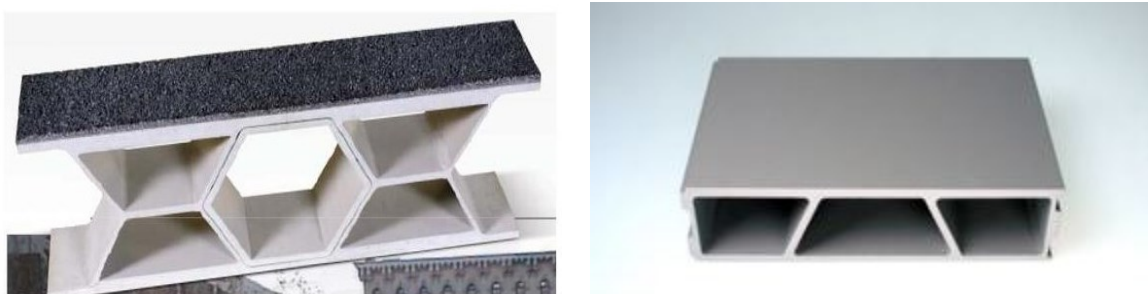
Figure 4-1: Fiber Reinforced Polymer (FRP) bridge deck samples –left (www.thomasnet.com) and right (www.materialstoday.com)

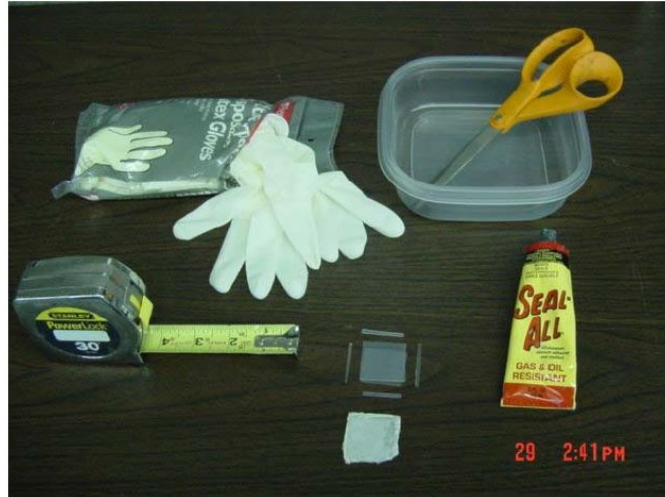
Figure 4-2: Materials used to prepare air-filled defects to be inserted into the GFRP bridge deck specimen (Vasudevan 2004)

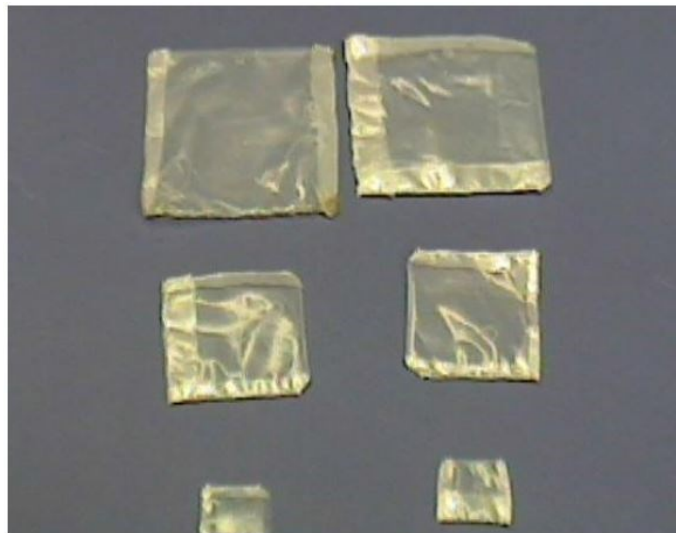
Figure 4-3: Water-filled defects of sizes 3" x 3", 2" x 2" and 1" x 1" to be inserted into the GFRP bridge deck specimen (Roy 2004)

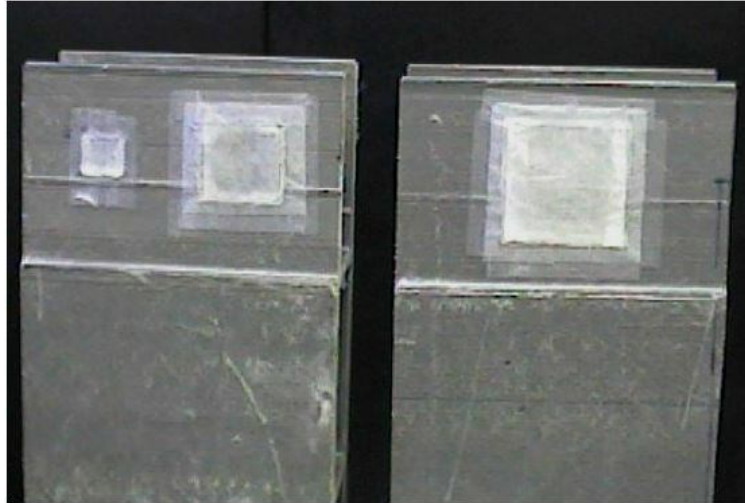
Figure 4-4: Water-filled defects embedded in the flanges of the FRP bridge deck specimens (Roy 2004)

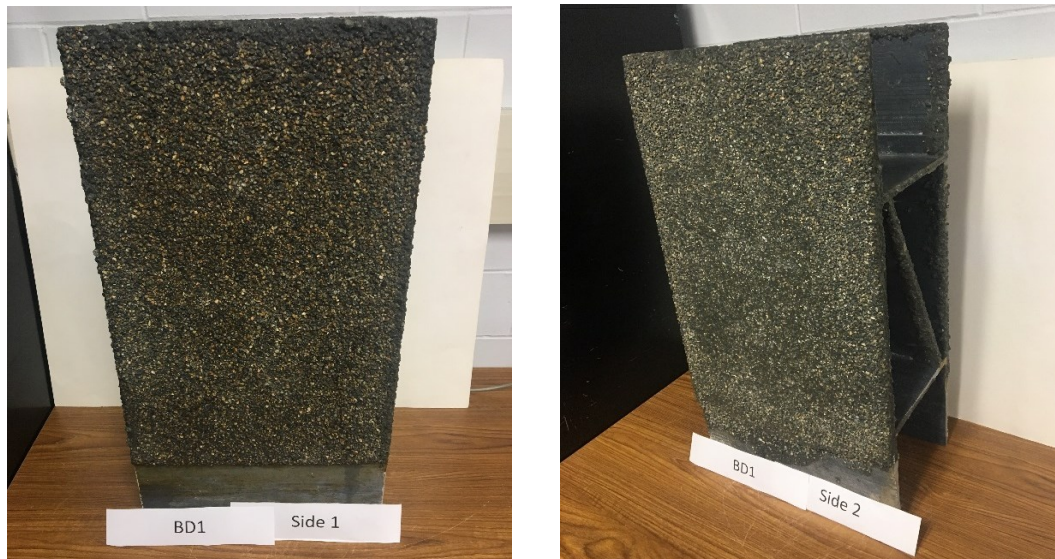
Figure 4-5: Side 1 (left) and Side 2 (right) of the GFRP deck specimen BD1

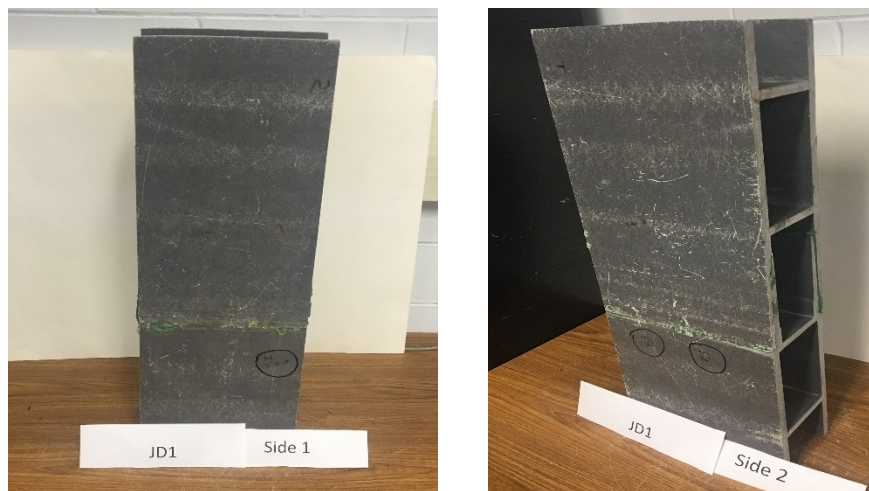
Figure 4-7: Side 1 (left) and Side 2 (right) of the GFRP deck specimen JD1

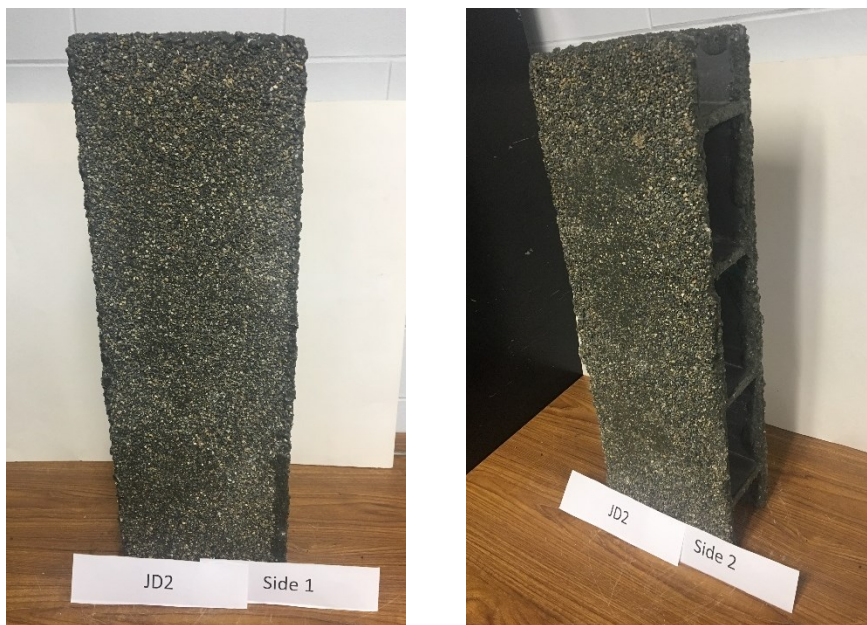
Figure 4-9: Side 1 (left) and Side 2 (right) of the GFRP deck specimen JD2

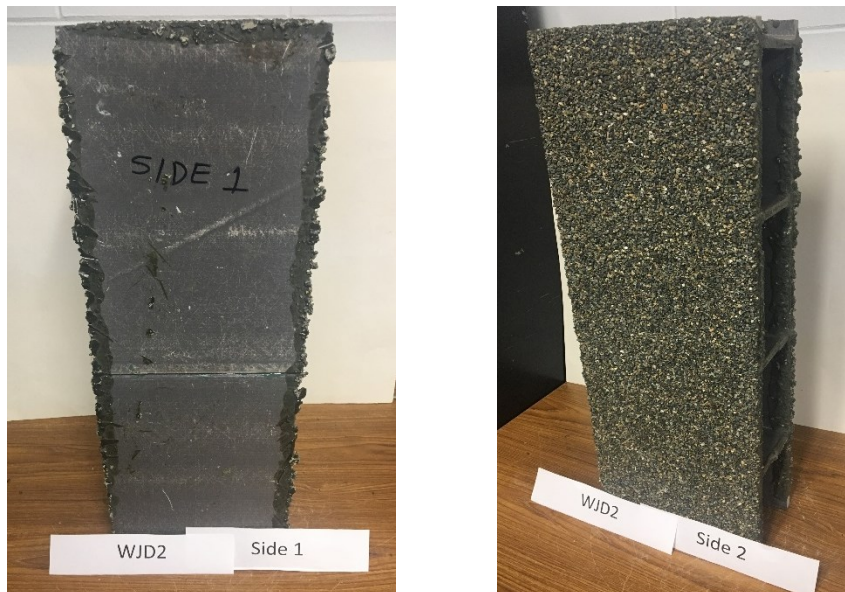
Figure 4-11: Side 1 (left) and Side 2 (right) of the GFRP deck specimen WJD2

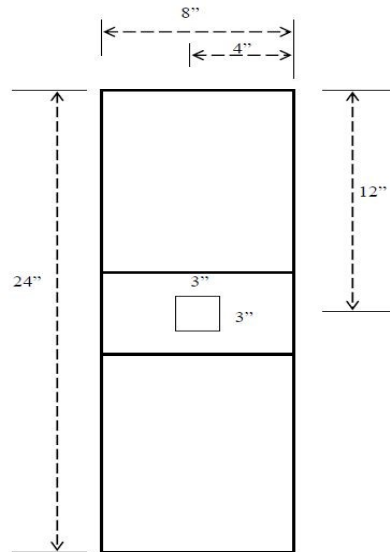
Figure 4-12: Schematic diagram of 3" x 3" sized debond on both sides of the GFRP deck specimen WJD2 (Roy 2004)

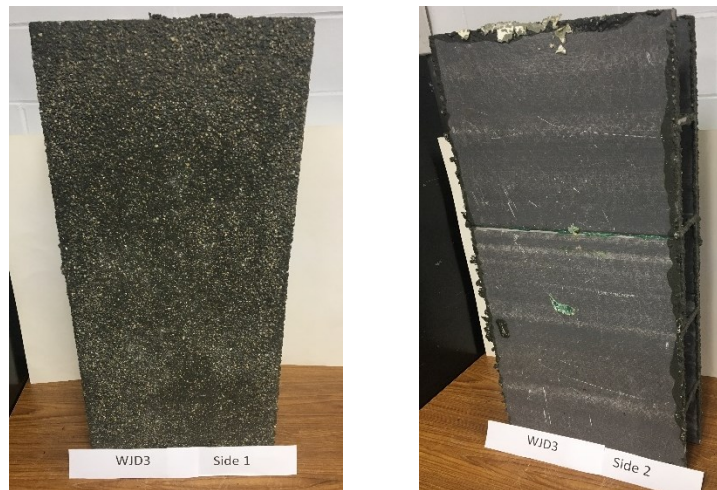
Figure 4-13: Side 1 (left) and Side 2 (right) of the GFRP deck specimen WJD3

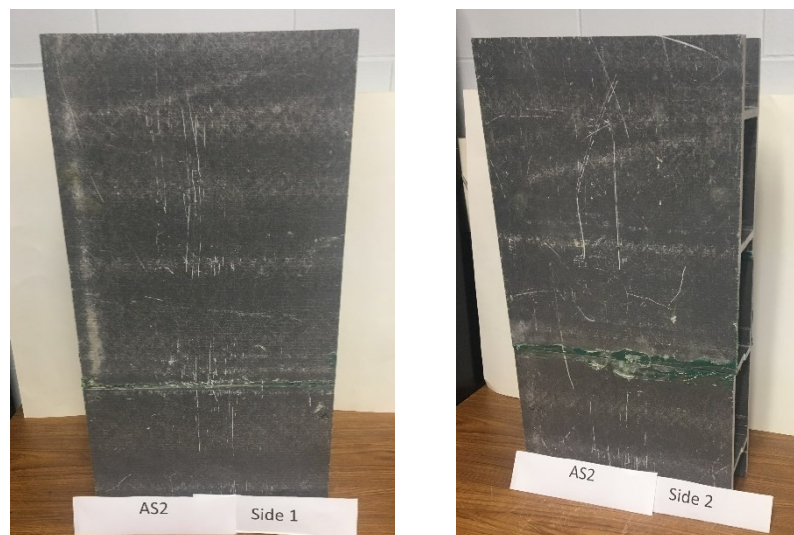
Figure 4-15: Side 1 (left) and Side 2 (right) of the GFRP deck specimen AS2

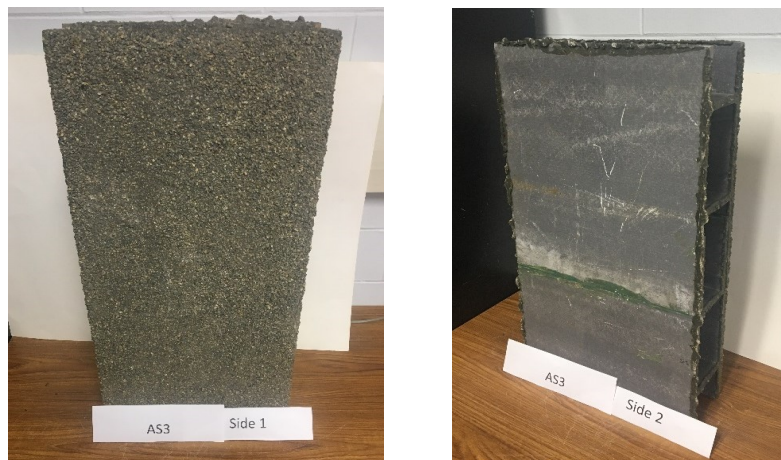
Figure 4-17: Side 1 (left) and Side 2 (right) of the GFRP deck specimen AS3

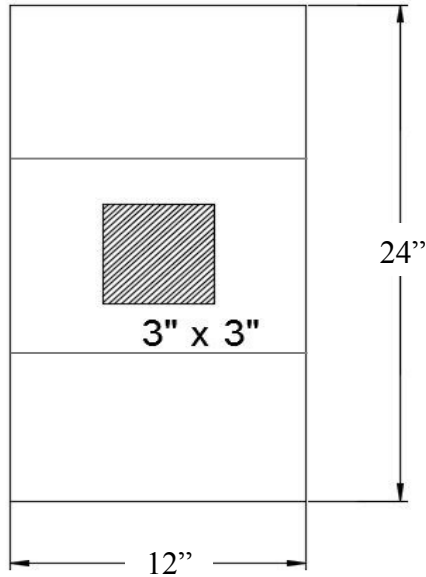
Figure 4-18: Schematic diagram of debonds on both sides of the GFRP deck specimen AS3

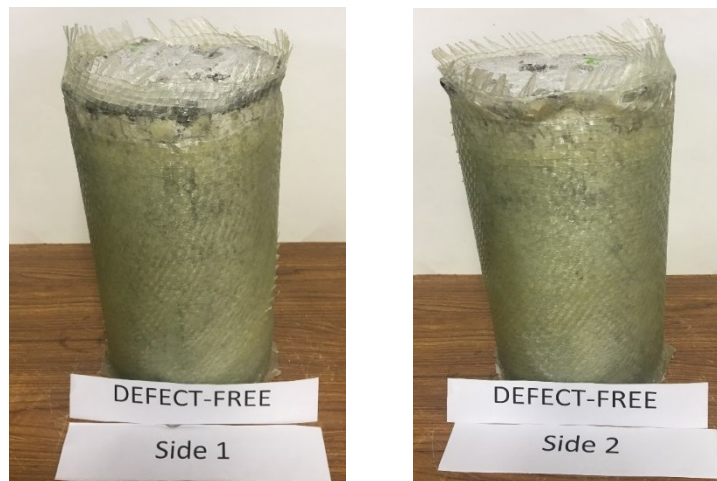
Figure 4-19: Side 1 (left) and Side 2 (right) of the defect-free GFRP-wrapped concrete cylinder

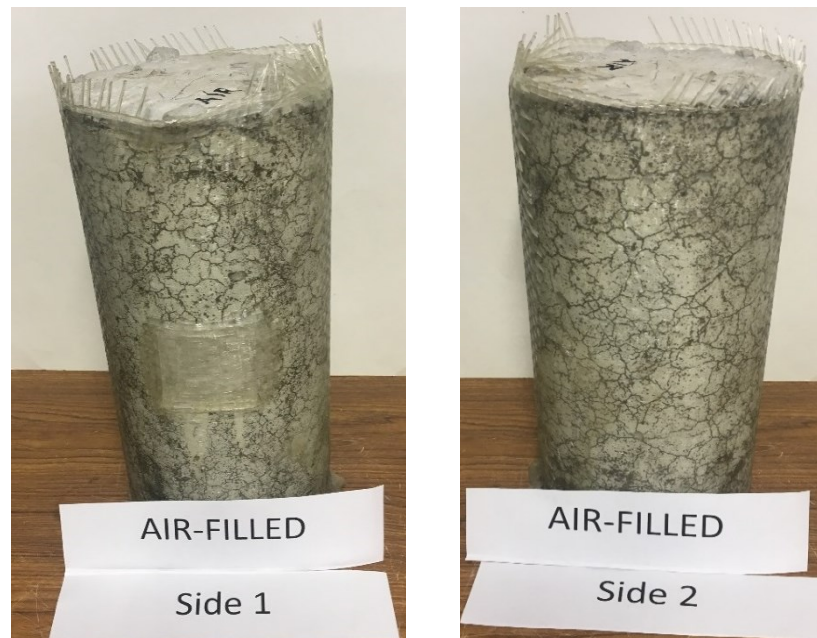
Figure 4-20: Side 1 containing air-filled defect (left) and defect-free Side 2 (right) of the GFRP-wrapped concrete cylinder

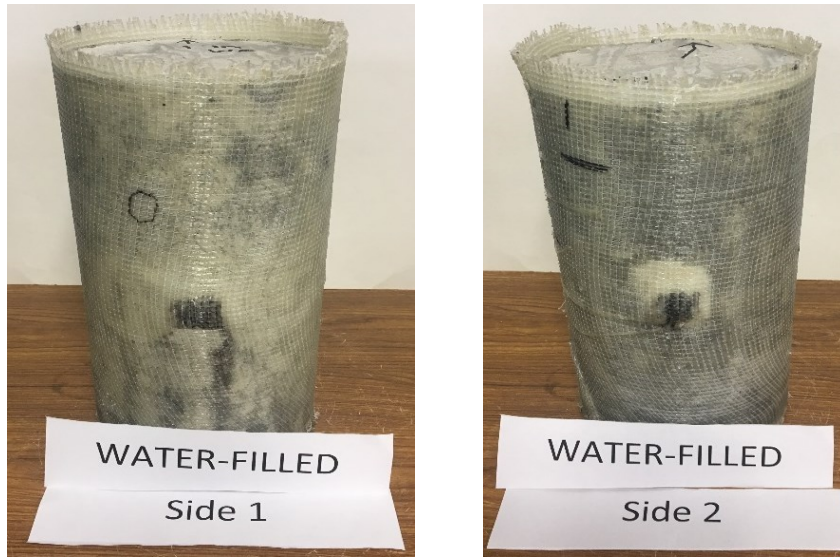
Figure 4-21: Side 1 (left) and Side 2 (right) of the GFRP-wrapped concrete cylinder, both containing 1” x 1” water-filled defect

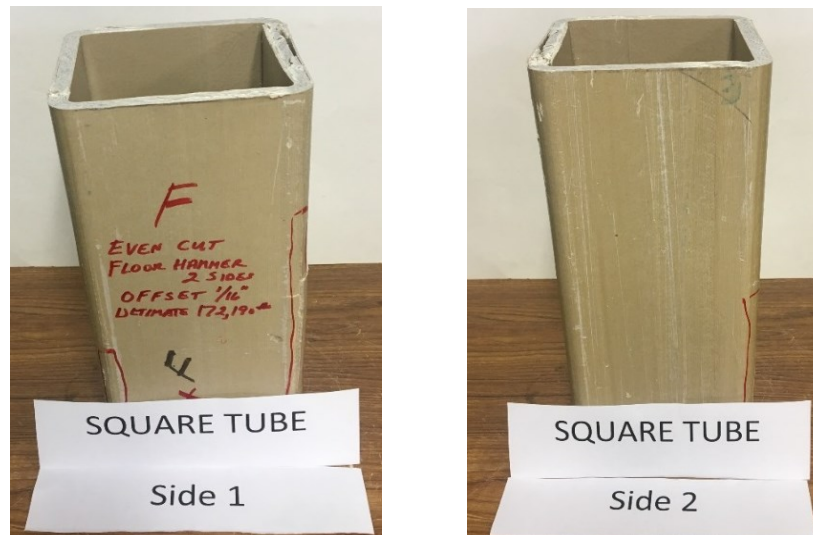
Figure 4-22: Side 1 (left) and Side 2 (right) of the GFRP composite square tube

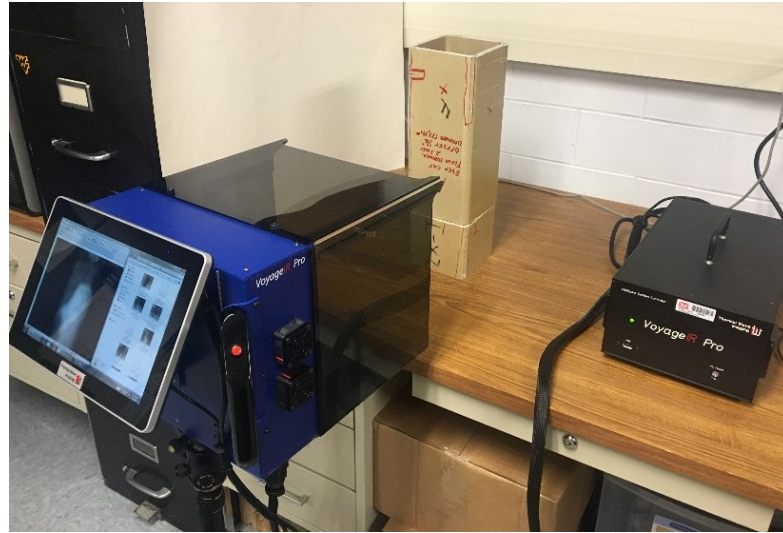
Figure 4-23: Laboratory setup of advanced infrared thermography on FRP specimens using VoyageIR Pro

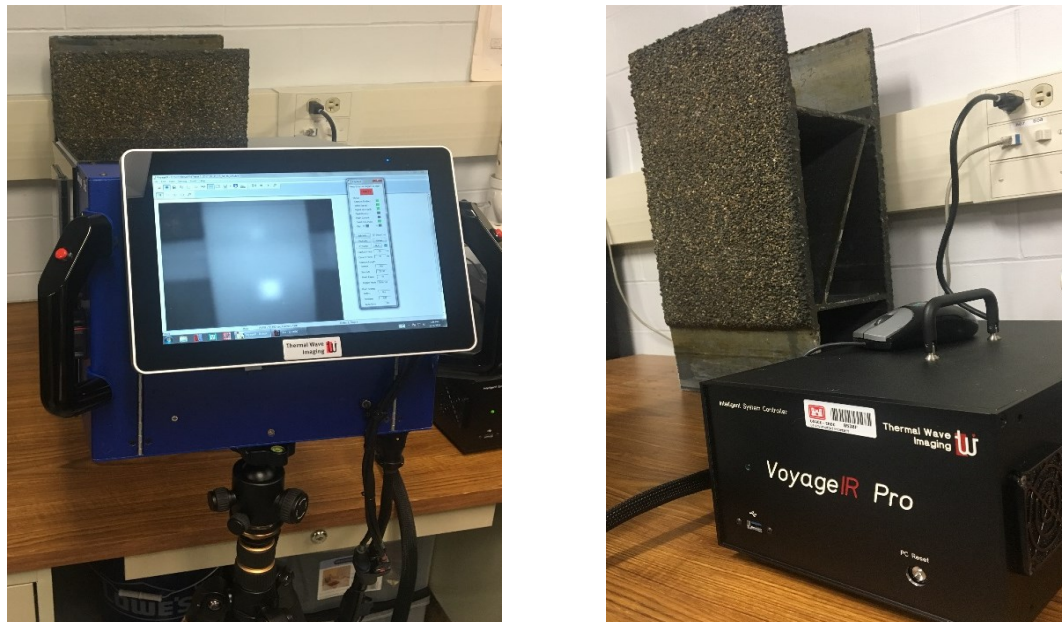
Figure 4-24: Components of VoyageIR Pro used in the laboratory experiment for advanced infrared thermography

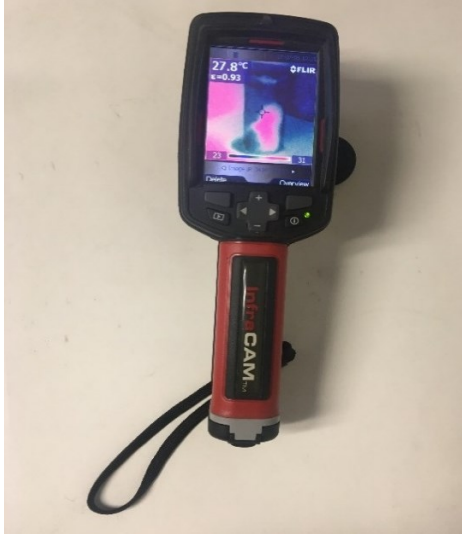
Figure 4-25: FLIR InfraCAM SD showing thermal image of a specimen in laboratory experiment

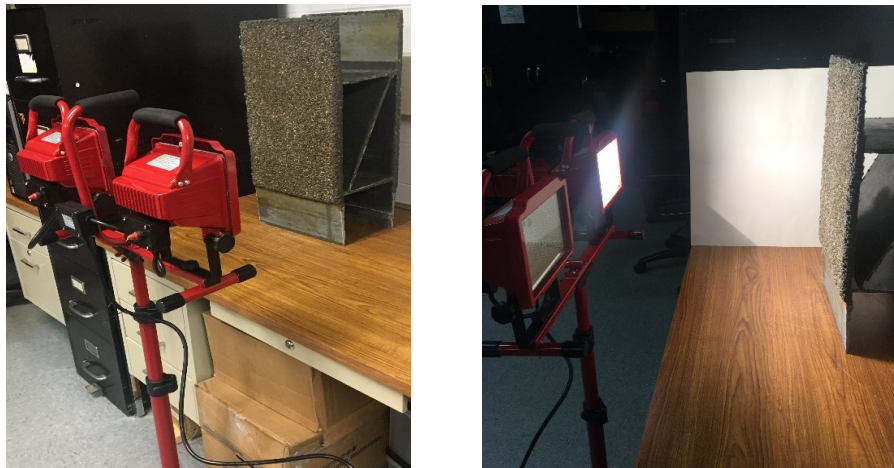
Figure 4-26: Laboratory setup of conventional infrared thermography using a halogen lamp heater

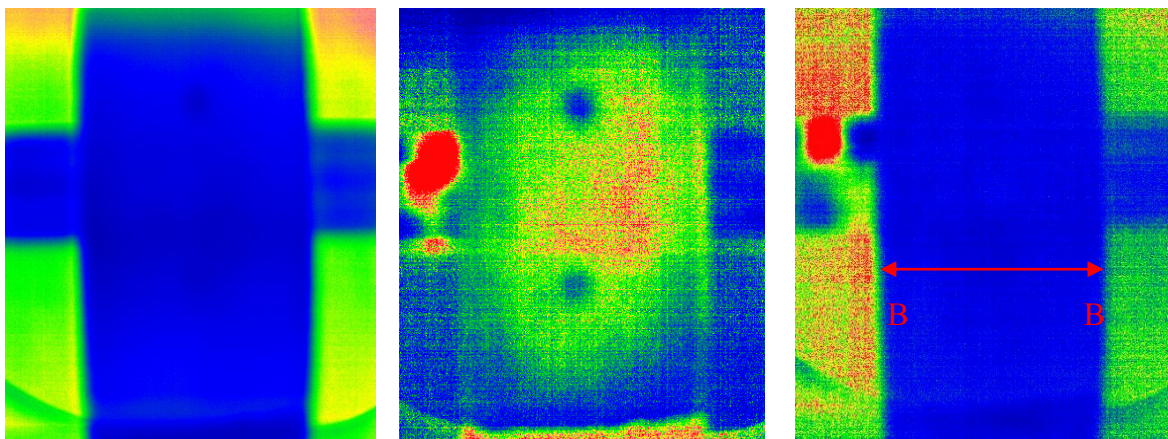
Figure 4-32: TSR image (left), 1st derivative image (center), and 2nd derivative image (right) of Side 2 of the deck specimen BD1 after 100 seconds of heating

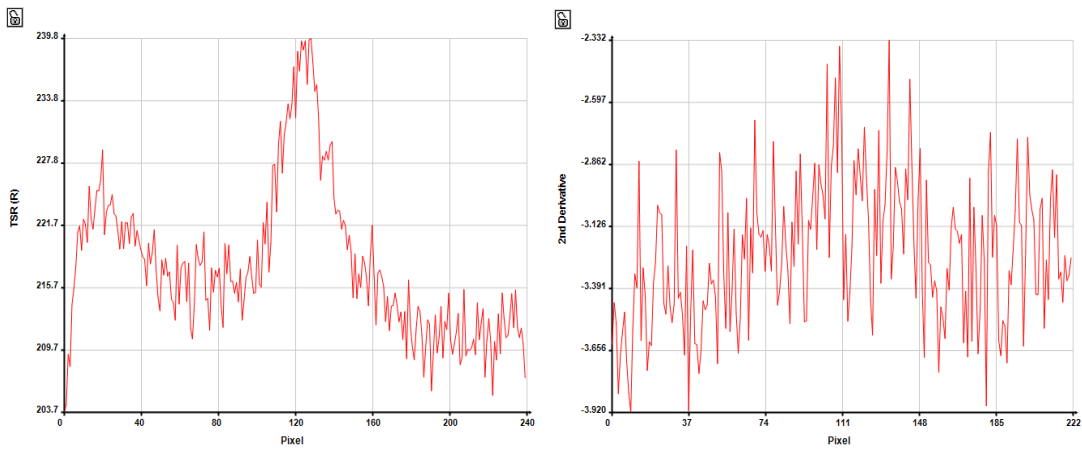
Figure 4-33: Plot of TSR intensity along line A-A (left) and of 2nd derivative intensity along line B-B (right)

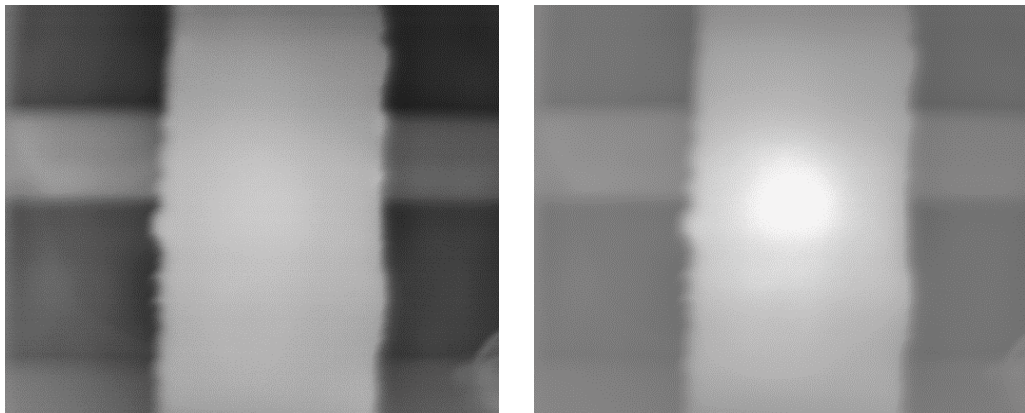
Figure 4-43: Raw thermal images of Side 1 of the deck specimen JD2 after 50 seconds of heating (left) and 200 seconds of heating (right)

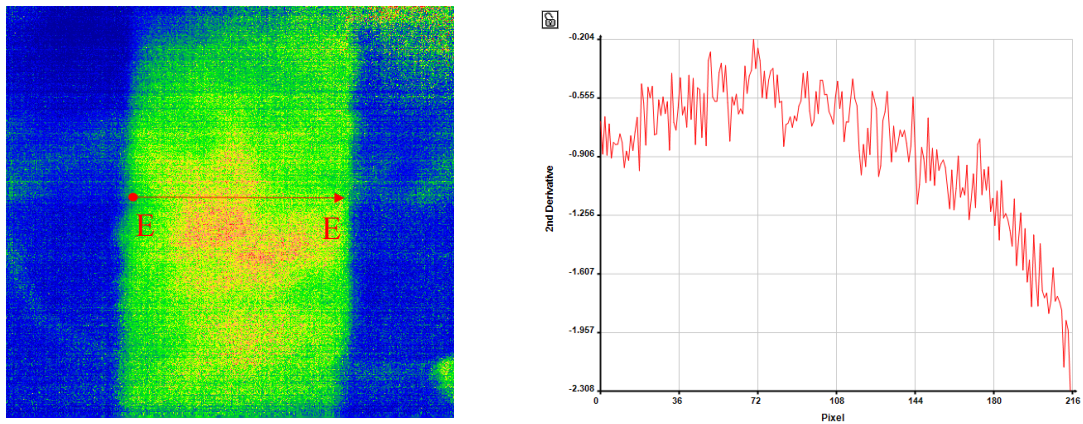
Figure 4-44: 2nd derivative image of Side 1 of the deck specimen JD2 after 100 seconds of heating (left) and plot of 2nd derivative intensity along the line E-E (right)

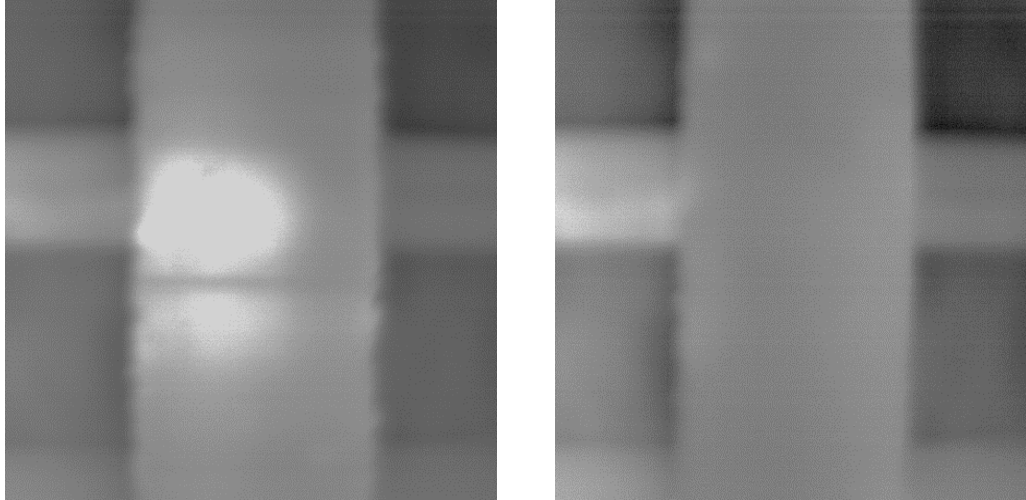
Figure 4-47: Raw thermal images of uncovered Side 1 (left) and covered Side 2 (right) of the deck specimen WJD2 after 50 seconds of heating

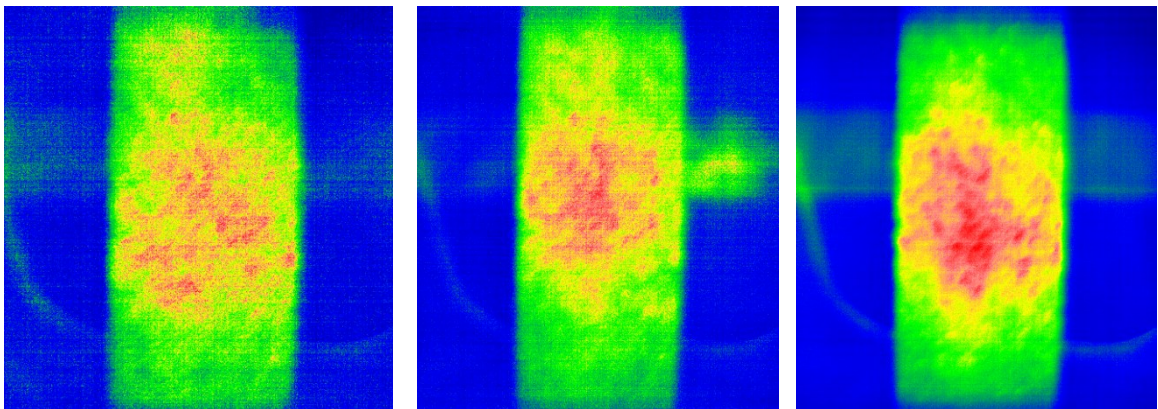
Figure 4-49: 1st derivative images of covered Side 2 of the deck specimen WJD2 after 50 seconds (left), 100 seconds (center), and 200 seconds (right) of heating

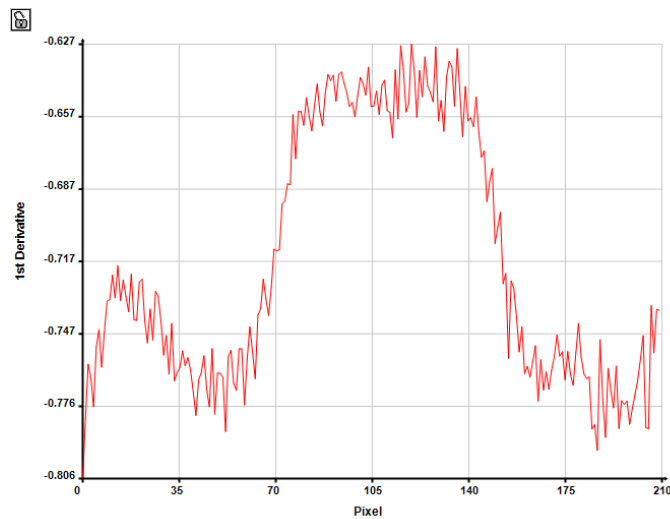
Figure 4-50: Plot of 1st derivative intensity along the line F-F on Side 1 of the deck specimen WJD2

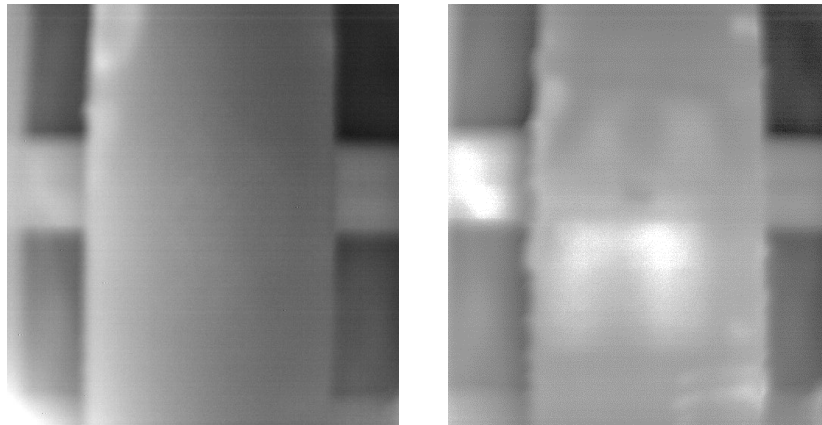
Figure 4-53: Raw thermal images of covered Side 1 (left) and uncovered Side 2 (right) of the deck specimen WJD3 after 50 seconds of heating

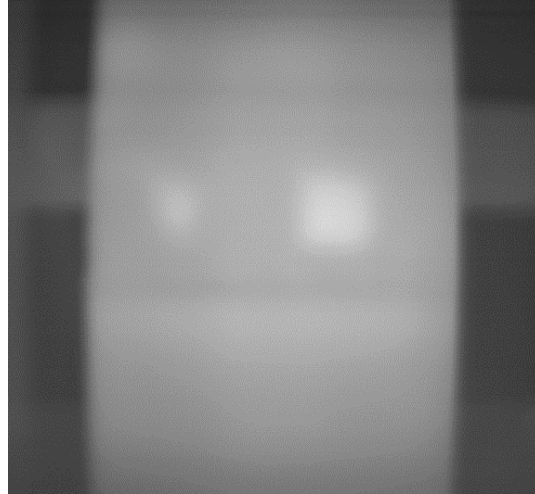
Figure 4-59: Raw thermal image of Side 1 of the deck specimen AS2 after 50 seconds of heating

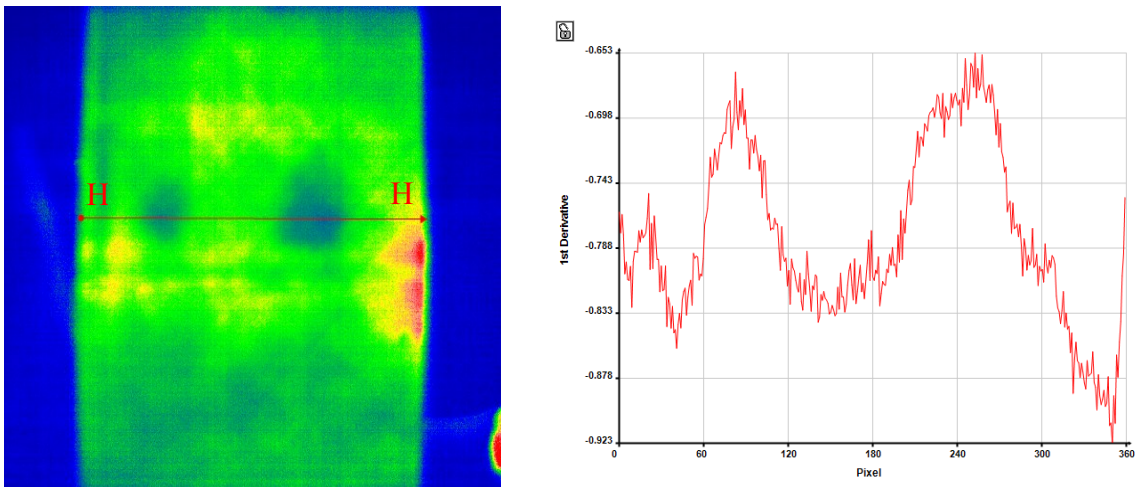
Figure 4-60: 1st derivative image of Side 1 of the deck specimen AS2 after 100 seconds of heating (left) and plot of 1st derivative intensity along the line H-H (right)

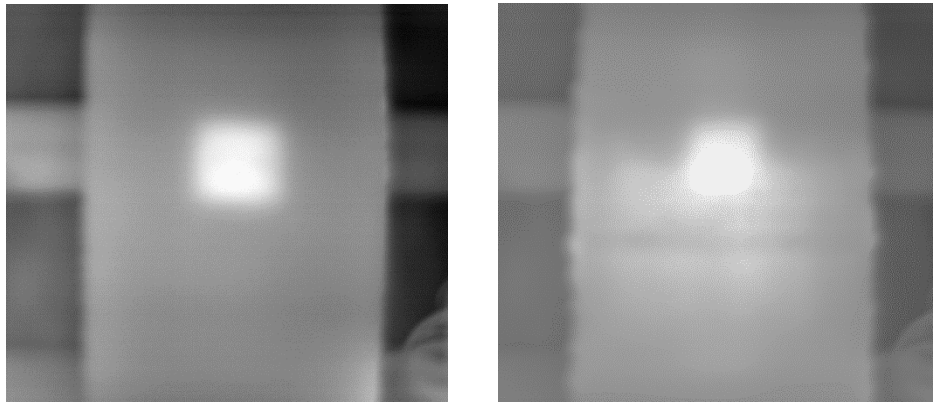
Figure 4-63: Raw thermal images of Side 1 (left) and Side 2 (right) of the deck specimen AS3 after 100 seconds of heating

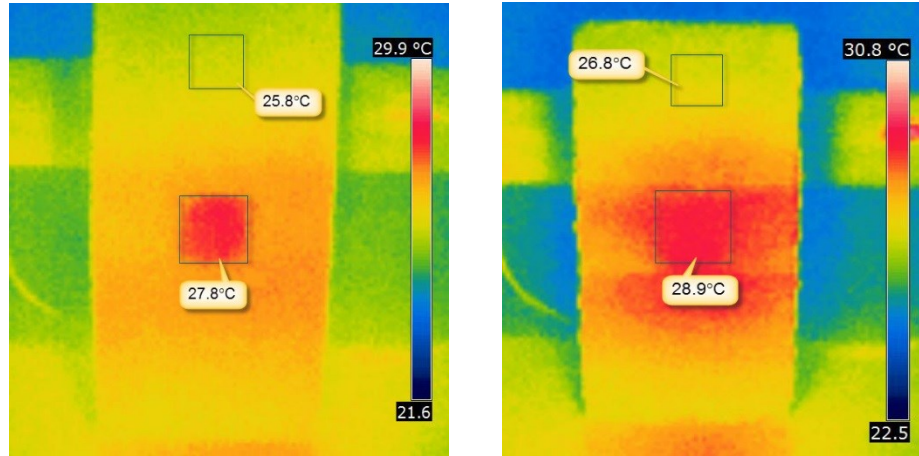
Figure 4-67: Thermal images of Side 1 (left) and Side 2 (right) of AS3 taken from FLIR InfraCAM SD after 50 seconds of heating from halogen lamp heater

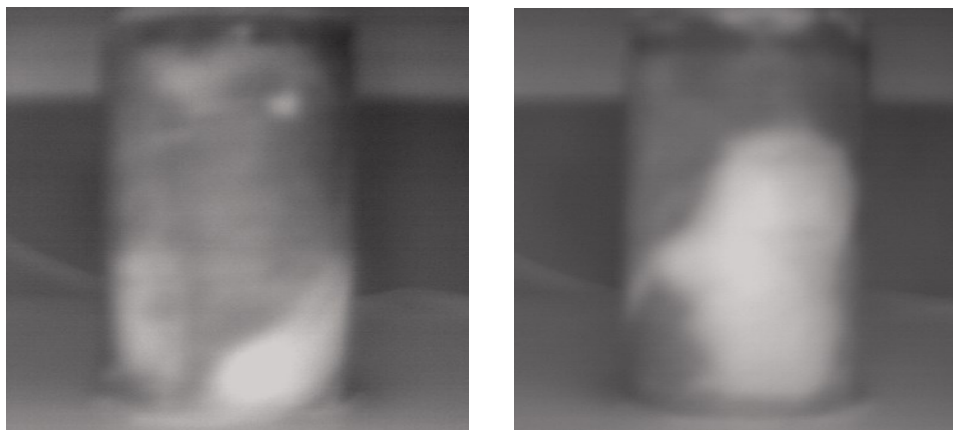
Figure 4-68: Raw thermal images of Side 1 (left) and Side 2 (right) of the defect-free cylinder specimen after 50 seconds of heating

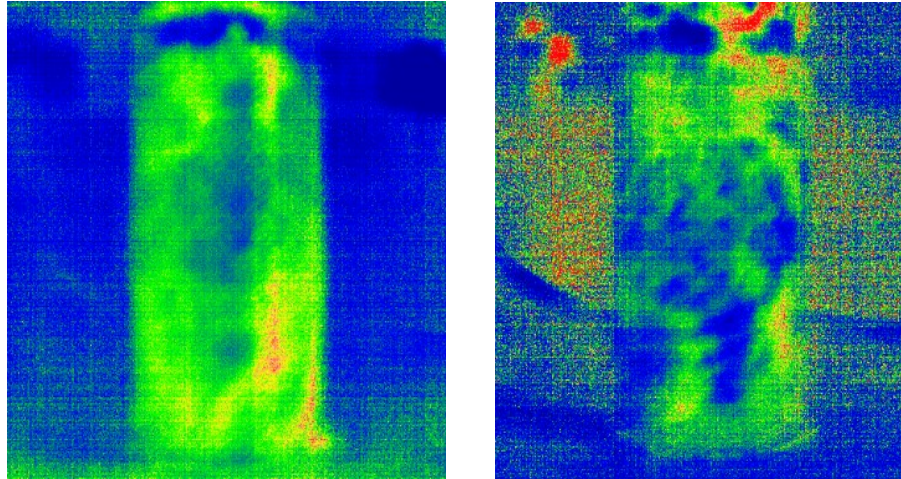
Figure 4-69: 2nd derivative images of Side 1 (left) and Side 2 (right) of the defect-free cylinder specimen after 50 seconds of heating
