Nondestructive evaluation of FRP composite bridge componenets using infrared thermography and digital tap tesing

Ruben Mangal Joshi

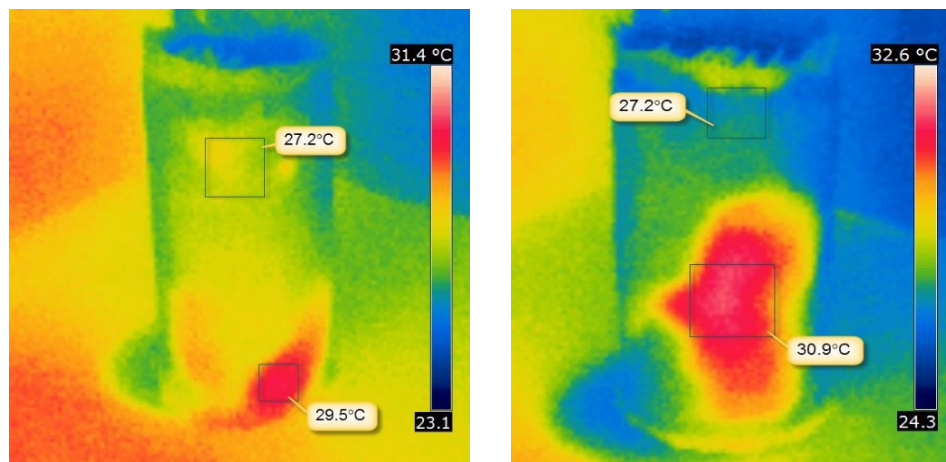
Figure 4-70: Thermal images of Side 1 (left) and Side 2 (right) of defect-free cylinder taken from FLIR InfraCAM SD after 50 seconds of heating from VoyageIR Pro system

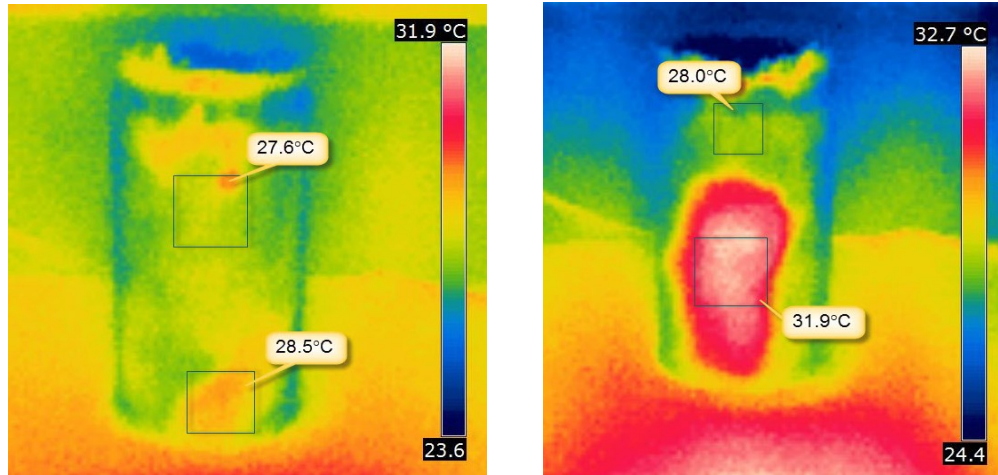
Figure 4-71: Thermal images of Side 1 (left) and Side 2 (right) of defect-free cylinder taken from FLIR InfraCAM SD after 50 seconds of heating from halogen lamp heater

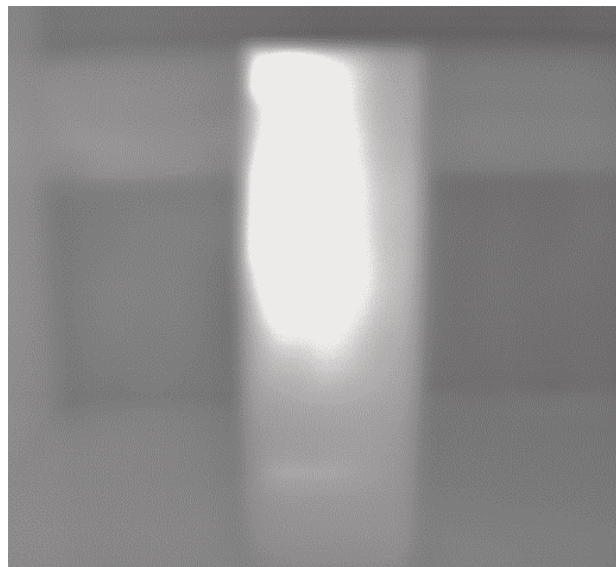
Figure 4-82: Raw thermal image of Side 1 (left) of the GFRP composite square tube specimen after 50 seconds of heating

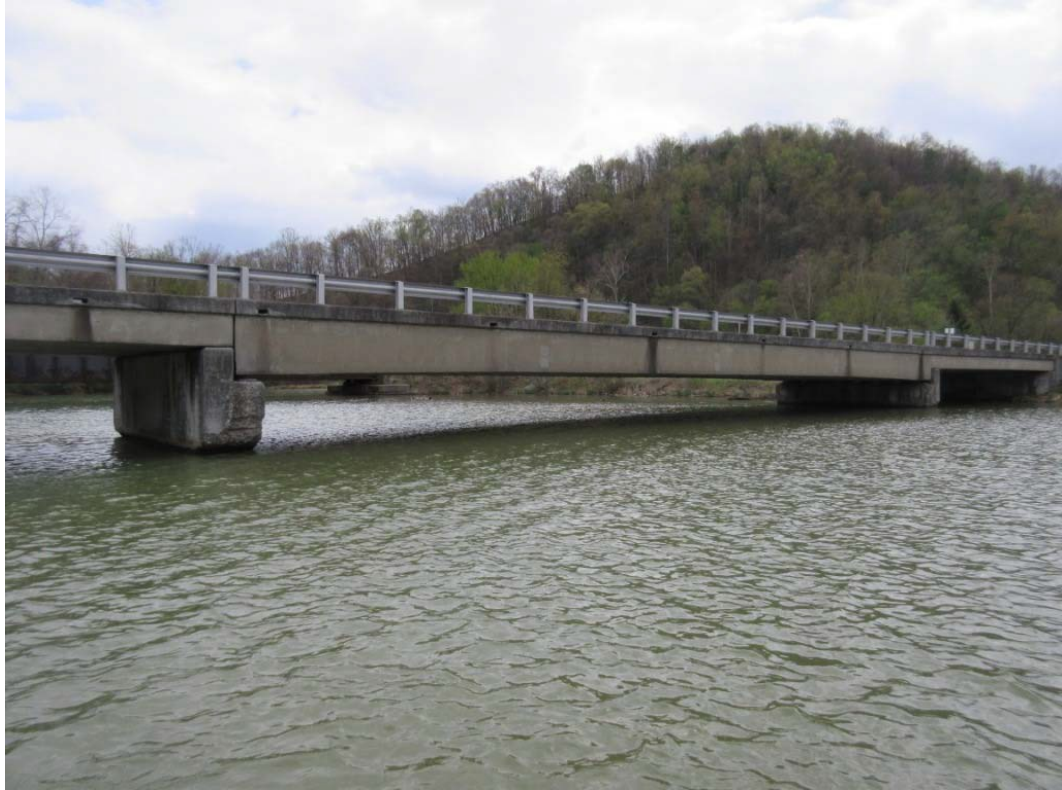
**Figure 5-2: West Elevation of the Whiteday Bridge
(Kollias 2015)**

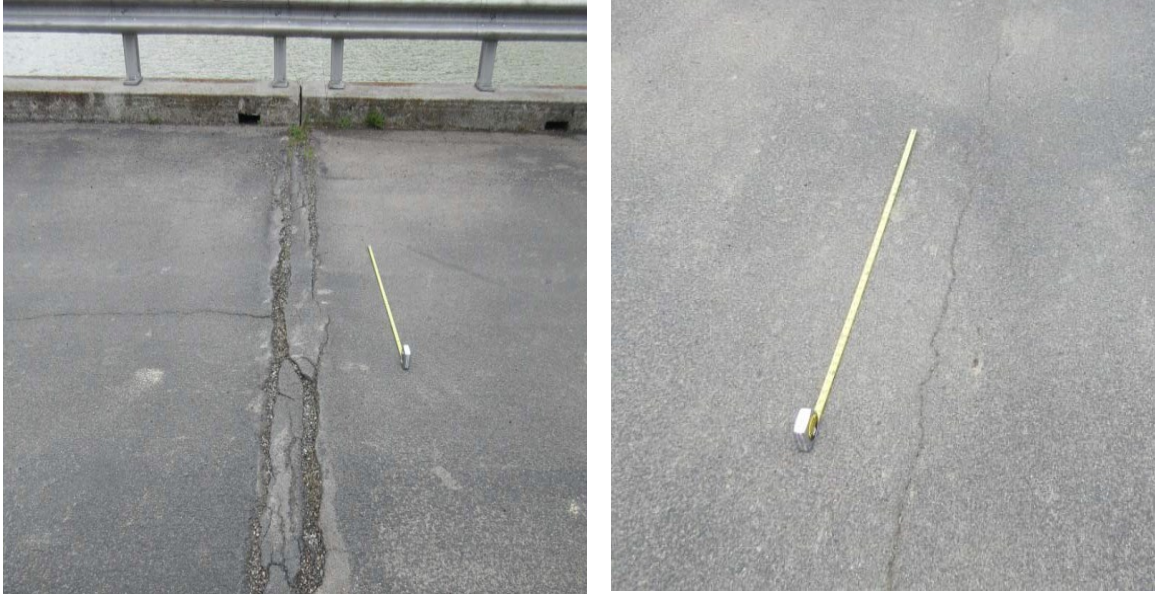
**Figure 5-4: Heaving on the wearing surface at Pier 2 deck joint (left) and Longitudinal cracks (right)
(Kollias 2015)**

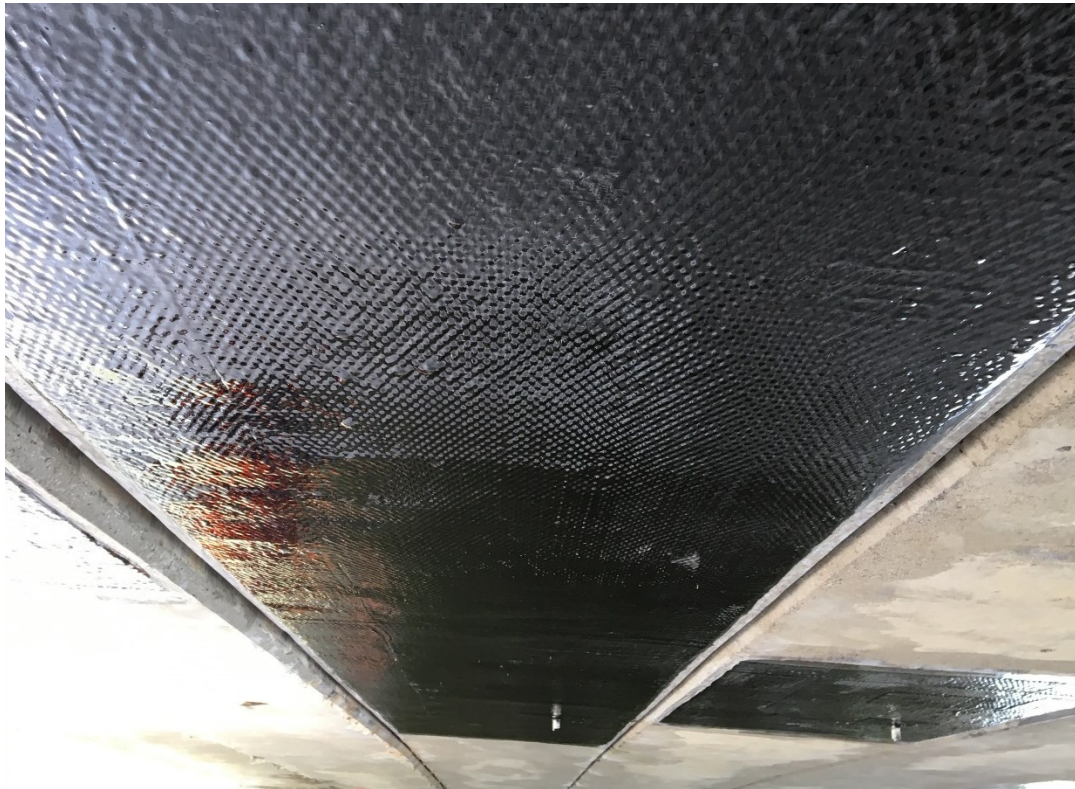
Figure 5-5: Main Span Beam repaired with CFRP fabric

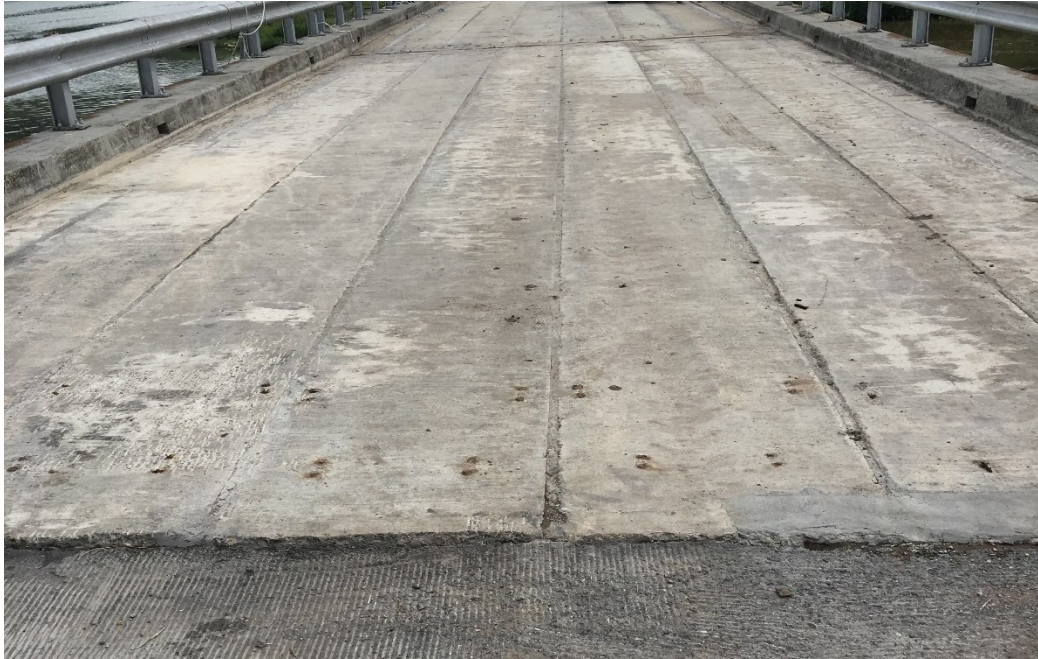
Figure 5-6: Wearing surface of the Whiteday Bridge under repair work

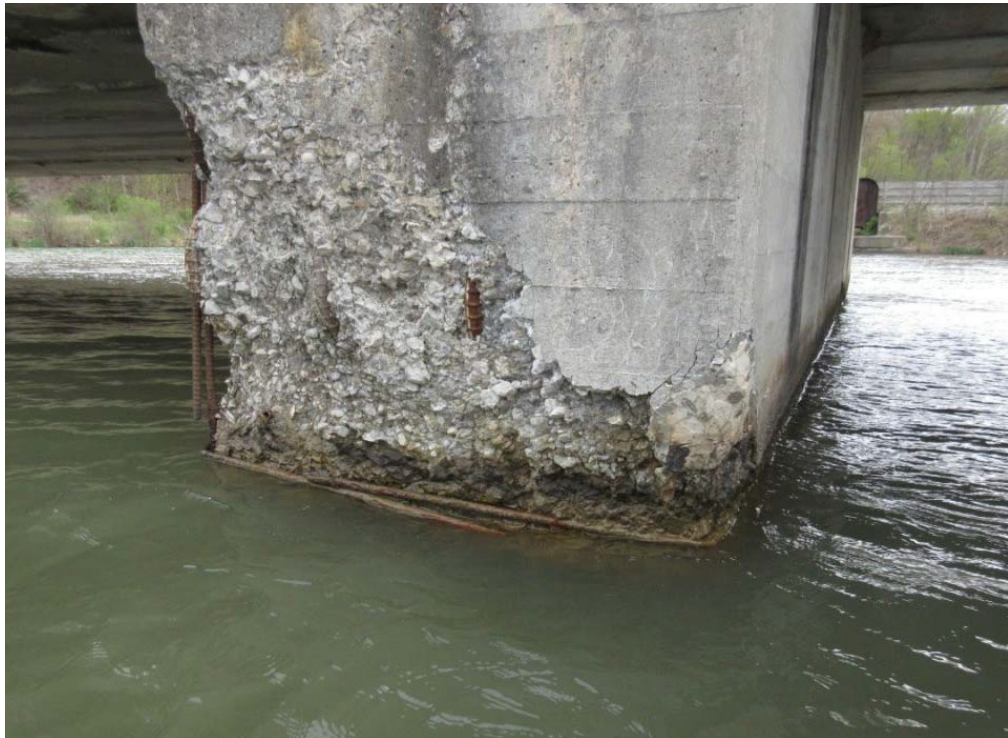
**Figure 5-7: Concrete spalling at the surface of contact with water in Pier 1
(Kollias 2015)**

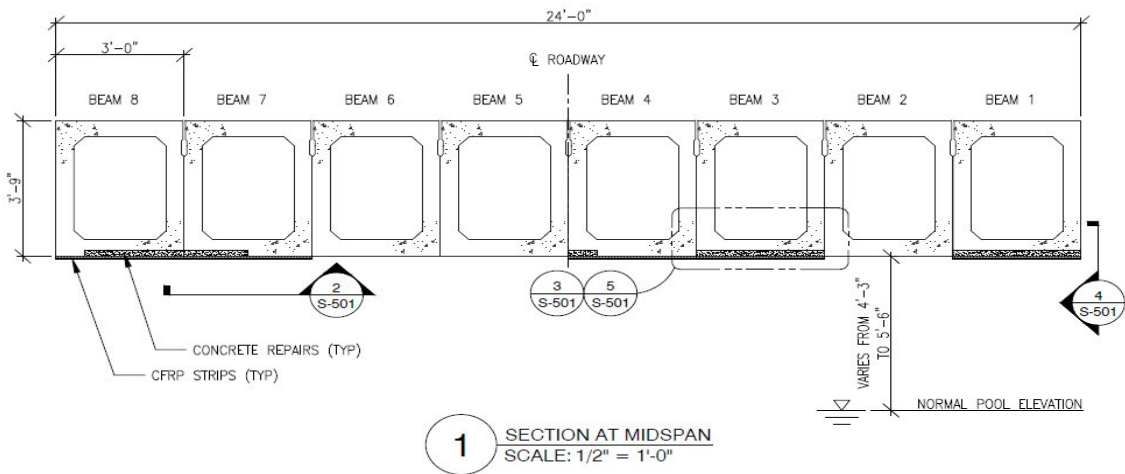
Figure 5-8: Cross-section at mid-span of the Whiteday Bridge (courtesy of USACE – Philadelphia District)

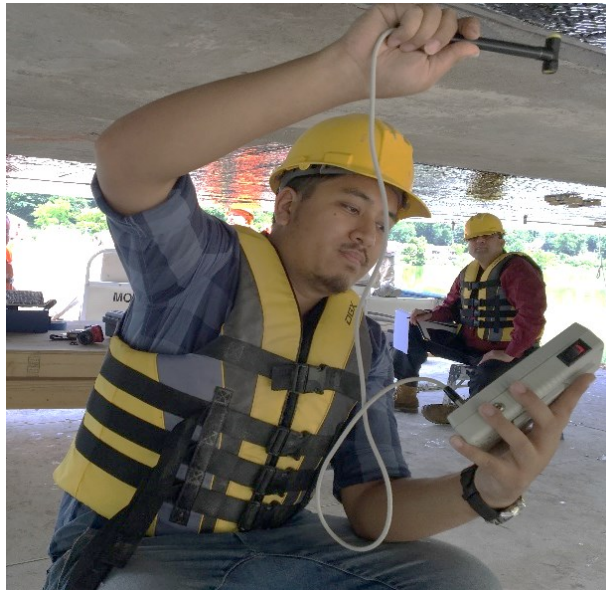
Figure 5-10: Digital Tap Testing with Rapid Damage Detection Device (RD³) on the Whiteday Bridge

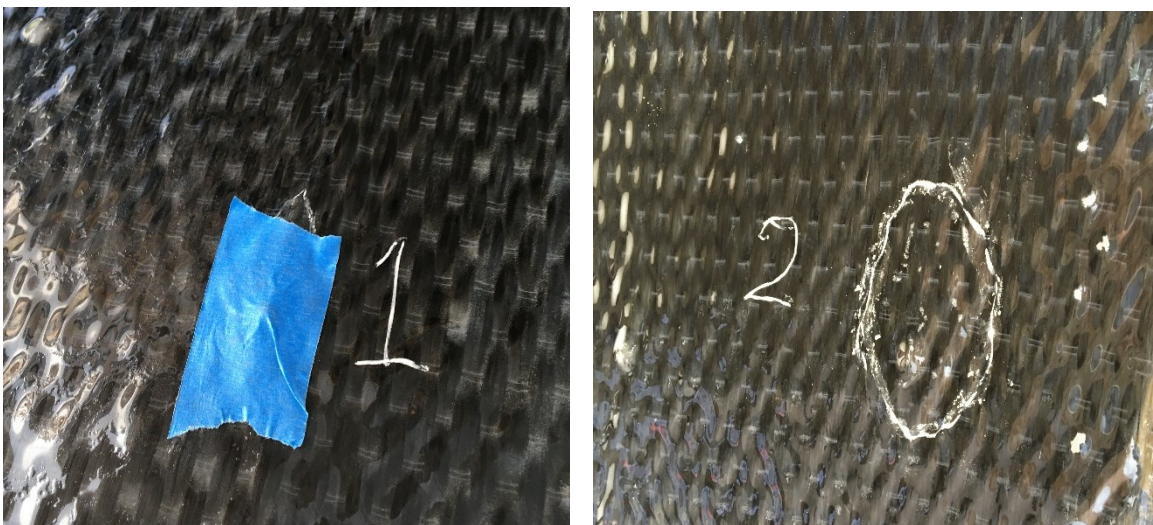
Figure 5-11: Marks and Labels on the Debonded Areas of the repaired beams

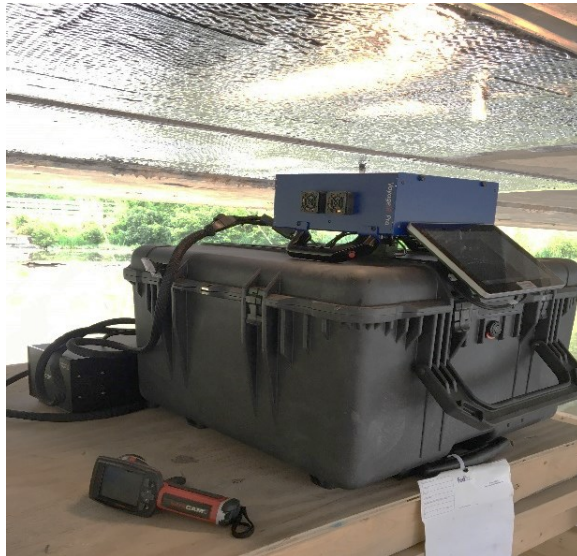
Figure 5-12: Infrared Test Setup with VoyageIR Pro and FLIR InfraCAM

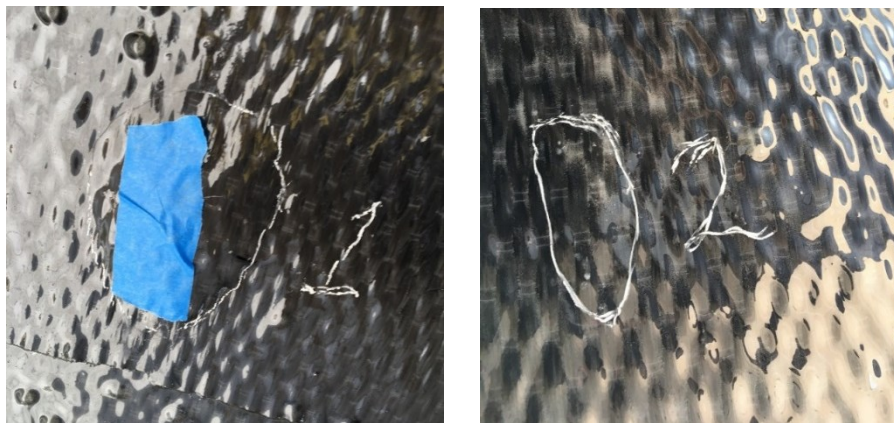
Figure 5-13: Defective Spots 1-1 (left) and 1-2 (right) on Beam 1 of the Whiteday Bridge

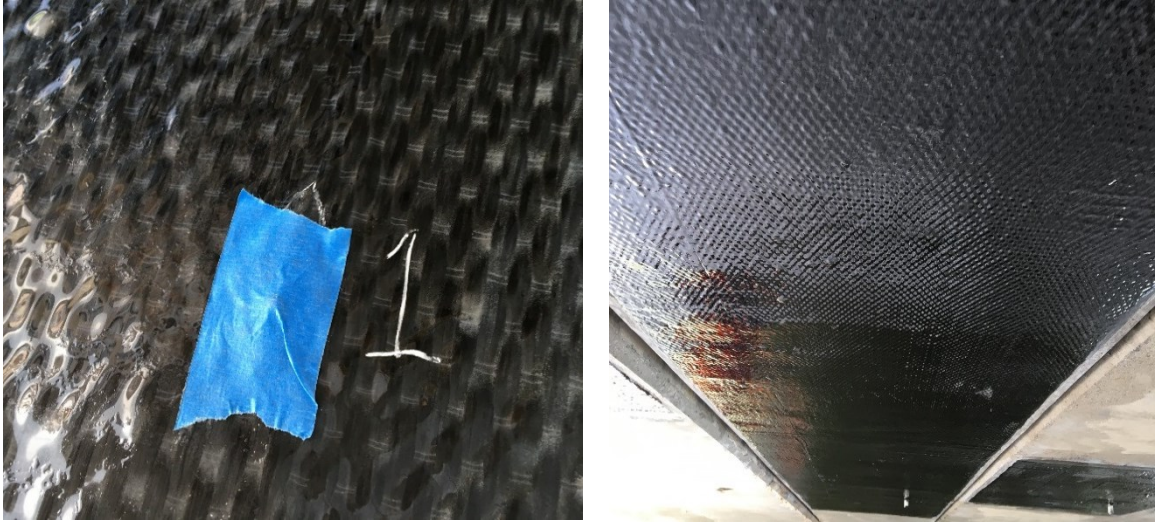
Figure 5-14: Debond 2-1 on Beam 2 (left) and Defect-free Beam 3 (right) of the Whiteday Bridge

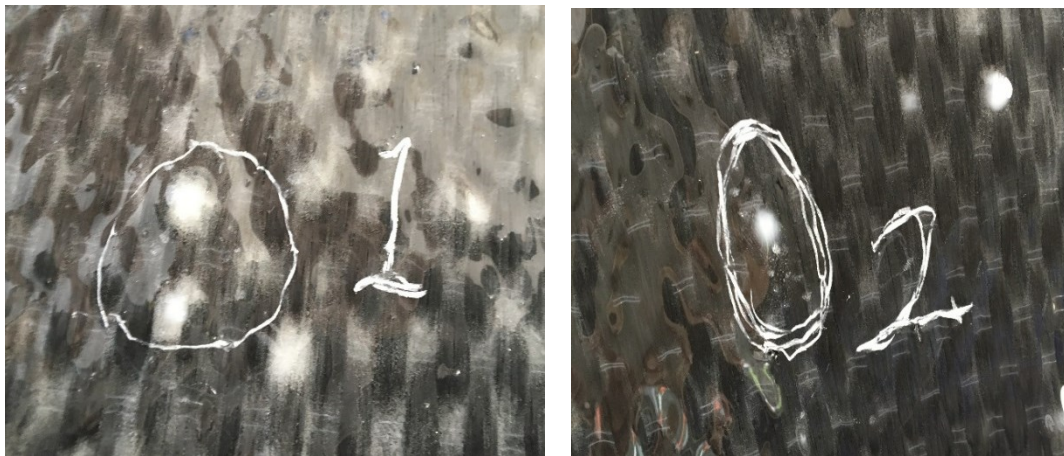
Figure 5-15: Defective Spots 4-1 (left) and 4-2 (right) on Beam 4 of the Whiteday Bridge

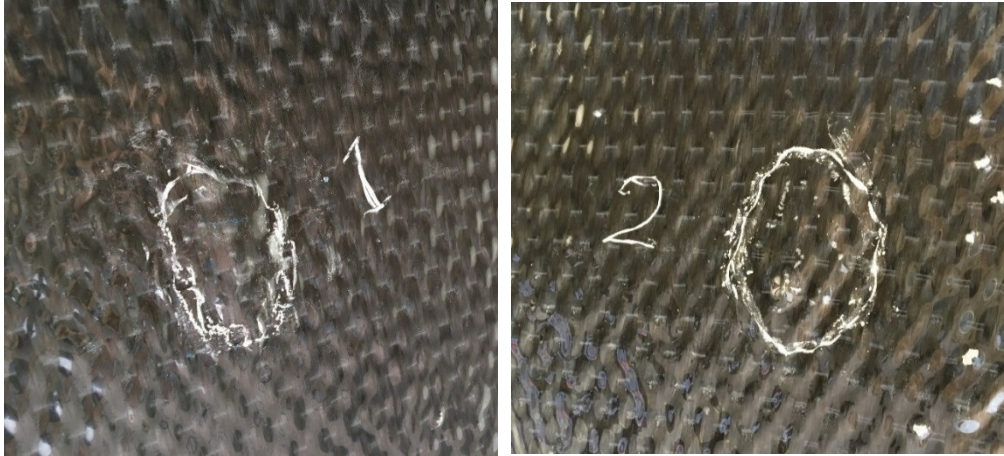
Figure 5-16: Debonds 7-1 (left) and 7-2 (right) on Beam 7 of the Whiteday Bridge

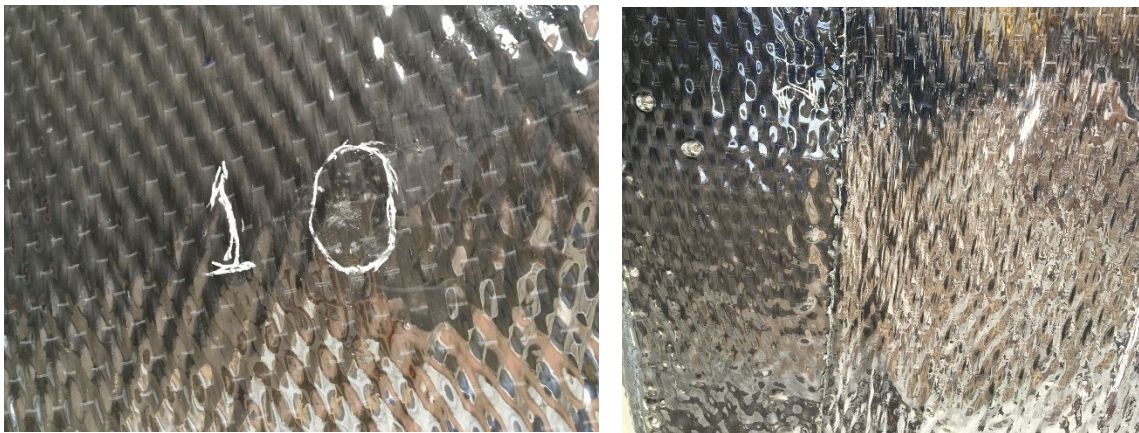
Figure 5-17: Defective Spots 8-1 (left) and 8-2 (right) on Beam 8 of the Whiteday Bridge

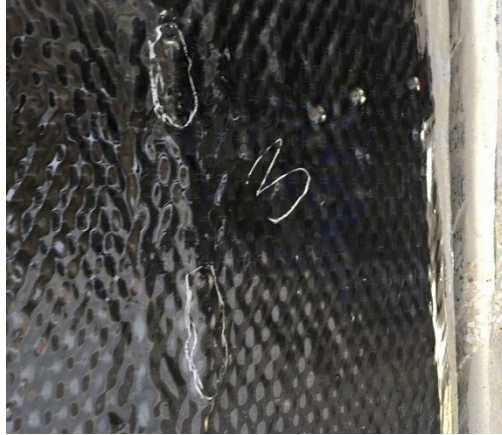
Figure 5-18: Debond 8-3 with two small pockets on Beam 8 of Whiteday Bridge

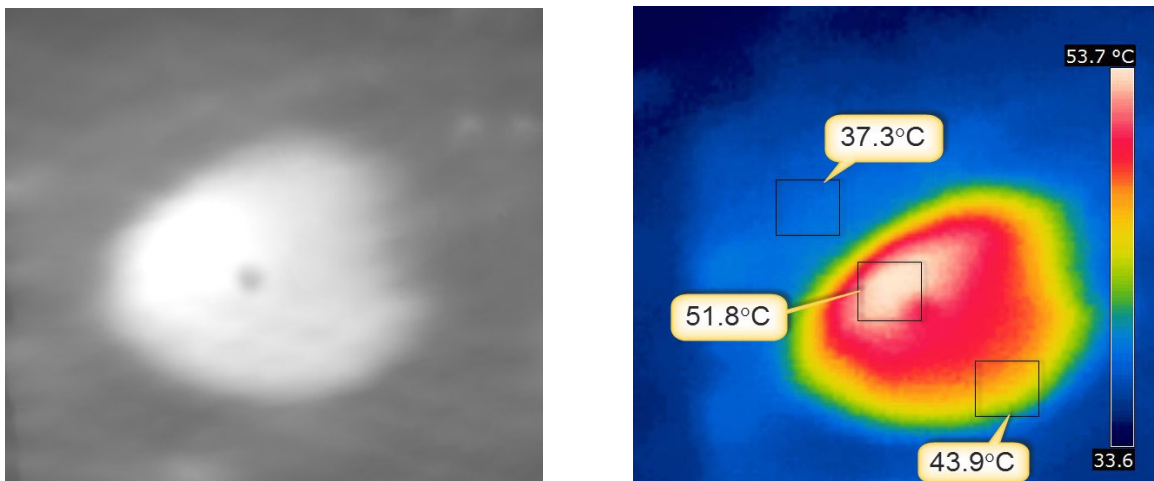
Figure 5-20: Raw Thermal Image from VoyageIR Pro (left) and Infrared Image from FLIR InfraCAM SD (right) of the Debond 1-1 on Beam 1 of the Whiteday Bridge

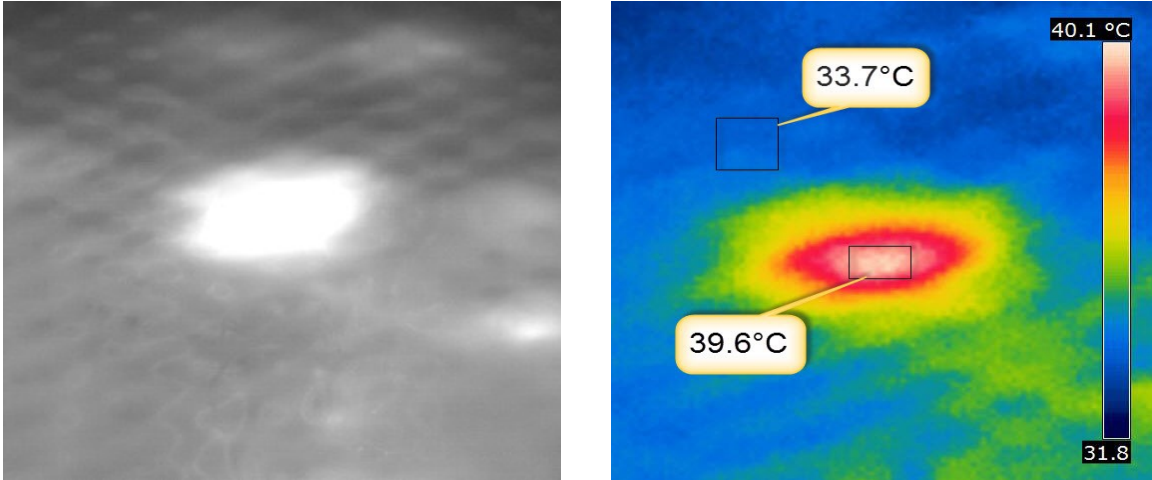
Figure 5-21: Raw Thermal Image from VoyageIR Pro (left) and Infrared Image from FLIR InfraCAM SD (right) of the Debond 1-2 on Beam 1 of the Whiteday Bridge

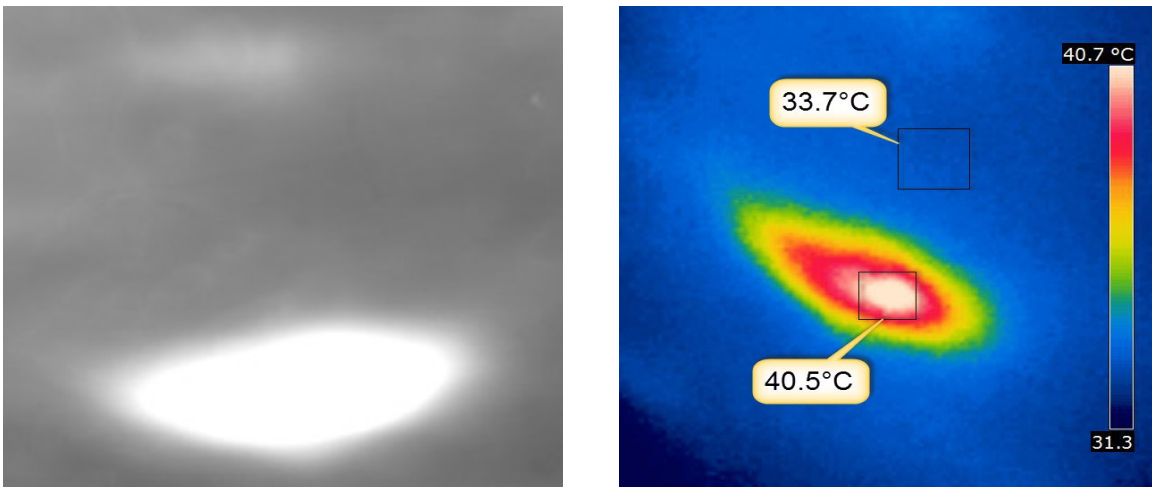
Figure 5-22: Raw Thermal Image from VoyageIR Pro (left) and Infrared Image from FLIR InfraCAM SD (right) of the Debond 2-1 on Beam 2 of the Whiteday Bridge

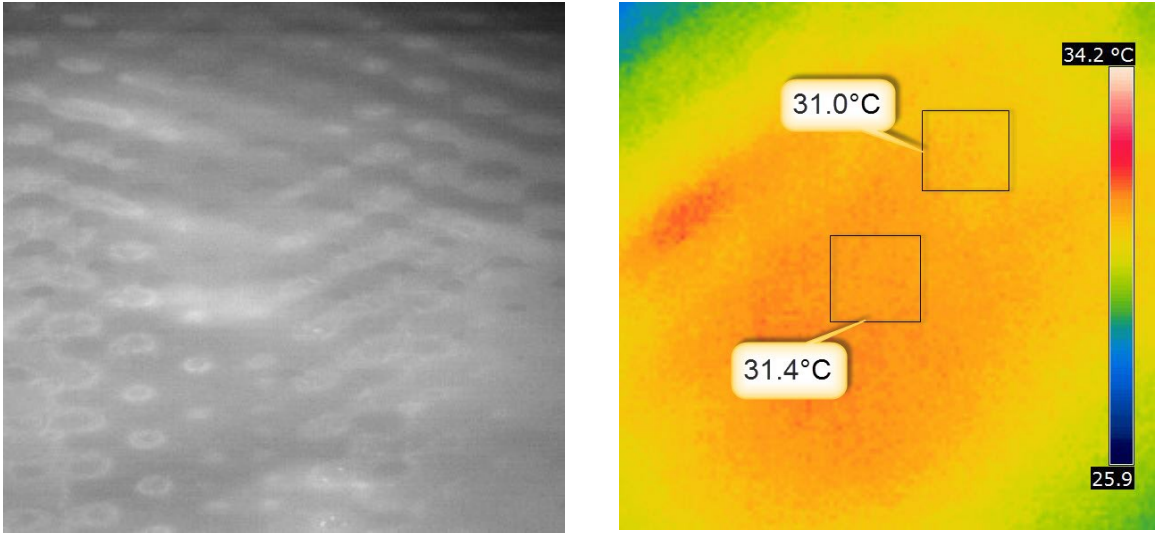
Figure 5-24: Raw Thermal Image from VoyageIR Pro (left) and Infrared Image from FLIR InfraCAM SD (right) of the Defect-free Beam 3 of the Whiteday Bridge

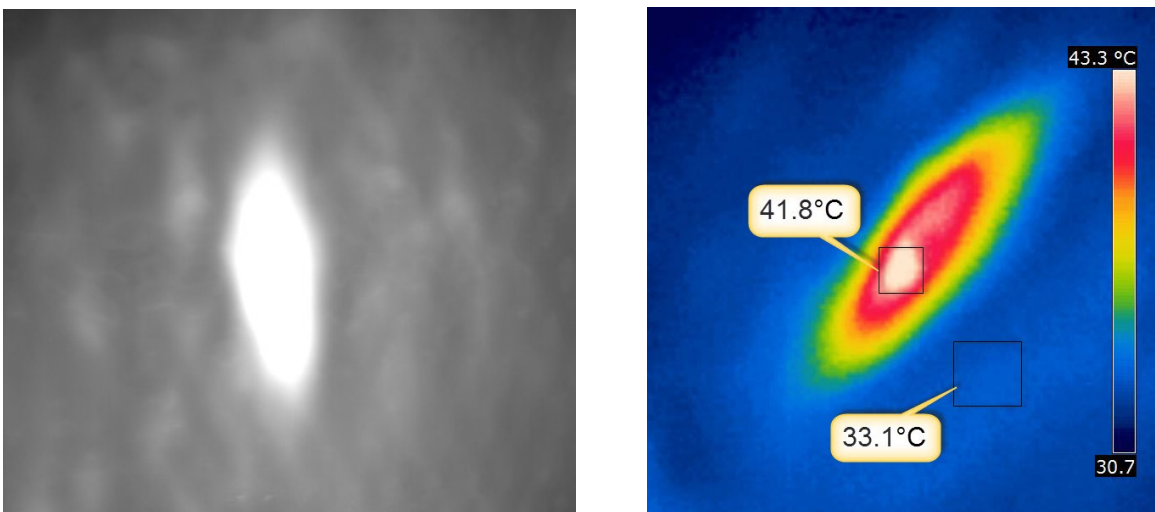
Figure 5-23: Raw Thermal Image from VoyageIR Pro (left) and Infrared Image from FLIR InfraCAM SD (right) of the Defective Spot 4-1 on Beam 4 of the Whiteday Bridge

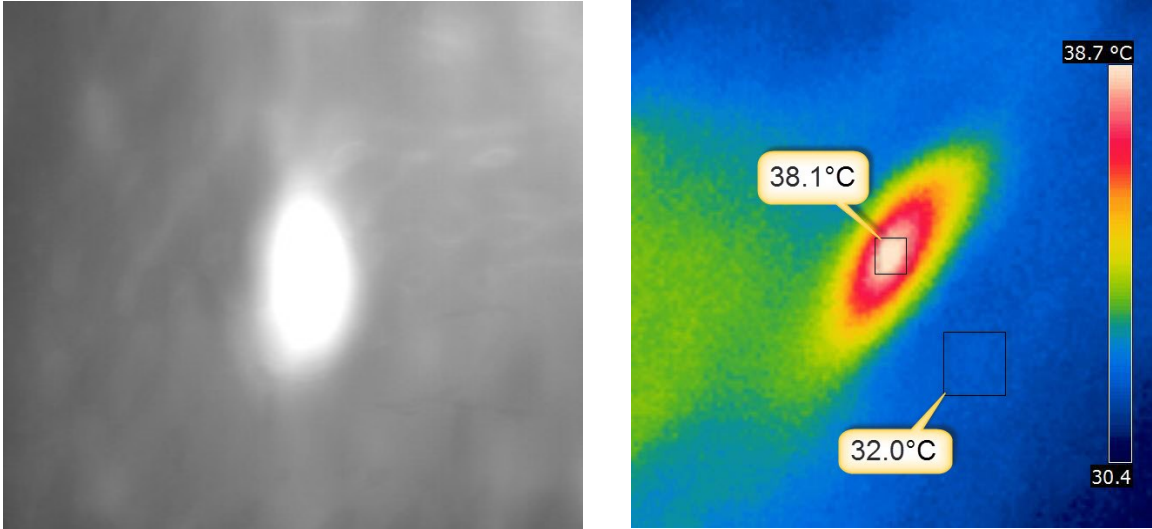
Figure 5-25: Raw Thermal Image from VoyageIR Pro (left) and Infrared Image from FLIR InfraCAM SD (right) of the Defective Spot 4-2 on Beam 4 of the Whiteday Bridge

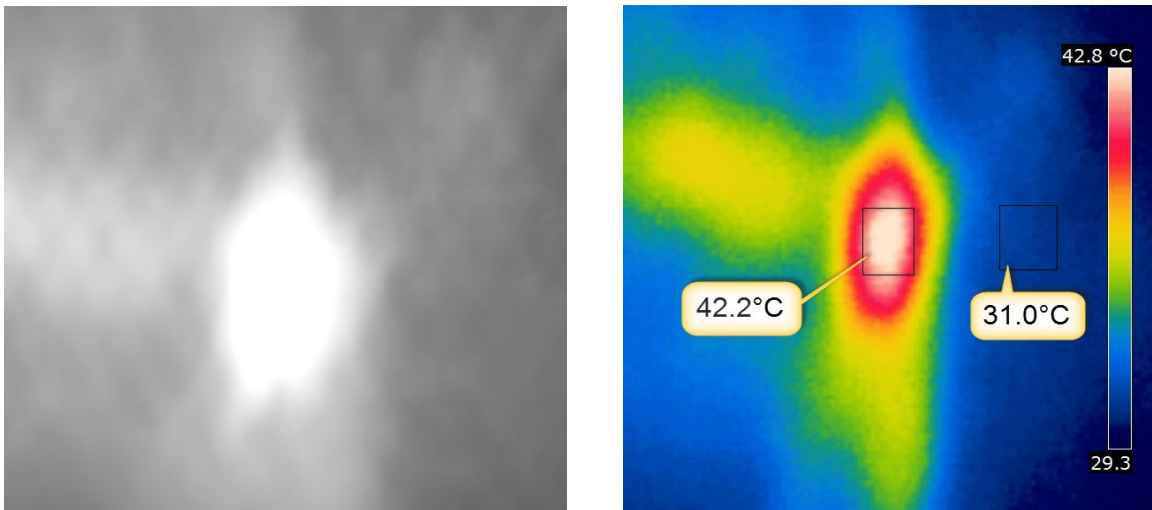
Figure 5-26: Raw Thermal Image from VoyageIR Pro (left) and Infrared Image from FLIR InfraCAM SD (right) of the Defective Spot 7-1 on Beam 7 of the Whiteday Bridge

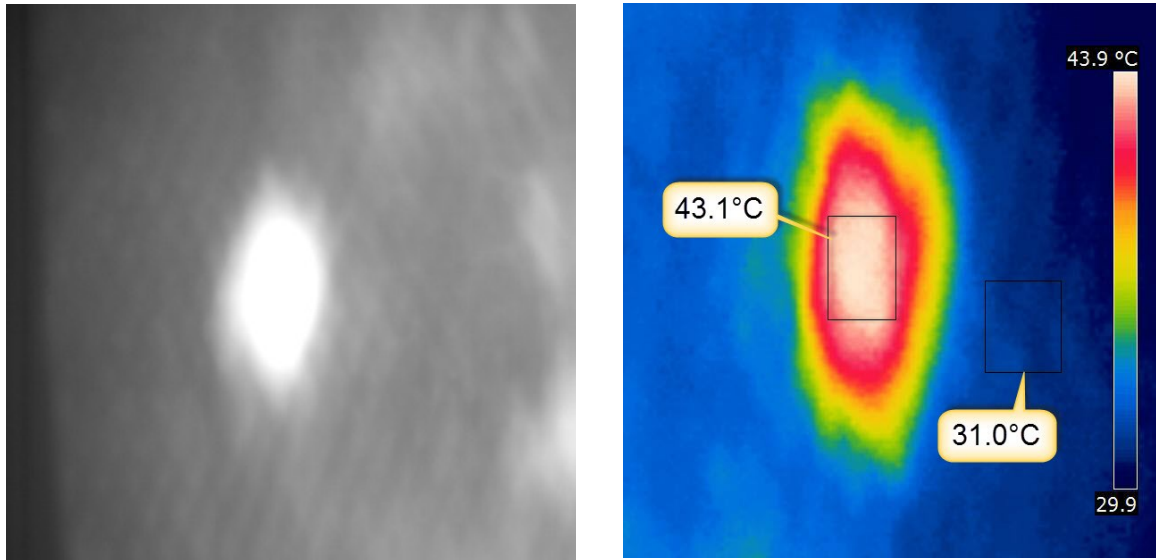
Figure 5-27: Raw Thermal Image from VoyageIR Pro (left) and Infrared Image from FLIR InfraCAM SD (right) of the Defective Spot 7-2 on Beam 7 of the Whiteday Bridge

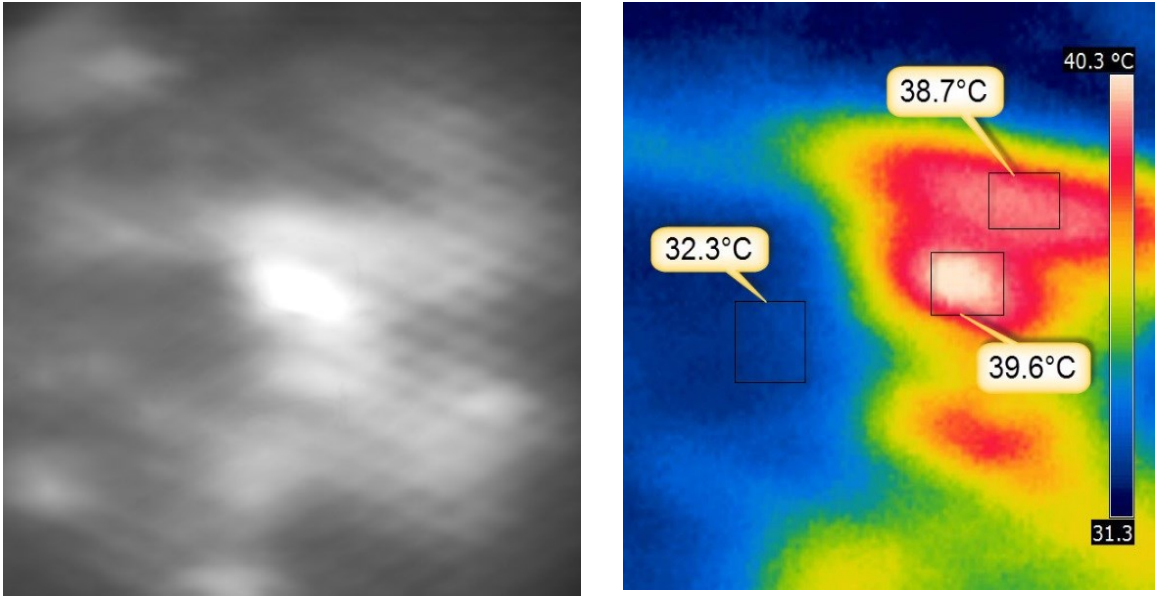
Figure 5-28: Raw Thermal Image from VoyageIR Pro (left) and Infrared Image from FLIR InfraCAM SD (right) of the Defective Spot 8-1 on Beam 8 of the Whiteday Bridge

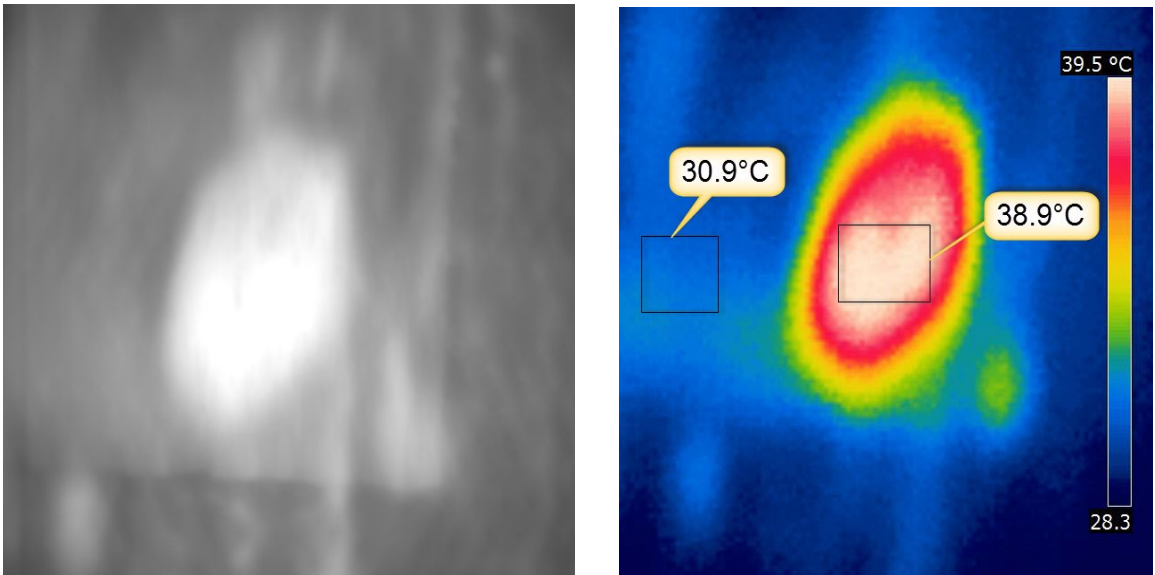
Figure 5-29: Raw Thermal Image from VoyageIR Pro (left) and Infrared Image from FLIR InfraCAM SD (right) of the Defective Spot 8-2 on Beam 8 of the Whiteday Bridge

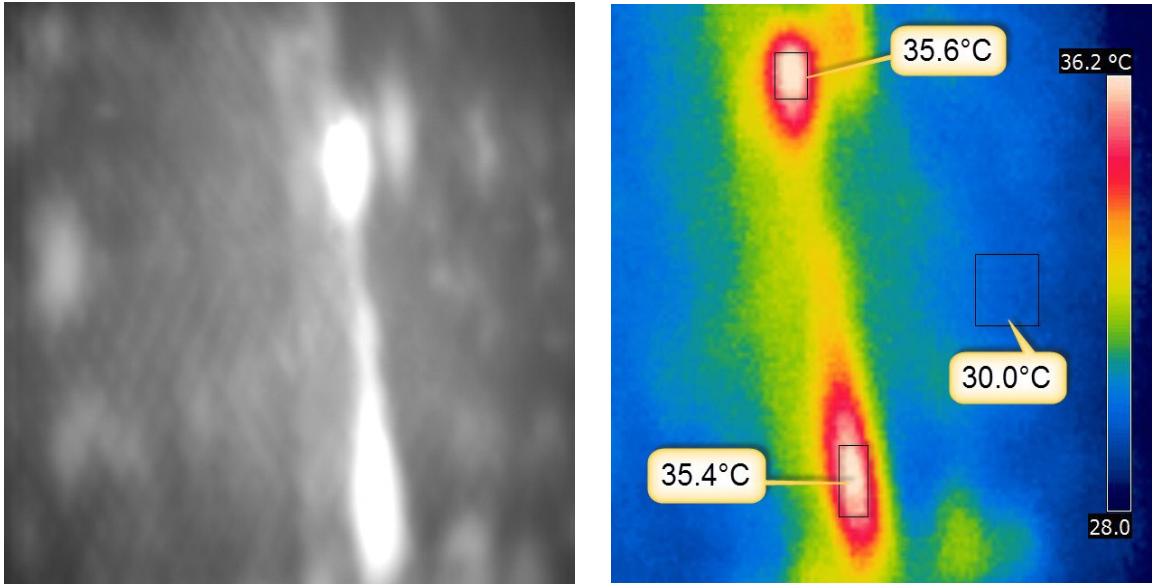
Figure 5-30: Raw Thermal Image from VoyageIR Pro (left) and Infrared Image from FLIR InfraCAM SD (right) of the Defective Spot 8-3 on Beam 8 of the Whiteday Bridge
