## Assessment of application, effectiveness, and compliance of forestry best management practices in West Virginia

**ASSESSMENT OF APPLICATION, EFFECTIVENESS, AND COMPLIANCE OF  
FORESTRY BEST MANAGEMENT PRACTICES IN WEST VIRGINIA**

**Keywords: Best Management Practices, Compliance Assessment, Water Quality,  
Timber Harvesting, Forest Operations, Forest Management**

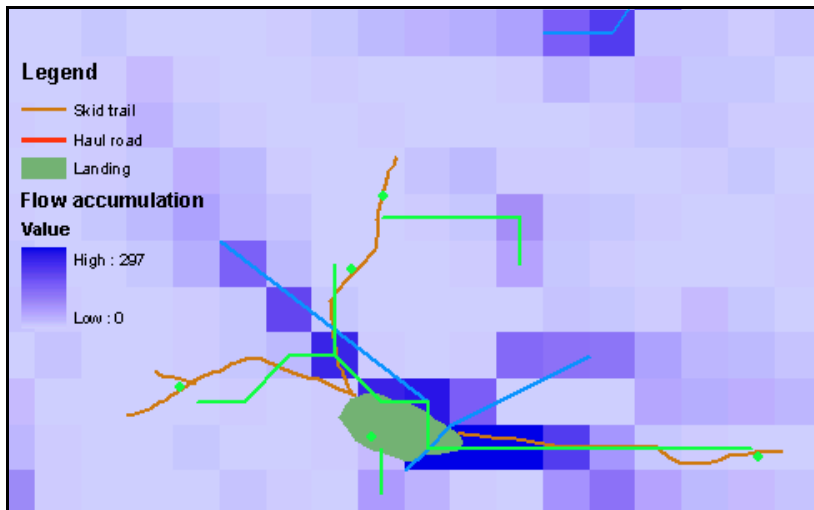
A poor example of SMZ buffer application is illustrated in Figure 3.6. The flow accumulation raster shows that the greatest amount of water is passing directly by or over the landing. Two of the skid trails cross the stream at high accumulation points. Due to the landing elevation and placement, the skid trails run downward onto the landing. This site in particular did not have the required number of water bars, and the ones that were in place received low effectiveness rankings. The grade of the skid trails exceeded 15% on numerous sections. Using this information and the soil characteristic of “slight” for both erosion and equipment limitation we can see where the greatest runoff may occur. The raindrop tool shows how overland flow will

drain. Without the proper water diversion, water would flow directly down the skid trail and into the stream. Sediment was noticed on this site, but there was sufficient seeding and mulching on the skid trails and landing to reduce most of the runoff. The compliance for this site was 78%. This was due to the proper reclamation of the steep skid trails, and a great amount of detail to the seeding and mulching of disturbed areas. Even with the steep grades and lack of water bars this site had high application and effectiveness levels for the other BMPs assessed.

Figure 3.6. Poor application on perennial stream.

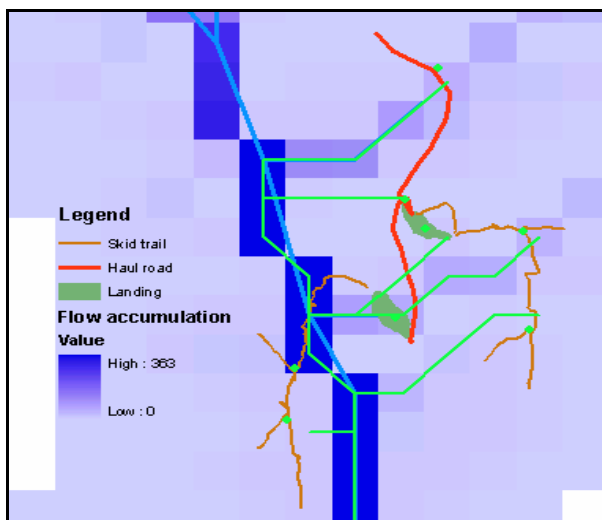
Figure 3.7. Good application of perennial stream.

Another site with a perennial stream, in which BMPs were applied with good effectiveness in the SMZ is shown in Figure 3.7. A major stream runs around the landing site, and along the skid trail. Soils on this site have “slight” erosion hazards and equipment limitations. The landing had no water diversion, and was not located on a dry site. It was seeded and mulched, but was located directly beside a stream. There were few water bars constructed, which led to erosion of the skid trail. As seen in the Figure 3.7 several sections of the skid trail were constructed directly beside the stream. The haul road for this site was graveled, but there no reclamation was performed for the stream crossing. The second landing was constructed at a higher elevation, and further from the stream. This landing did not receive as much overland flow as the bottom landing did. The BMPs did not have good application or effectiveness levels, which led to a compliance level of only 54%.

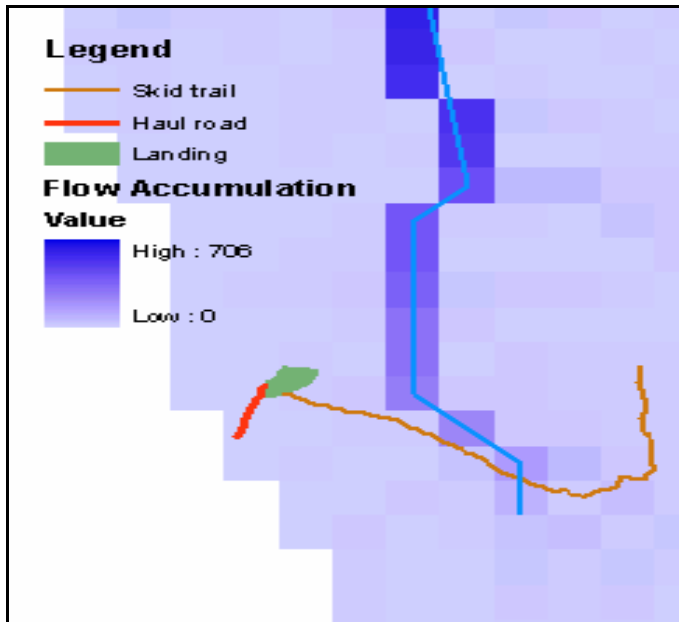
Intermittent streams also require a 100 ft. buffer. The required buffer and BMPs were applied to this site (Figure 3.8). A culvert was installed at the stream crossing, and the skid trail was seeded and mulched for the proper distance on both sides of the stream. Riprap was also installed at the lower end of culvert for better erosion control. The landing and haul road were constructed at a higher elevation than the stream. The landing had the proper water diversion and was also seeded and mulched. The BMPs assessed on this site ranked very well in application and effectiveness. The site was well drained with “severe” equipment limitations. These limitations could have affected the compliance if the BMPs had not been applied with as much detail. The overall BMP compliance on this tract was 84%.

Figure 3.8. Good application of intermittent stream.

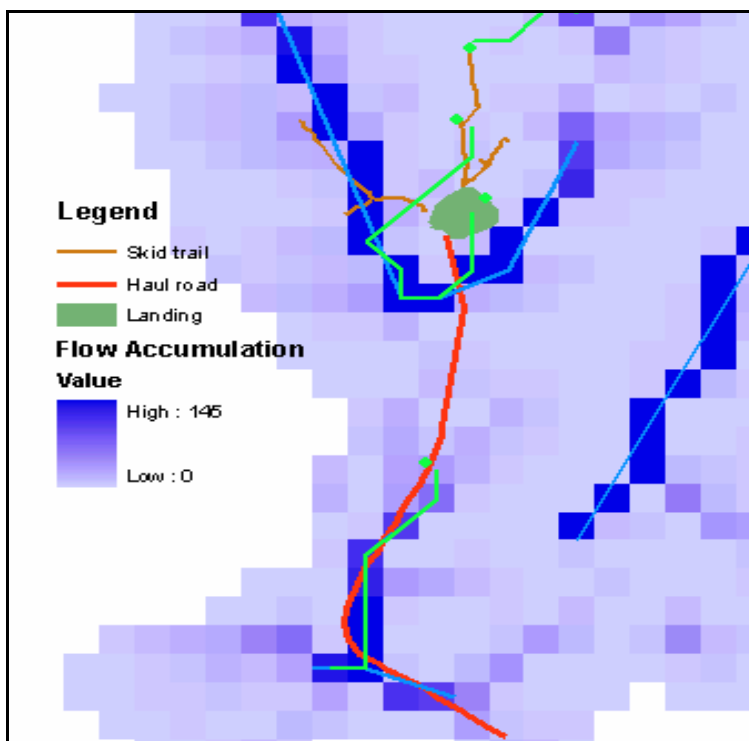
Figure 3.9. Poor application of intermittent stream.

The extended stream network was affected by the skid trail and haul road on this site (Figure 3.9). There was a “severe” equipment limitation and “moderate” erosion hazard for this

soil. The landing was constructed at a higher elevation than the streams, which aided in drainage of the landing. This also reduced the amount of water running onto the landing. The skid trail, which crossed a major flow accumulation point did not have any reclamation performed. The stream crossing had a great deal of rutting and runoff into the stream. The haul road leading to a main road had received no gravel, and had severe rutting. Sediment was found in the stream next to the haul road. With the “severe” equipment limitations the main flow accumulation points should have been avoided if at all possible. The lack of reclamation and the SMZ violations reduced the compliance for this tract to 50%.

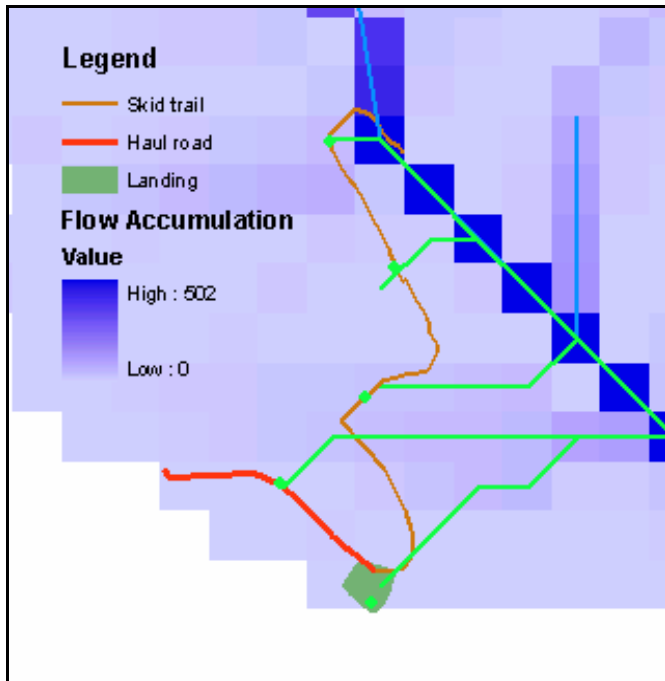
The skid trail came into contact with the ephemeral stream on this particular site (Figure 3.10). The skid trail was reclaimed properly with an excellent ranking. The haul road and landing were constructed out of the SMZ, and at a higher elevation. This limits the runoff from the skid trail, which had the correct number of water bars, and was drained properly. The soil for this area was well drained with “severe” equipment limitations and erosion hazards. With these soil characteristics the placement of the landing was crucial. The possibility of erosion would have greatly increased had the landing been placed at a lower elevation and closer to the stream. The effectiveness of the water bars in the skid trail did not receive a perfect ranking, but they were applied often enough to reduce runoff. This tract had an overall BMP compliance of 78%, which was among the highest for the sites with ephemeral streams.

Figure 3.10. Good application of ephemeral stream.

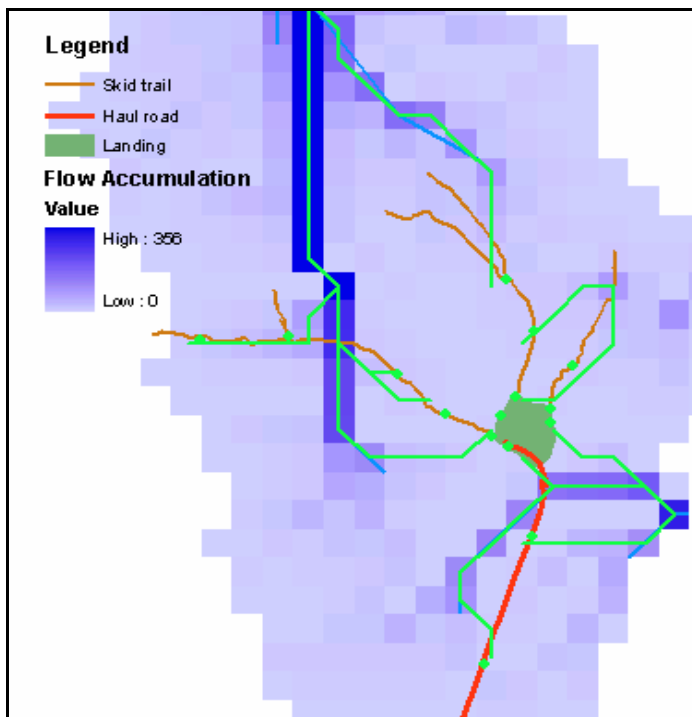
Figure 3.11. Poor application of ephemeral stream.

Two ephemeral streams were found during the time of assessment on a site where sections of the skid trail crossed these streams (Figure 3.11). During the assessment the eastern most skid

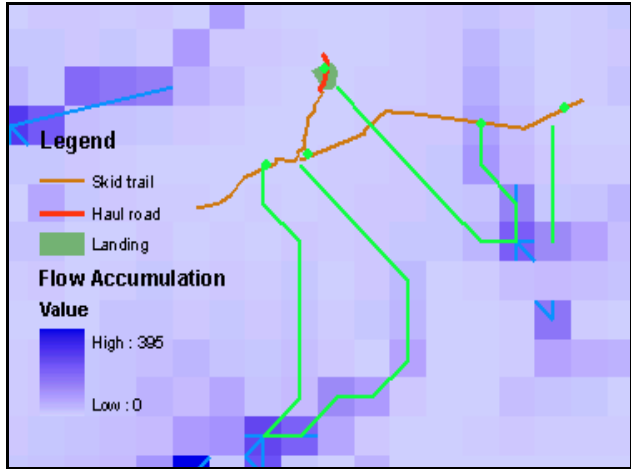
Figure 3.13. Correct SMZ width.

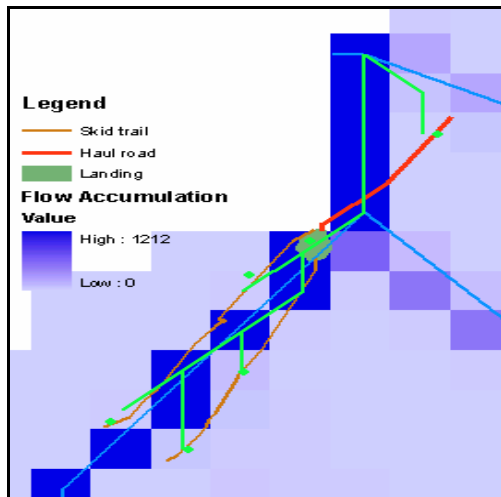
Figure 3.14. Incorrect SMZ width.

Another example showed that a perennial stream flowed directly through the site (Figure 3.14). The landing was placed beside of the stream, and the skid trail followed the stream up through the harvest. The soils on this site have “slight” erosion hazards and equipment limitations. The landing had no water diversion, and was not located on a dry site. It was not constructed at an elevation higher than the stream, nor was it seeded or mulched. There were few water bars constructed, which led to erosion of the skid trail. As seen in Figure 3.14 several sections of the skid trail were constructed directly beside the stream. There was some sediment into the stream, and ruts had formed in the skid trails. The haul road for this site was graveled, but there was no

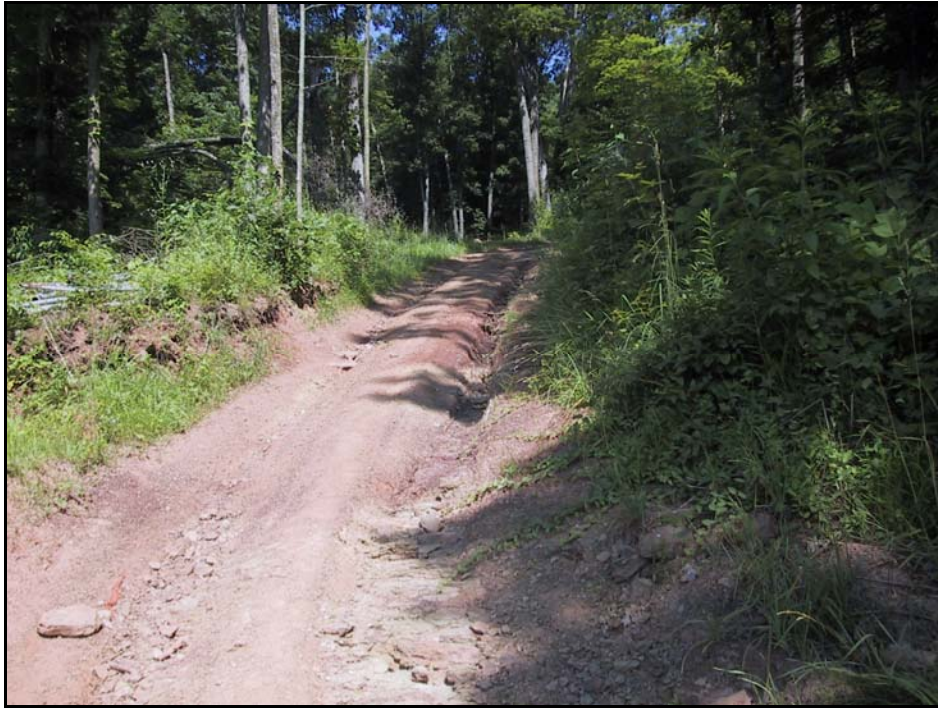
Figure A.1. Poor application of waterbars on a skid trail.

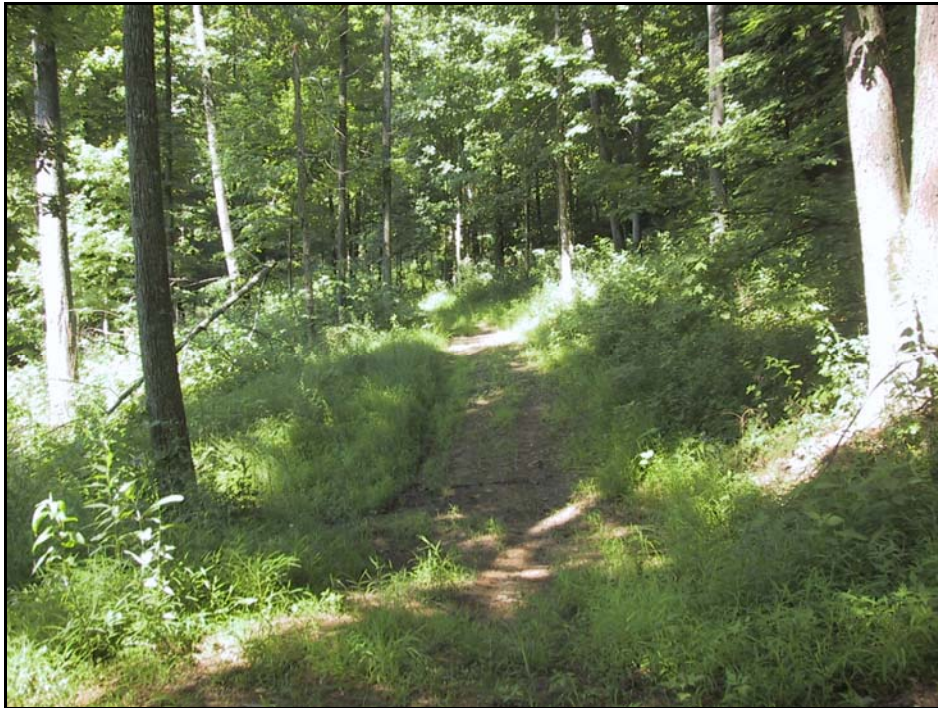
Figure A.2. Good application of outsloping on a skid trail.

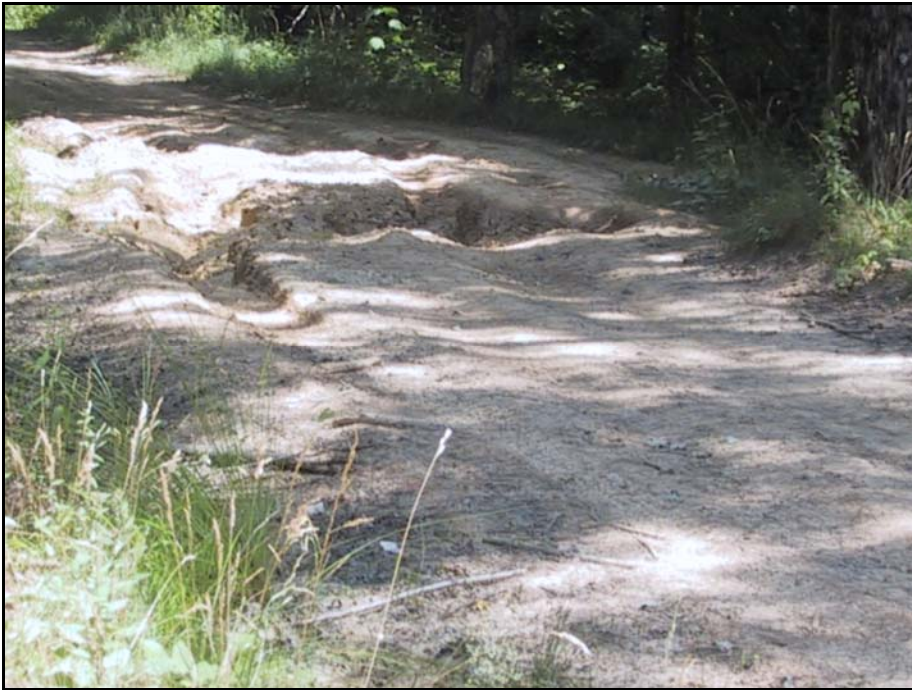
Figure A.3. Poor application of cross drainage in a haul road.

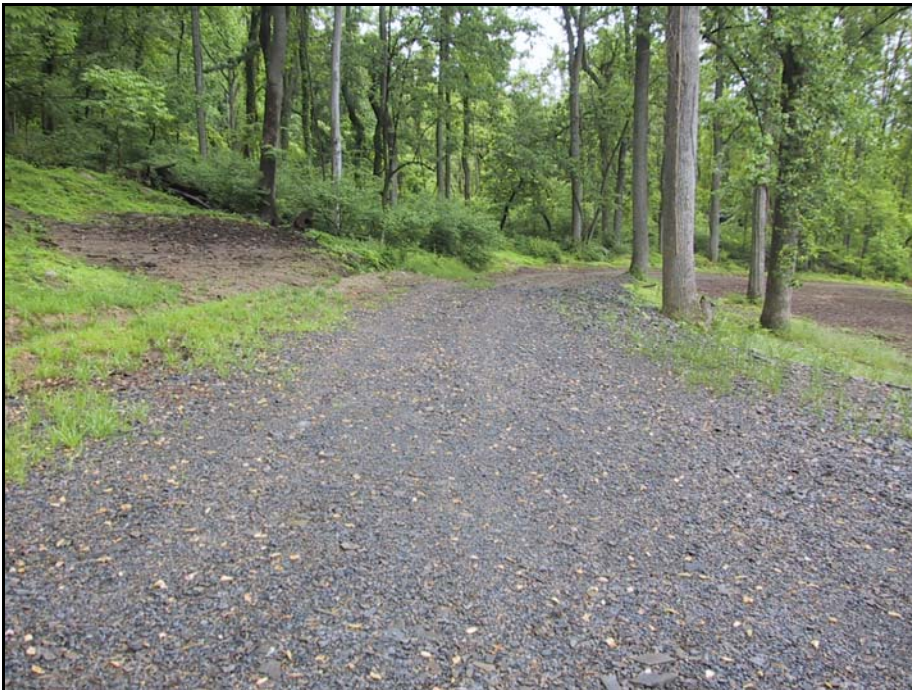
Figure A.4. Good application of gravel applied to a haul road.

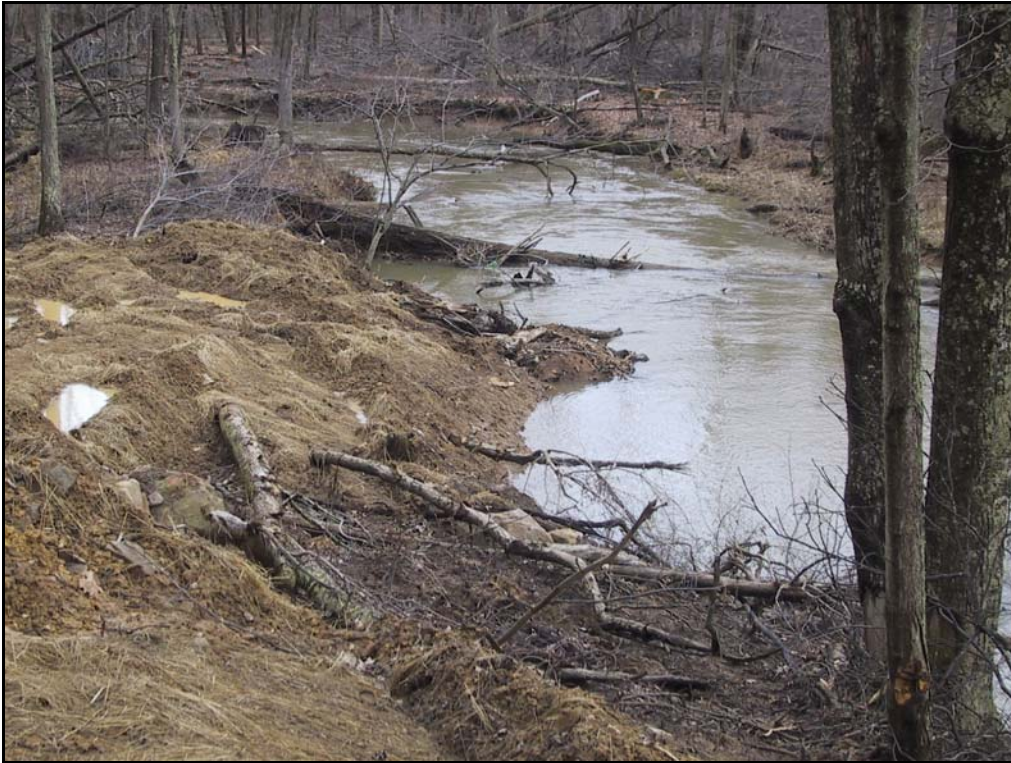
Figure A. 5. Poor application, effectiveness, and compliance of reclamation in a SMZ.

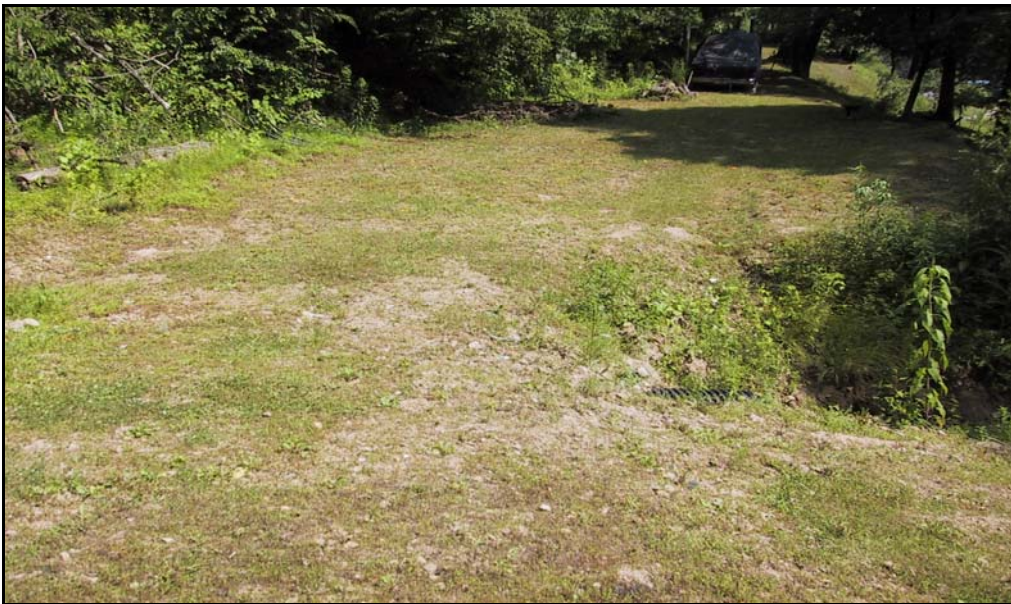
Figure A.6. Good application of culvert installation in a SMZ.

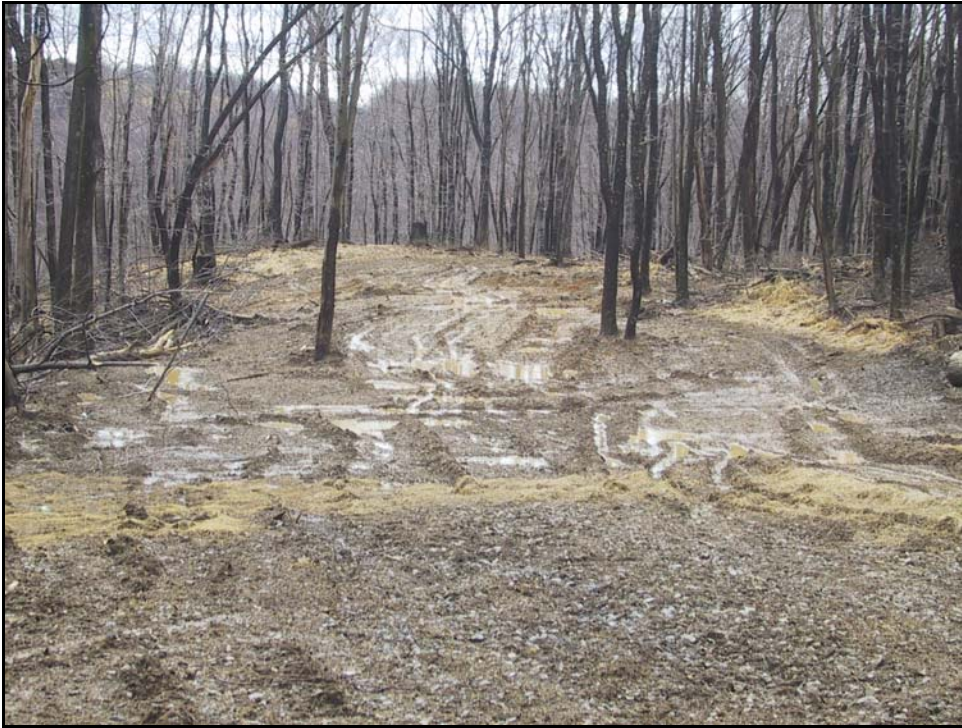
Figure A.7. Poor application and compliance of drainage on a landing.

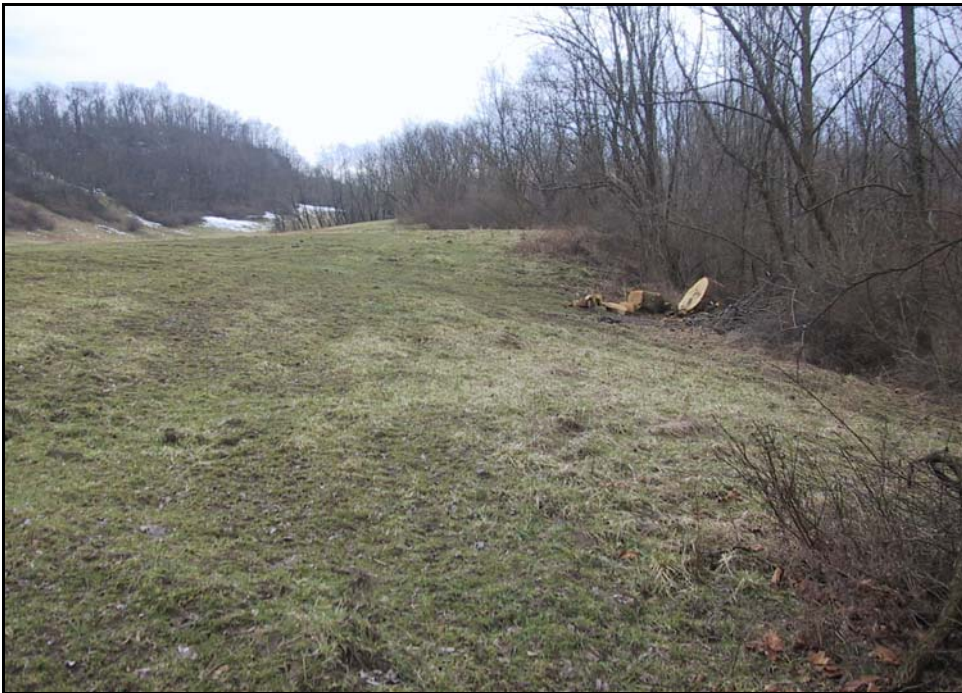
Figure A.8. Good application and compliance of reclamation on a landing.
