This article focuses on an original case history of replacement of a leaky 245 kV OIP bushing of a 220/132/33 kV, 160 MVA, transformer on site at the 220 kV Jabalpur substation, in Madhya Pradesh state in India with an available 245 kV OIP bushing having longer L-2.

Retrofitting of 245 kV OIP bushing with longer oil-end

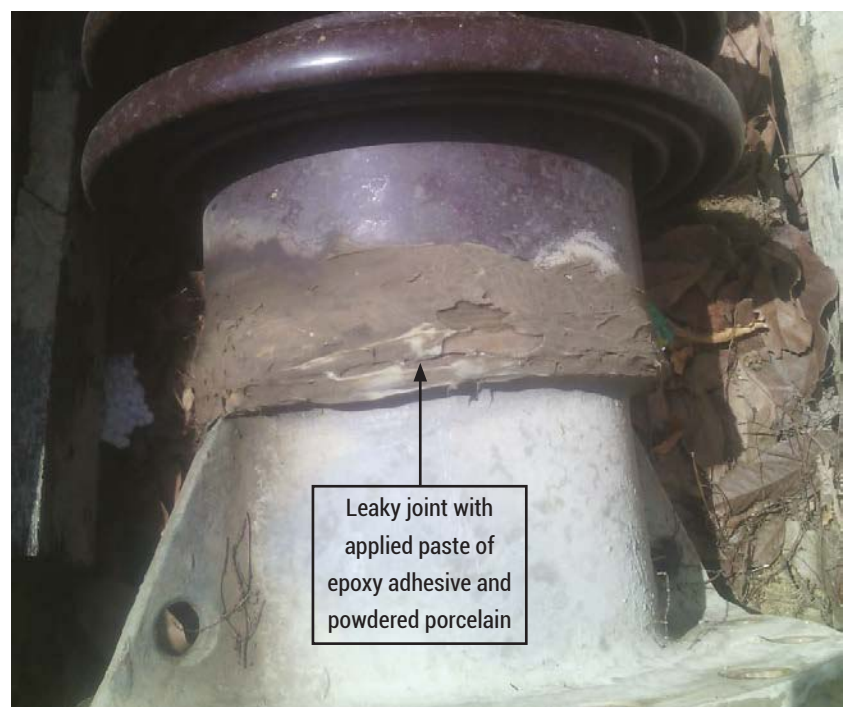
S. No	Observations / Tests	Action taken / Remarks																
1	Profuse leakage of transformer oil from the cemented joint between the porcelain bushing shell and the metallic flange which is fixed onto the turret.	Checked the oil level of the bushing, found that the oil level has reduced.																
2	Insulation resistance and PI (Polarization Index) checked with 5 KV motorized Megger.	Found satisfactory. Insulation resistance converted to 60°C value in MΩ dated 08.06.16.

The seepage of oil could not be arrested by pasting/application of homogeneous paste made of porcelain powder mixed with Araldite (epoxy adhesive) Fig. 2.

Topping up of the transformer oil into the bushing was done, however, this kind of remedy was short lived and only lasted for about 4-6 months. Threat of failure of the 160 MVA, 220/132/33 kV transformer made by GEC prevailed consequent to threat of failure/bursting of the said leaky 245 kV OIP bushing of '1U' terminal of the subject transformer.

Figure 2. Leaky 245 kV OIP bushing of 1U- phase of the transformer with application of homogeneous paste of Araldite (epoxy adhesive) and the powdered porcelain.

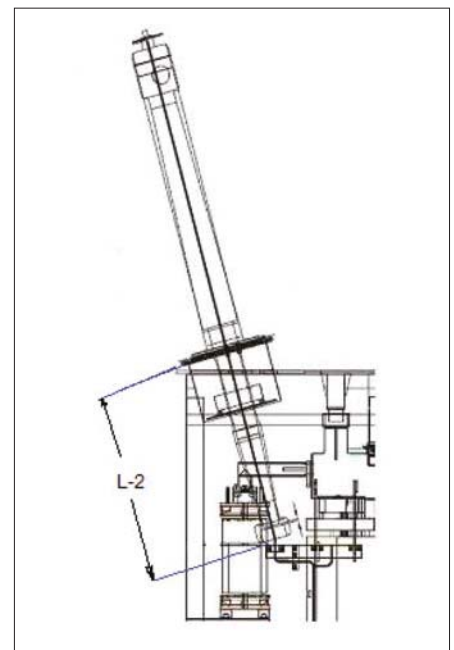
Figure 4. Longer L-2 fouling with core coil assembly clamping frame.

Since the length L-2 of the new OIP bushing was 300 mm longer than the original bushing (1130 mm vs 830 mm), it was obvious that the oil end portion of the new bushing would foul with the core coil assembly clamping frame (end frame) of the transformer, Fig. 4.

- To fabricate an adopter on the turret in a manner that would allow enough clearance to be achieved from the clamping frame of the core coil assembly and to seat the bushing flange thereon
- To extend the HV lead length of draw lead type bushing
- To extend the equalizer pipes

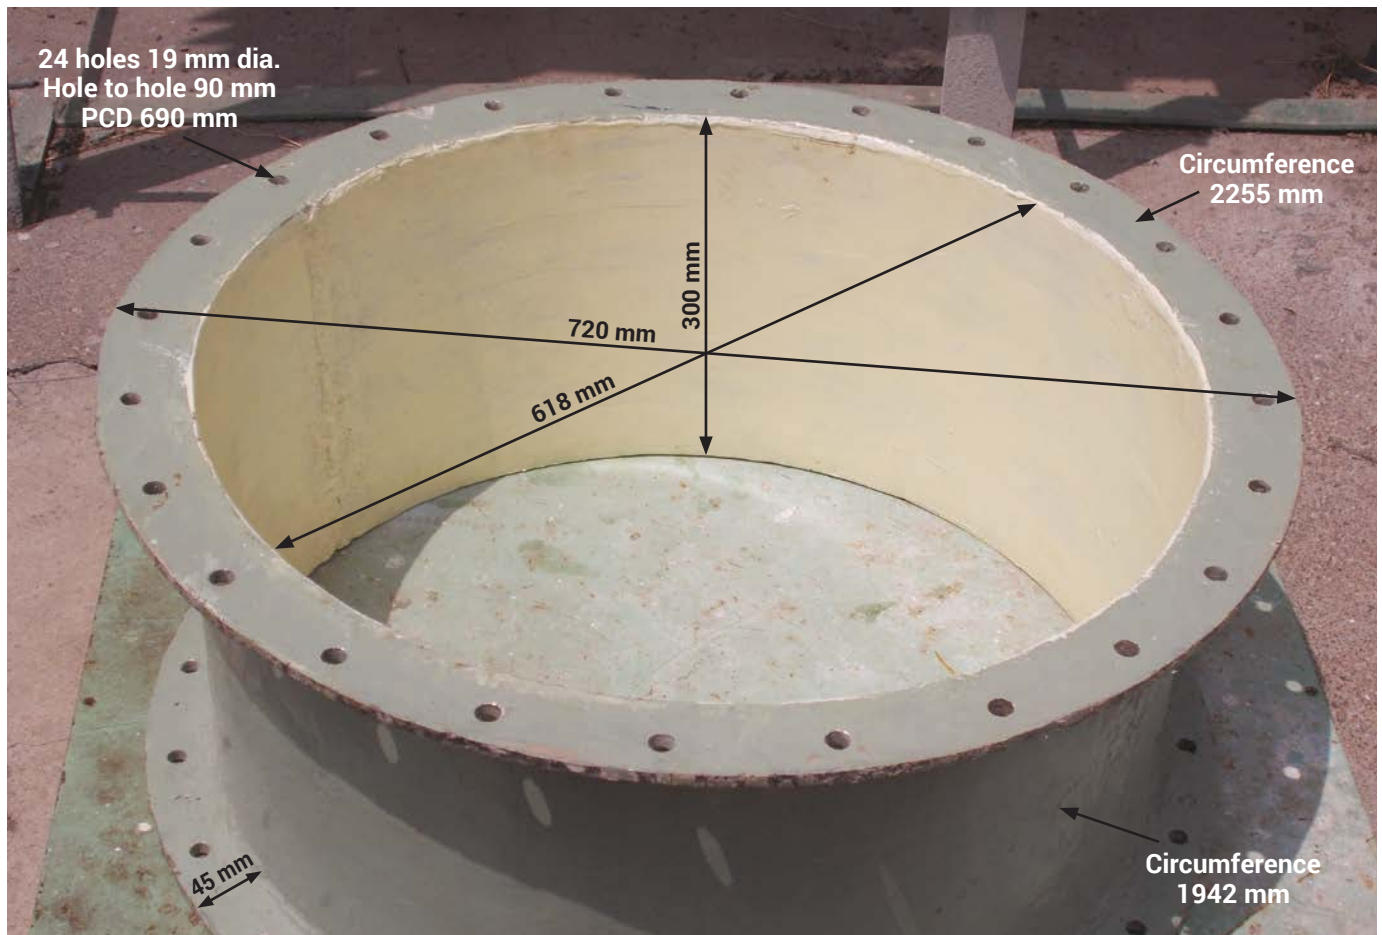
Figure 5. In-house fabricated turret adopter.

To fulfill the conditions mentioned above, the wall thickness and the flange collar of wrought iron should be such that they should be equivalent to the original turret wall thickness and the flange collar.

A cylindrical extension piece was locally fabricated with a 8 mm thick wrought iron plate with dimensions: 618 mm diameter, 300 mm length and 8 mm thickness with flange on both ends fabricated with 8 mm thick wrought iron plate with internal diameter of 618 mm and external diameter of 720 mm; they have 24 bolting holes of 19 mm diameter at diameter of 690 mm (PCD) and hole to hole distance of 90 mm. The turret adopter fabricated is shown in Fig. 5.

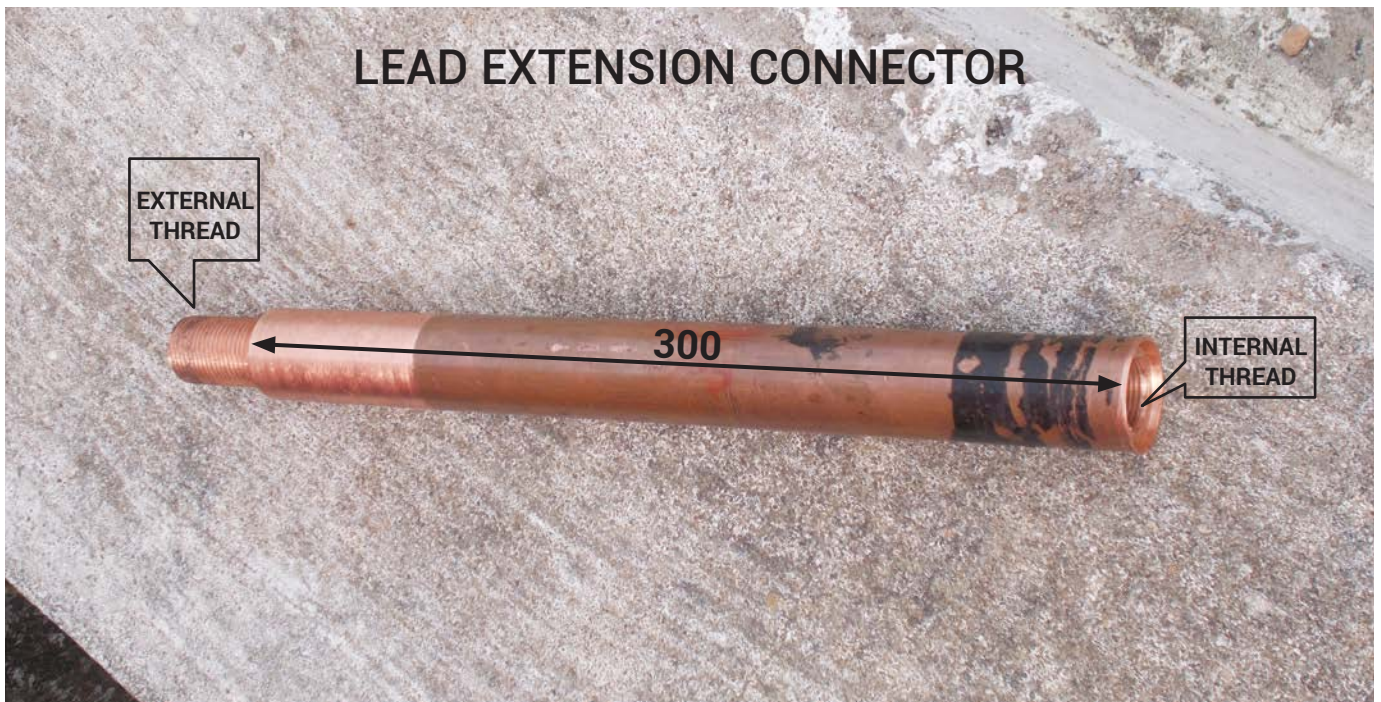
Figure 6. Copper extension piece showing suitably turned threads at both ends.

The length of the draw lead was extended by 300 mm using a 360 mm copper rod available in the substation of a draw rod type bushing by suitably turning the threads on either ends for fixing the lead-end and the terminal-end thimble, Fig. 6. The fabricated copper rod extension piece for elongation of the connecting draw lead was screwed to the original draw lead stud of the bushing and on the other end to the terminal to the thimble. The extended turret adopter is depicted in Fig. 7.

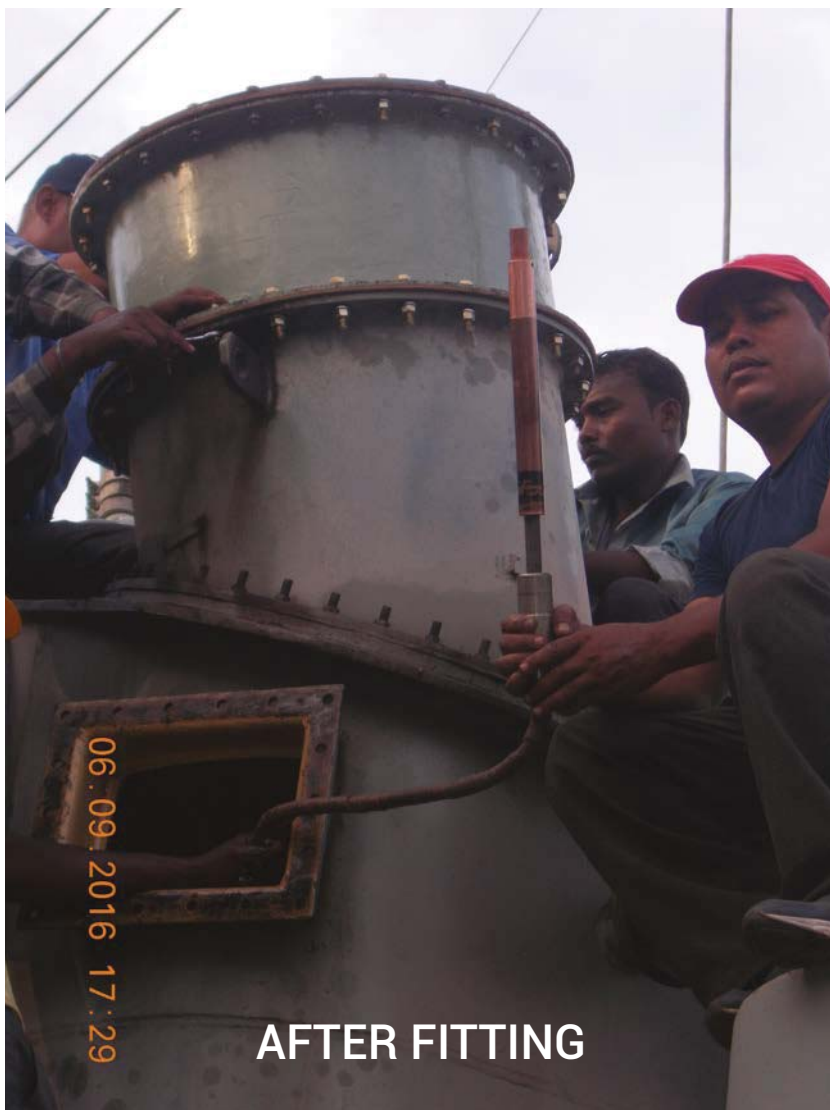
Figure 7. Fitting of extended turret adopter and extension of draw lead.

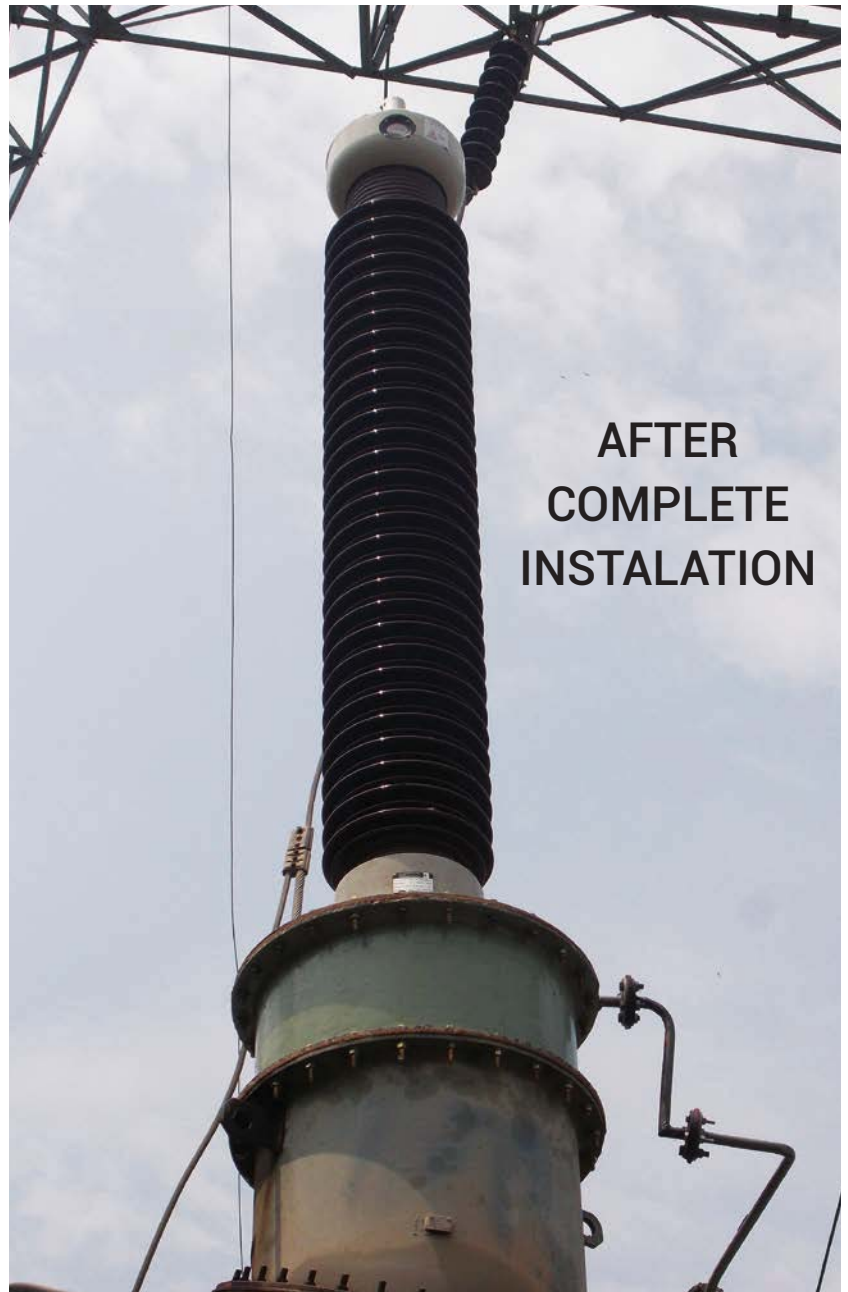
Figure 8. Completion of the installation of the new bushing with L2 1130 mm on the fabricated bushing turret adopter.

The new 245 kV OIP bushing was finally installed on the turret adopter with Neoprene rubberized gasket of ½” thickness, Fig. 8. After completion of installation of the new bushing with L2 1130 mm over the fabricated turret adopter, the oil topping up with filtered transformer oil was done.
