In Situ Corrosion Studies on the Battleship USS Arizona

In Situ Corrosion Studies on the Battleship USS *Arizona*

JOHN D. MAKINSON, *RSI Materials Engineering*
 DONALD L. JOHNSON, *University of Nebraska-Lincoln*
 MATTHEW A. RUSSELL, DAVID L. CONLIN,
 AND LARRY E. MURPHY, *U.S. National Park Service*

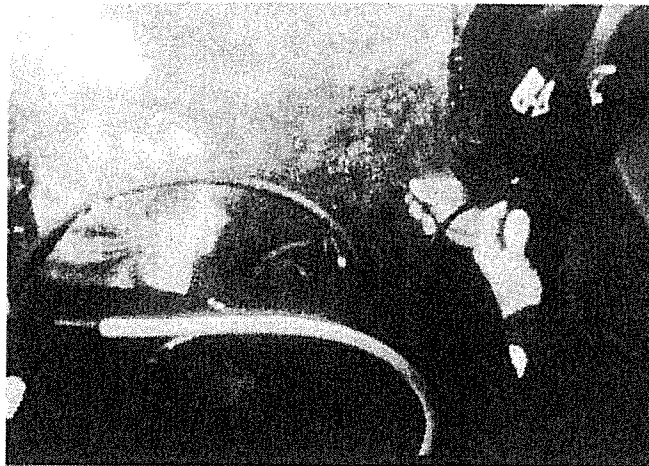
FIGURE 1

Divers taking E_{corr} measurements on the USS *Arizona*. NPS photo by Brett Seymour.

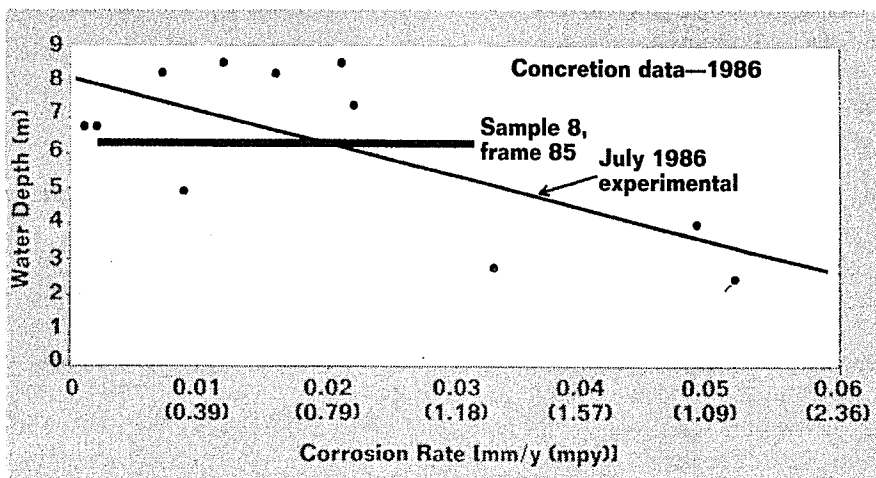
FIGURE 2

Corrosion rate from concretion data (1986) and Hull sample (1988).

(0.005 to 1.8 mm) is equivalent to a penetration rate of between 0.001 to 0.031 mm/y. These data, superimposed on Figure 2, are consistent with corrosion rate from weight gain in the concretion at that depth.

Based on data obtained in 1986, the corrosion rate decreases with water depth. The oxygen concentration measured in 1986 decreased by a factor of two or more, possibly explaining the effect of depth on the corrosion rate observed at that time.

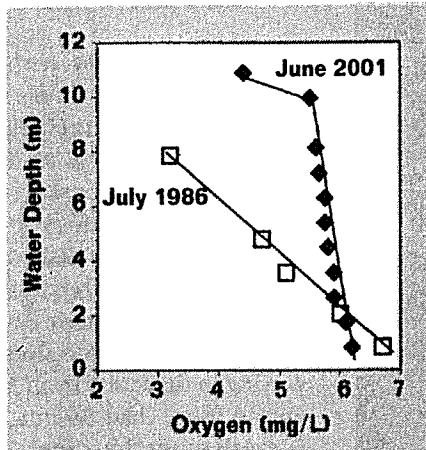
FIGURE 3

Oxygen concentration as a function of depth: 1986 and 2001.

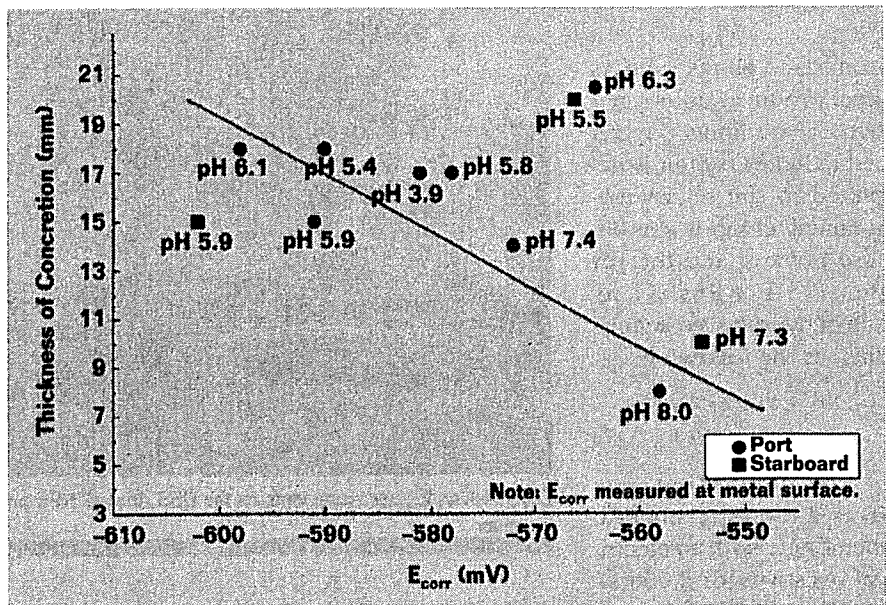
FIGURE 4

Corrosion potential and corresponding pH as a function of concretion thickness data; taken September 2000.

From a compilation of data obtained in September 2000, E_{corr} is dependent on concretion thickness. The concretion, as a barrier to oxygen diffusion, reduces oxygen availability at the metal surface. The crevice effect decreases pH at the concretion to the metal/concretion interface. Three interdependent factors control the corrosion process: hydrogen discharge, oxygen availability, and transportation of iron ions from the metal into the concretion. How these factors interact is not well-understood, but they may be related to the spatial separation of reactions in the concretion.

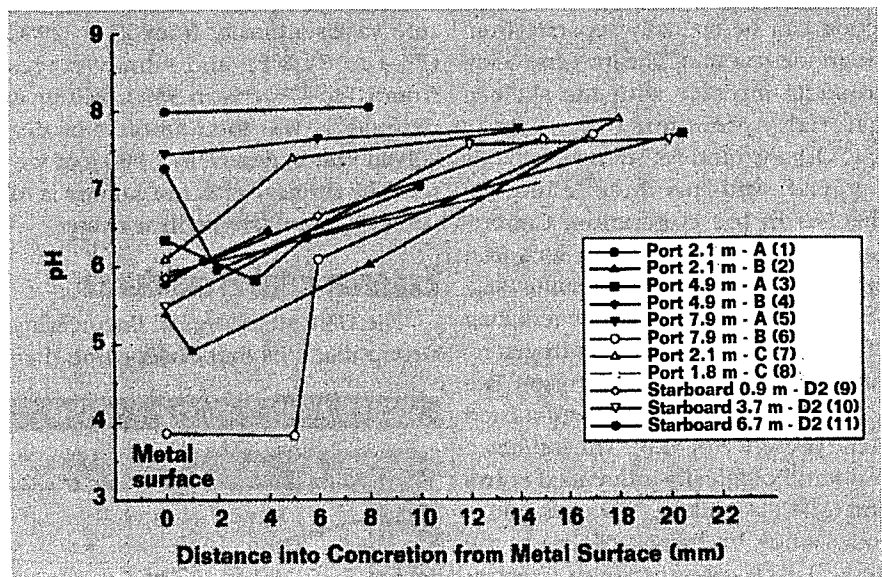
FIGURE 5

Relationship between pH and concretion thickness data taken September 2000.

metal as tabulated in Table 1. The pH measurements were obtained at each drill depth and are plotted in Figure 5. On a Pourbaix diagram for iron/water, all of the data points fall within the region where corrosion is active. According to MacLeod,¹⁰ a more negative corrosion potential indicates a lower corrosion current. Although this finding is consistent with reduced oxygen availability under thicker concretions, it is inconsistent with reduced pH and conventional interpretation of the sign.
