7. Surface Ruptures Observed at Ejido Saltillo, Baja California after the Mexicali Valley Earthquake of 9 June, 1980

R.V. Sharp

8. A Review of Geological Effects and Damage Distribution of the June 9, 1980 Mexicali Valley Earthquake

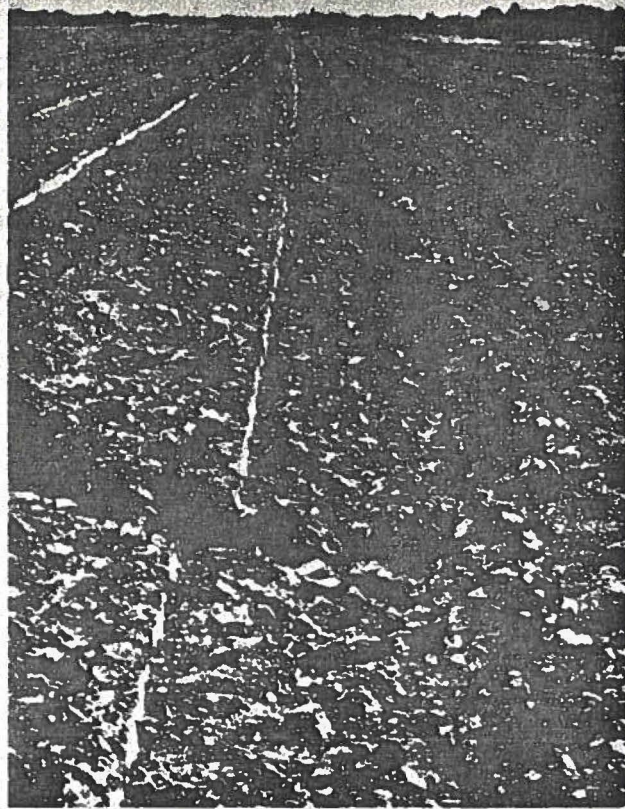
Locality A: The surface fractures at this location were pristine on June 12, and they showed the greatest displacement that we found. The breaks consisted of an en echelon series of slightly gaping fissures oriented about north-south, and the zone of breaks trended about 10° – 15° west of north (Figure 7.3). Pre-earthquake harrow-disc grooves in this field provided reference marks from which the displacement could be determined accurately; at A the largest component of slip, 16.5cm, was right lateral in sense, and the vertical component, up on the west, was 10cm. At most other places in this field, the horizontal component was much less and the vertical component appeared to be nearly zero.

Figure 7.3 Offset crop rows at locality A. View toward west-southwest. Pen lying on ground on near side of fracture gives, scale.

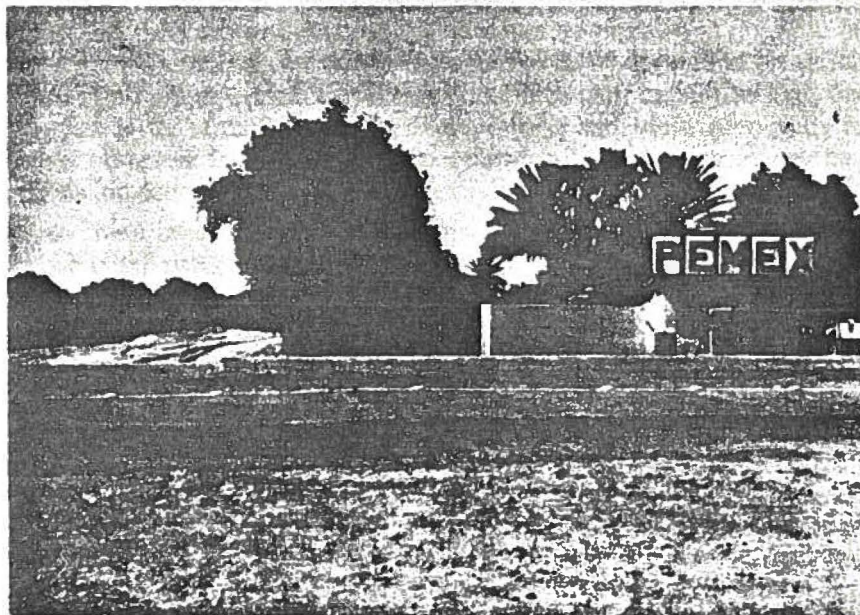
Figure 7.4 En echelon fractures and vertical deformation at locality D. View is toward north.

Locality D: The pavement of Pascualitos—Pescaderos highway was broken by a set of left-stepping en echelon fractures (Figure 7.4) that coincided with the crest of a zone of vertical displacement at least 2 meters wide. Although the fractures appeared to be relatively fresh, it is possible that new movement enlarged preexisting fractures. The sense of the vertical displacement was down to the west, and the painted line showed no obvious horizontal shift. The profile of deformation and the position and pattern of the cracks was similar to that observed at the Brawley fault zone that broke in the Imperial Valley in 1975 and 1979.

Neither cracks nor vertical displacement could be detected on the dirt shoulders of the pavement, thus casting doubt on the significance of the deformation in the pavement. However, the location of the break in the pavement is exactly at the intersection of dirt roads converging from the north and south. The volume of traffic over these dirt roads and on the shoulders of the highway was sufficient to have erased fractures in the three days before our visit, but not so for the obliteration of vertical relief comparable to that in the pavement. I conclude that most of the vertical deformation occurred at unknown times before the Victoria earthquake and that vertical and horizontal components of new slip must have been either very small or broadly distributed.
