Corrosion of Steel Shipwreck in the Marine Environment: USS *Arizona*—Part 1

Corrosion of Steel Shipwreck in the Marine Environment: USS Arizona—Part 1

The USS Arizona has remained submerged in Pearl Harbor, Hawaii, since the Japanese attack on **December 7, 1941. The ship presents a potential hazard** from fuel oil still present in the ship's hull. As an important factor in management decisions, the effect of corrosion after nearly 65 years is being studied to determine the integrity of the ship's structure. Coupon samples from the hull revealed decreasing corrosion rates from ~1 to 3 mpy (0.03 to 0.08 mm/y) from just below the water surface to the mudline. This is about one-third of that expected in the absence of biofouling or concretion. Methods of determining the corrosion rate, including correlation of chemistry and properties, are discussed.

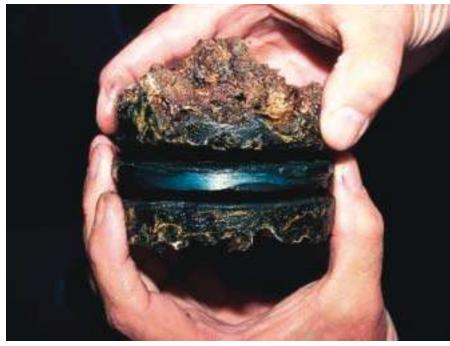
FIGURE 3

Composite interior/exterior concretion with hull metal coupon from USS Arizona; sample taken from a water depth of 5 ft (1.5 m), port side.

near amidships frame 75 (each frame represents a 4-ft [1.2-m] section of the hull, beginning at the bow with frame 1), from near the water line to just below the mudline. The ship's blueprints were consulted to ensure that no compartments containing oil would be penetrated. Figure 3 is a picture of a core sample taken at a depth of 5 ft (1.5 m) with intact concretion on

both sides. Samples from greater depths exhibited little concretion on the interior surfaces. Interior water in these locations was anaerobic. After removal, each location was plugged and sealed with marine epoxy. One location was plugged with a removable stopper to allow for the future retrieval of internal water samples as part of the long-term monitoring program.

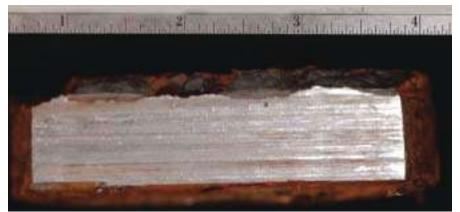
FIGURE 4

Cross section of metal coupon from USS Arizona; sample taken from a water depth of 19.5 ft (5.9 m), port side.

Multiple optical metallographic measurements were made on each metal coupon at Rail Sciences Laboratory in Omaha, Nebraska. Figure 4 shows the cross section of a typical sample taken at 19.5 ft (5.9 m) below the water surface. General corrosion was evident in this macrophotograph, as it was on the other seven samples. For comparison, the sample in Figure 3 taken near the water's surface shows severe corrosion from wave action and corrosion from both sides. The bar graphs in Figure 5 (port) and 6 (starboard) are representations of the results of this analysis in terms of metal loss as a function of original plate thickness and water depth. The original nominal hull plate thickness was identified from original cross-section drawings, amidships, at frames 75 and 93. Thicknesses in the original blueprints were expressed in terms of weight per unit area (lb/ft²). The magenta on each horizontal bar corresponds to metal lost during 61 years of seawater exposure. The direct corrosion rate is determined by subtracting the thickness of metal remaining from the original thickness, dividing the result by time (61 years), and multiplying by 1,000. The equation is given by:

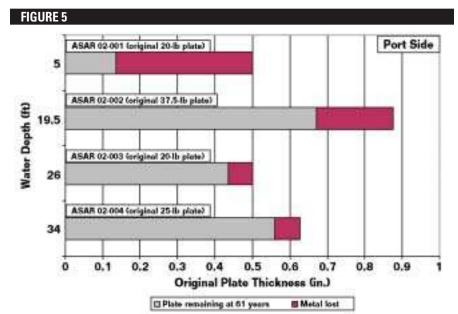
Metal loss (magenta) on USS Arizona as a function of water depth, port.

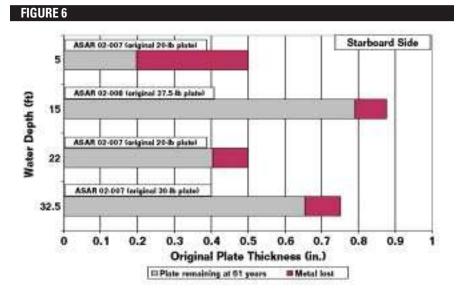
Metal loss (magenta) on USS Arizona as a function of water depth, starboard.

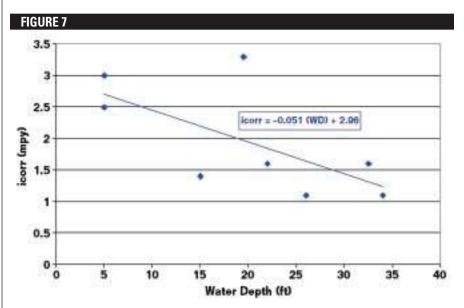
Figure 7 illustrates the corrosion rate as a function of water depth for all of the samples collected at frame 75.

Based on metal coupon analysis at frame 75, the corrosion rate on USS Arizona's exterior hull is ~3 mpy (0.08 mm/y) near the surface and decreases by nearly one third to ~1 mpy (0.03 mm/y) just below the mudline. By comparison, corrosion rates for unconcreted steel in open seawater at the surface are reported to be in the 7 to 8 mpy (0.18 to 0.20 mm/y) range.1 Lower-than-predicted corrosion rates are directly related to metal/concretion interaction and subsequently decreased oxygen availability. Studies are ongoing to evaluate the role of the concretion and its effect on corrosion in marine environments.

Corrosion rate as a function of water depth for USS Arizona; data compiled from coupon results at Frame 75.
