## TRUCK ROUTE ACCESS EVALUATION

Seaboard Farms  
Graves County  
Site #2623

Report Number KTC-99-12

February 1999

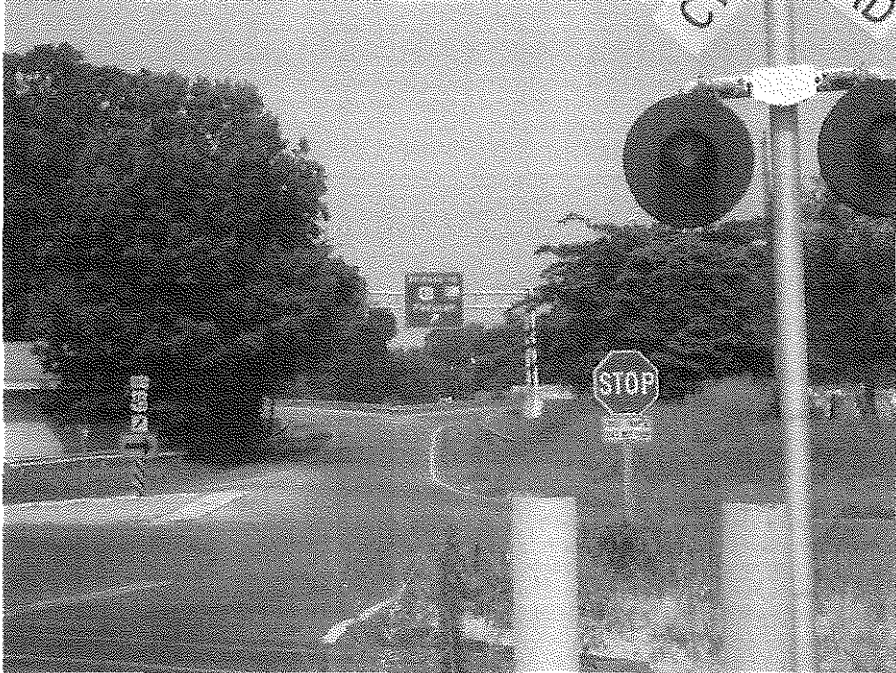
**Figure 2: Entrance to US 45B (as seen from Macedonia Road)**

There is one route used for access to the NHS, the Purchase Parkway in this case. Trucks leave the facility by Macedonia Road and travel west through the intersection of US 45 and Macedonia Road onto US 45B (bypass) as seen in Figure 2. Once on the bypass, the first ramp to the right allows trucks to proceed north to either the ramp for the westbound Purchase Parkway or US 45B runs directly into the eastbound Purchase Parkway at milepost 0.958. Trucks traveling to the facility can proceed directly south on the Purchase Parkway (turns into US 45B) if they are southbound, or remain on the parkway if they are eastbound. At the intersection of US 45B and US 45, trucks turn left and proceed northeast on US 45 for approximately 0.2 miles (as seen in Figure 3). US 45 is a two-lane, one-way road (from US 45B to the intersection of Macedonia Road). Trucks then turn right onto Macedonia Road, cross the railroad tracks, and then turn left into the Seaboard Farms entrance approximately 200 feet from the intersection. Total route length is approximately 0.5 miles for outgoing trucks and 0.65 miles for incoming trucks. The average daily traffic (ADT) on US 45 is 6,100 vehicles per day (from 1996 KYTC traffic counts) and the ADT on US 45B is 7,274 vehicles per day (from 1998 KYTC traffic counts).

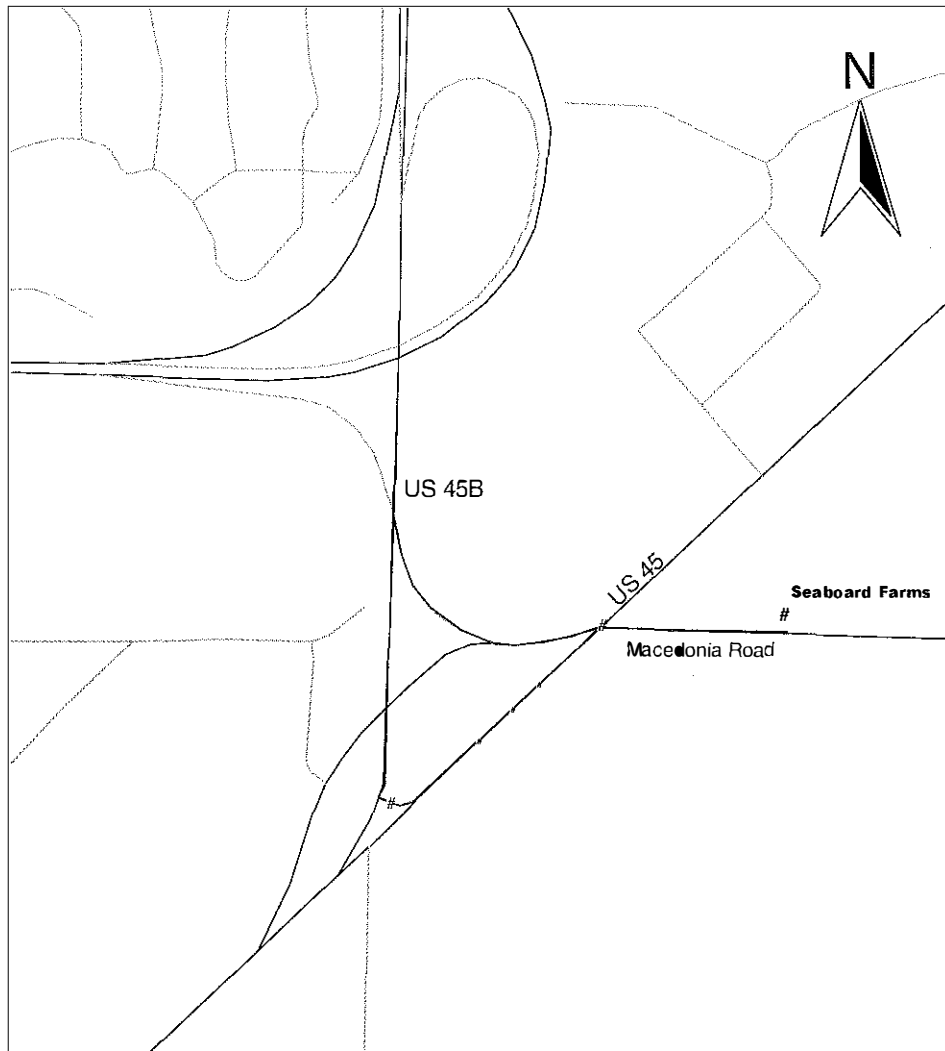
Figure 4: Accident Locations (1995 - 1997)

Figure 4 shows the locations of accidents during the years 1995, 1996, and 1997. A summary of the accidents along the truck route (for all roads, not just state-maintained roads) is shown in Table 2 for the same three-year period. Just 1 of 21 accidents on the route involved a truck. Thus, truck accidents are assumed to not be a problem for the route. However, the relatively high numbers of accidents occurring at the intersections of US 45 and US 45B (8 accidents) and US 45 and Macedonia Road (8 accidents) suggest that there are some concerns for these intersections from a recent accident history point of view. More discussion of the intersection of US 45 and Macedonia Road can be found in Section 3.4 and of the intersection of US 45 and US 45B in Section 3.8.

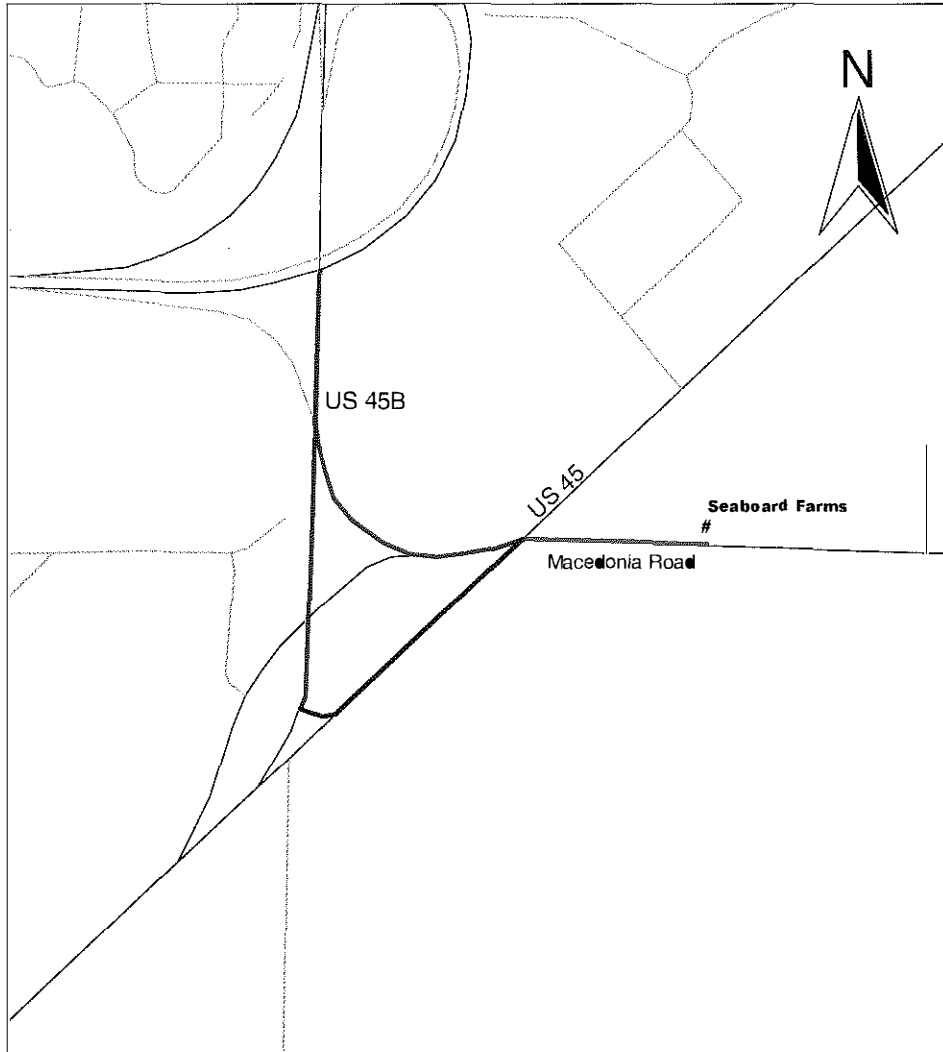
Figure 5: Lane Widths

Figures 5 and 6 illustrate the sections of the route with different lane widths and shoulder types, respectively. Macedonia Road has only 10-foot lanes and 2- to 4-foot turf shoulders, both of which are “less than adequate”. US 45 has “adequate” 11-foot lanes and “less than adequate” 2- to 4-foot turf shoulders. US 45B has “preferred” 12-foot lanes (the ramp portions have 16-foot lanes) and the southern portion (milepost 0 – 0.69) has “less than adequate” 5-foot turf shoulders. The northern section (milepost 0.69 – 0.96) has “adequate” 10-foot turf shoulders.

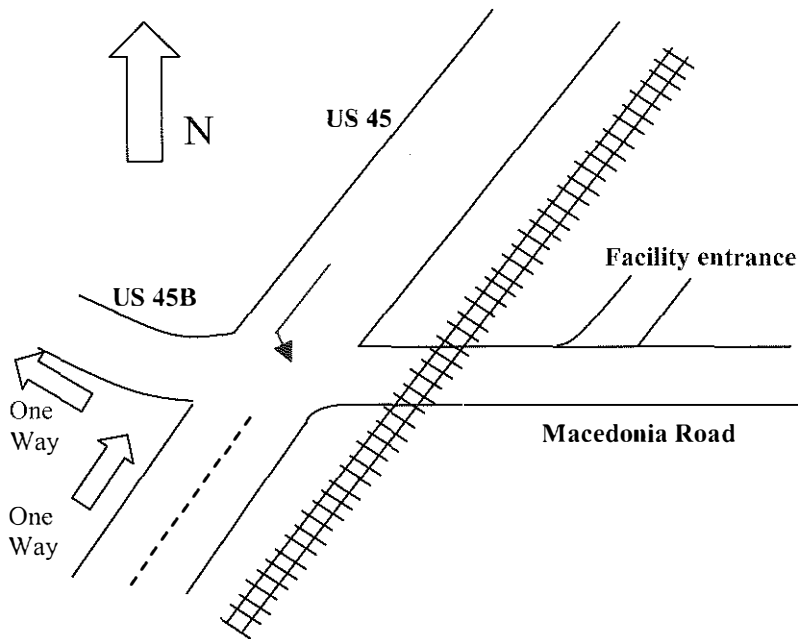
**Figure 7: Intersection of US 45 and Macedonia Road**

One left-turning radius (shown in Figure 7) was observed as being problematic for trucks. The intersection of US 45 and Macedonia Road has a sharp left-turning radius for trucks (turning left from southbound US 45). During the site visit for data collection, trucks were observed encroaching into opposing lanes in order to make the turn onto Macedonia. This intersection is not problematic for right-turning trucks. However, it is still “less than adequate” for the purposes of this study.

There is one at-grade railroad crossing along this route. The crossing is on Macedonia Street immediately west of its intersection with US 45 (see Figure 7). There are no problems with sight distance at this crossing and warning lights (but no gates) are present. The crossing surface is in good condition. One potential problem with this crossing is its proximity to the stop-controlled intersection of US 45. When a train is passing over the crossing, traffic can back up on US 45 and/or Macedonia Road. A semi-trailer can not be waiting at the stop bar at the end of Macedonia because the trailer would back up onto the tracks. However, given the character of the area and the long tangent available for sight along the tracks, trucks should have adequate warning before a train enters into the area. Thus, the crossing is not problematic and is considered to be “preferred”.

The intersection of US 45 and Macedonia Road could be improved by widening the lanes on Macedonia so that trucks have more space available to turn into. However, with the railroad crossing so close to the intersection, this may not be feasible. Consideration should be made for placing warning signs on US 45B so that drivers are aware of the turning bay deficiencies. In order to correct the lane width and shoulder problems along this route, complete reconstruction would be necessary. However, the problems associated with lane and shoulder widths are not severe enough to warrant such action.

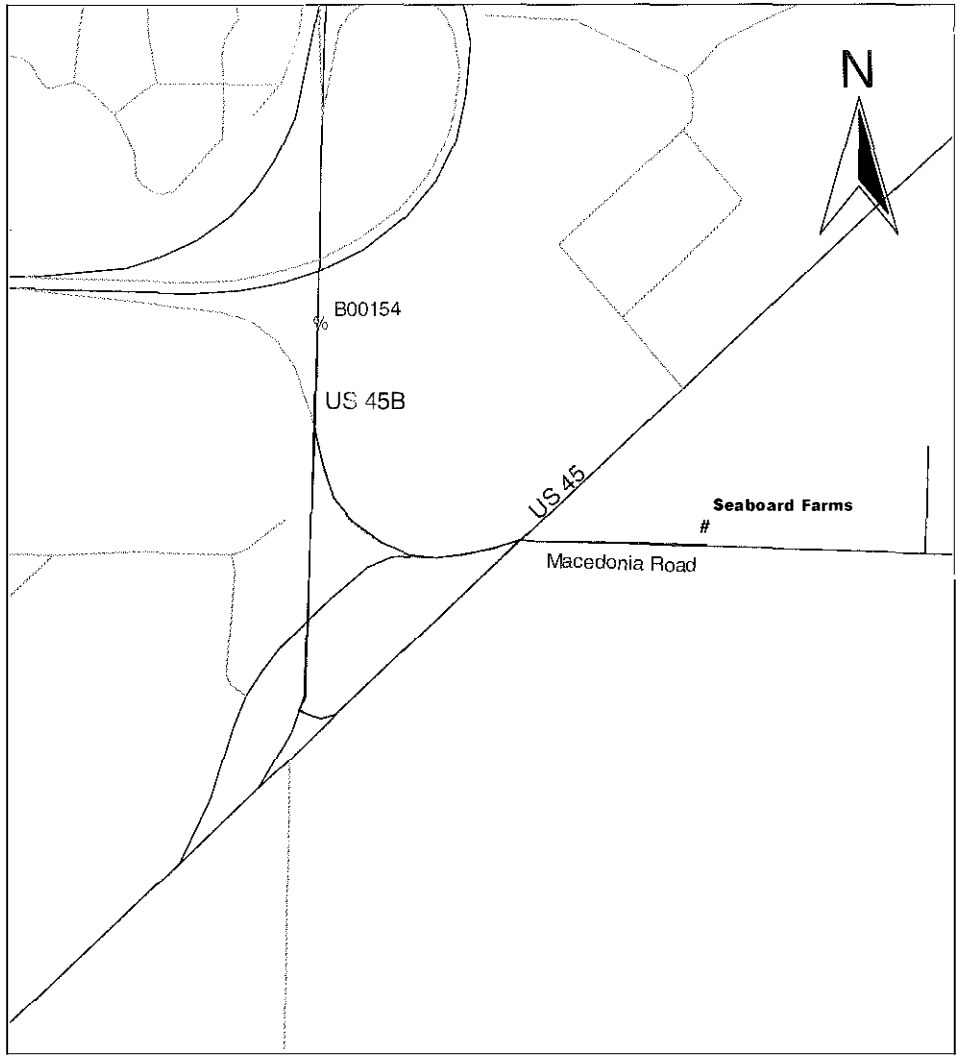
**Figure 8: Bridge Location**

There is one bridge on US 45B, shown in Figure 8. The Kentucky Transportation Cabinet’s Division of Operations maintains a database of bridge sufficiency ratings that are based on the serviceability (as well as other factors) of the structure. This bridge, located just south of the Purchase Parkway, received a sufficiency rating of 76.1 which is considered “adequate”.

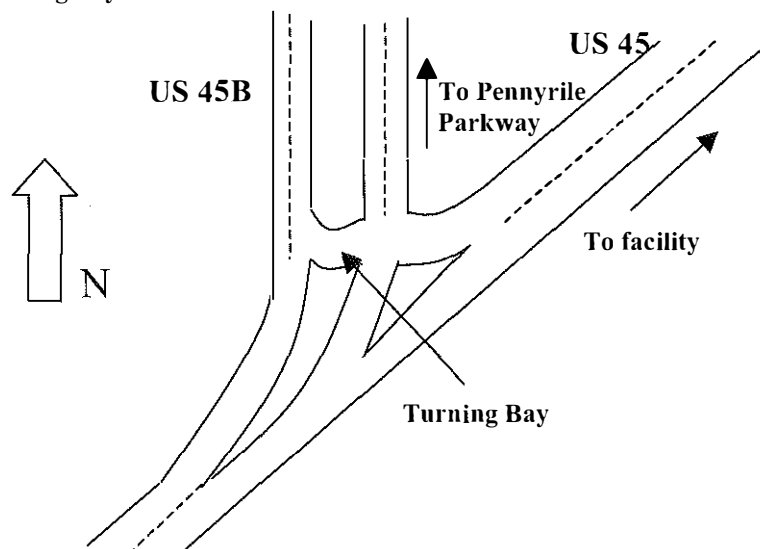
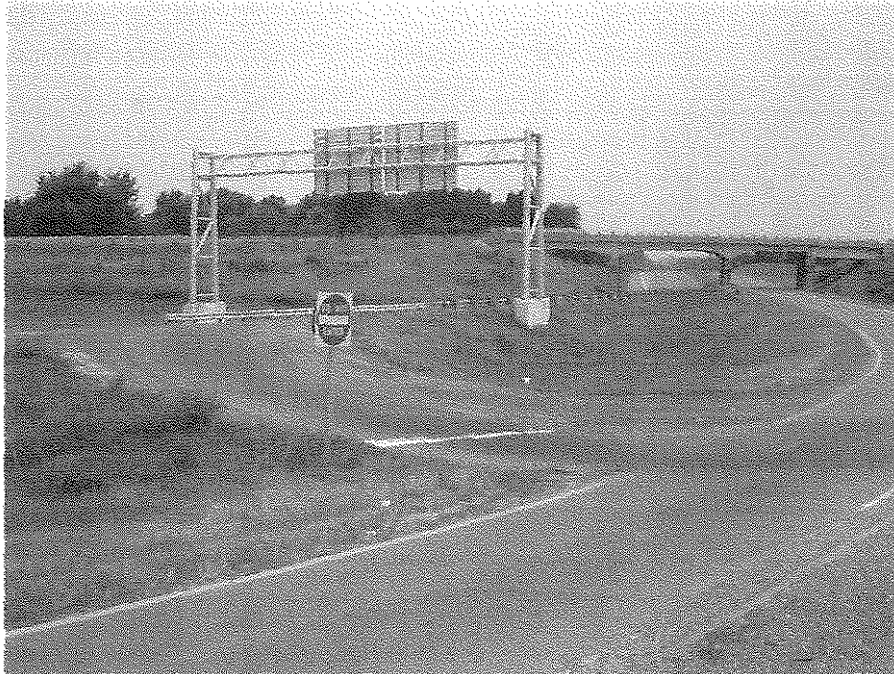
There are no inadequacies in clear zone along the route’s length. Pavement along all route sections was in good condition, with the exception of the turning bay from US 45B to US 45. Pavement along the northern side of the turning bay is in poor condition.

The phone survey indicated that trucks sometimes miss the exit from US 45B onto the southbound Purchase Parkway and try to turn back northbound (back onto US 45B) at the intersection with US 45. The left turning bay (pictured in Figures 9 and 10) at this intersection requires very sharp turns to make such a maneuver. In addition, the turning bay does not provide adequate room for storage of trucks making left turns from US 45B onto US 45. The bay is approximately 45 feet in length, which requires that trucks have portions of their trailers remaining in the left lane of US 45B since there is no turn lane or storage queue.

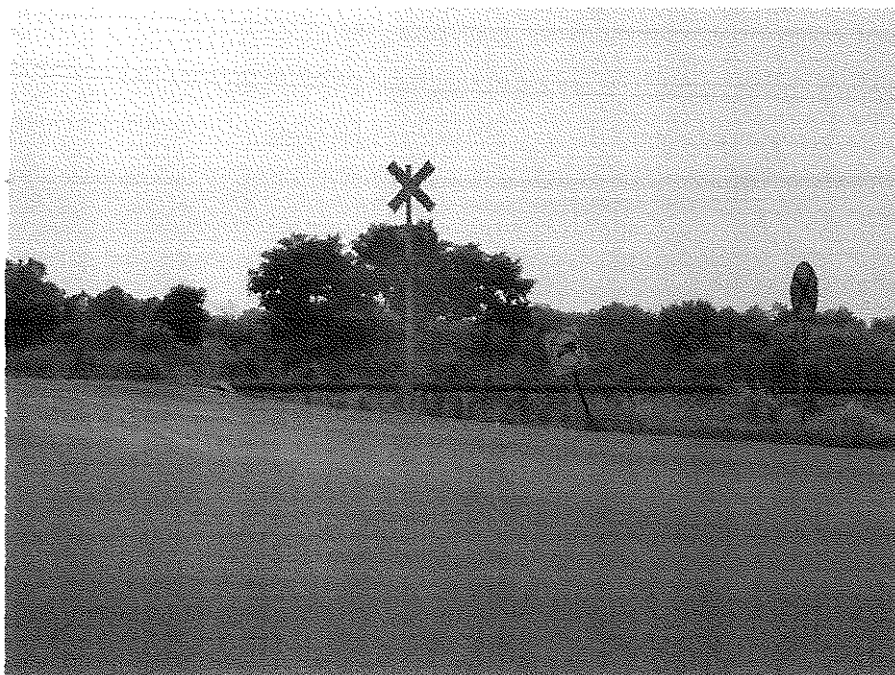
**Figure 11: "No Trucks" Sign as Seen from Southbound US 45**

Another route feature worthy of mention is shown in Figure 11. The “No Trucks” sign at the intersection of Macedonia Road and US 45 indicates that Macedonia is closed to through-truck traffic, but the sign can only be seen from southbound US 45. It is believed that the only trucks utilizing Macedonia are traveling to Seaboard Farms’ mill. Truck usage of the route should be clarified and appropriate signs should be installed.
