**Research Report  
KTC-99-51**

**EXPERIMENTAL MAINTENANCE PAINTING  
BY OVERCOATING ON THE  
I-64, I-71 AND KY-22 BRIDGES**

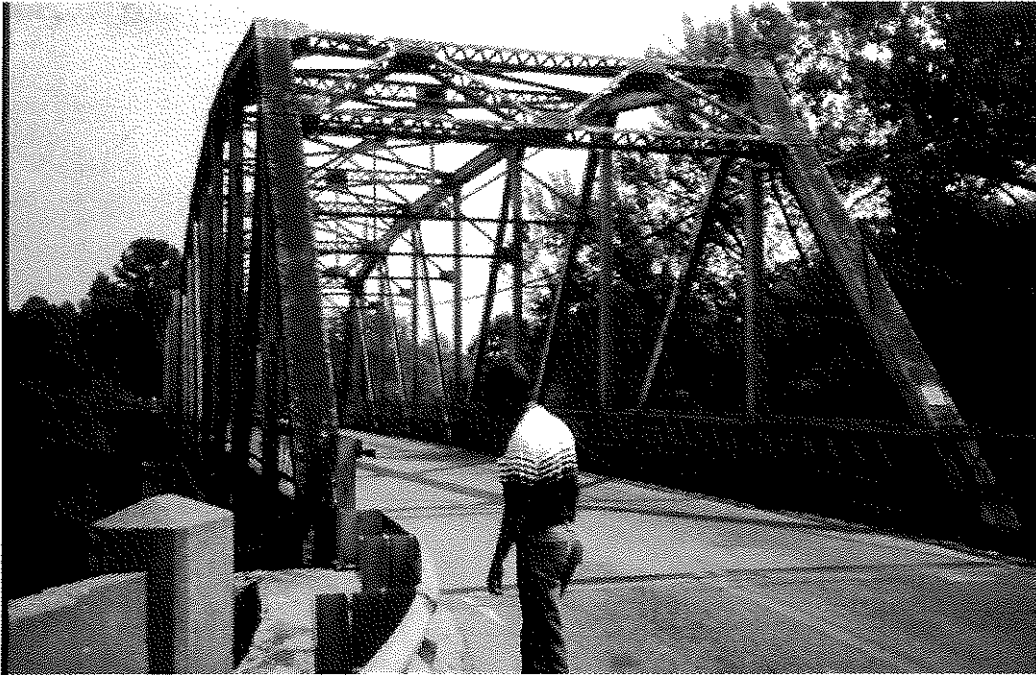
**FIGURE 1. KY-22 BRIDGE AT FALMOUTH SHOWING POOR CONDITION OF EXISTING PAINT.**

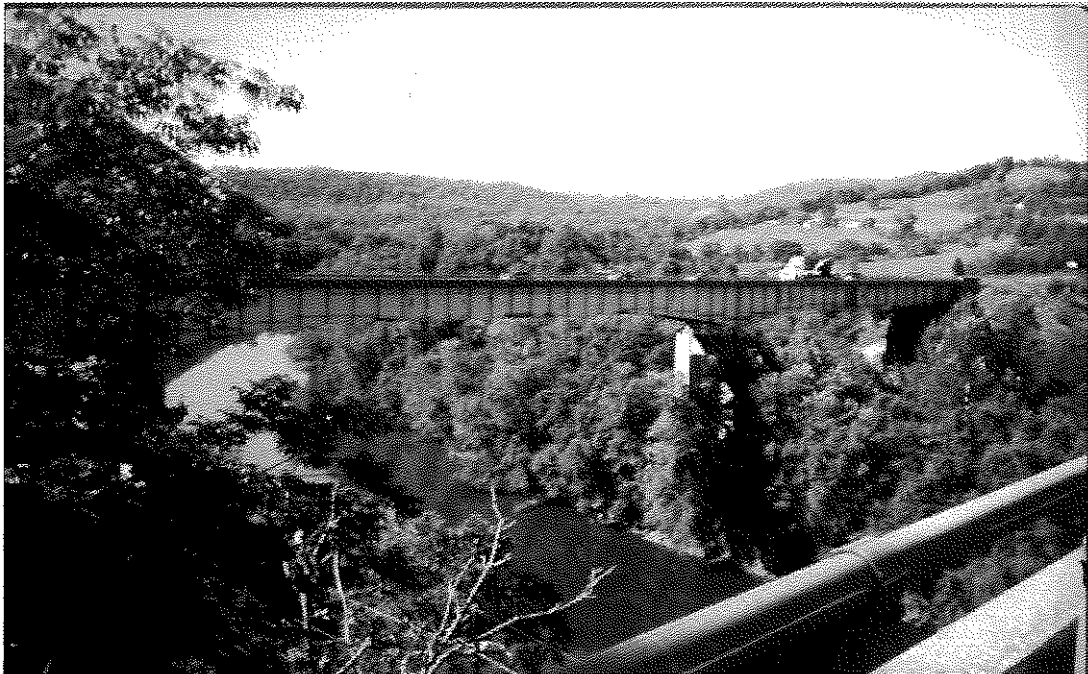
**FIGURE 2. SOUTH MAIN GIRDER OF THE I-64 EASTBOUND BRIDGE OVER THE KENTUCKY RIVER SHOWING SEVERE DISBONDING OF THE EXISTING PAINT ON EXTERIOR FACE OF GIRDER.**

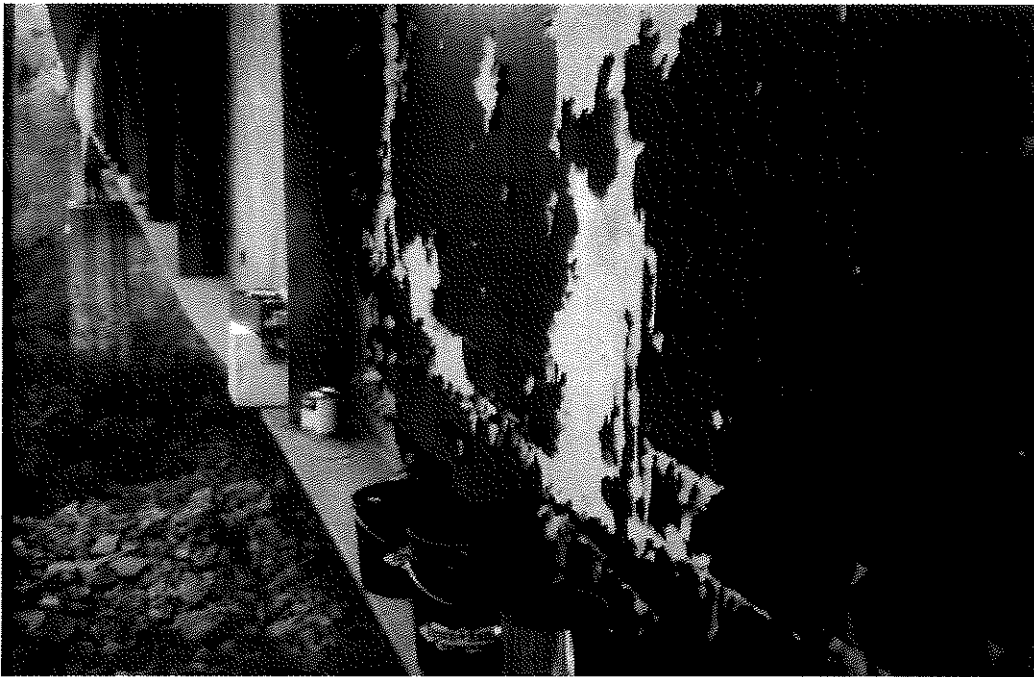
FIGURE 3. I-64 WESTBOUND OVER THE KENTUCKY RIVER SHOWING THE CONDITION OF THE EXISTING PAINT.

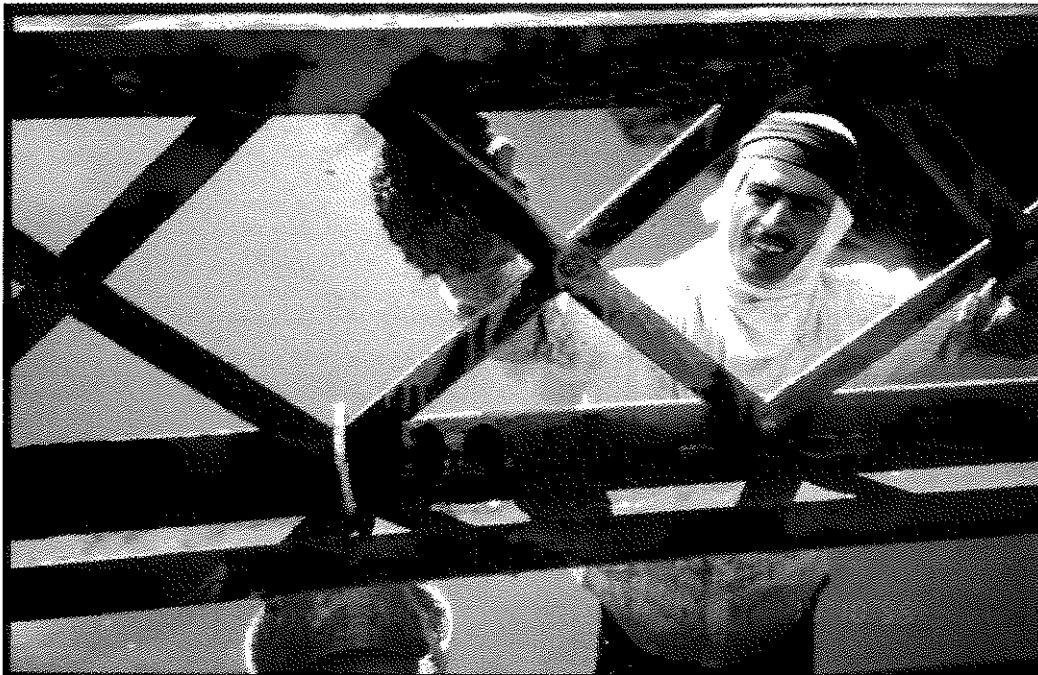
**FIGURE 5. PRESSURE WASHING OF THE I-71 NORTHBOUND BRIDGE OVER THE KENTUCKY RIVER AT CARROLTON. NOTE THE REMOVAL OF CHALK BY THE WASHING PROCESS.**

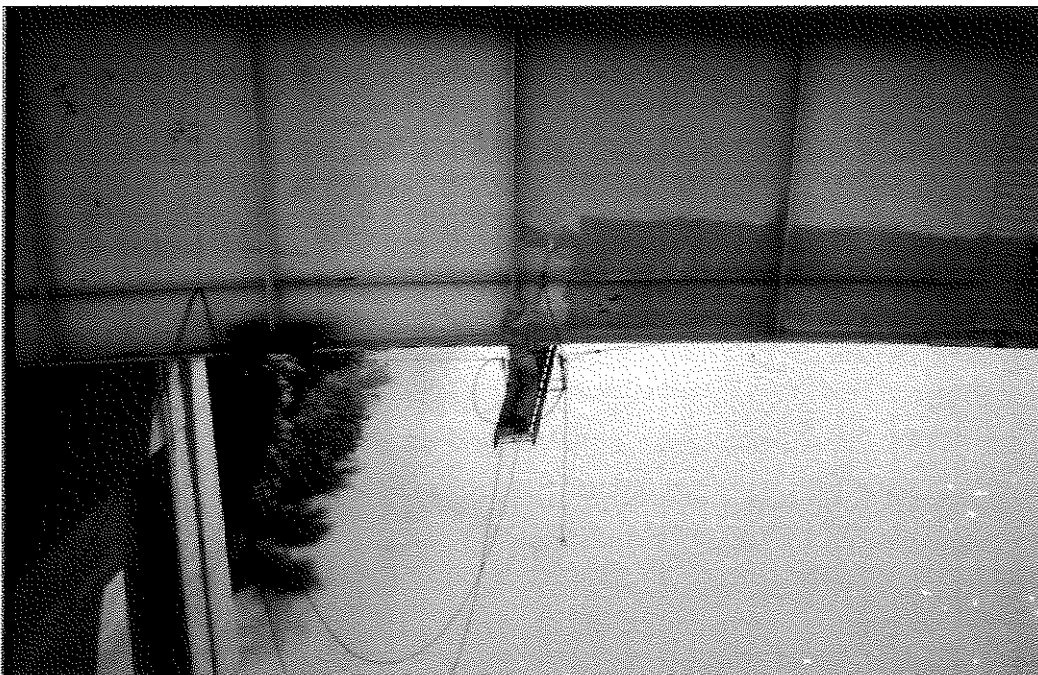
**FIGURE 6. TRUSS ON THE KY-22 BRIDGE SHOWING EXTENSIVE REMOVAL OF THE EXISTING PAINT BY PRESSURE WASHING. PAINTER IS USING A MITT TO APPLY THE SPOT PRIMER.**

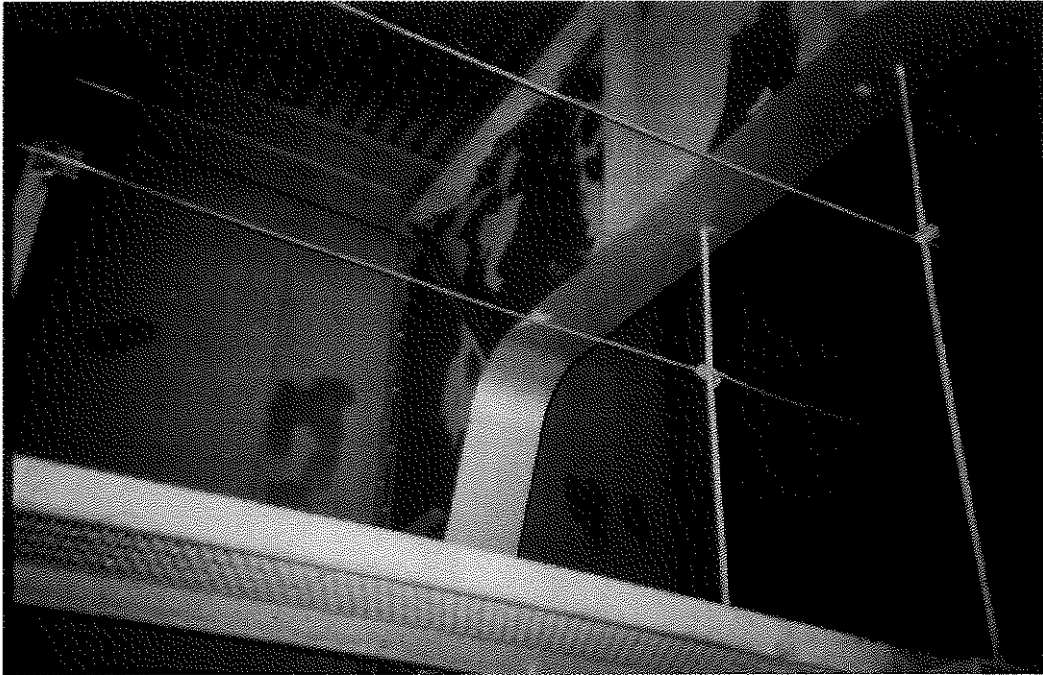
**FIGURE 7. SPOT PRIMING ON THE WESTBOUND I-64 BRIDGE.**

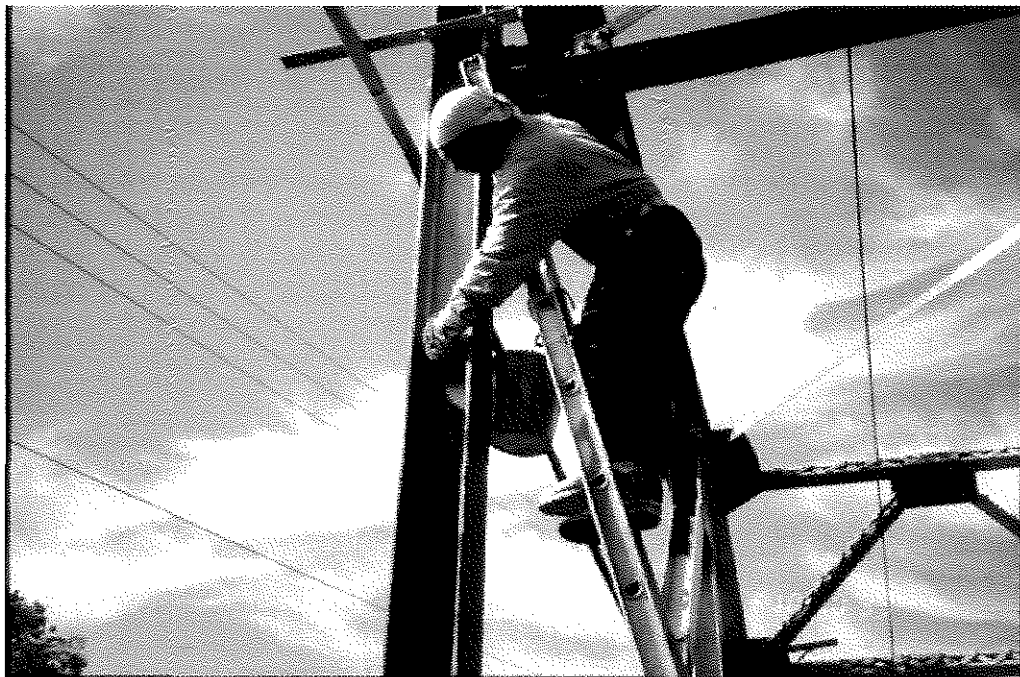
**FIGURE 14. SPRAYING TOPCOAT ON I-64 WESTBOUND OVER THE KENTUCKY RIVER.**

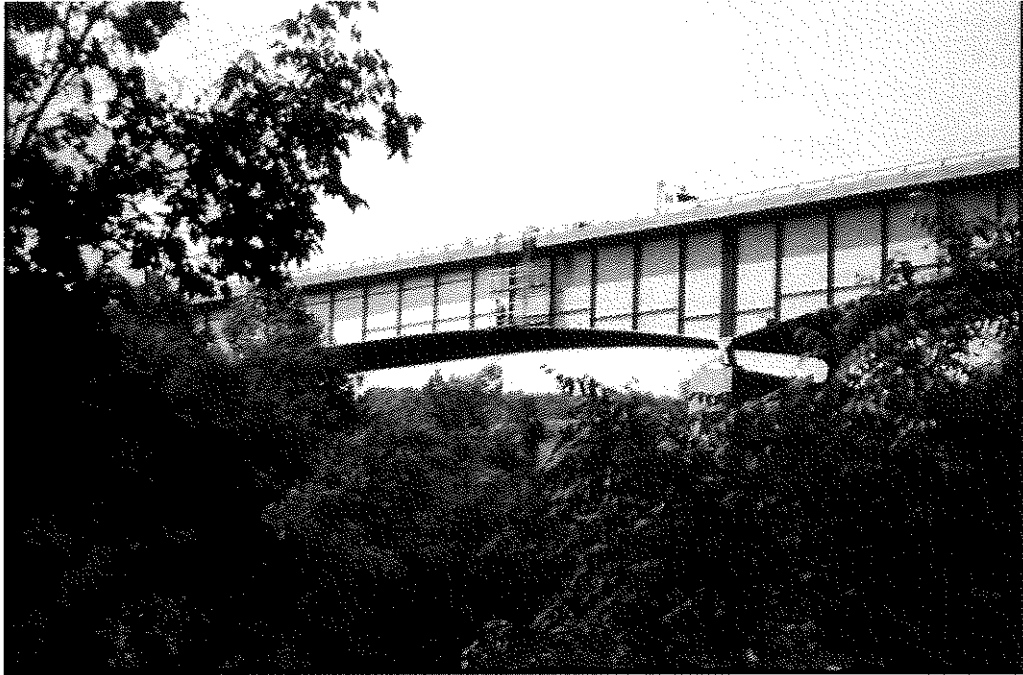
**FIGURE 15. TWO-LEVEL SCAFFOLD USED IN PAINTING MAIN GIRDERS ON THE I-64 BRIDGES OVER THE KENTUCKY RIVER.**

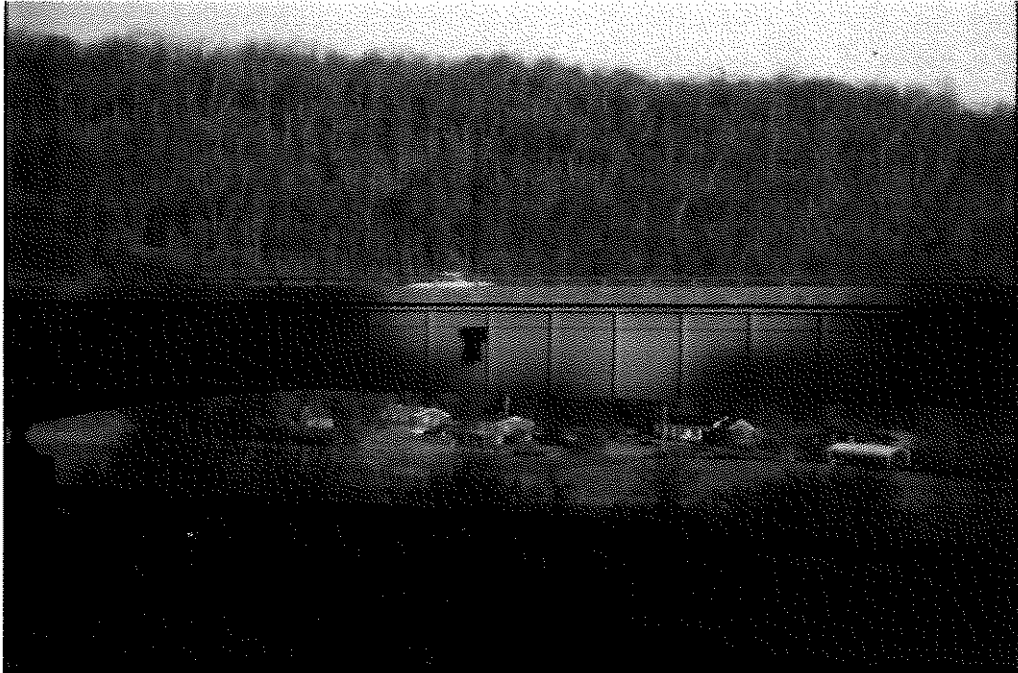
**FIGURE 18. DISBONDING ON THE EXTERIOR FACE OF THE SOUTH MAIN GIRDER OF THE WESTBOUND I-64 BRIDGE OVER THE KENTUCKY RIVER.**

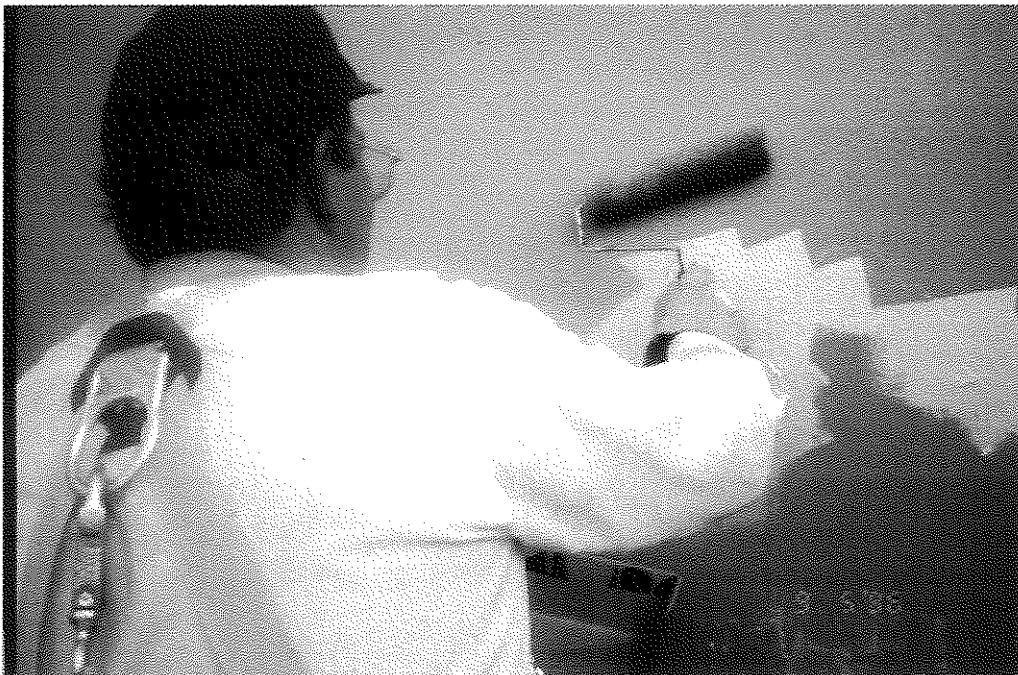
**FIGURE 19. KTC PERSONNEL REPAIRING PAINT DISBONDING SITE ON THE I-64 WESTBOUND BRIDGE OVER THE KENTUCKY RIVER.**

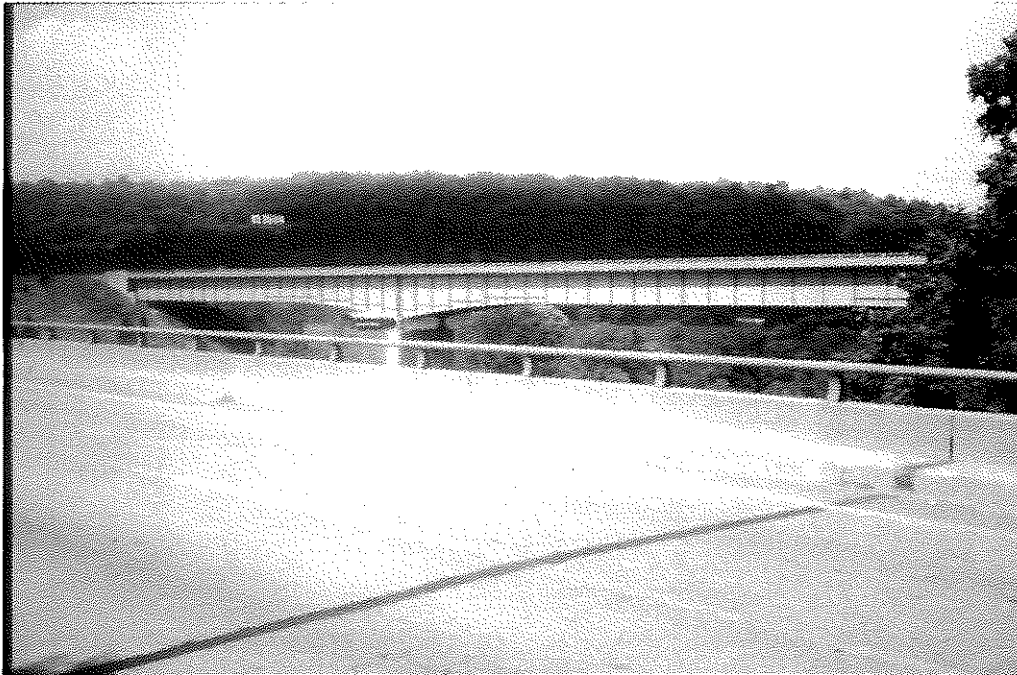
**FIGURE 20. THE EXTERIOR FACE OF THE SOUTH MAIN GIRDER OF THE WESTBOUND I-64 BRIDGE OVER THE KENTUCKY RIVER AFTER SPOT PAINT REPAIR.**

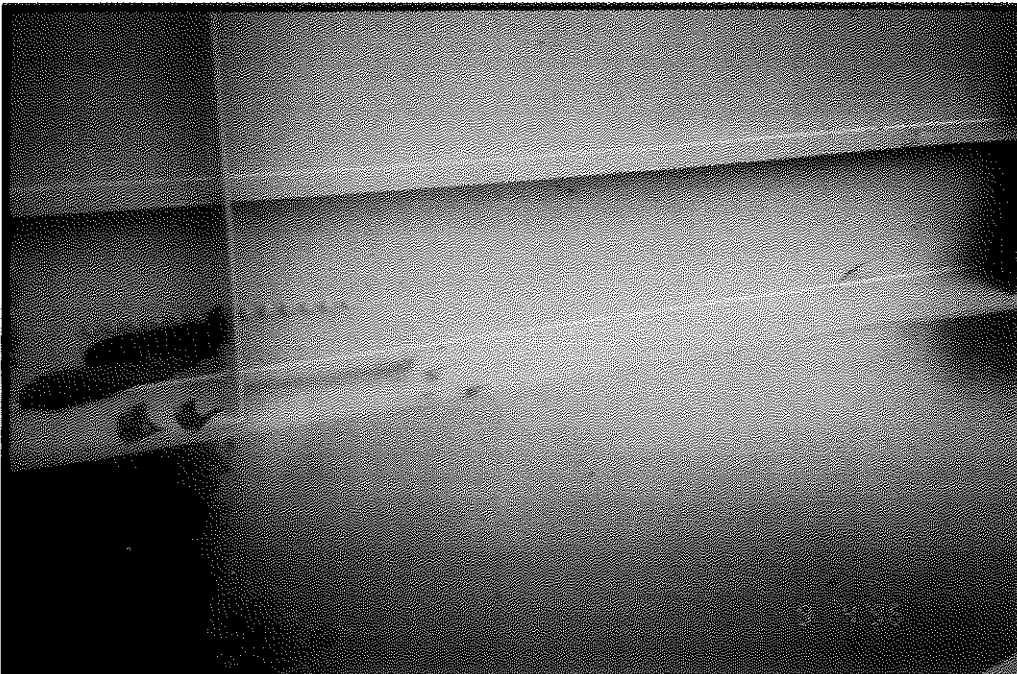
**FIGURE 21. RUSTING ON UPPER FACE OF THE LOWER FLANGE ON THE LEFT SIDE OF THE VERTICAL STIFFENER. NOTE THE SMALL DISBONDING SITE ON RIGHT OF VERTICAL STIFFENER (1996).**

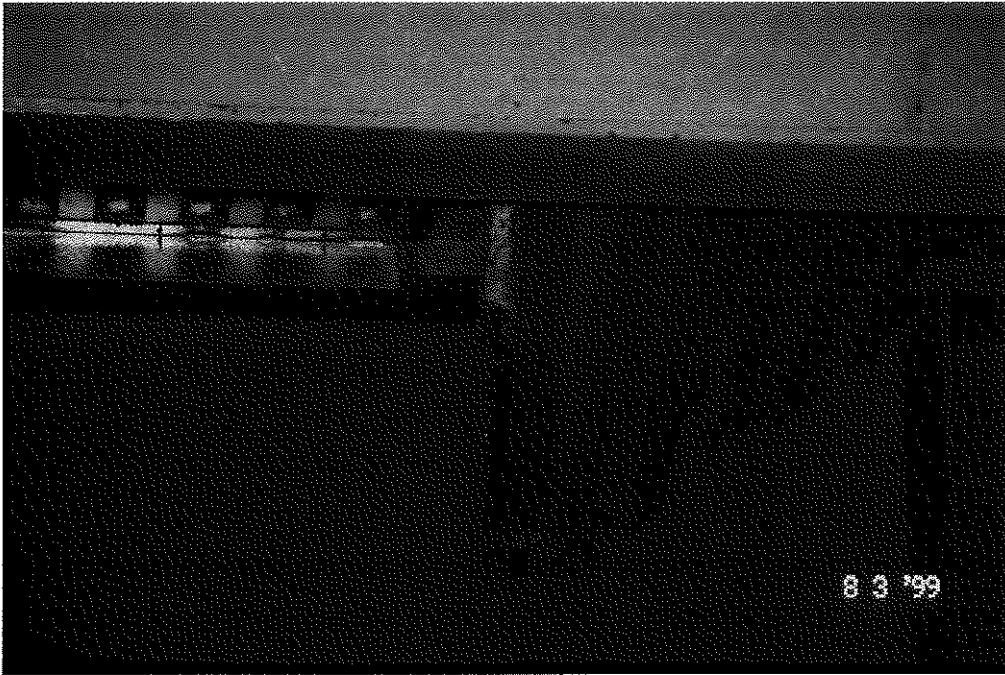
**FIGURE 22. PARTIALLY DETACHED STAY-IN-PLACE FORM UNDER WESTBOUND I-64 BRIDGE OVER THE KENTUCKY RIVER.**

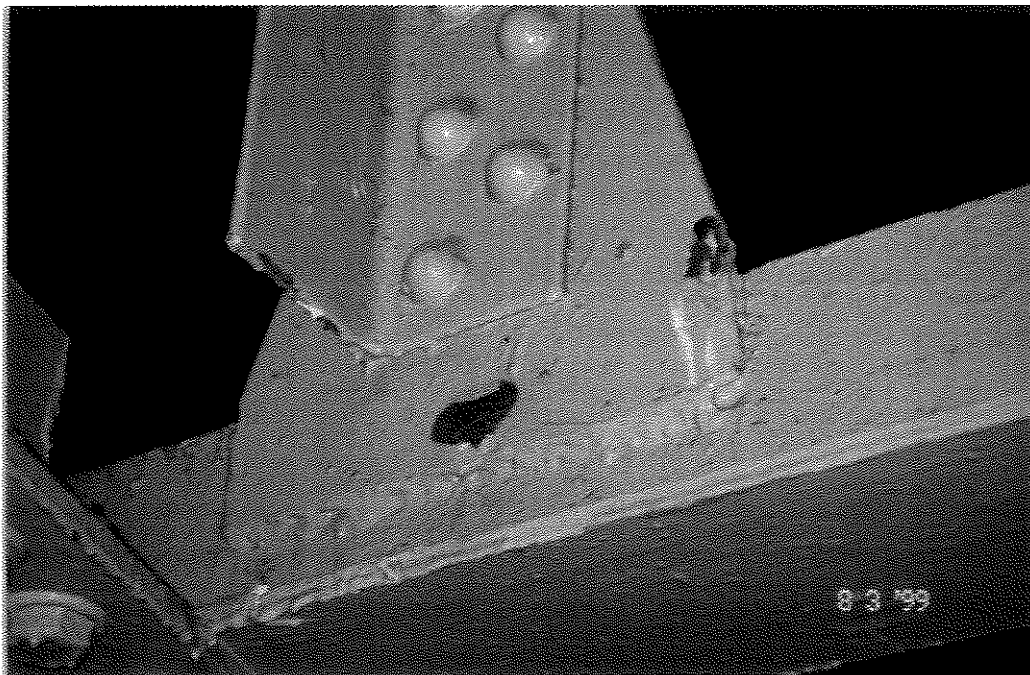
**FIGURE 23. PAINT DAMAGED BY FALLING CONCRETE.**

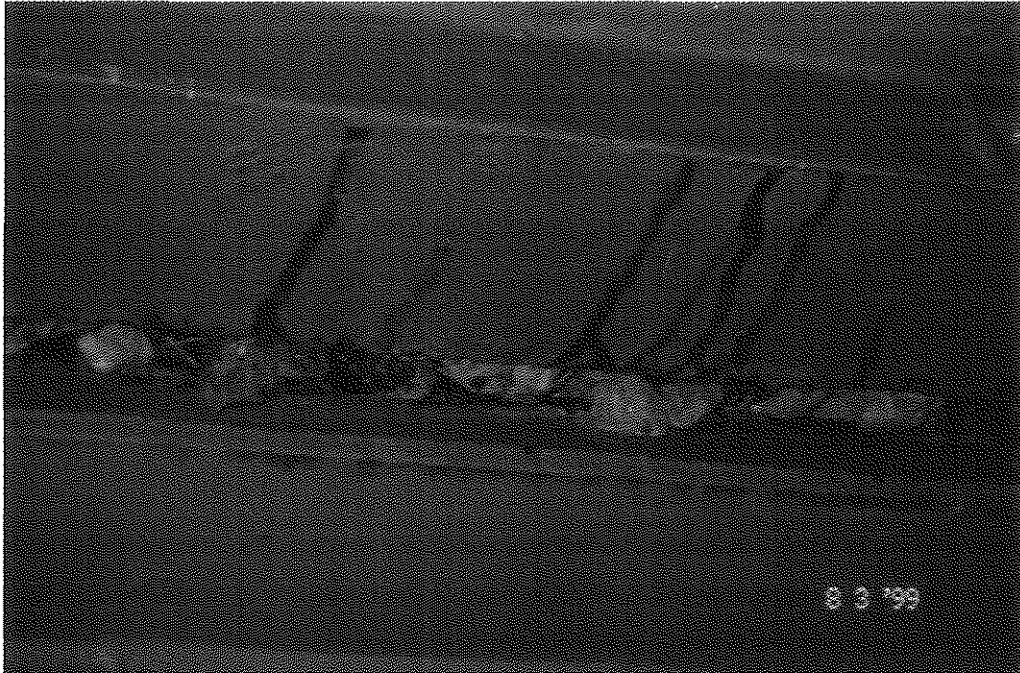
**FIGURE 24. DECK JOINT FILLED WITH CONCRETE AFTER DECK WORK.**

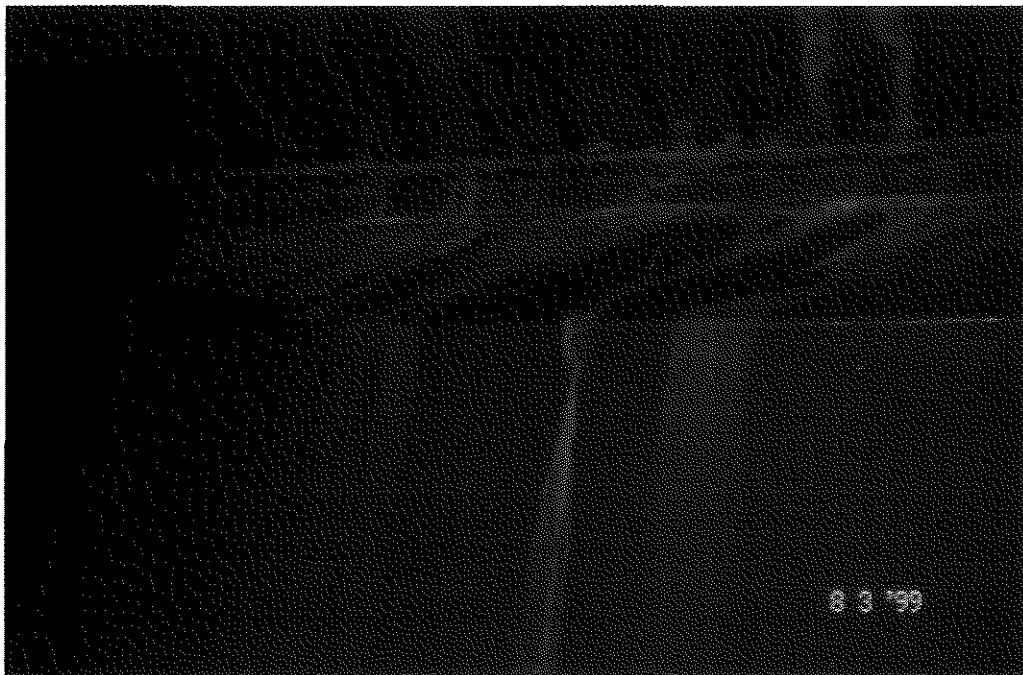
**FIGURE 25. CONCRETE STAINING CAUSED BY DECK WORK.**

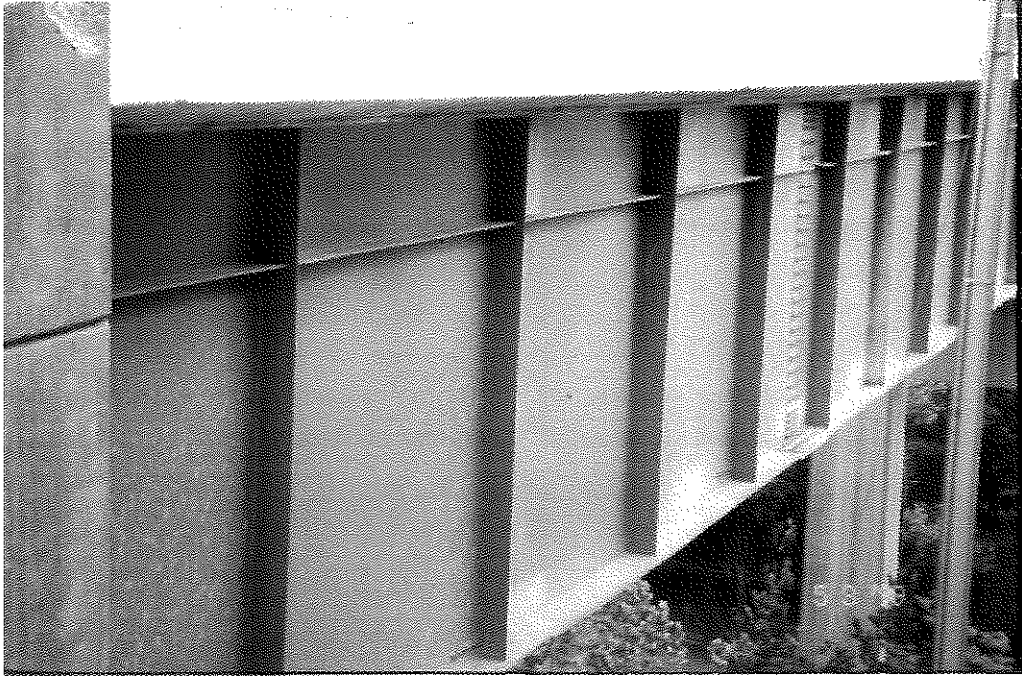
**FIGURE 26. CONCRETE STAINING ON I-64 BRIDGE OVER KY 420.**

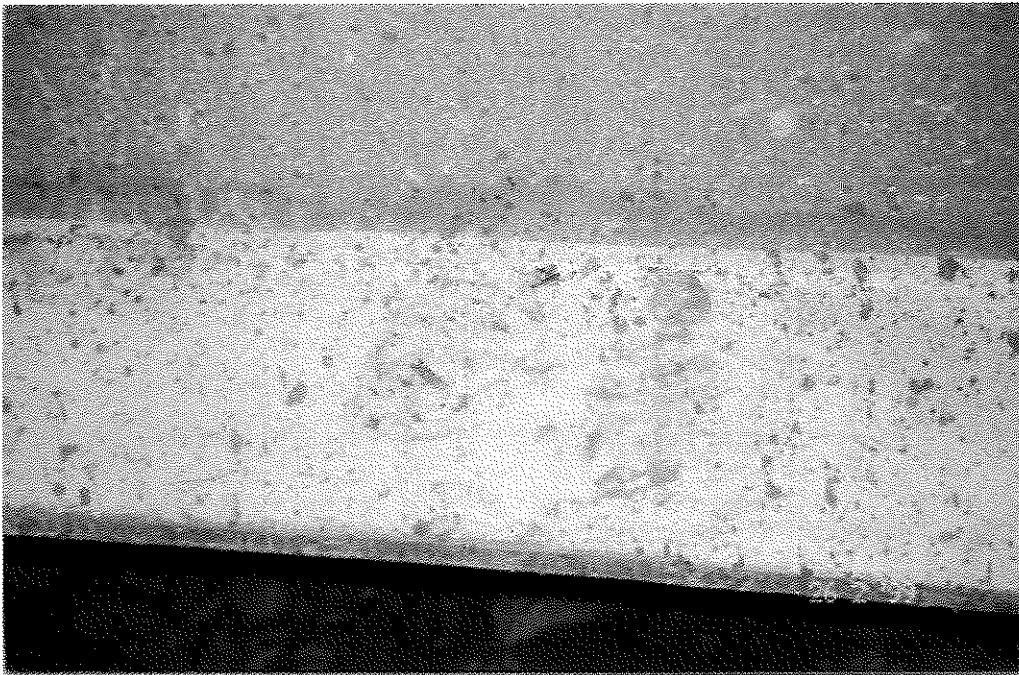
**FIGURE 27. CLOSE-UP OF STAINING AND DEPOSITS ON I-64 OVER THE KY 420.**

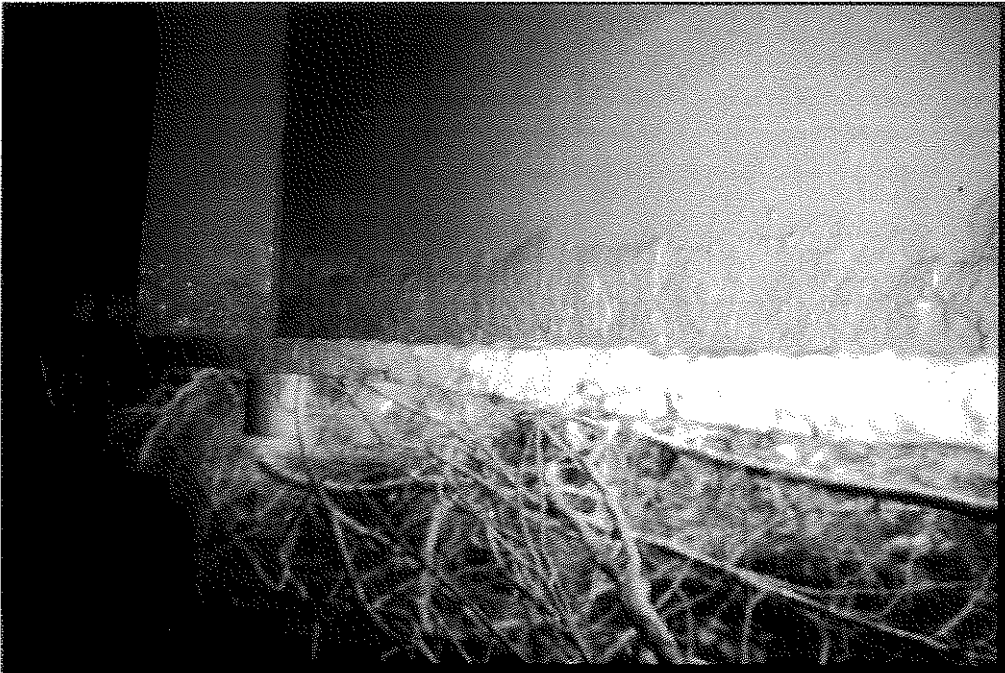
**FIGURE 28. I-64 EASTBOUND OVER KY 420 SHOWING CORROSION WHERE COATING WAS APPLIED STRATIFIED RUST (1997).**

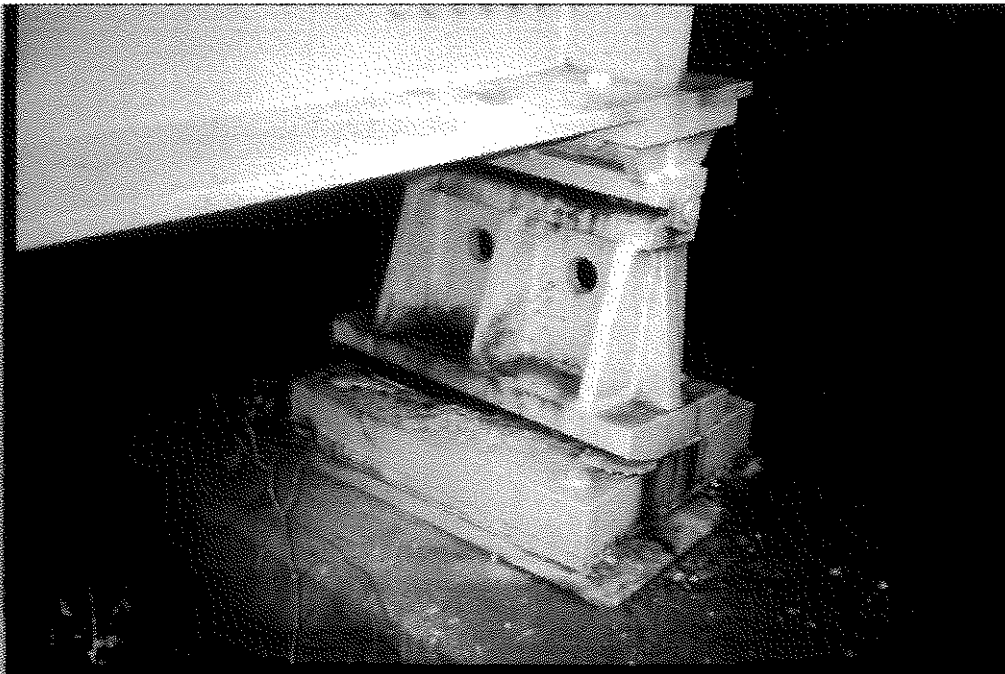
**FIGURE 29. I-64 EASTBOUND OVER KY 420 SHOWING BEARING CORROSION (1997).**

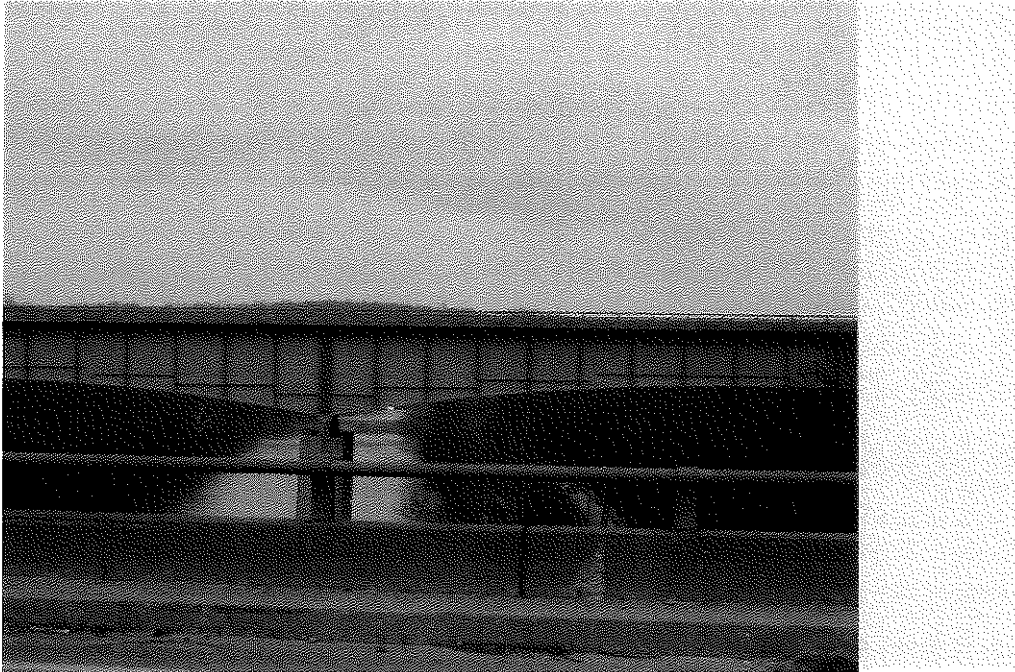
**FIGURE 20. I-64 WESTBOUND OVER THE KENTUCKY RIVER IN 1997.**

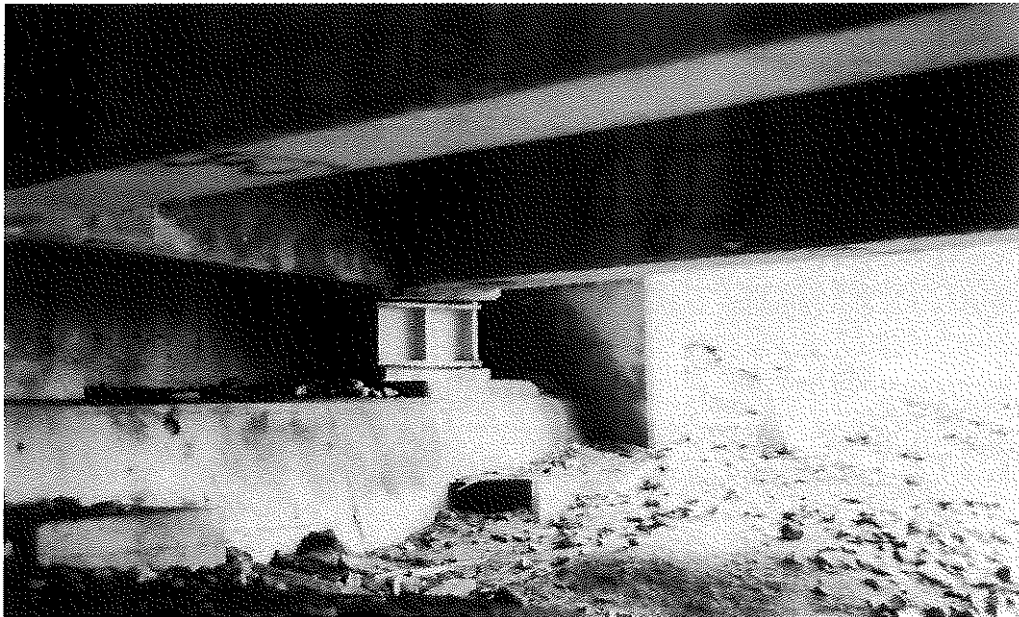
FIGURE 34. I-71 CONCRETE OVERPASS BRIDGE SHOWING STEEL BEARING CORROSION (1997).

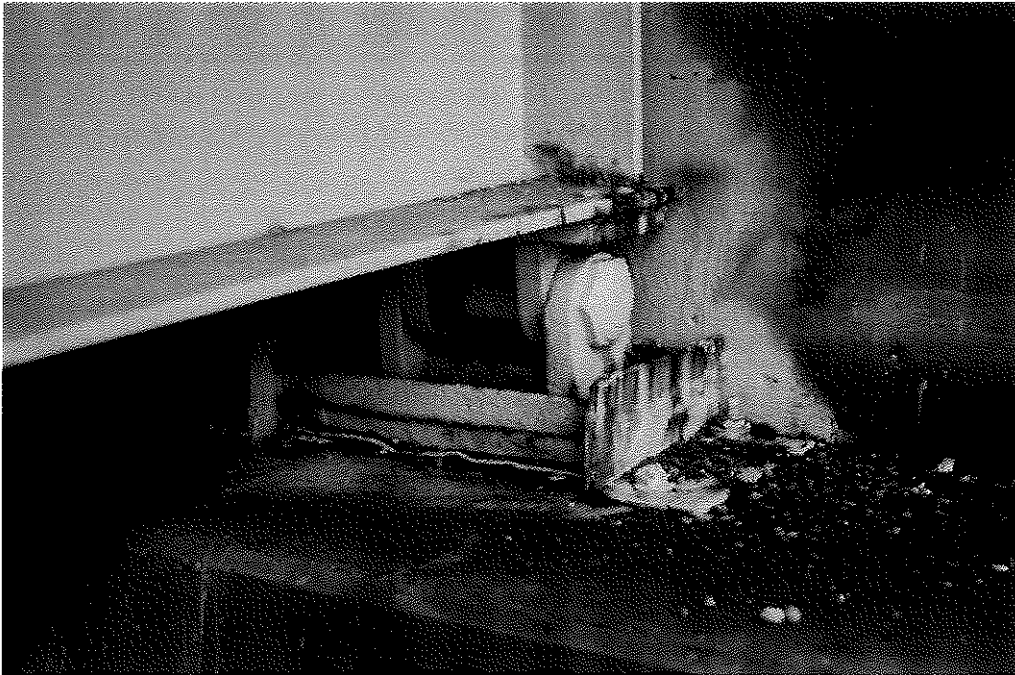
**FIGURE 35. I-71 STEEL MAINLINE BRIDGE OVER SULPHUR CREEK AND THE CSX RAILROAD SHOWING BEARING CORROSION (1997).**

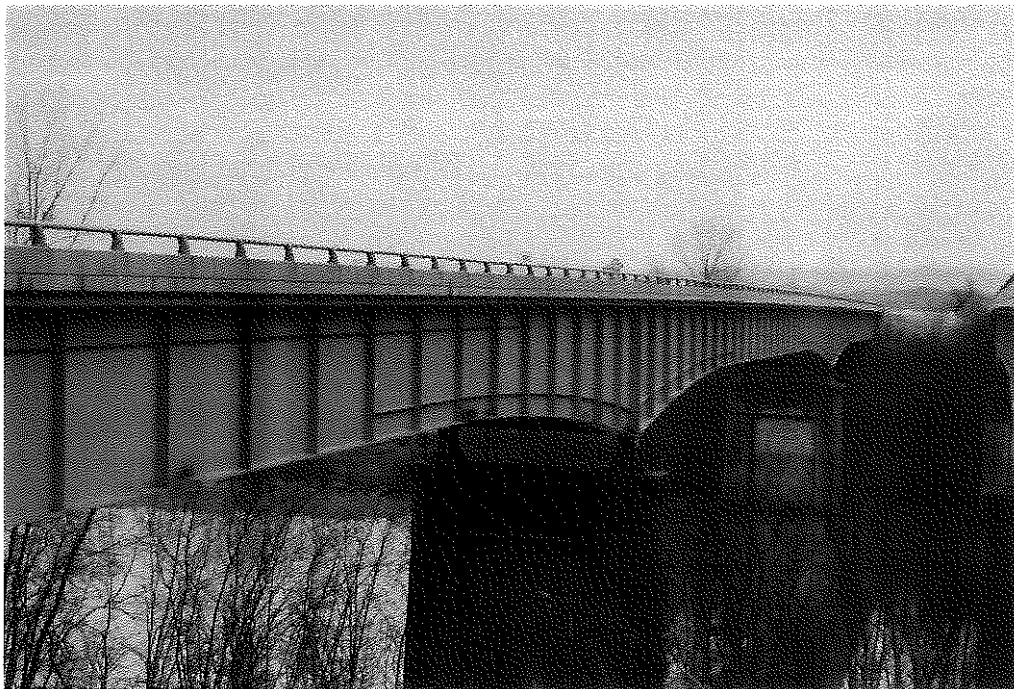
**FIGURE 36. I-71 SOUTHBOUND MAINLINE BRIDGE OVER THE KENTUCKY RIVER SHOWING CORROSION ON LOWER WEB AND FLANGE. NOTE THE CORROSION UNDER DECK JOINTS (1997).**

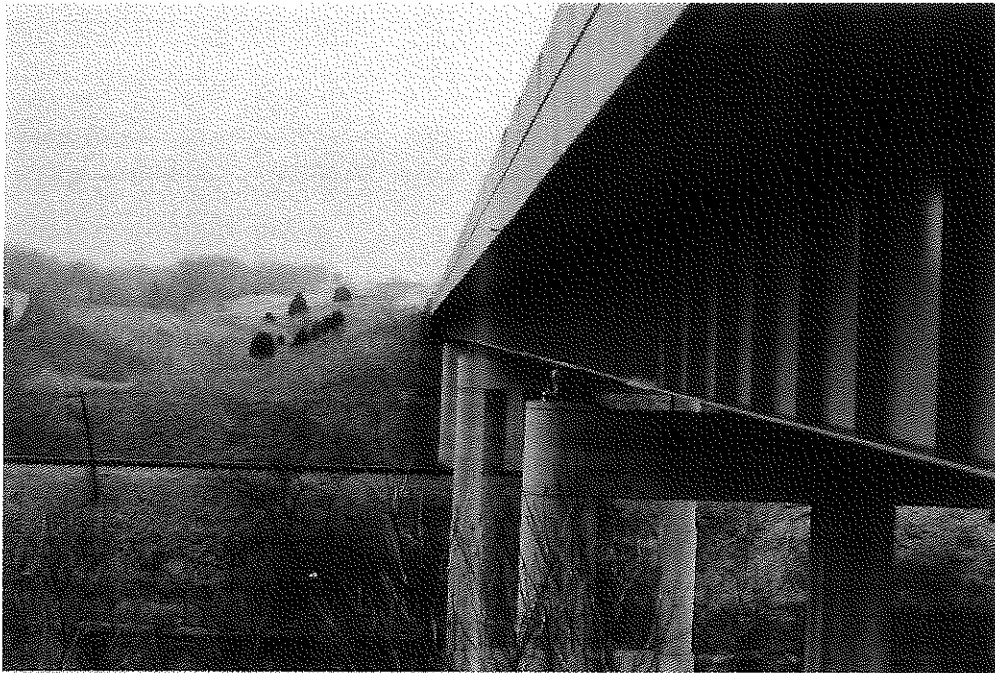
**FIGURE 37. I-71 STEEL MAINLINE BRIDGE OVER SULPHUR CREEK AND THE CSX RAILROAD SHOWING PAINT IN GOOD CONDITION (1997).**

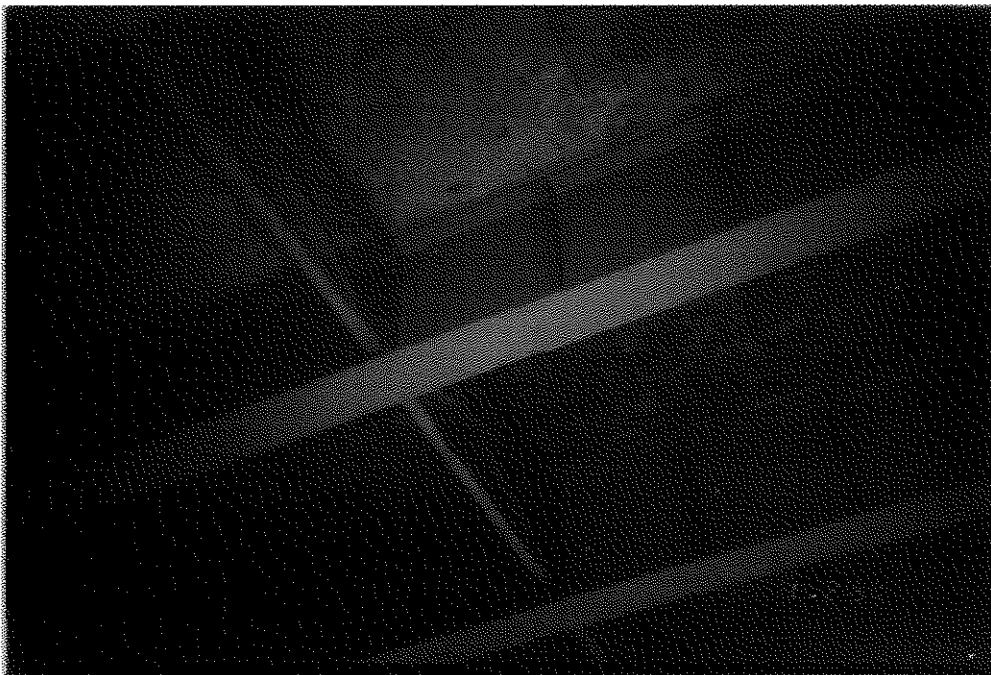
**FIGURE 38. I-71 OVERPASS BRIDGE GIRDER SHOWING SPOT CORROSION AT BRACING AND ALONG EDGES OF LOWER FLANGE (1997).**

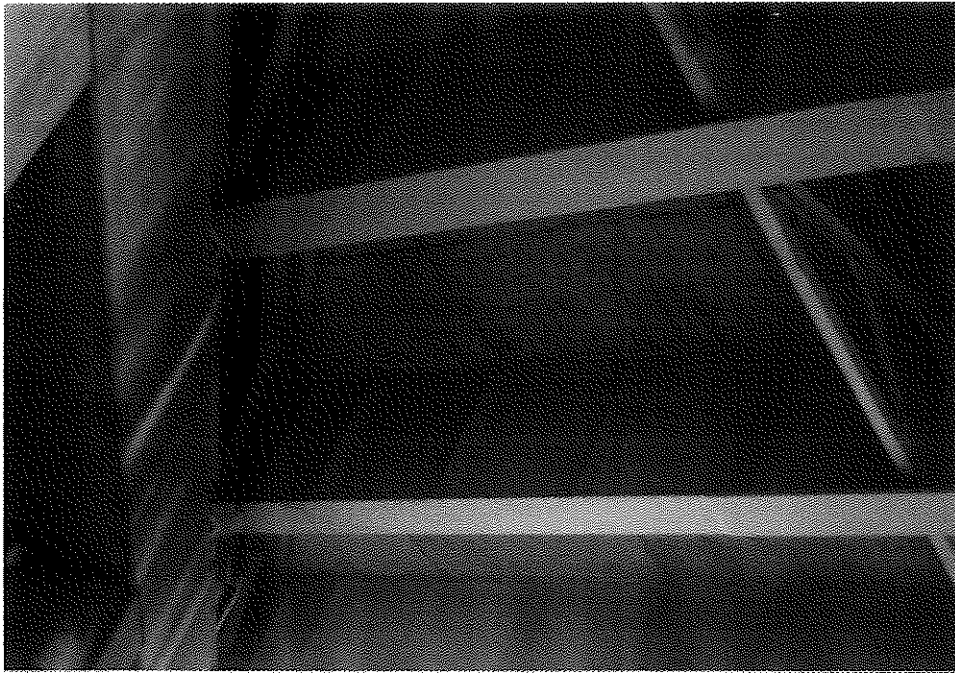
**FIGURE 39. I-71 OVERPASS BRIDGE GIRDER SHOWING SPOT CORROSION ON LOWER FLANGE AT END OF GIRDER BRACING AND ALONG EDGES OF LOWER FLANGE (1997).**

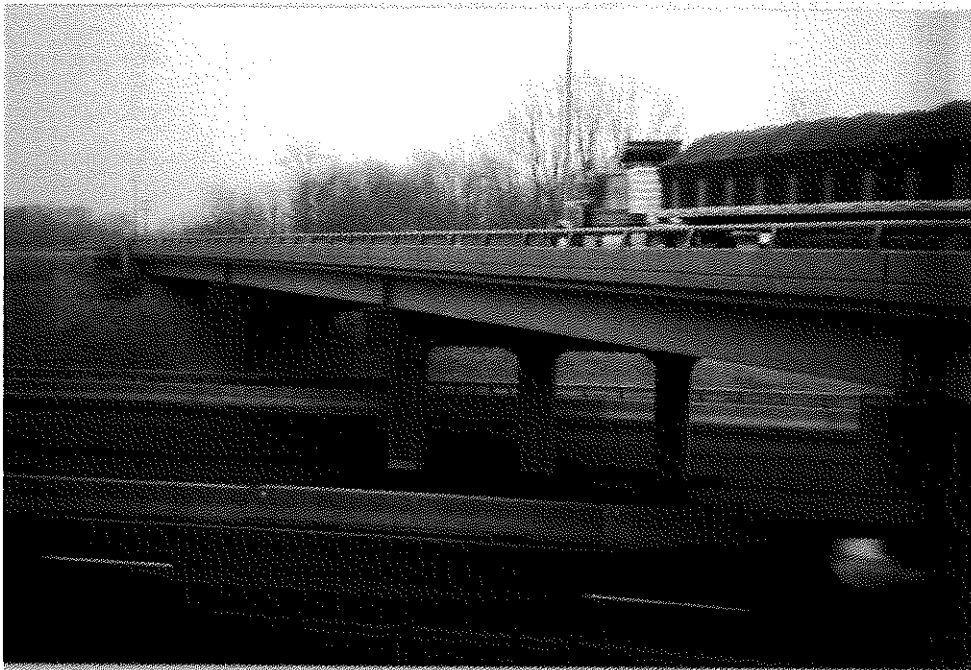
**FIGURE 40. I-71 NORTHBOUND BRIDGE OVER I-75 SHOWING CORROSION ON LOWER FLANGE OF FASCIA GIRDER (1999).**

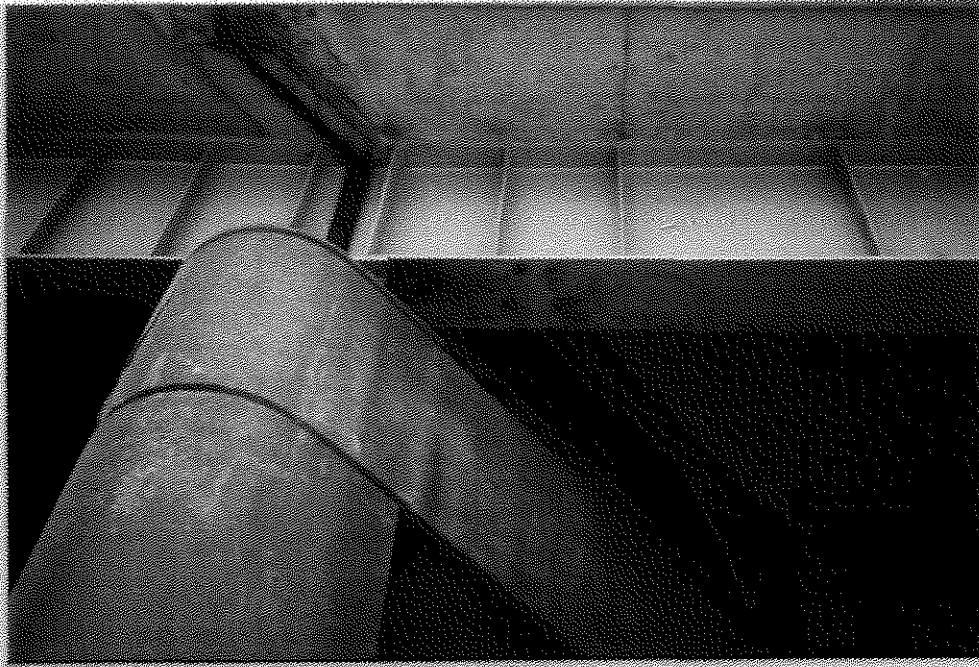
**FIGURE 41. KY 146 OVERPASS BRIDGE OVER I-71 SHOWING CORROSION ON LOWER FLANGE UNDER DECK JOINT (1999).**

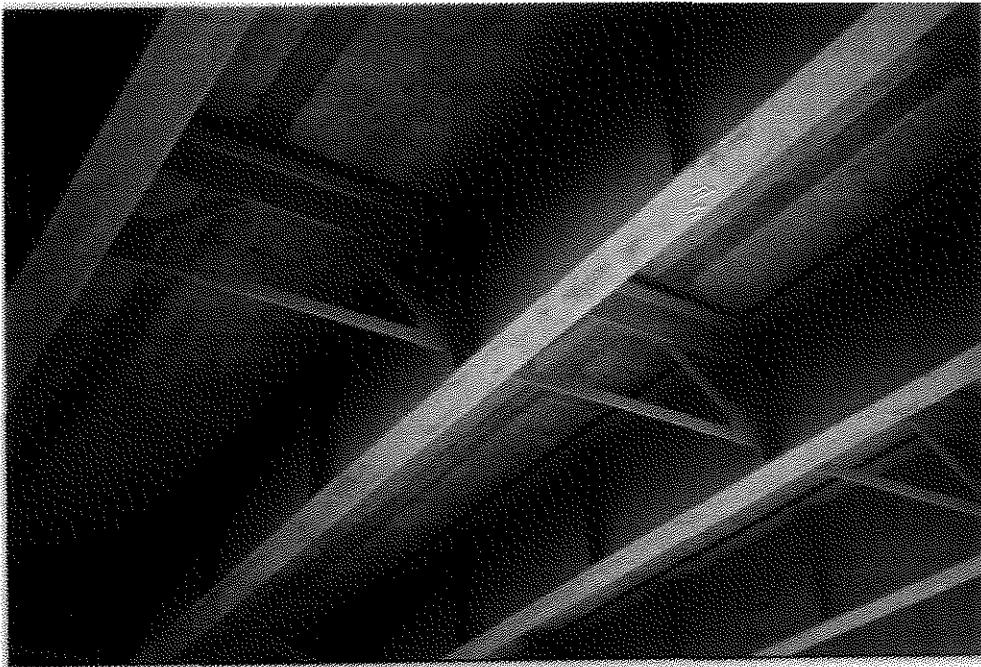
**FIGURE 42. LIME KILN LANE BRIDGE OVER I-71 SHOWING CORROSION ON TRANSVERSE BRACING AND LOWER FLANGES (1999).**

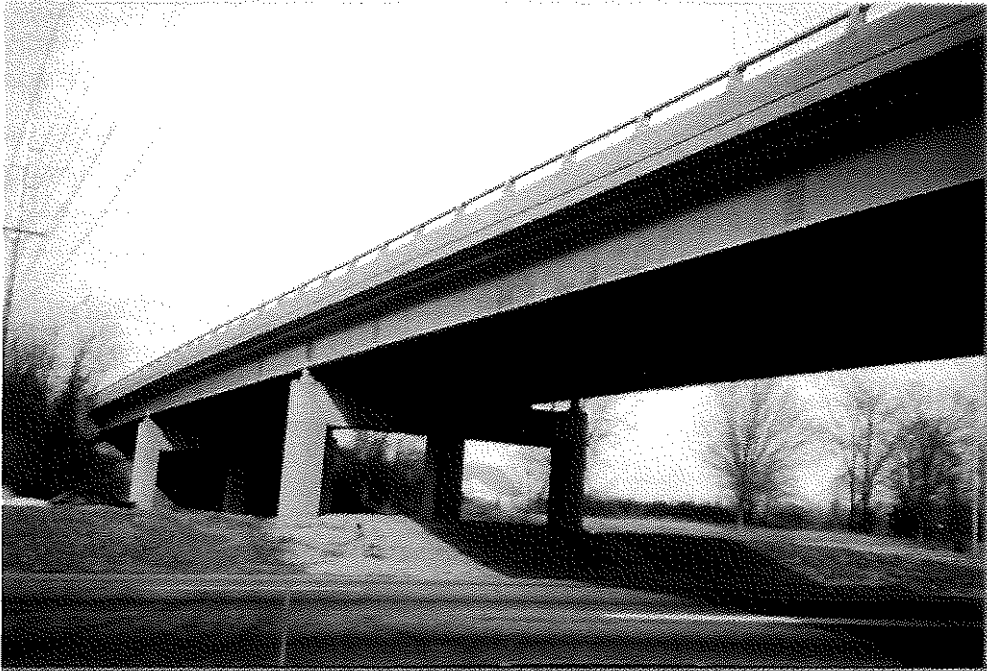
**FIGURE 43. SPRINGDALE ROAD BRIDGE OVER I-71 SHOWING CORROSION ON EXTERIOR FACE OF FASCIA GIRDER (1999).**

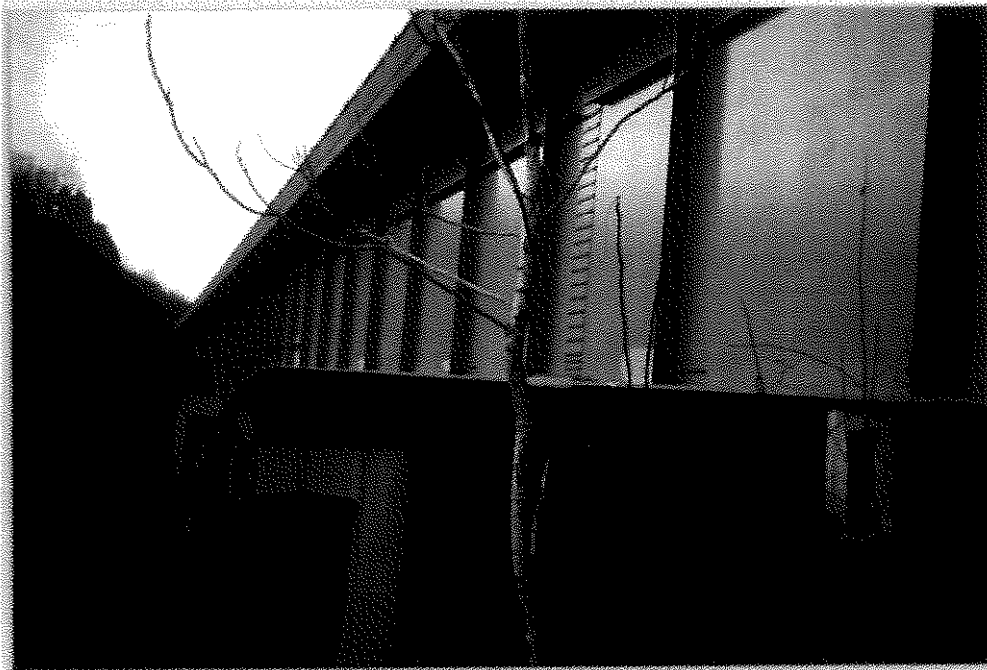
**FIGURE 44. I-71 NORTHBOUND MAINLINE BRIDGE OVER SULPHUR CREEK AND THE CSX RAILROAD SHOWING PAINT IN GOOD CONDITION (1999).**
