**Research Report  
KTC-99-51**

**EXPERIMENTAL MAINTENANCE PAINTING  
BY OVERCOATING ON THE  
I-64, I-71 AND KY-22 BRIDGES**

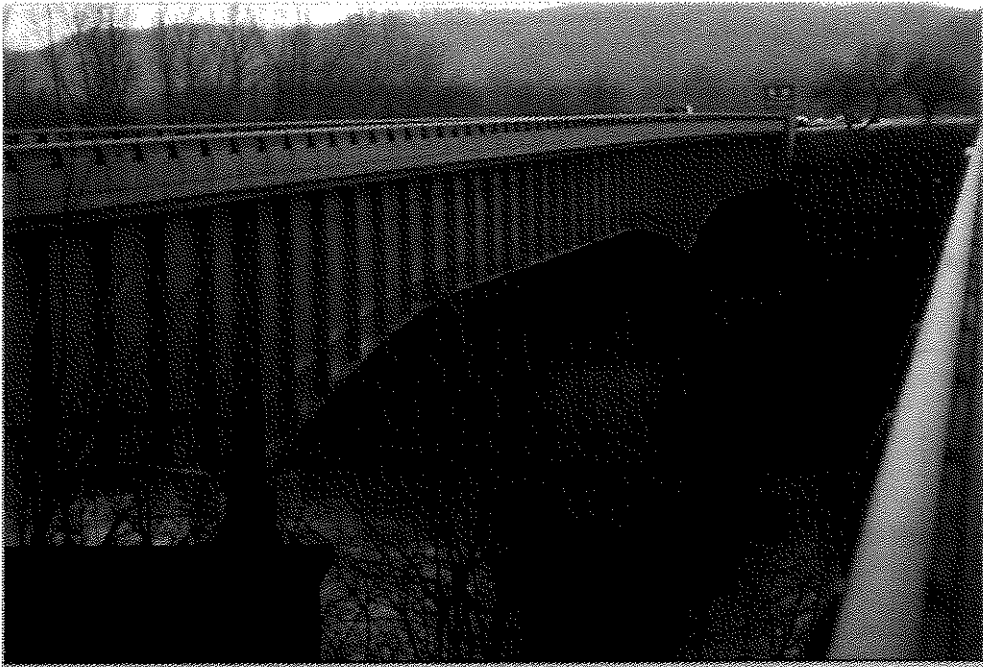
**FIGURE 45. I-71 SOUTHBOUND MAINLINE BRIDGE OVER THE KENTUCKY RIVER SHOWING A SLIGHT INCREASE IN CORROSION OVER 1997 - REF. FIGURE 36 (1999).**

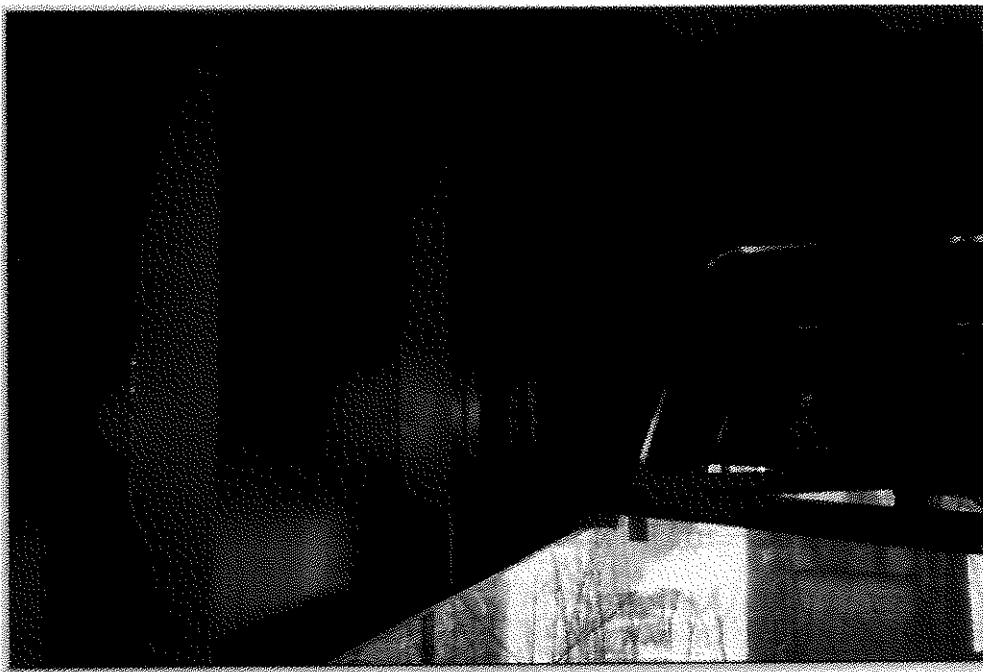
**FIGURE 46. CORROSION ON I-71 NORTHBOUND BRIDGE FLOOR BEAMS UNDER DECK JOINT (1999).**

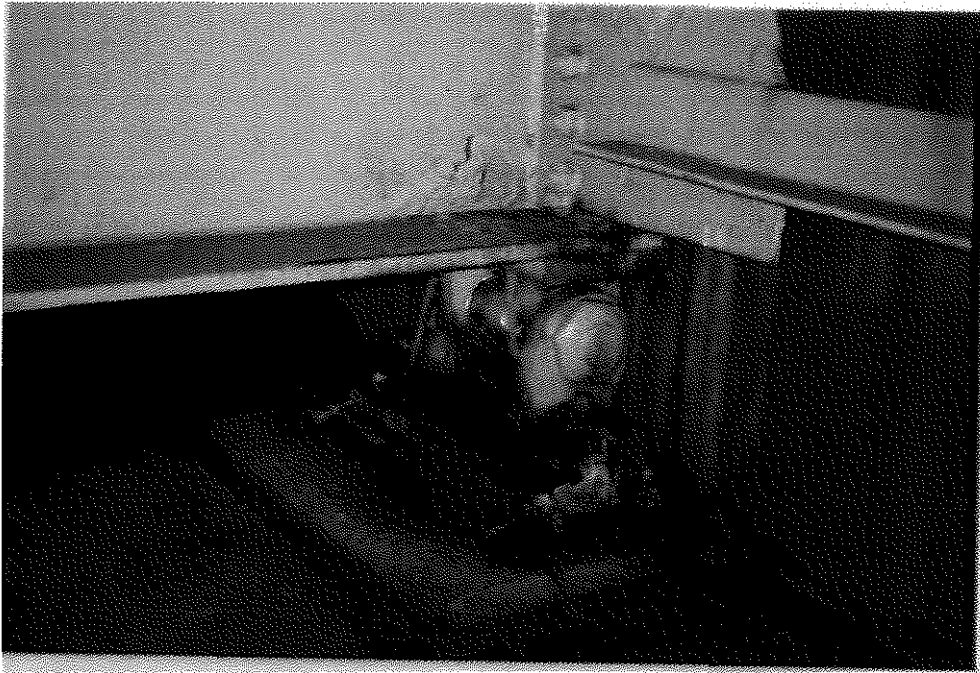
**FIGURE 47. I-71 NORTHBOUND MAINLINE BRIDGE OVER SULPHUR CREEK AND THE CSX RAILROAD SHOWING PAINT FAILURE AND BEARING CORROSION (1999).**

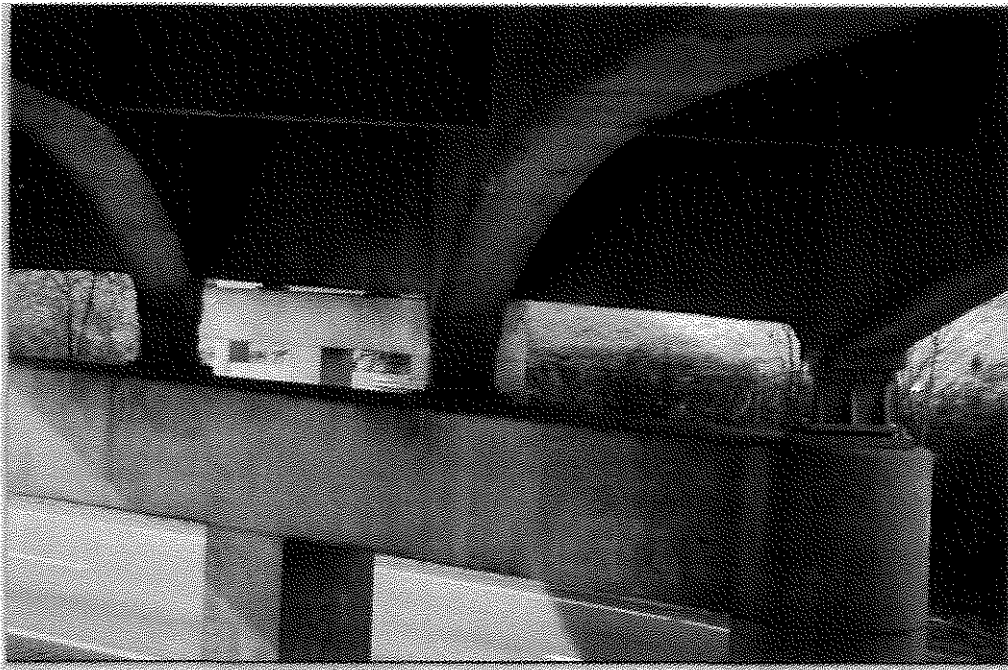
**FIGURE 48. I-71 CONCRETE BRIDGE SHOWING PIER BEARING IN GOOD CONDITION (1999).**

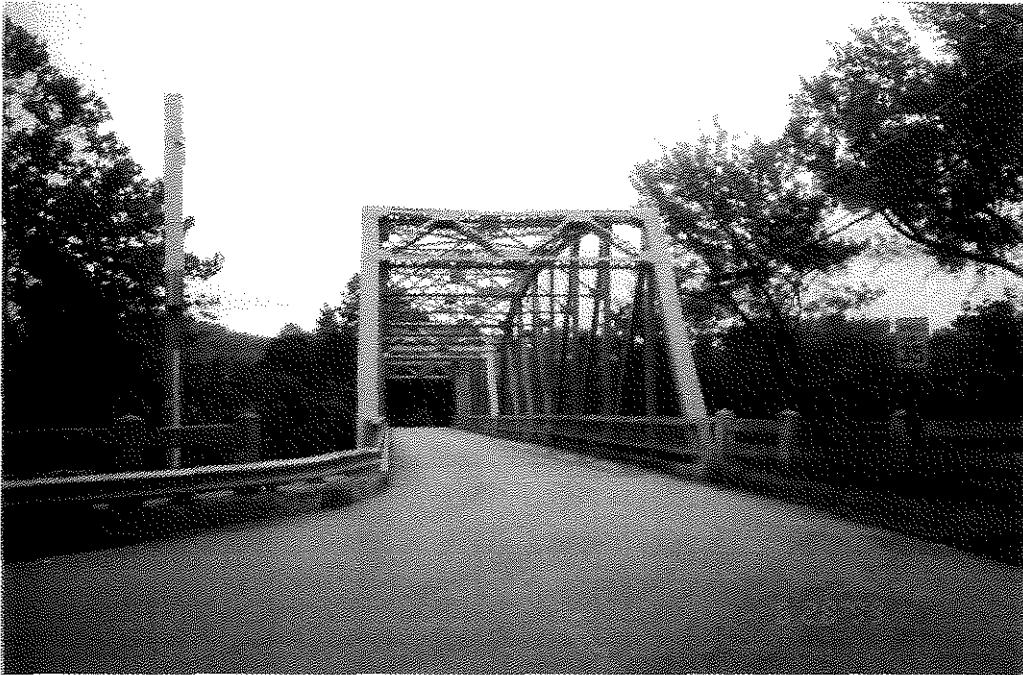
**FIGURE 49. NORTH END OF THE KY 22 BRIDGE.**

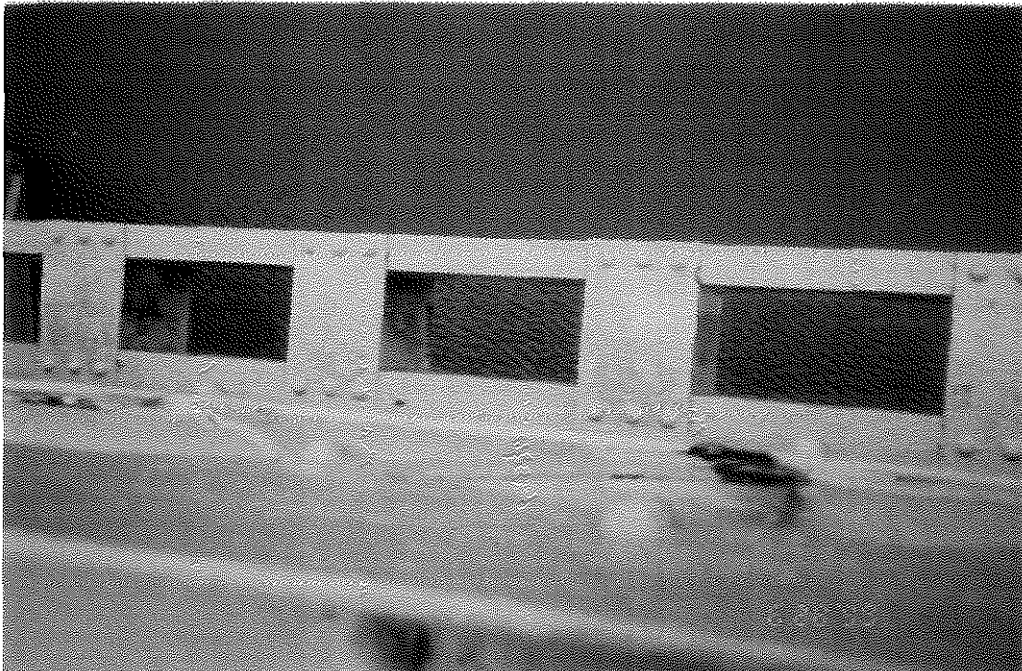
**FIGURE 50. BATTEN PLATES ON DOWNSTREAM LOWER CHORD OF KY 22 BRIDGE SHOWING PAINT IN GOOD CONDITION.**

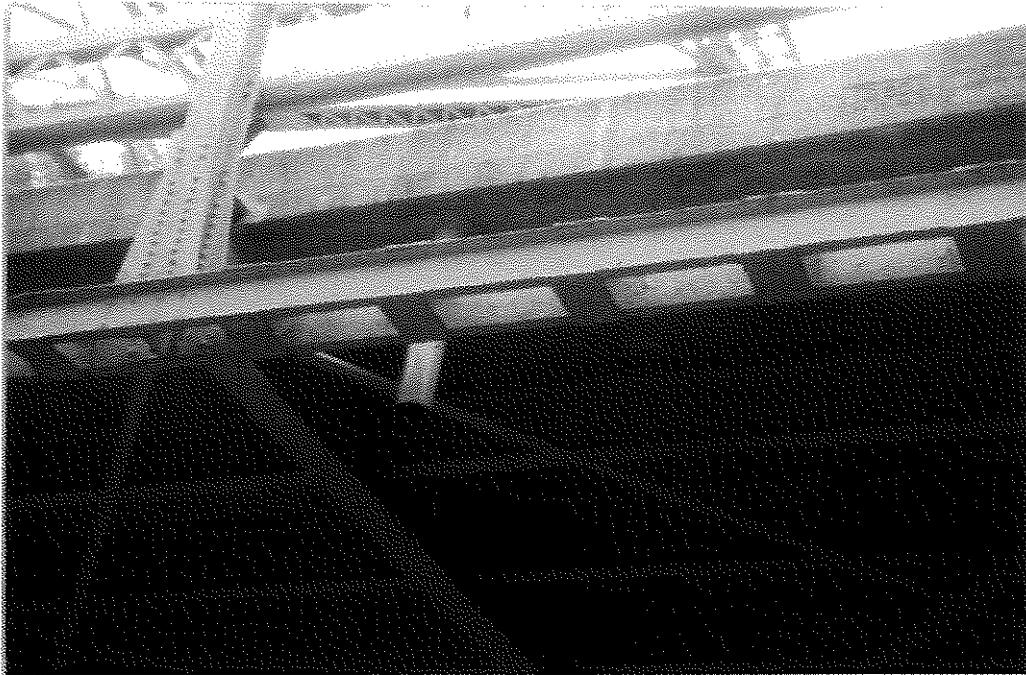
**FIGURE 51. BATTEN PLATES ON DOWNSTREAM LOWER CHORD OF KY 22 BRIDGE SHOWING SLIGHT CORROSION AND RUST STAIN ON WEB.**

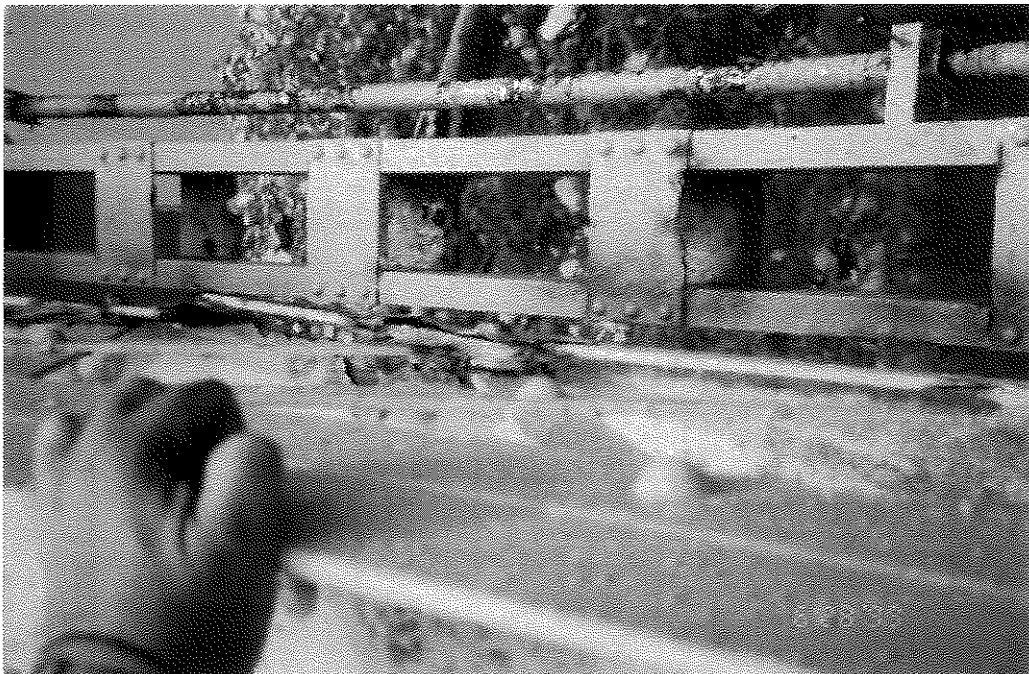
**FIGURE 52. BATTEN PLATES ON UPSTREAM LOWER CHORD OF KY 22 BRIDGE SHOWING COATING FAILURE.**

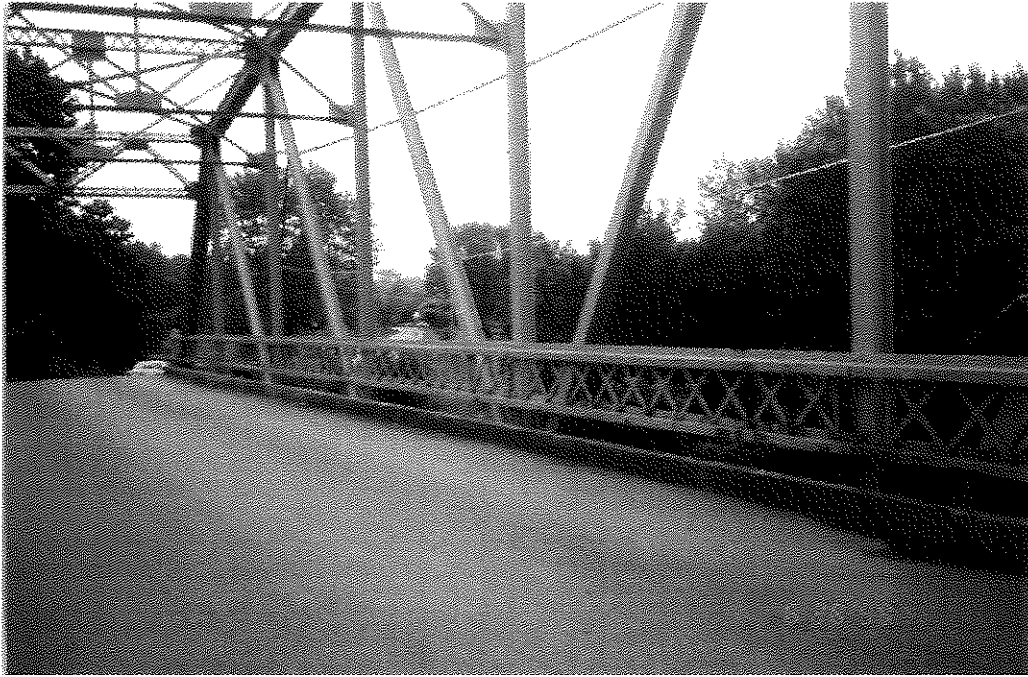
**FIGURE 53. KY 22 BRIDGE GUARDRAIL SHOWING EXTENSIVE COATING FAILURE.**

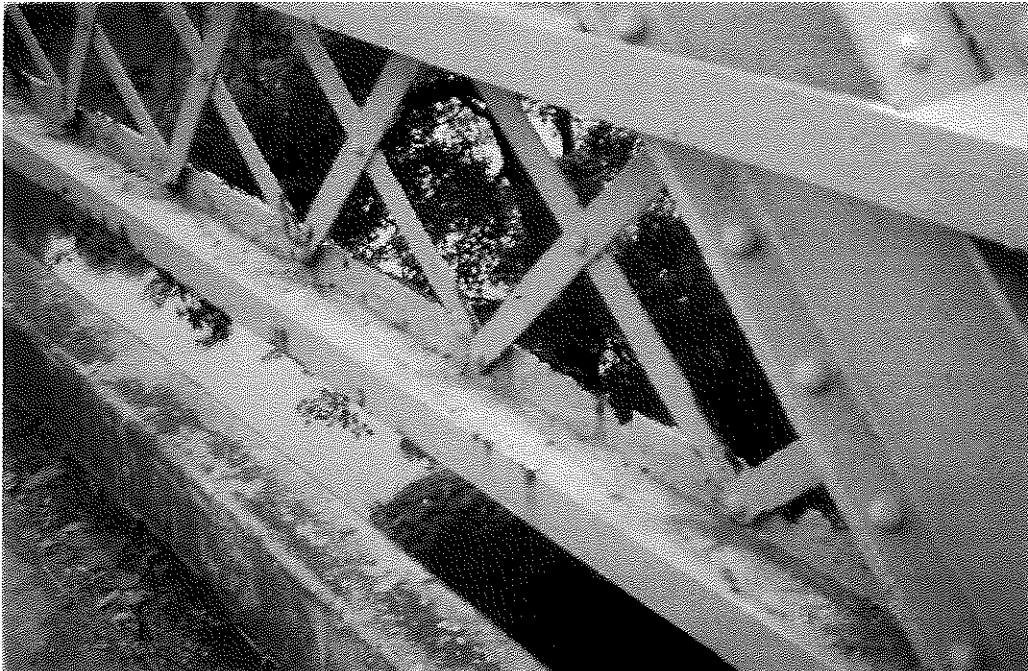
**FIGURE 54. KY 22 BRIDGE GUARDRAIL SHOWING EXTENSIVE COATING FAILURE AT EDGES OF LACING BARS.**

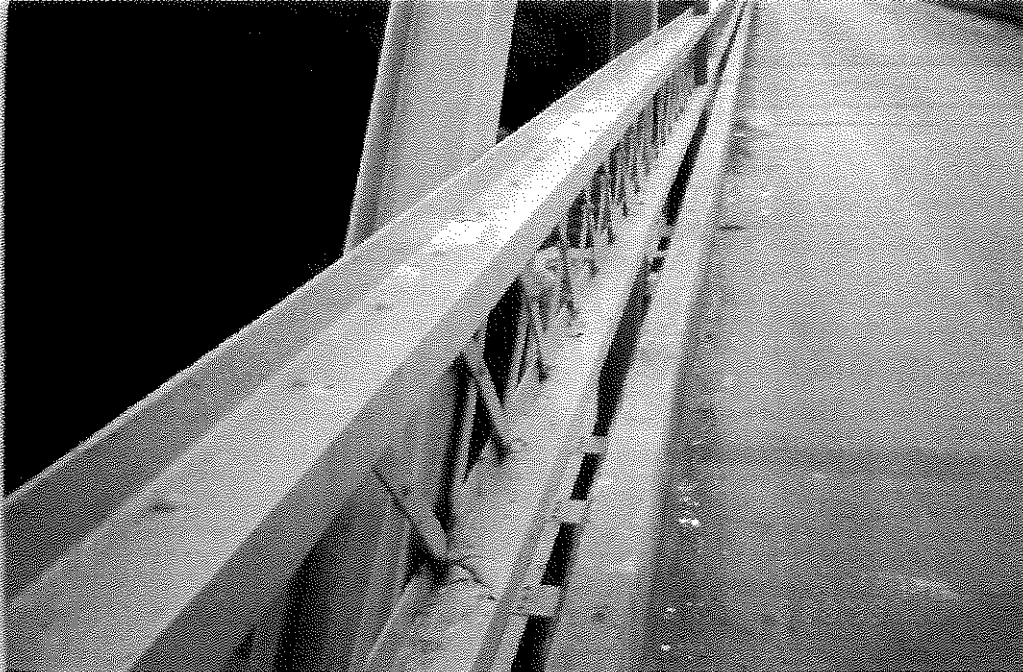
**FIGURE 55. KY 22 BRIDGE GUARDRAIL SHOWING DISBONDING ON HORIZONTAL SURFACE OF TOP RAIL.**

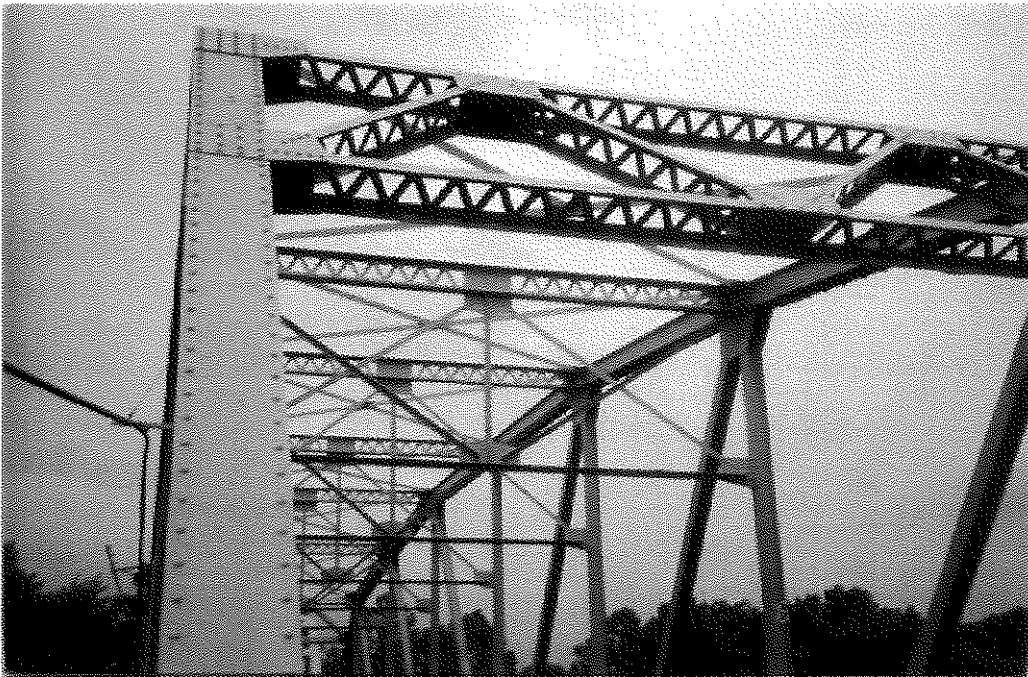
**FIGURE 56. SOUTH SPAN END BENT, PORTAL AND UPPER CHORD OF KY 22 BRIDGE SHOWING PAINT IN GOOD CONDITION.**

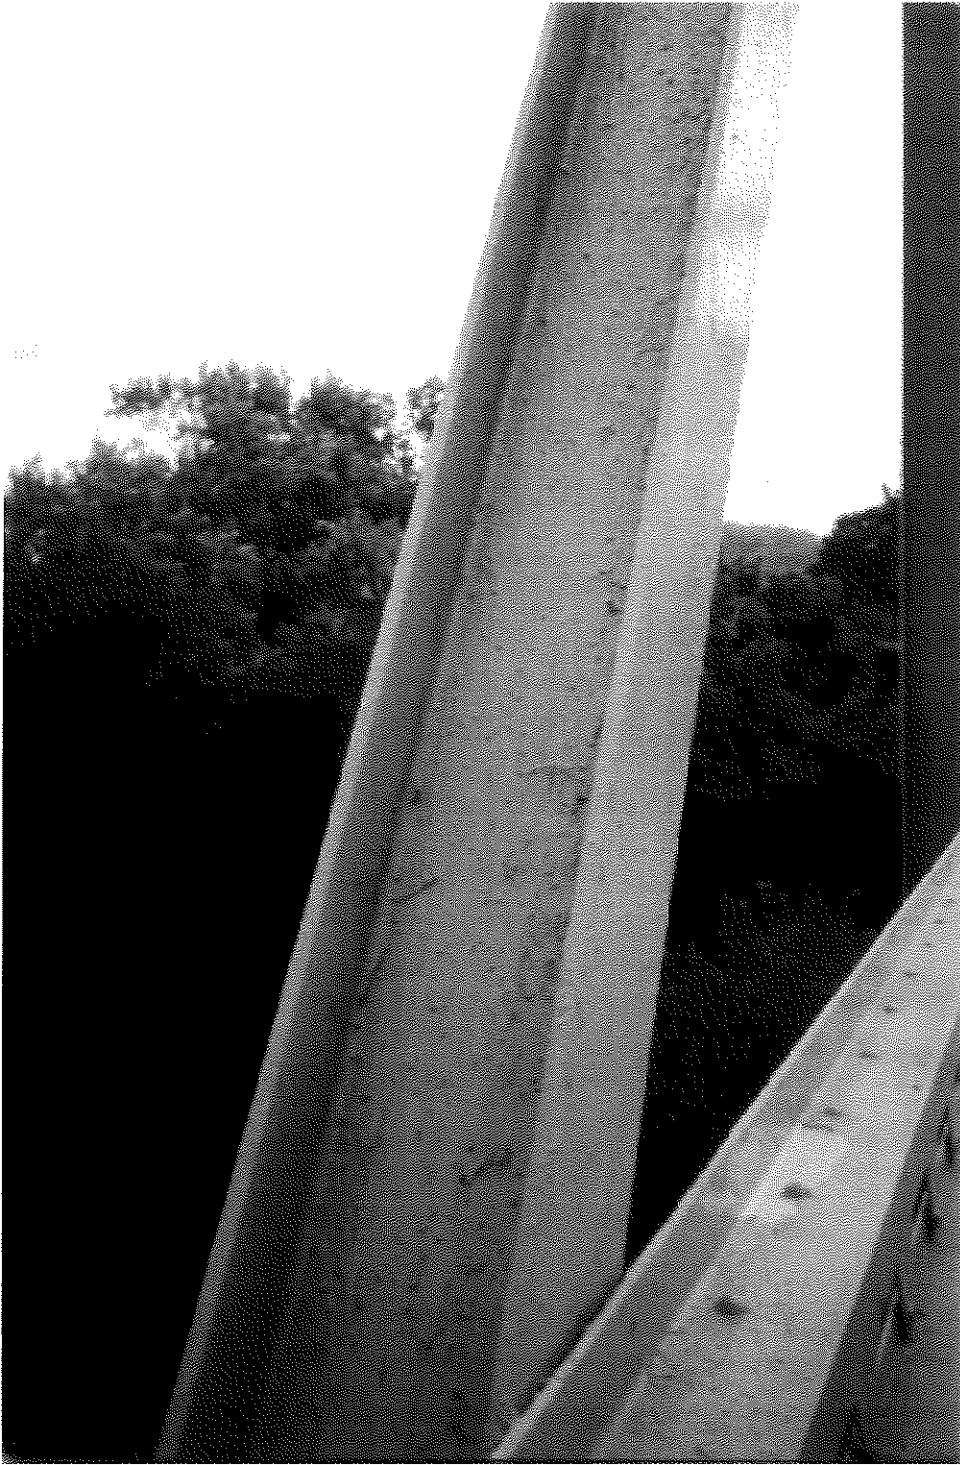
**FIGURE 57. KY 22 BRIDGE DIAGONAL SHOWING PAINT RUNS AND DIRT BUILD-UP.**

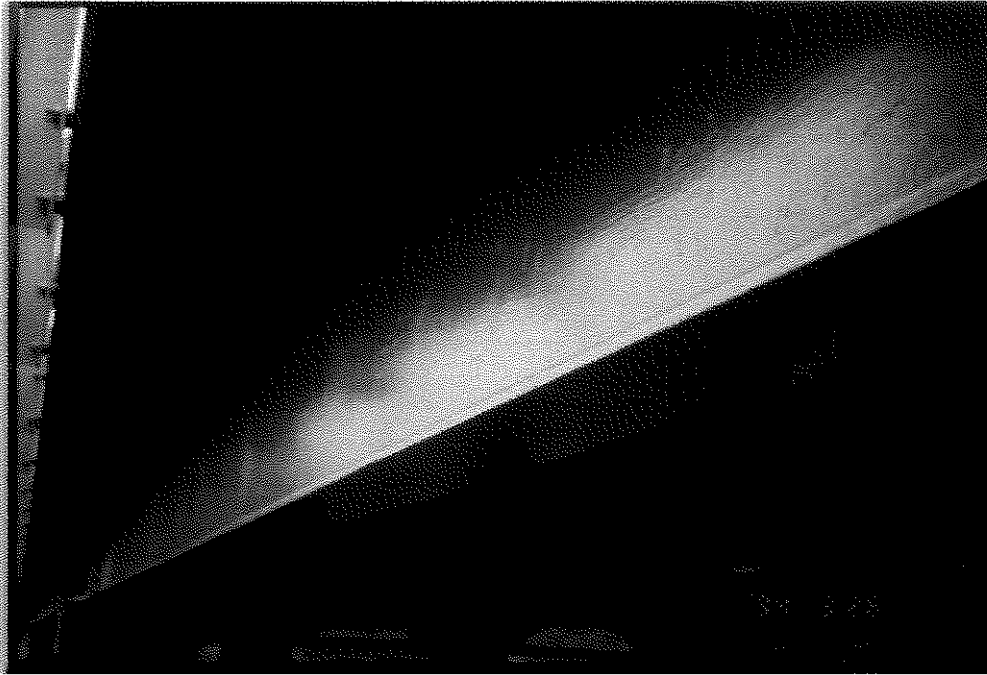
**FIGURE 58. I-71 OVERPASS BRIDGE SHOWING ROUGH SURFACE FINISH OBTAINED USING TWO-COAT PAINT SYSTEM.**

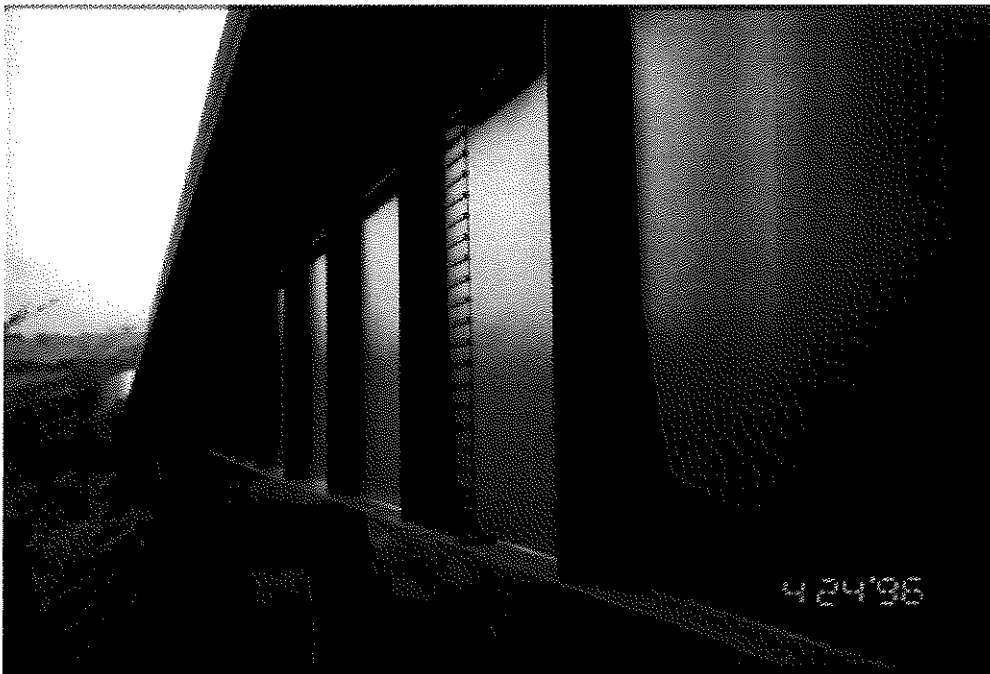
**FIGURE 59. WESTBOUND I-64 BRIDGE OVER THE KENTUCKY RIVER SHOWING SMOOTH FINISH OBTAINED USING THREE-COAT PAINT SYSTEM.**
