Research Report
KTC-96-17

EVALUATION OF EDGE DRAINS
ON INTERSTATE 64
FAYETTE, SCOTT, AND WOODFORD COUNTIES

July 1996

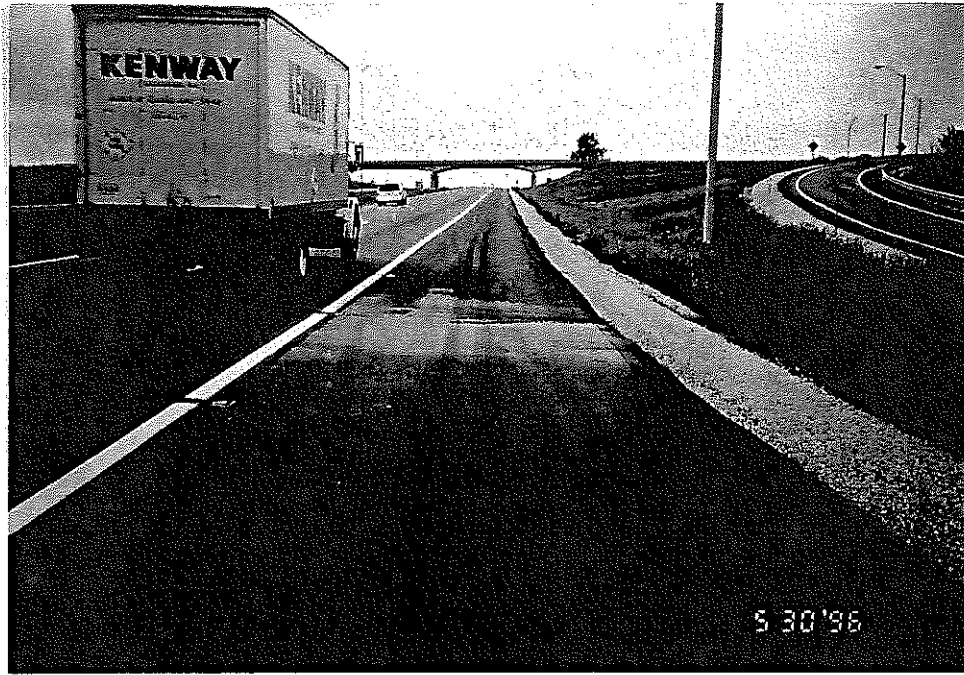
FIGURE 1. SIGNS OF PUMPING AT SHOULDER CONSTRUCTION JOINT.

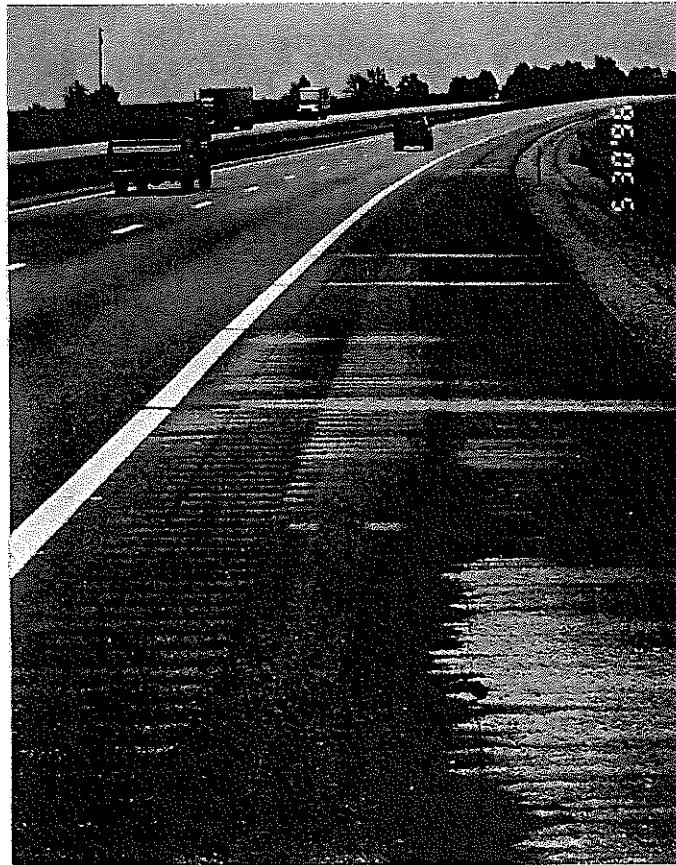
FIGURE 2. SIGNS OF PUMPING THROUGHOUT SHOULDER.

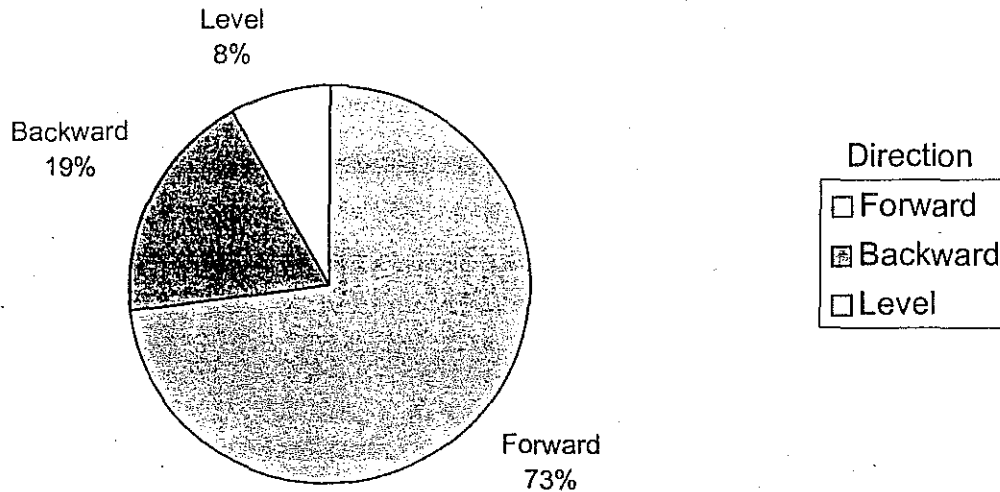
Of the 106 outlets inspected, approximately 19 percent were tilted backwards, 8 percent were level, and 73 percent had a positive slope (Figure 3). Figure 4 indicates that of the 73 percent that were tilted forward, 57 were below the recommended 4.1 % grade ($\frac{1}{2}$ inch drop per linear foot inside the headwall). Approximately 148 headwalls were inspected after construction in 1991. At the time of the inspection, approximately 57 percent of the outlets had a positive slope, 23 percent were level, and 20 percent had a negative slope. Headwall inspection information is contained in Appendix A. Backward tilting was also observed on an edge drain project on Pennyryle Parkway. A new headwall design was recommended in Research Report KTC-96-11.

FIGURE 3. PERCENT OF HEADWALLS TILTED.

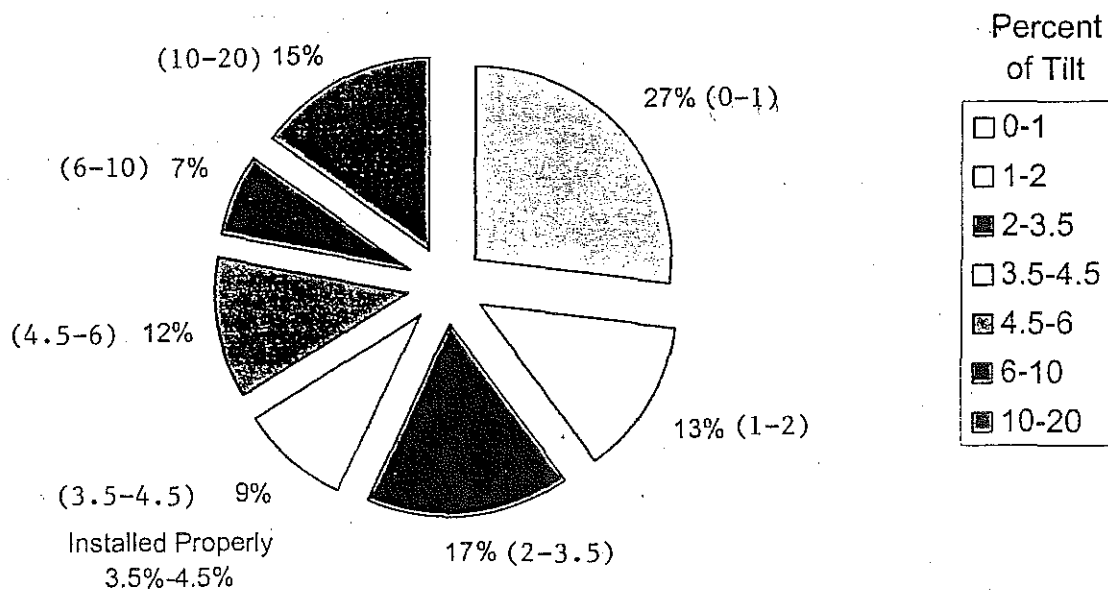
FIGURE 4. PERCENT OF TILT IN FORWARD LEANING HEADWALLS.

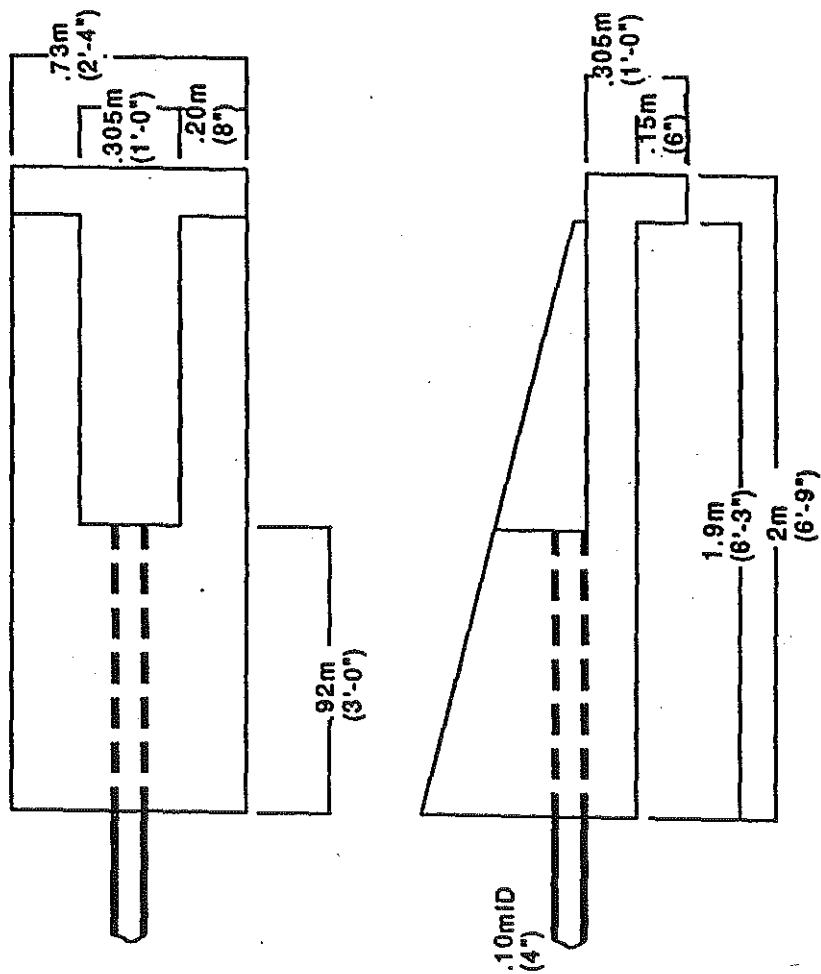
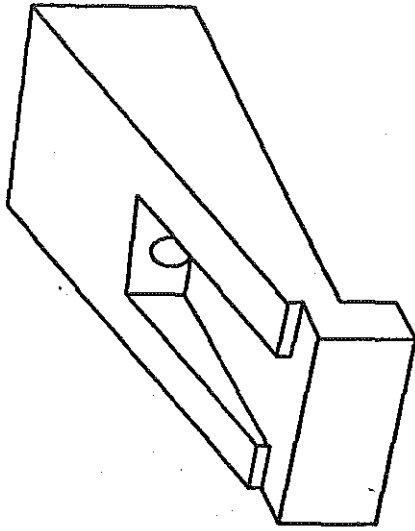
FIGURE 5. CURRENT HEADWALL DESIGN.

The recommended headwall design has an inclined positive flow invert, which will allow the headwall to be placed on a level footing and increase the stability. The centroid of the headwall was moved from the rear to the middle of the headwall, which should help eliminate the backwards settling of the headwall. The outlet was also raised off the base of the invert to allow for some accumulation of debris in the headwall. The current headwall design is shown in Figure 5 and the recommend

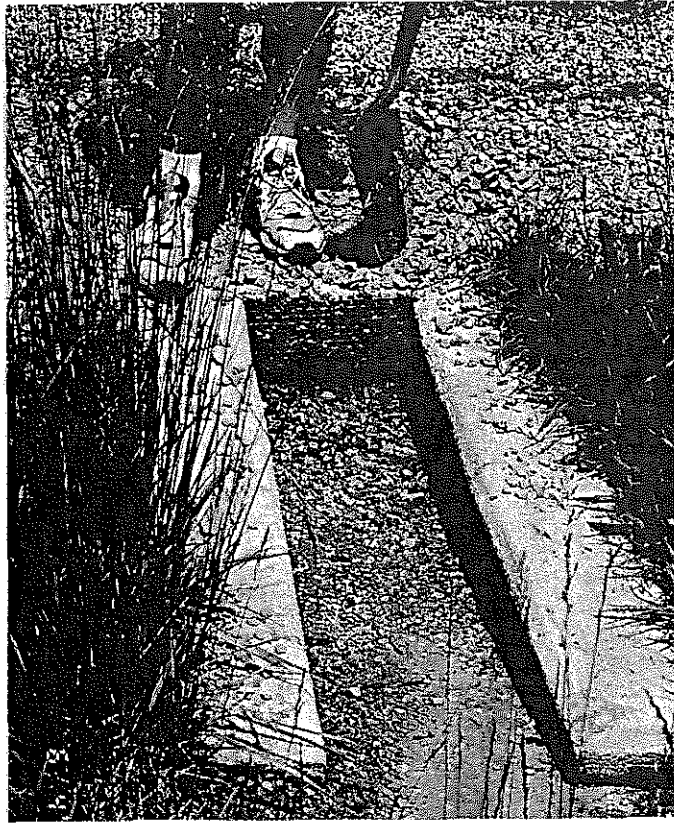
Significant amounts of debris were noted in ends of the outlet pipes and in the trough of the headwalls. Approximately 60 percent of the outlets were clean, 34 percent were partially open, and 6 percent were totally plugged. A significant amount of the material blocking the outlets in the shoulder drains was No. 8 stone which was used to dress outside the paved shoulder (Figure 7). Significant amounts of calcium carbonate were also observed in the headwalls and on the screens (Figure 8). Most of the material blocking median drains was soil and vegetation (Appendix A). It is also apparent from discussion with Federal and State Officials that several of the outlets had been cleaned prior to the investigation.

FIGURE 7. GRAVEL PARTIALLY BLOCKING OUTLET.

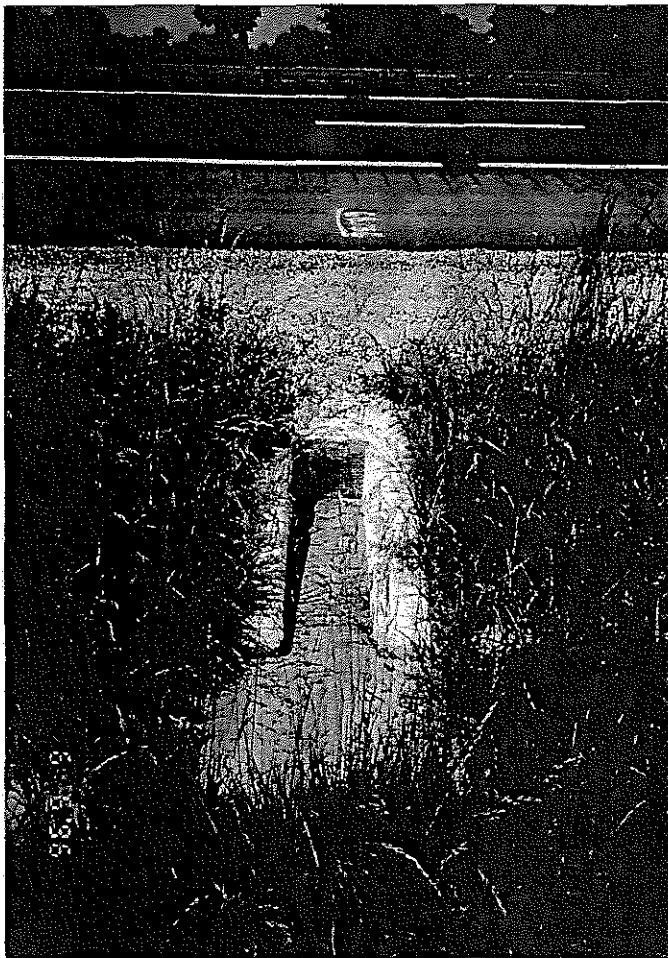
Approximately 12 percent of the outlets inspected did not have rodent screens. Approximately 50 percent of the screens were clean, 32 percent were partially blocked, and 6 percent were completely blocked. A significant portion of the material blocking the screens appears to be calcium carbonate from the broken concrete.

FIGURE 8. HEAVY AMOUNTS OF CALCIUM CARBONATE IN HEADWALL.

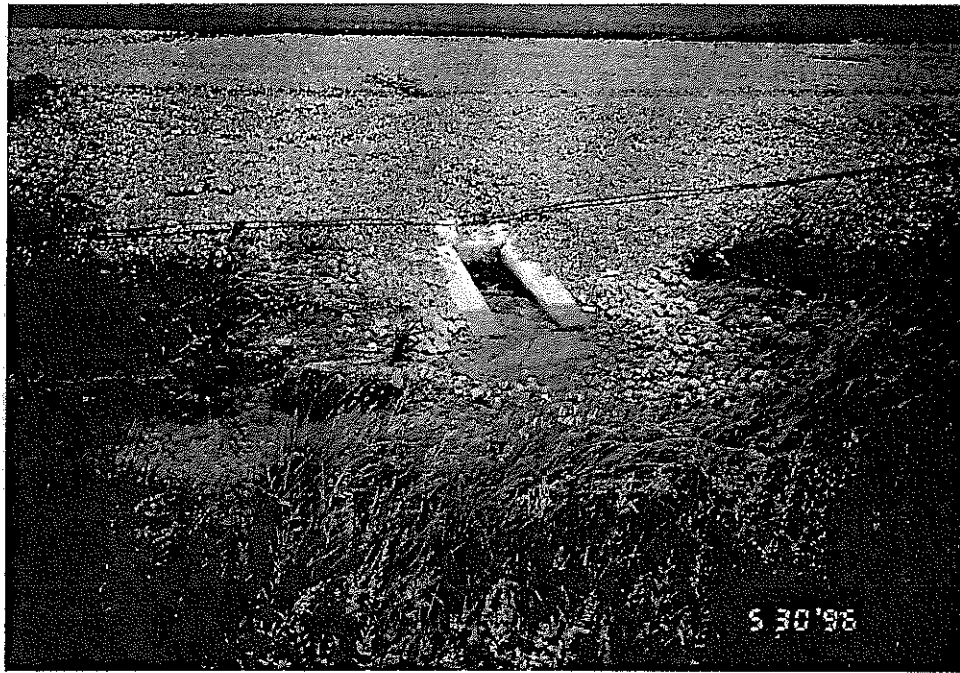
In several areas, the ditch lines were not sufficiently deep to drain the water away from the headwalls (Figure 9).

FIGURE 9. HEADWALL TOO LOW IN DITCH LINE, PARTIALLY UNDER WATER.

It is recommended in cuts that the ditch lines should be under cut. A perforated pipe should be placed in the base of the ditch and backfilled with a permeable aggregate (Figure 22). If there is not sufficient room for the edge drain headwall on the slope, then the outlet should be tied into the pipe in the ditch drain (Figure 23).

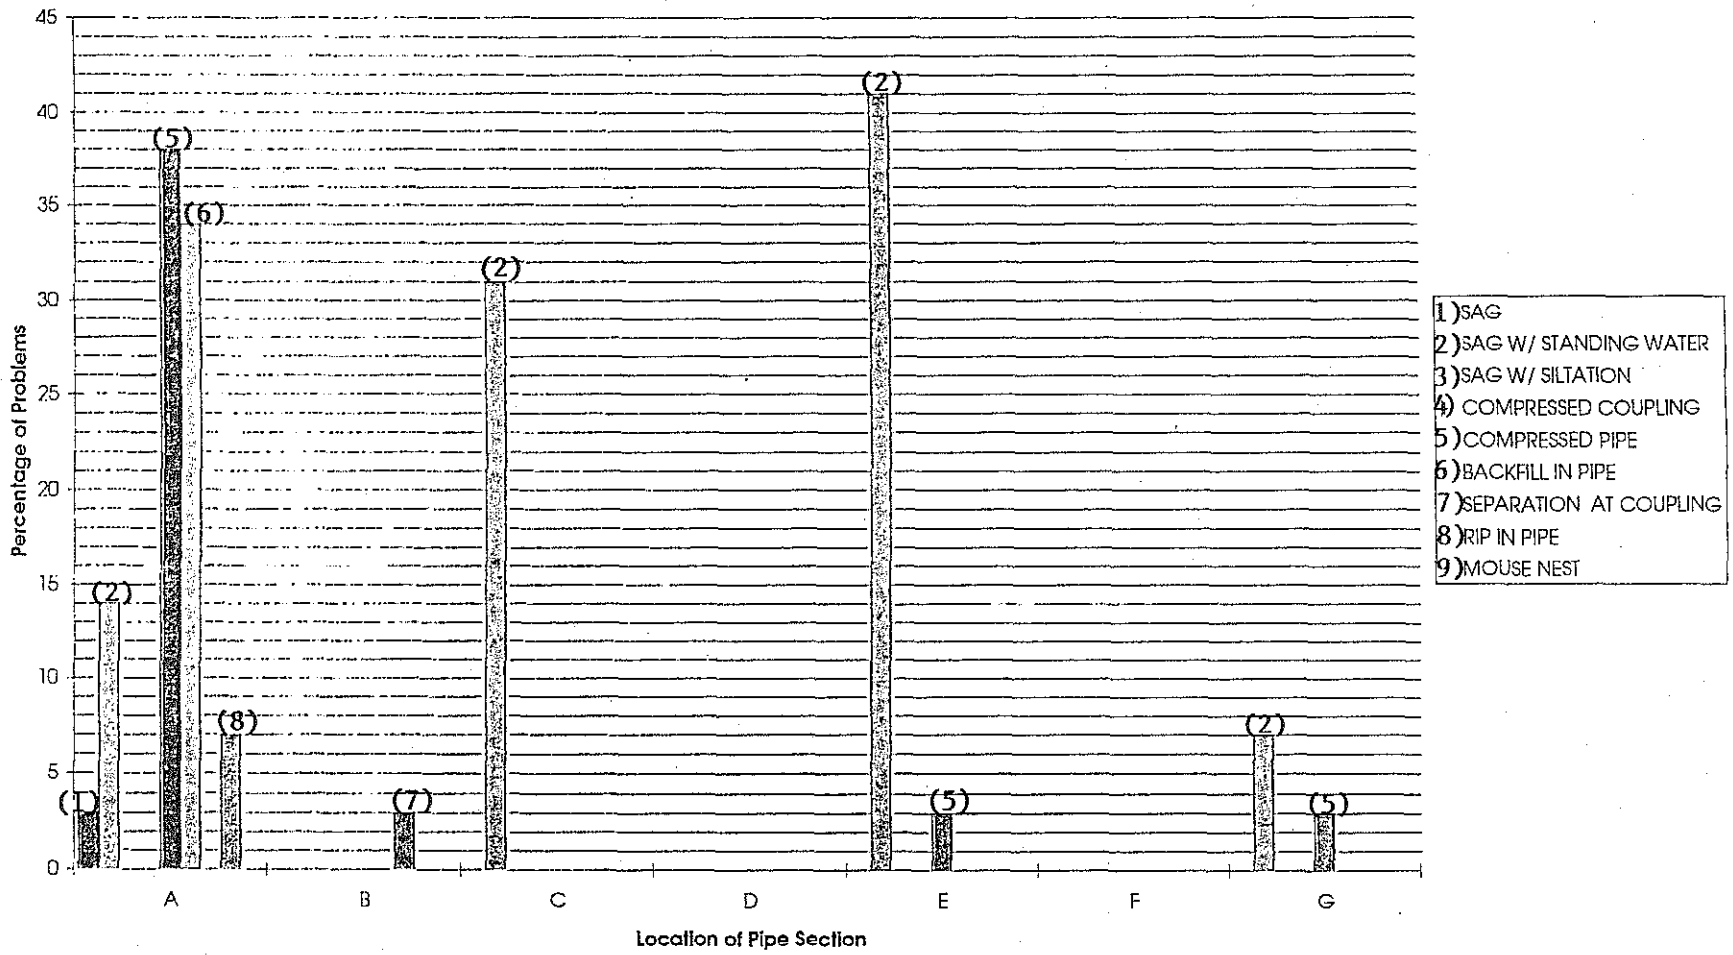
The edge drain outlet pipes were inspected for sags, siltation, standing water, compression, rips, and other noticeable distress. The edge drain system was inspected with a mini camera. The system was divided into sections for inspection and analysis. The assigned outlet pipe sections are shown in Figure 10. Detailed information from the inspection is contained in Appendix B. The inspection revealed that, on the average, approximately 32 percent of the 106 outlet pipes were not fully functional. Significantly more distress was observed on the backside of the headwall than any other place in the outlet pipe system. Table 1 shows the type and frequency of distress recorded in each pipe section. This information is also shown in Figures 11, 12, and 13.

FIGURE 11. PROBLEMS OBSERVED IN EASTBOUND SHOULDER EDGE DRAINS.

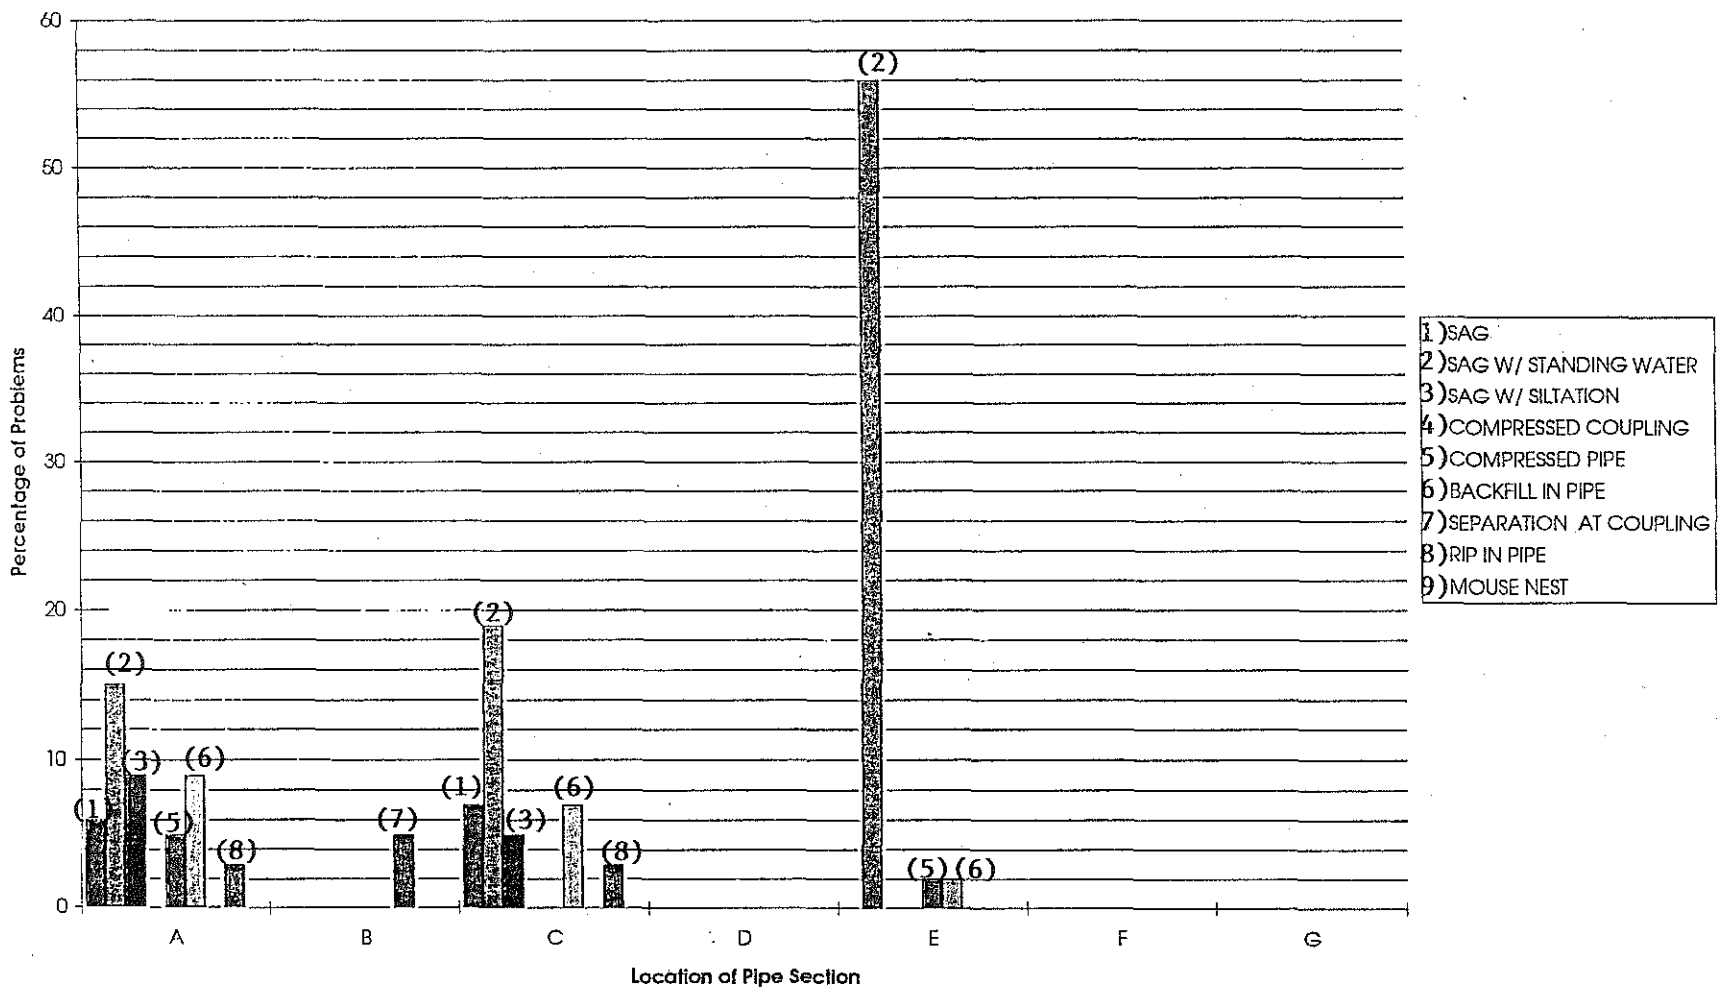
FIGURE 12. PROBLEMS OBSERVED IN WESTBOUND SHOULDER EDGE DRAINS.

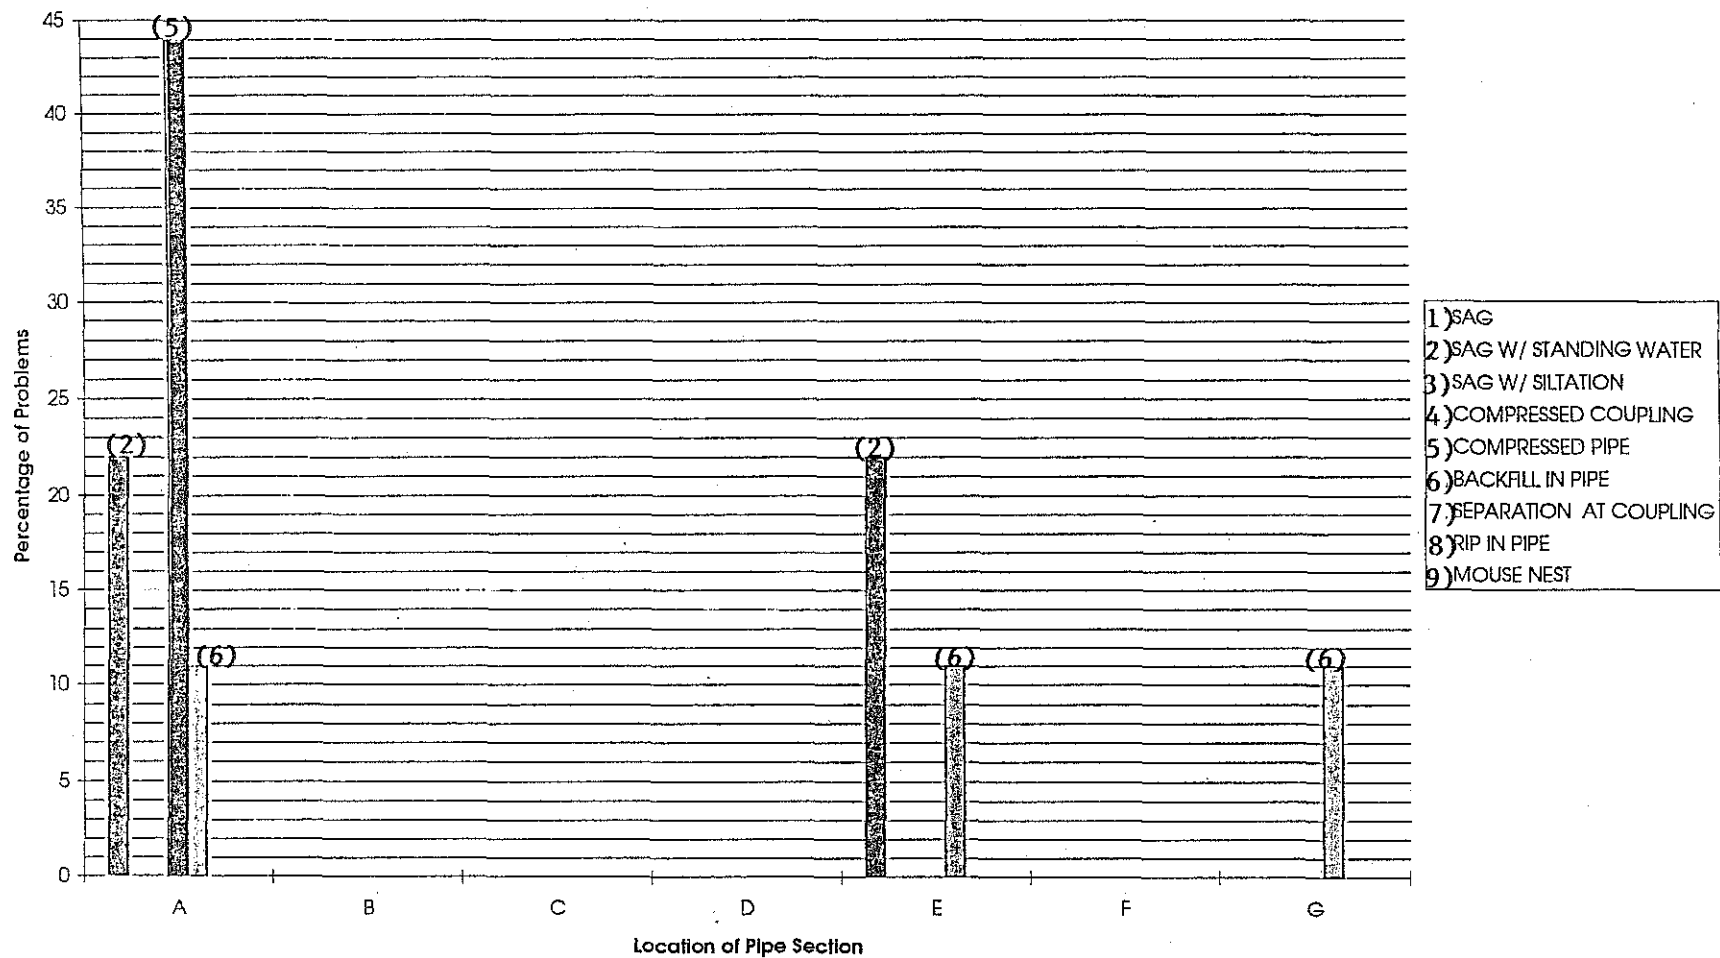
FIGURE 13. PROBLEMS OBSERVED IN MEDIAN DRAINS.

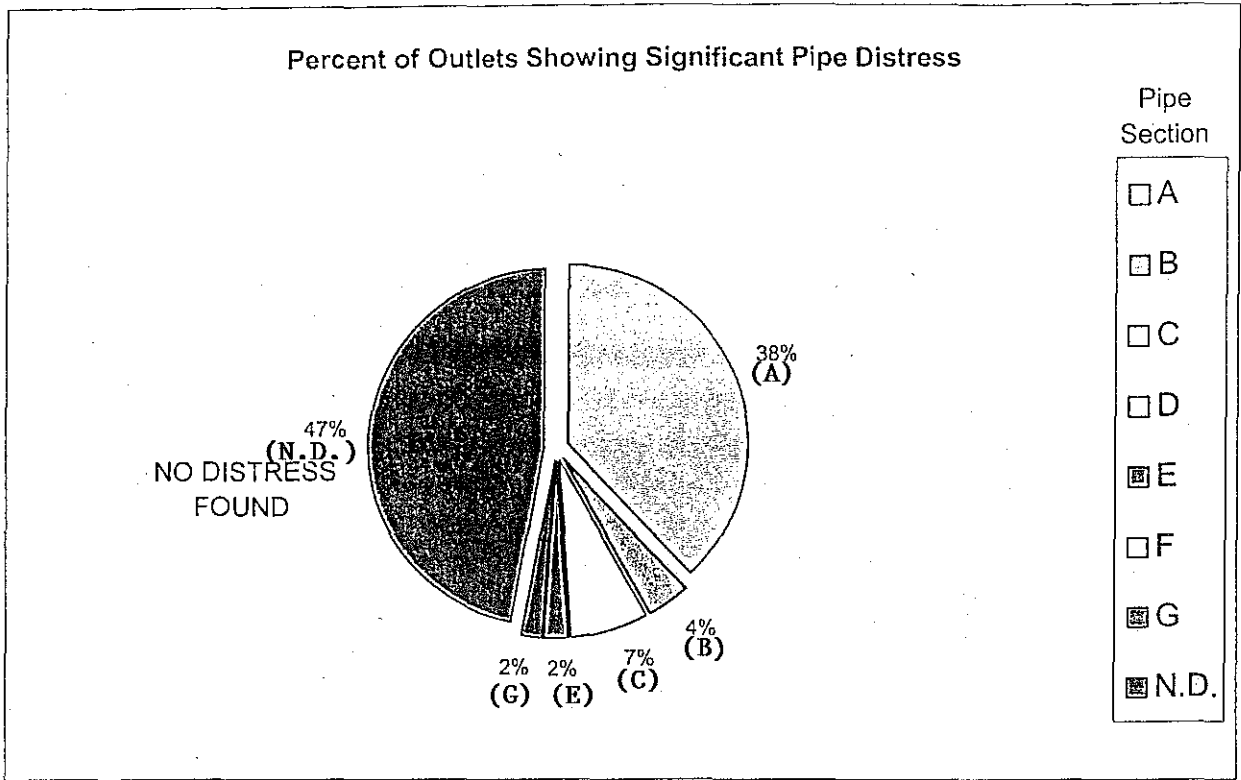
Approximately 38 percent of the significant distress (compressed coupling, compressed pipe, backfill, separated coupling, and rips) that was recorded was occurring directly behind the headwall in pipe sections A (Figure 14).

FIGURE 14. PERCENT OF OUTLET PIPES WITH SIGNIFICANT DISTRESS.

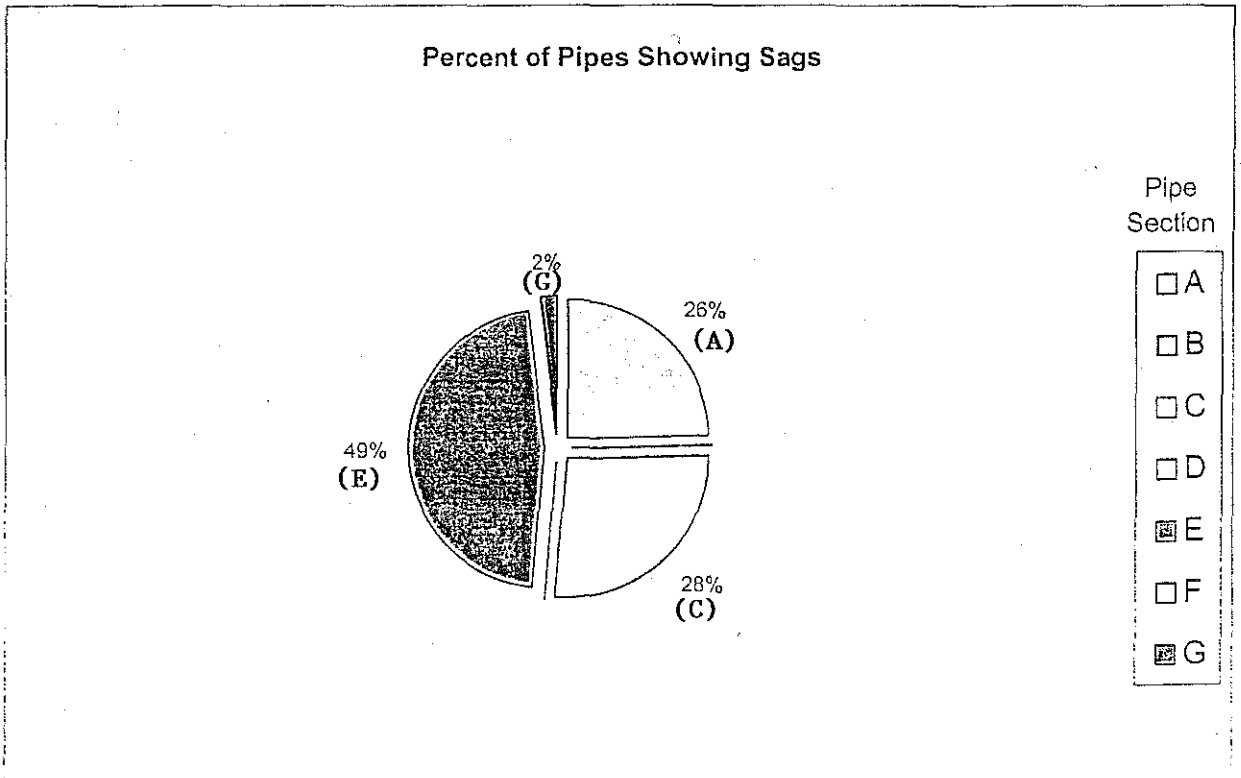
Significant sagging was observed under the asphalt shoulder in section E of the outlet pipe system. This was also observed during the initial construction of the project (Figure 15).

FIGURE 15. PERCENT OF OUTLET PIPES WITH SAGS.

Inspections conducted on the double-wall pipe on several projects indicated that sagging is still occurring. It is recommended that a stiffer landfill grade polyethylene be evaluated for future use by the Kentucky DOH for edge drain outlets.

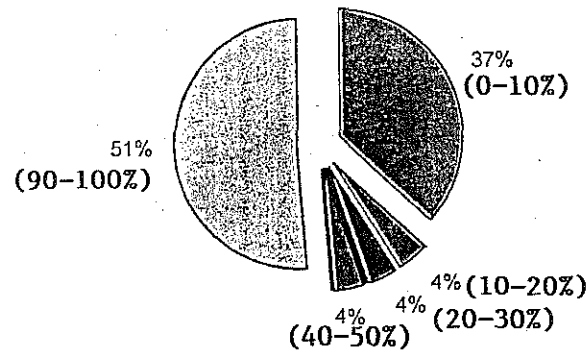
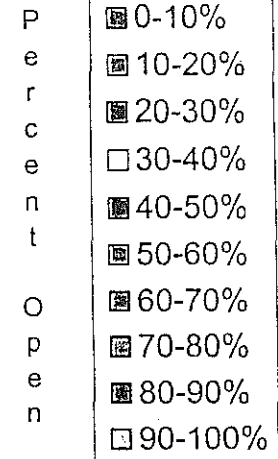
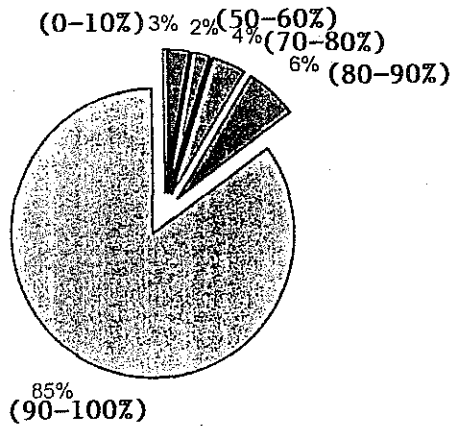
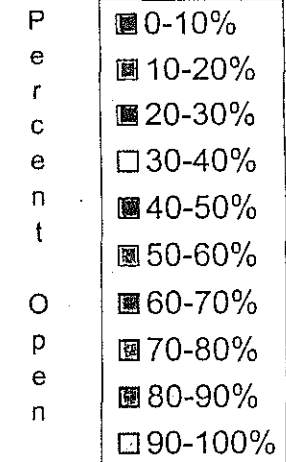
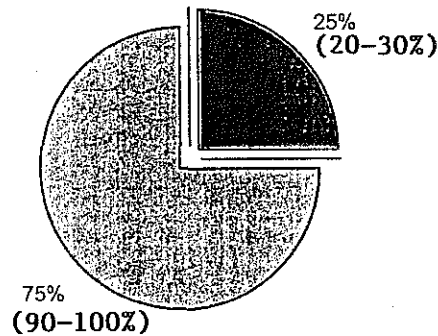
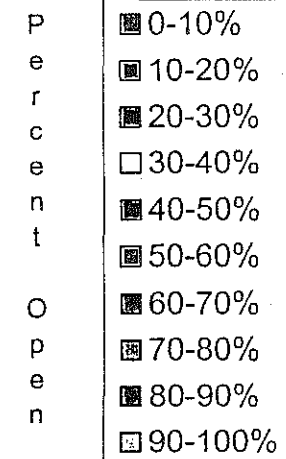
The open area or area available to handle the flow had been reduced considerably in several areas due to vertical compression in the pipe. An estimate of the open area was documented during the inspection. On the average, only 68 percent of the outlet pipes were 90 to 100 percent open (Figure 16).

FIGURE 16. PERCENT OPEN AREA IN OUTLETS PIPES AND 4-INCH PIPE EDGE DRAINS.

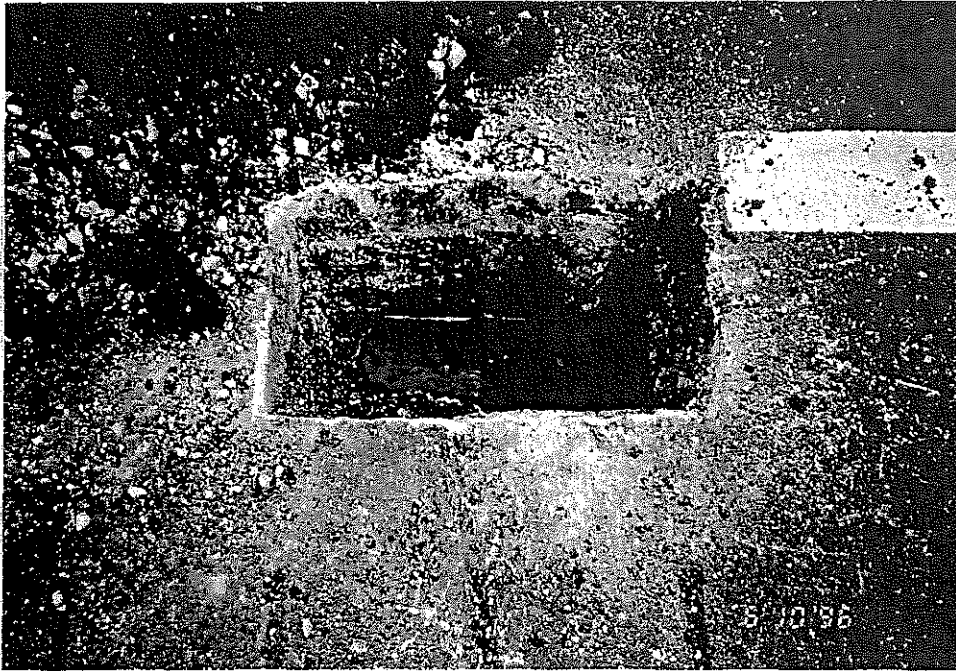
The Hydraway panel drain was excavated in three areas around Milepost 68, in an area where pavement pumping had been occurring. A significant amount of water was observed standing in the pavement at the time of the excavation (Figure 17). At all three sites, the panel had been significantly compressed. It appears that the core area of the drain had been reduced by approximately 30 to 40 percent (Appendix C). The edge drains were inspected after installation and after significant settlement had occurred in the trench shortly after installation. Slight to moderate distress was observed after installation. The panel was inspected in several areas prior to and after break and seating and it appeared that the breaking was not causing additional distress to the panel. At this time, it is uncertain when the additional distress occurred in the panel. It could be isolated areas that were not identified during the previous borescopings.

FIGURE 17. WATER STANDING WITHIN PAVEMENT LAYERS

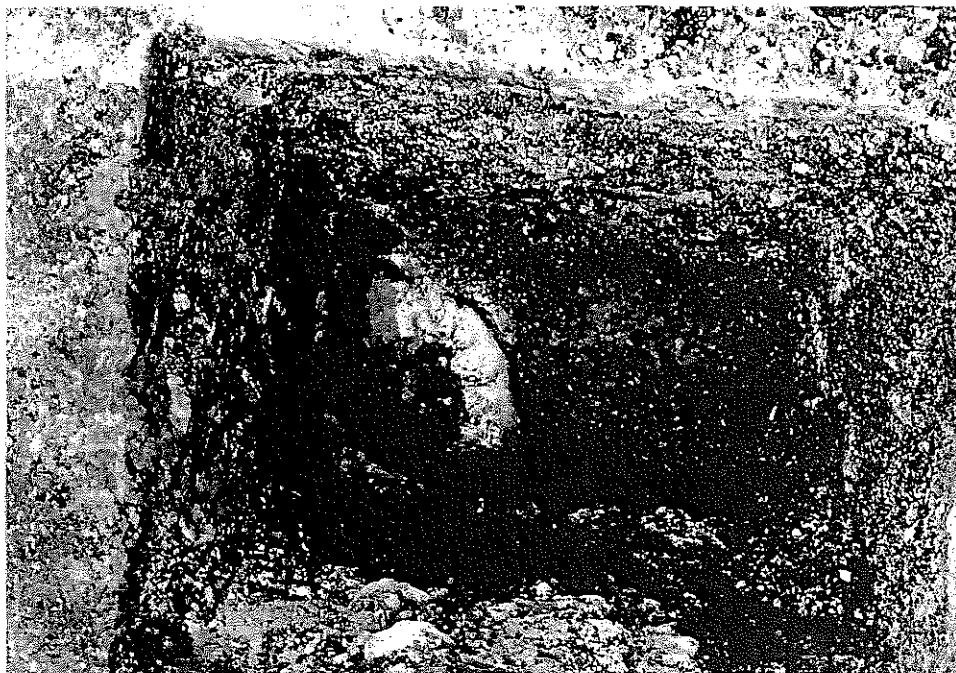
A panel/outlet connection was extracted at milepost 67.916, it is apparent that the panel had been bent ninety degrees to connect to the outlet. The bend in the panel had reduced the flow going to the outlet (Figure 18).

FIGURE 18. BEND IN PANEL AT OUTLET CONNECTION.

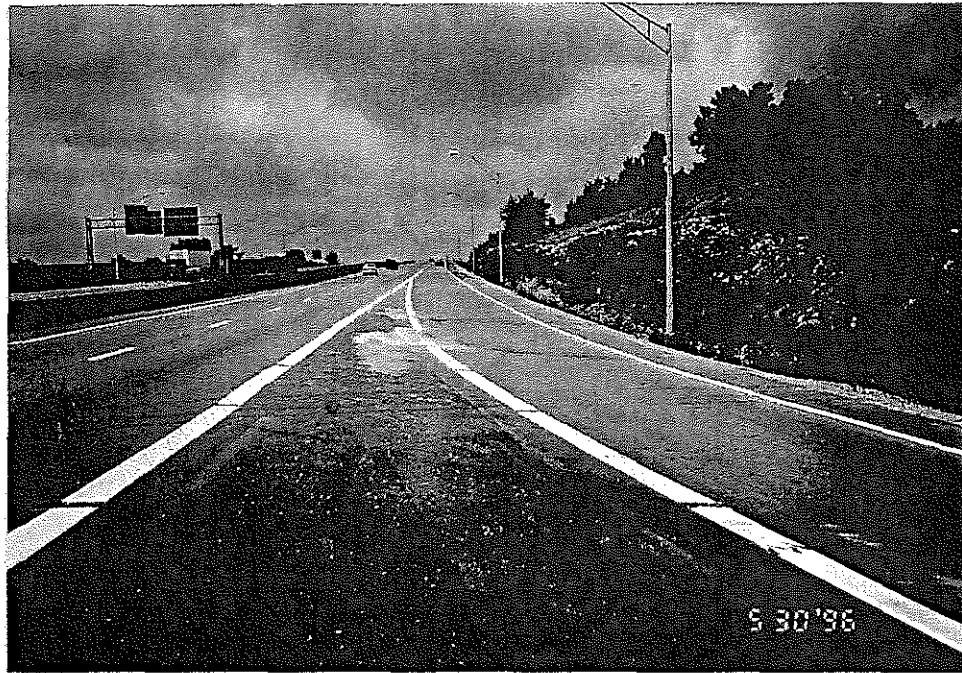
Infrared scans were conducted on the east end of the project at the I-75 and I-64 Interchange. Significant staining was observed between the ramp and the mainline (Figure 19). Figure No. 20 shows a thermal scan of westbound I-64 on ramp. Significantly higher temperatures were observed in the ramp than the two driving lanes. It appears that there is water being held under the driving lanes and it is coming up at the construction joint between the ramp and the driving lane. The contractor and State Officials stated that edge drains were not installed through this area.

FIGURE 19. PHOTO SHOWING DISTRESS ON RAMP, AT I-64/1-75 INTERCHANGE.

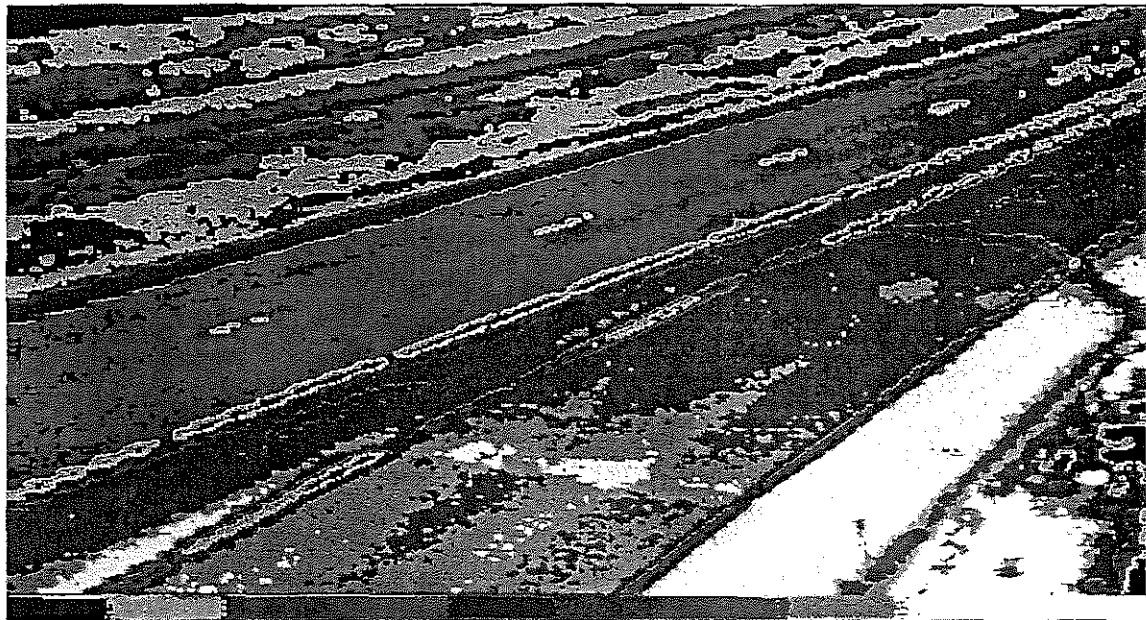
FIGURE 20. INFRARED IMAGE ON RAMP.

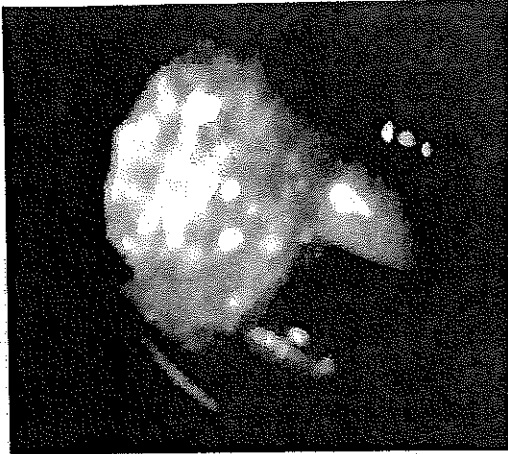
PARTIAL OPEN CORE AREA

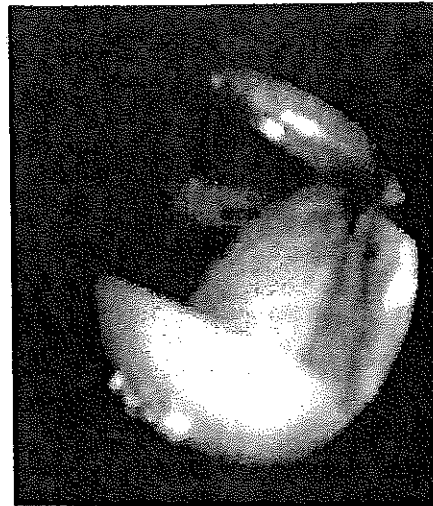
FOLDING AT BASE OF DRAIN

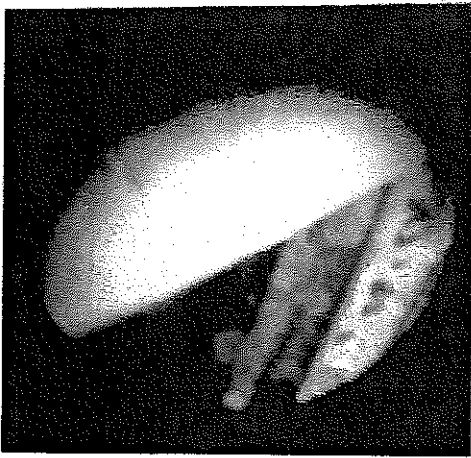
PARTIALLY CORE COLLAPSE

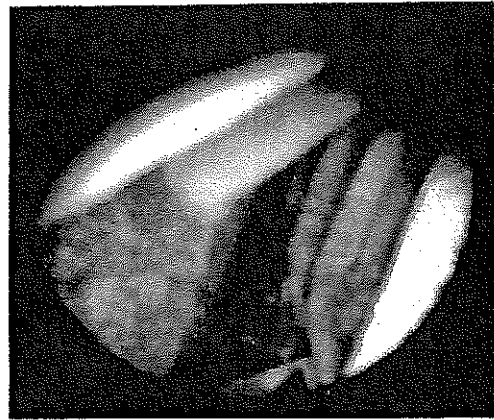
PARTIAL CORE COLLAPSE

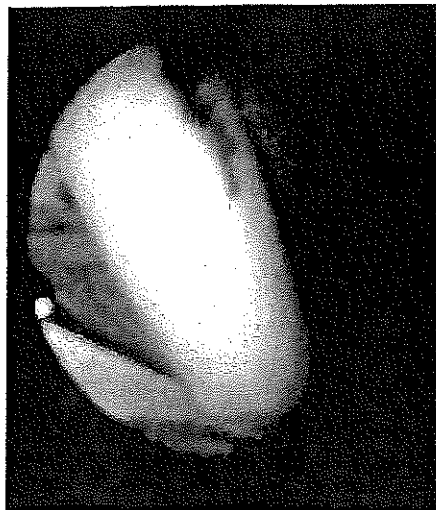
COMPLETE CORE COLLAPSE
