**Research Report
KTC 96-7**

**Environmentally Safe Protective Coatings for Steel
Structures-New Construction and Maintenance Painting**

**Kentucky Transportation Center
College of Engineering
University of Kentucky
Lexington, Kentucky**

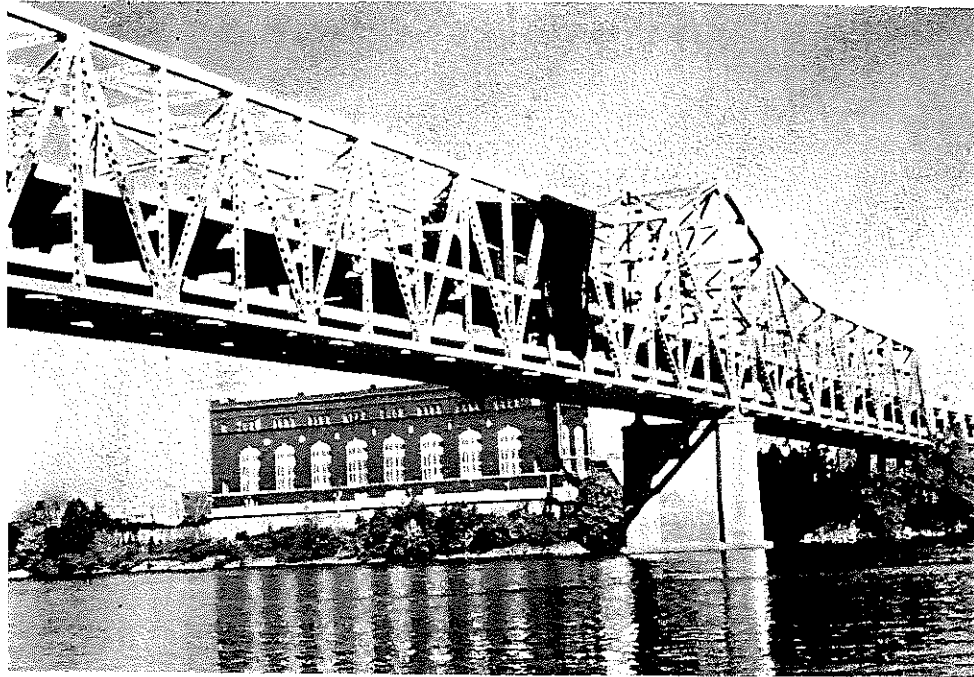
KTC field inspections conducted at both projects revealed operational deficiencies. At the I-75 bridge, large quantities of dust was observed to be leaking at open seams between the wind screens. Several workers on that project experienced high blood lead levels and citations were issued due to improper handling and disposal of abrasive blasting wastes. At the US 23 bridge, dust leakage was also observed at gaps in the seams. The painting contractor on that project complained about high losses of steel abrasives. However, that problem is usually indicative of poor containment practice.

Figure 1. Containment Windscreens Employed on the I 75 Bridge at Covington (1990).

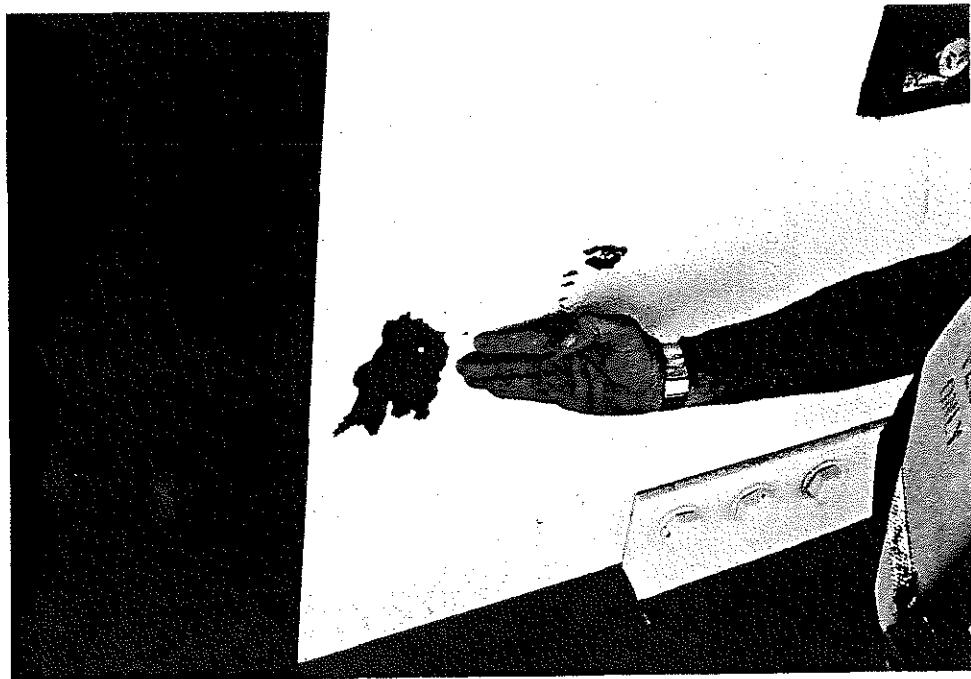
Coating Problems on the US 27 Bridge at Covington - In October 1993, the US 27 bridge was being erected over the Ohio River between Covington, KY and Cincinnati, OH. The superstructure was being shipped by barge from one of two fabrication shops providing steel for the truss superstructure. The steel was shipped with two shop-applied coats, the inorganic zinc primer and the epoxy intermediate coat. The acrylic polyurethane topcoat was to be applied in the field. Inspectors at the job site detected many spot failures of the coating.

KyTC and KTC personnel conducted an inspection at the job site to investigate the problem. They observed what initially appeared to be cases where epoxy was flaking off the inorganic zinc primer at points where the steel had been lifted or incidentally scrapped (Figure 2). Closer inspections also revealed a few failure locations where the inorganic zinc had disbonded from the abrasive-blasted steel substrate. Probing exposed paint edges at failure locations indicated a low cohesive strength within the inorganic zinc. Low tensile adhesion test values at various locations 0.9-3.6 MPa (100-400 psi) confirmed that suspicion. KyTC and KTC personnel concluded that the moisture-cure inorganic zinc primer was incompletely cured when the epoxy was applied.

KyTC officials checked with the fabrication shop inspector who confirmed that the inorganic zinc had passed the curing test (ASTM D-4752, 50 MEK double-rubs). This curing test had been recommended by the fabrication shops prior to the onset of shop painting and had been incorporated into the contract. In the past, KyTC officials had specified a one-day cure for inorganic zinc prior to application of subsequent coats. Curing had not been a problem with earlier projects as that application of the top coat was commonly field-applied providing a suitable curing time.

Figure 2. Coating Failure on New Construction Steel on the US 27 Bridge at Covington (1993).

KyTC officials determined that incomplete curing of the inorganic zinc should not result in further problems beyond those incurred at the time of erection. The second shop was notified about the problem. The decision was made to repair the chipped paint after all of the bridge steel was erected, prior to topcoating.

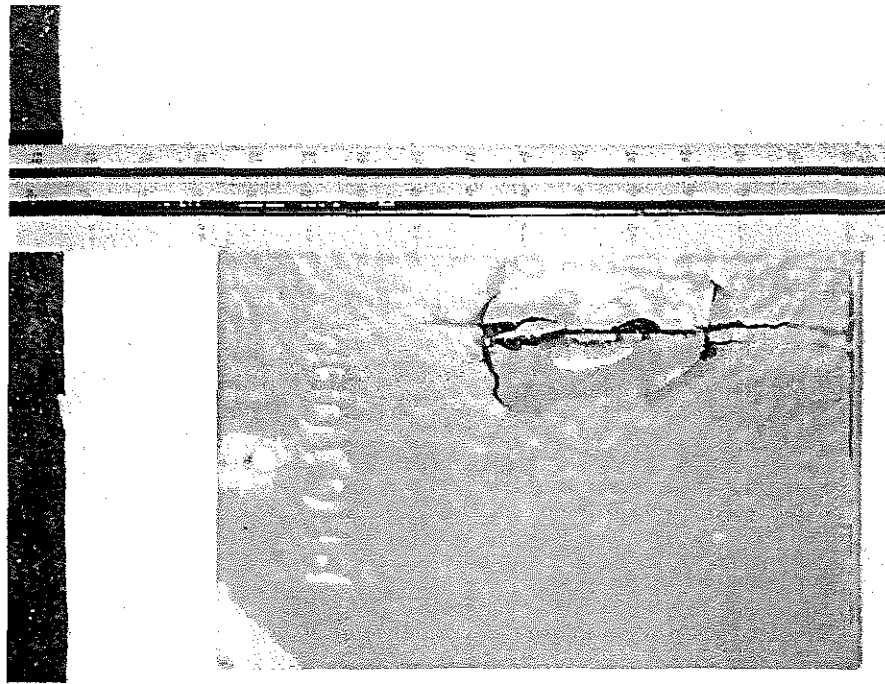
Tests results revealed that all of the new construction specimens passed. However, 2 of the overcoating systems passed with the others failing by rust undercutting (Figure 3).

The failure mechanism of the overcoating systems raised two concerns about those tests. An abrasive blasted substrate is rational for the new construction systems as it represents the actual substrates employed by that category of coatings. However, mill scale substrates do not reflect the primary substrate encountered in overcoating. About 90-95 percent of the paint applied on an overcoating project will be placed directly over existing paint. The remaining coverage may be over either exposed mill scale or rust.

Figure 3. Accelerated Corrosion/Weathering Overcoating Specimen that Failed by Undercutting at the Scribe (1996).

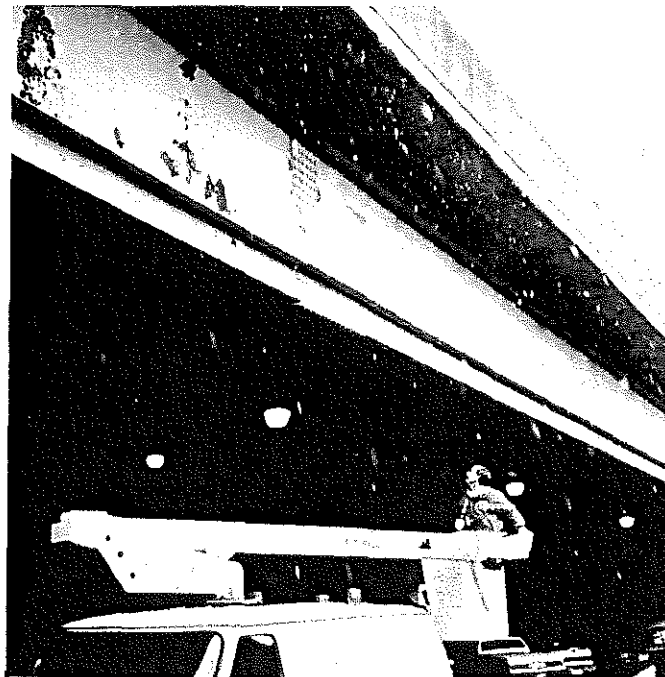
Test patches were subsequently applied on the exterior portion of a fascia girder of the I-65 expressway near Preston St (Figure 4). The weather was cold, about 2 °C (36 °F) with light rain and snow flurries. The existing lead paint on the fascia girders was weathered with spot corrosion. The paint thickness measured between 225-300 microns (9-12 mils).

The corroded areas were power-tool cleaned with a wire cone brush on a grinder and the areas to be painted were cleaned by dry wiping. Two separate patches with areas of about .18 m² (2 ft²) were applied, one with a brushed-on coat of an experimental aluminum-pigmented moisture-cure polyurethane primer between 75-100 microns (3-4 mils) thick and the other with a brushed-on coat of an experimental zinc-pigmented moisture-cure polyurethane primer between 50-200 microns (2-8 mils) thick.

Figure 4. Completed Field Exposure Test Patches on the I-65 Expressway at Preston Street in Louisville (1992).

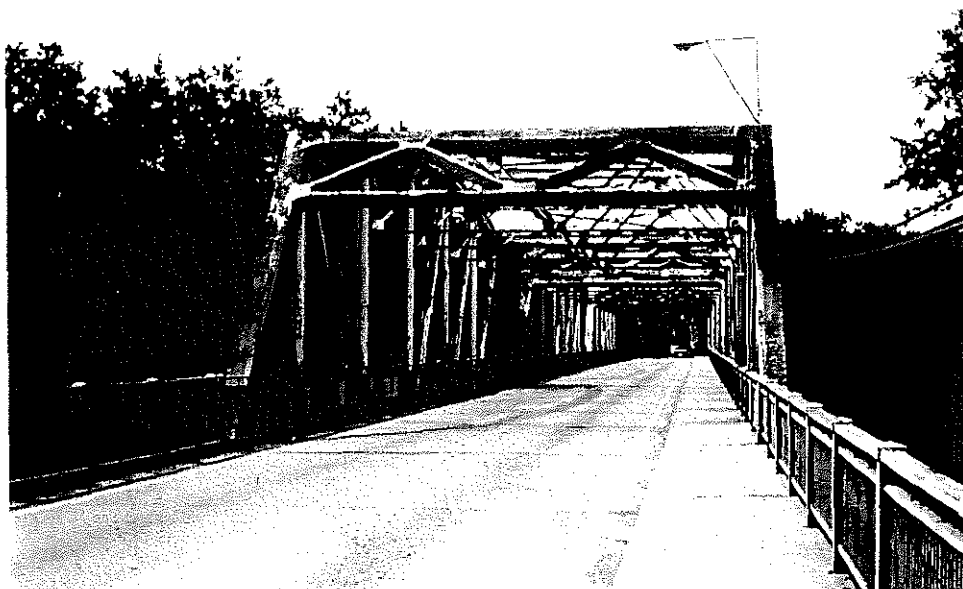
Figure 5. Initial Condition of the KY 177 Bridge Showing Severe Weathering of the Alkyd Topcoat (1992).

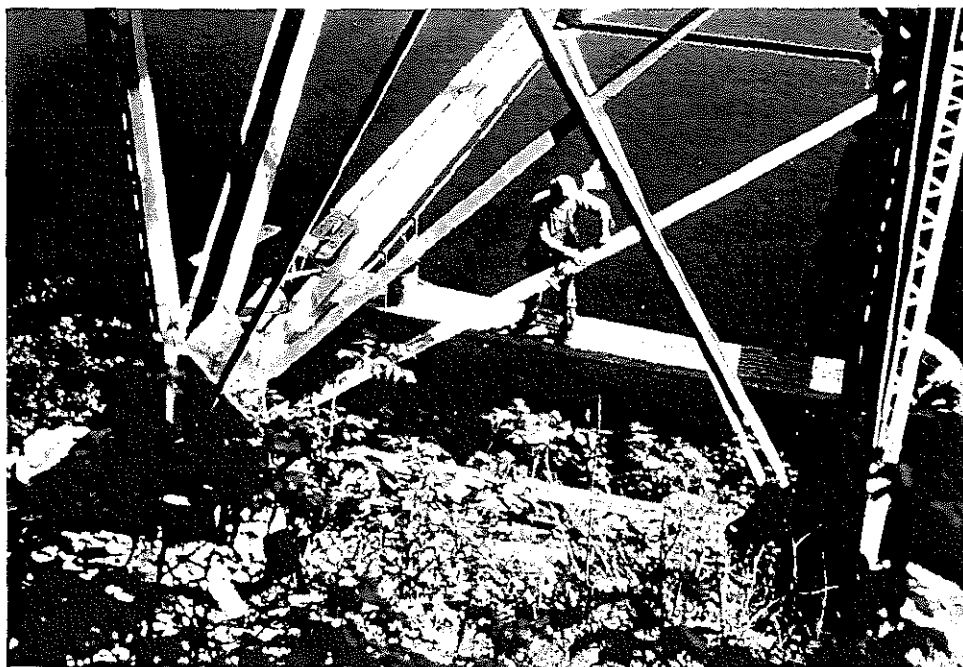
Figure 6. Application of Overcoating System on the KY 152 Bridge by Rolling (1992).

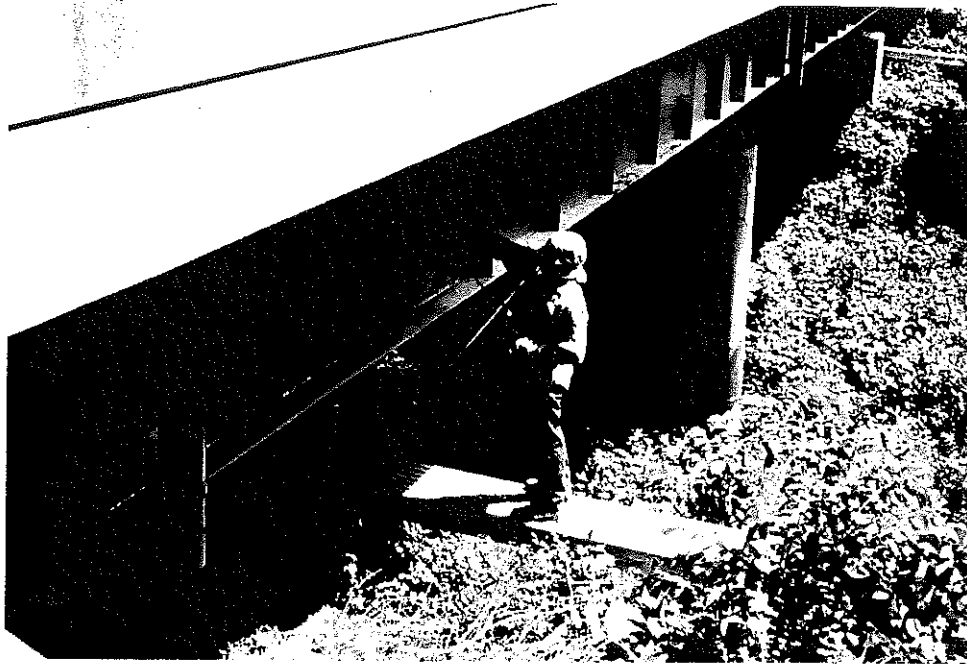
Figure 7. Application of Overcoating System on the KY 728 Bridge by Spraying (1992).

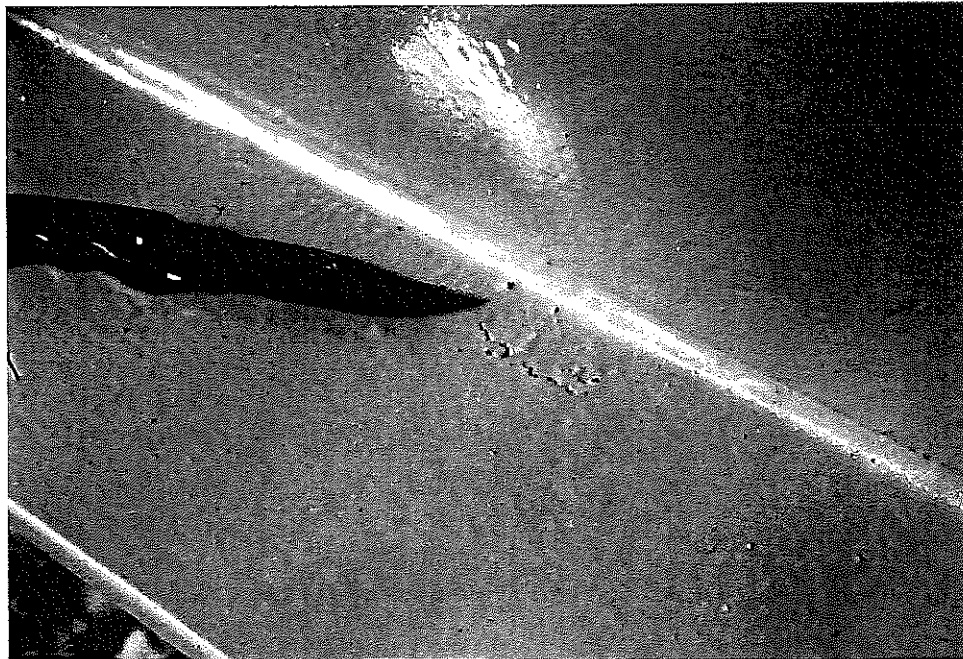
Figure 8. Lifting Tear Reflected Through Successive Coats of Paint on the KY 728 Bridge (1992).

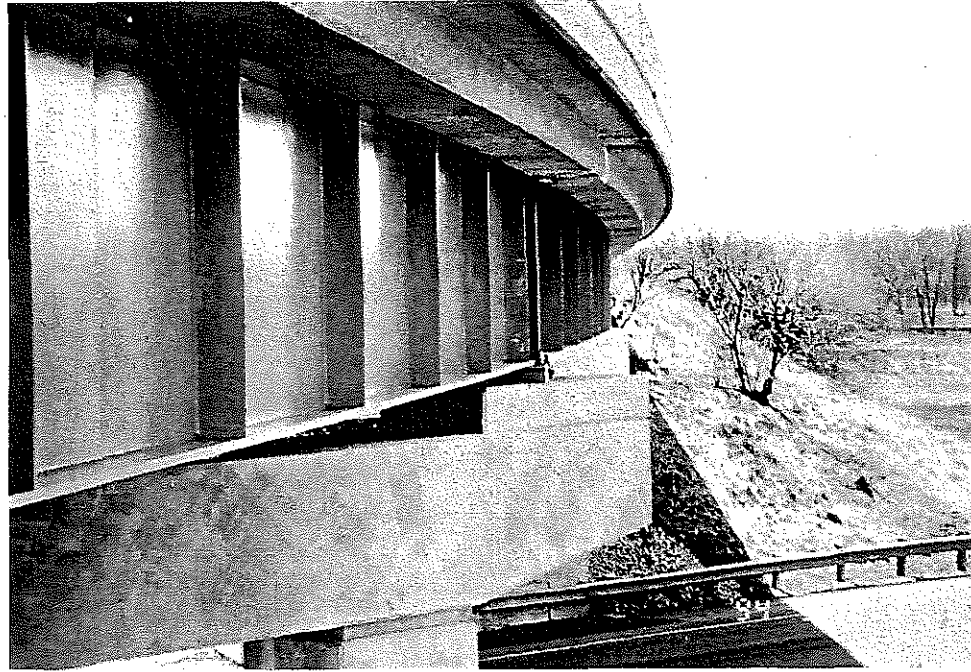
Figure 9. . High-Gloss Polyurethane Topcoat on the Overcoated Bluegrass Parkway Bridge over US 60 (1994).

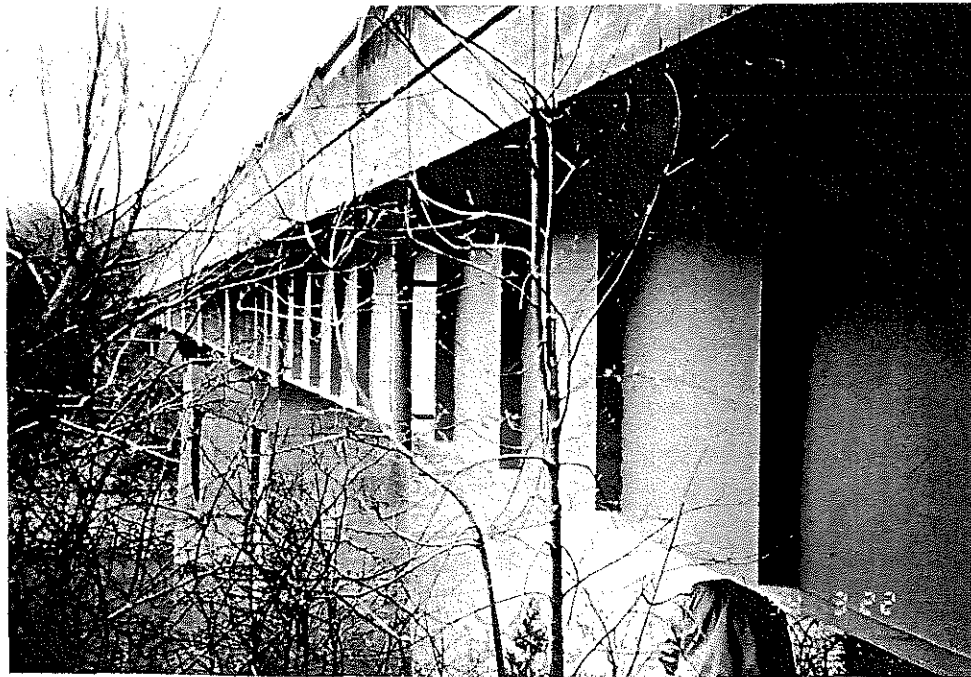
Figure 10. KY 1015 Bridge after Overcoating (1994).

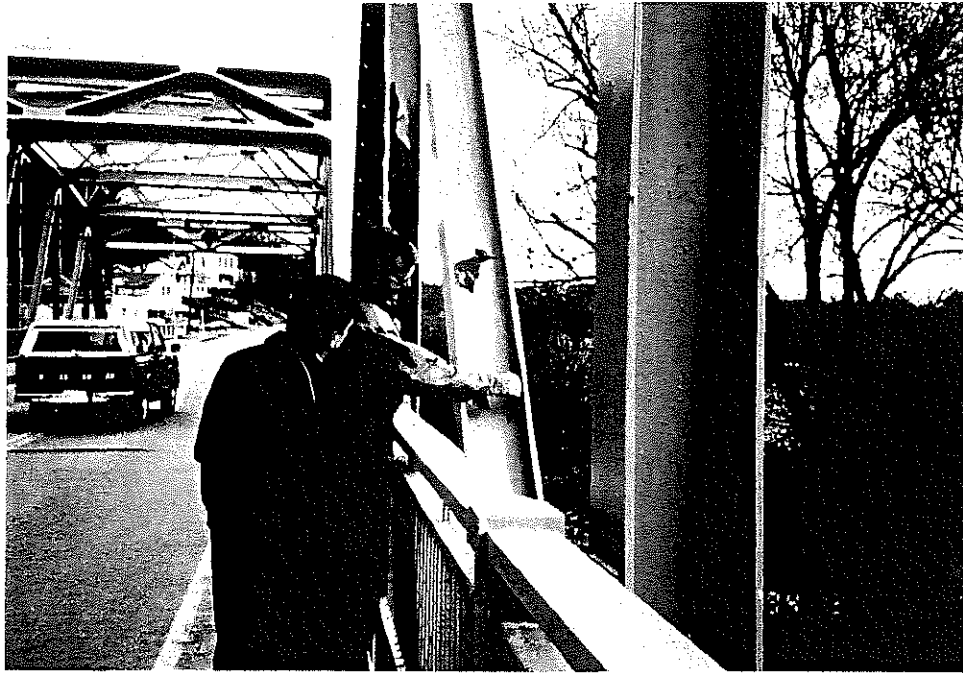
Figure 11. Disbonding Failure of Overcoating System on the KY 177 Bridge (1994).

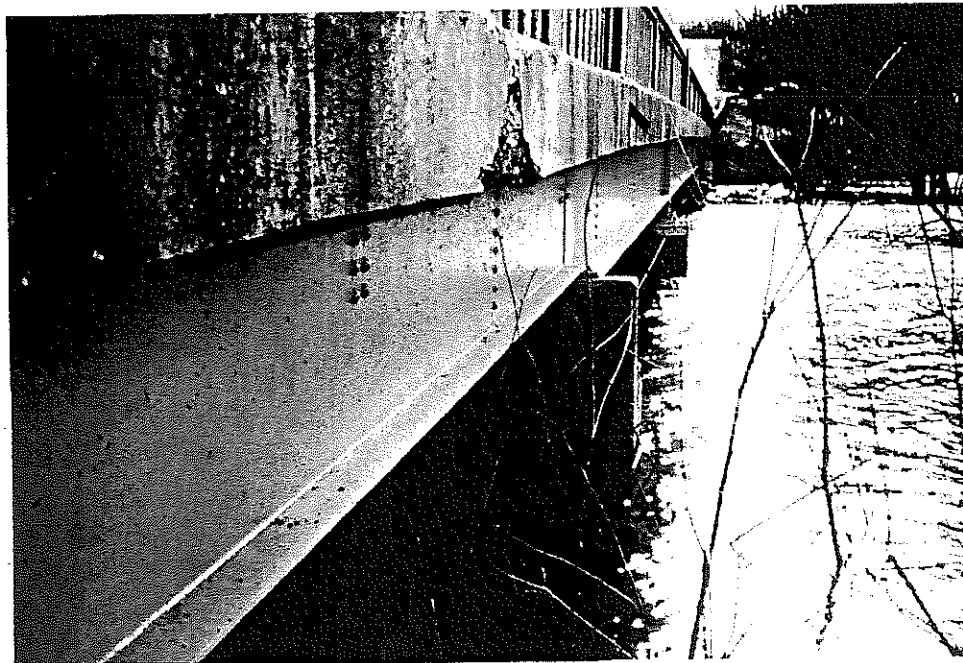
Figure 12. KY 20 Bridge after Overcoating (1994).

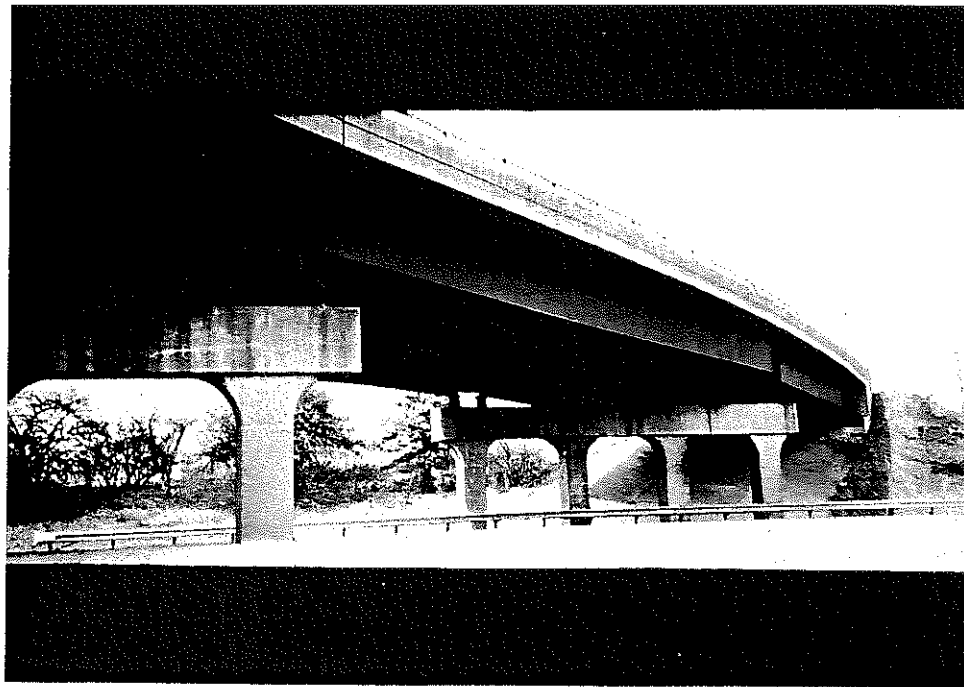
Figure 13. US 25 Bridge after Overcoating (1994).

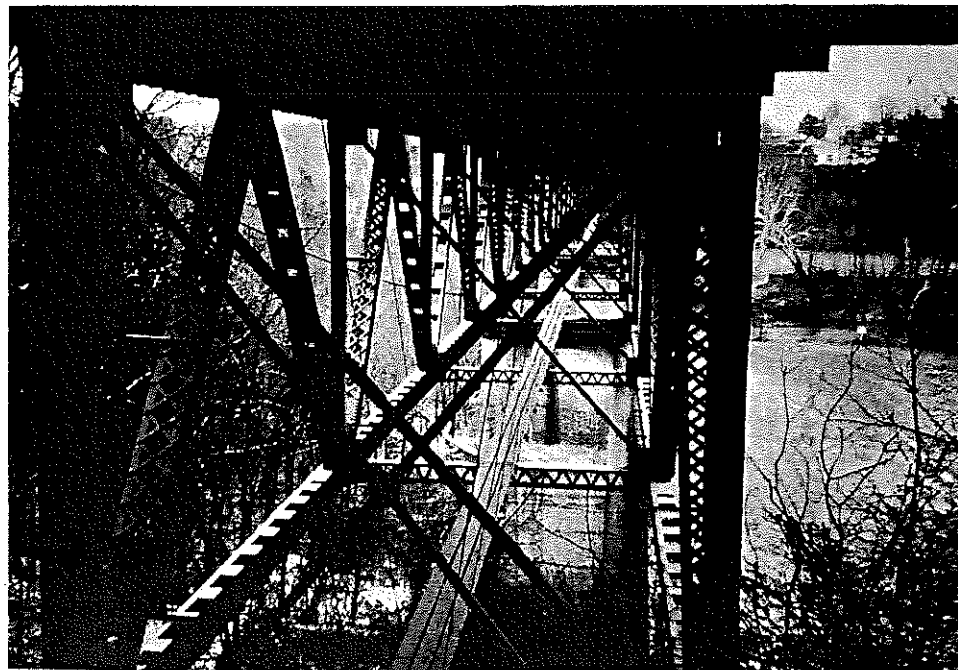
Figure 14. US 31W Bridge after Overcoating (1995).
