Research Report  
KTC-95-2

FIELD PERFORMANCE REPORT  
ON PVC PIPE CAMPBELL COUNTY

The Kentucky Transportation Center was requested by the Kentucky Transportation Cabinet to monitor the field performance of Polyvinyl Chloride (PVC) Pipe on KY 9 in Campbell County (Project NO. FSP 019 0009 013-015 C-DE-STPM 0020 (804)).

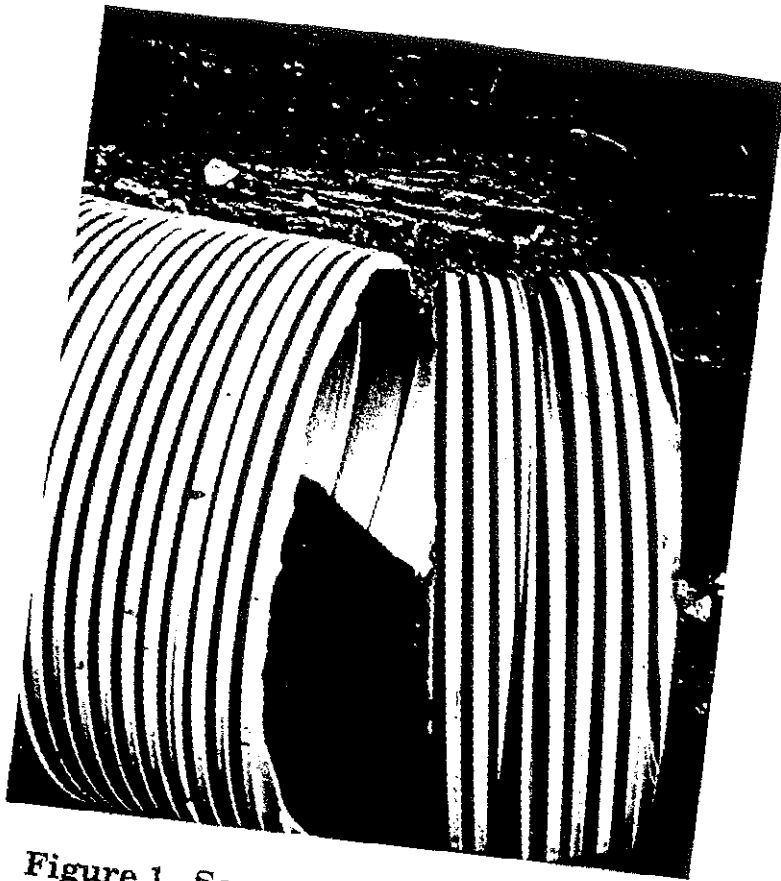
Prior to installation, on December 11, 1992 the PVC pipe was inspected in the stockyard at the construction site on KY 9 shortly after delivery. Approximately 19 out of 65 pipe sections had been slightly to significantly damaged during delivery (Figures 1 and 2). The Resident Engineer indicated that several of the pipes had fallen off the truck during unloading. The pipes were fairly brittle at the time they were being unloaded due to the cold temperatures (approximately  $-9^{\circ}\text{C}$  ( $15^{\circ}\text{F}$ )). Figure 3 was derived from the Uni-Bell Handbook (1) and extrapolated to colder temperatures. Figure 3 indicates the impact strength of the pipe could be as much as 40 percent lower when comparing strength properties at  $23^{\circ}\text{C}$  and  $-9^{\circ}\text{C}$  ( $73.4^{\circ}\text{F}$  and  $15^{\circ}\text{F}$ ).

Figure 1. Severely Damaged PVC Pipe

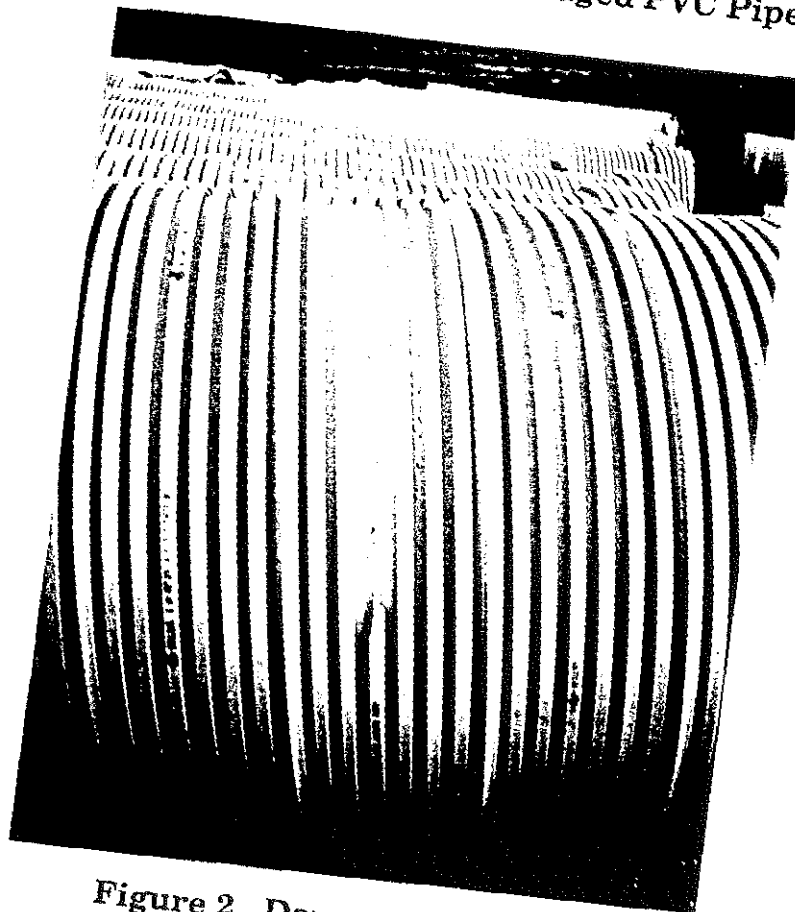
Figure 2. Damaged Exterior Rib

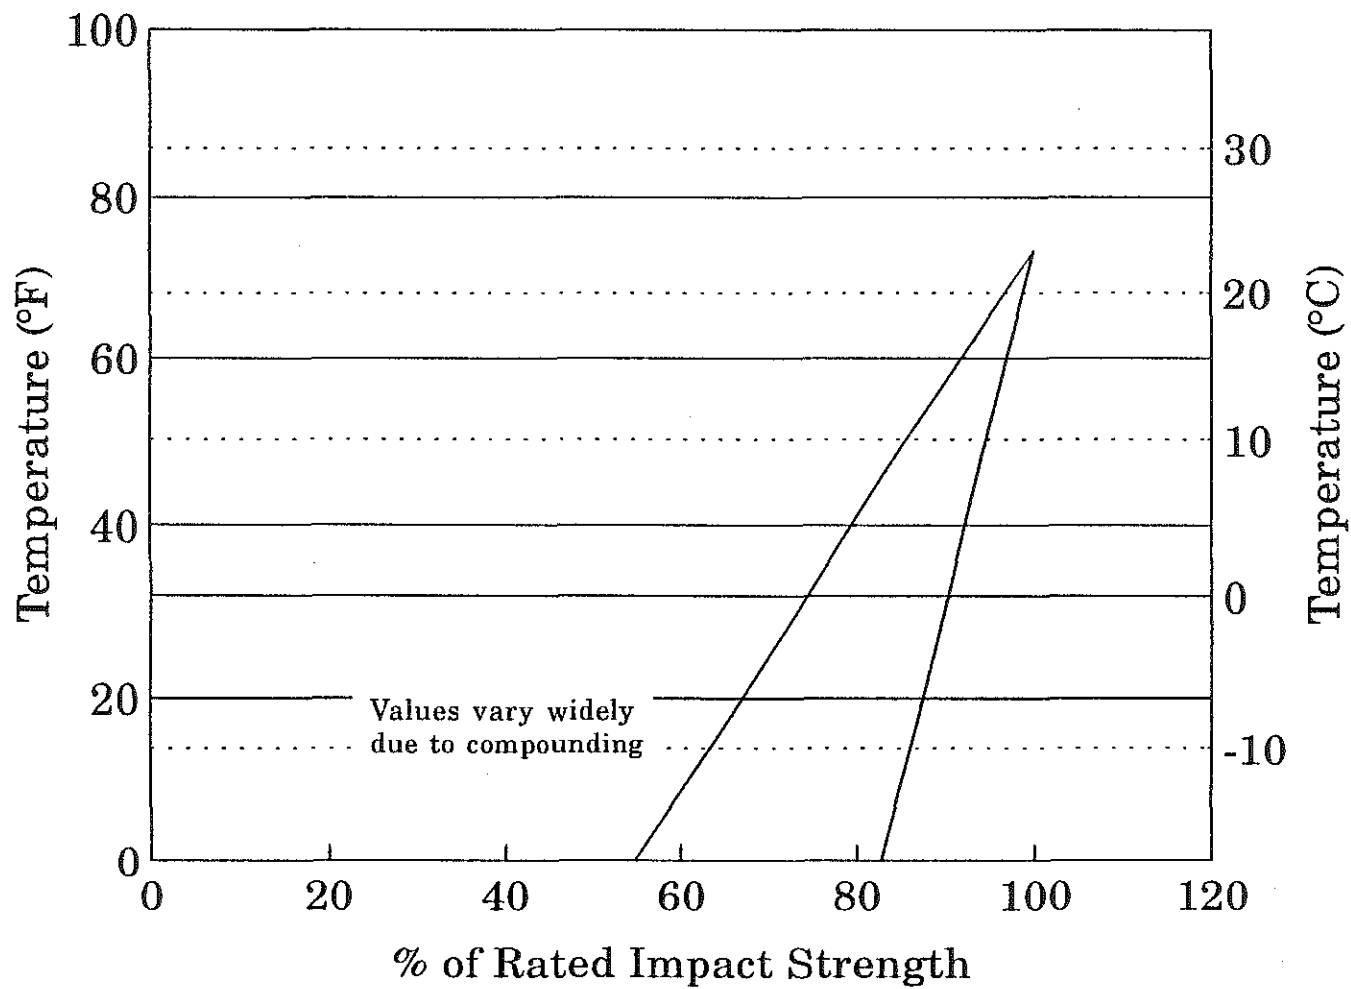
It is apparent the pipe is brittle at lower temperatures, and caution should be exercised during cold weather construction.

Figure 3. Effect of Cool Temperatures on Impact Strength of PVC Pipes

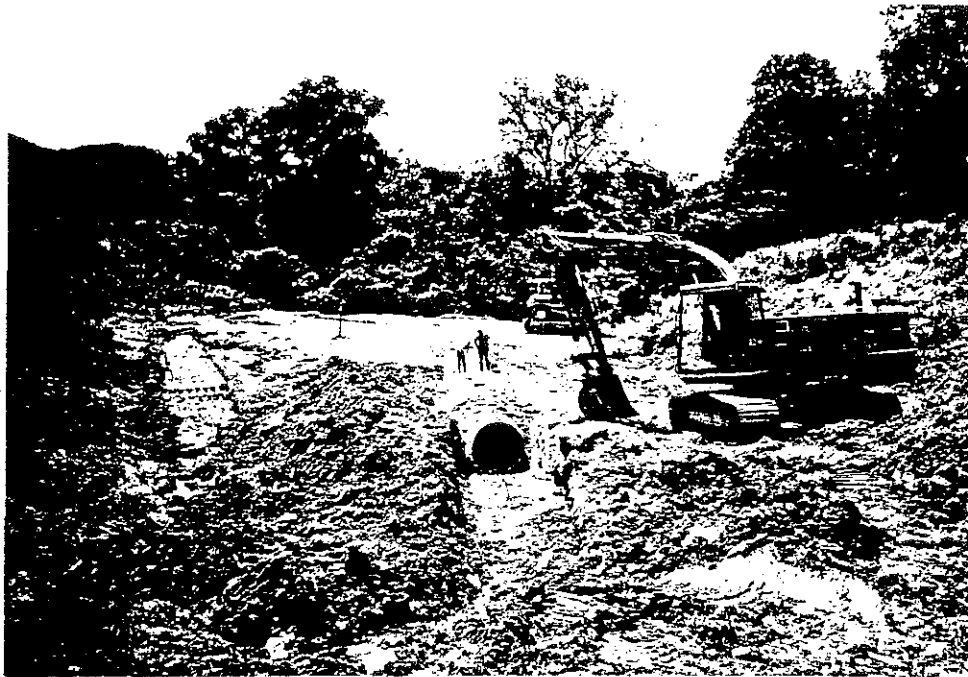
**Figure 4. Installation of 1.2m Pipe at Station 104+70**

The construction project was postponed due to unstable embankment conditions and only a portion of the pipes were installed. Prior to the project being postponed, six cross drains had been installed. The pipes were backfilled with a clean sand slightly over the crown of the pipe (Figures 4 and 5). Since the final fill elevations were not achieved, the fill heights were established by survey (Figure 6). The maximum fill height obtained during construction was approximately 4 meters (12 feet) at Station 160+00.

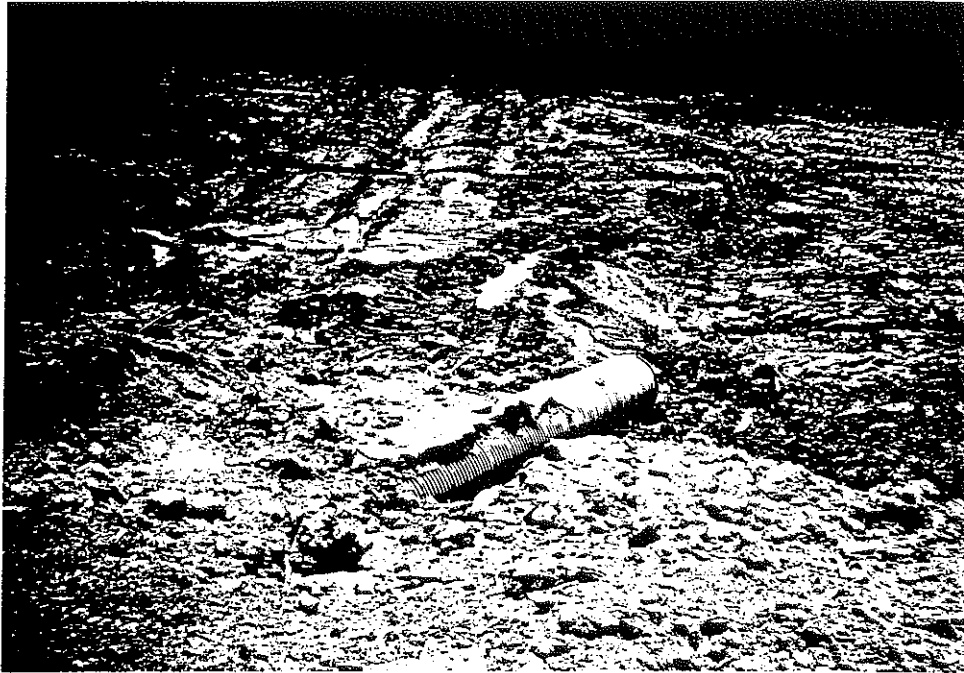
**Figure 7. Outlet End of PVC Pipe at Station 129+72**

The cross drains were monitored during construction, and have been visually inspected several times since installation. The pipes were last inspected in December 1994 with a Cues Mini Camera. A majority of the cross drains appear to performing well. Significant distress was observed in one of the cross drains. The distress was observed in a 0.61 m (24 inch) cross drain at Station 129+72. Distress was observed toward the outlet end of the cross drain. During a visual inspection shortly after installation, approximately 2.4 meters (8 feet) of pipe on the outlet end was unsupported (Figure 7). It was apparent that the pipe had not been cut off and/or the fill around the pipe had eroded. In October, 1993, at a later inspection, it was apparent that this section of pipe had been covered during the reshaping of a sliding embankment (Figure 8). It appears that in this process the pipe was bent down causing the pipe to crack and deflect approximately 8.3 percent (Figure 9).
